***OBSERVATIONS ON OPERATIONS  
OF THE  
PETTIBONE HYDRO-SLASHER PM 800***

***C. Fred Cammack, Mechanical Engineer  
and  
Boone Y. Richardson, Director***

**ED&T 2272 TSI Slash Treatment**

**FEBRUARY 1980**

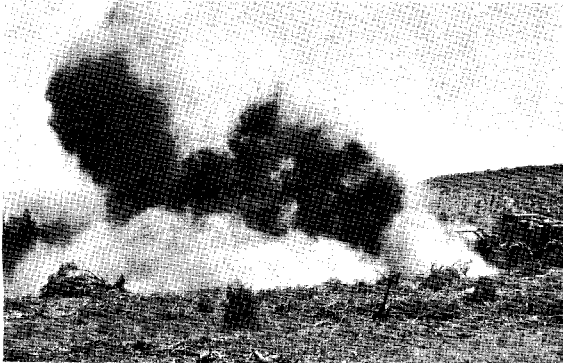
Reverse rotation is a safety hazard to nearby personnel because the material is thrown up to 100-ft high and 200 ft in front of the machine (fig. 3). For operation in juniper, this was not considered a problem. The direction of rotation did not appear to make a significant difference in end results. However, the operator preferred reverse rotation because visibility problems were less when debris and dust were thrown away from the machine.

**Figure 3.** Machine operation during Site 1 treatment using reverse rotation of the reduction head.

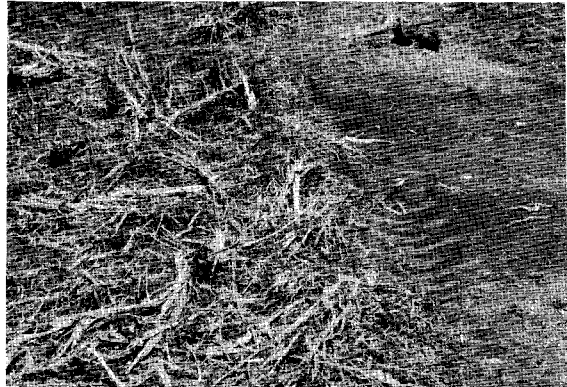
Treatment resulted in minimum surface disturbance and left a light litter cover plus stems and chunks (fig. 4). Observers generally commented that the amount and size of material left on the ground was good. Some indicated a preference for heavier treatment and the head was operated in contact with the ground for a short distance to check out this idea. The result was a scalping action that removed the top layer (2 in) of soil and was considered unacceptable (fig. 5). Measurement of the

**Figure 5.** Comparative treatment strips on Site 1. The strip on the right shows the result of dipping the reduction head into the ground. The strip on the left resulted from operation approximately 2 to 4 inches above ground.

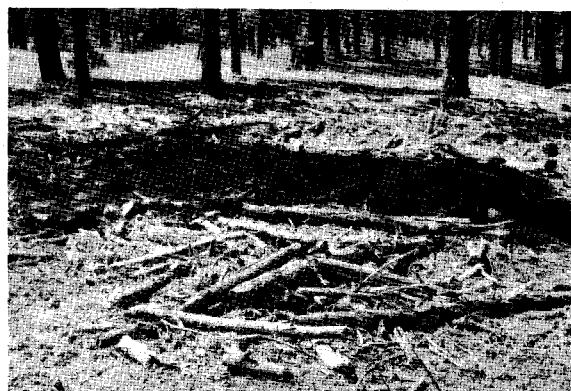
**Figure 10. Aftermath of pile treatment on Site 4 using reverse rotation of the reduction head. Note the larger materials are scattered but not broken up well.**

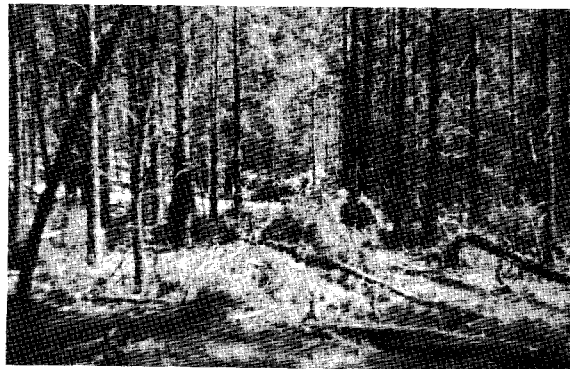
The machine was unable to maneuver after entering the stand so a decision was made to limit operation to strip thinning. Single pass treatment was not satisfactory (fig. 18).

All of the reasons for poor performance were not determined as a hydraulic hose failure stopped the operation after completion of three strips of less than 50-ft length. Operation of the push bar, drop in rotor rpm, apparent lack of power, and jamming of flails all contributed to failure to achieve the treatment objective. Other factors and the relative importance of these were not determined.

Figure 18. Aftermath of strip thinning attempt on Site 7.

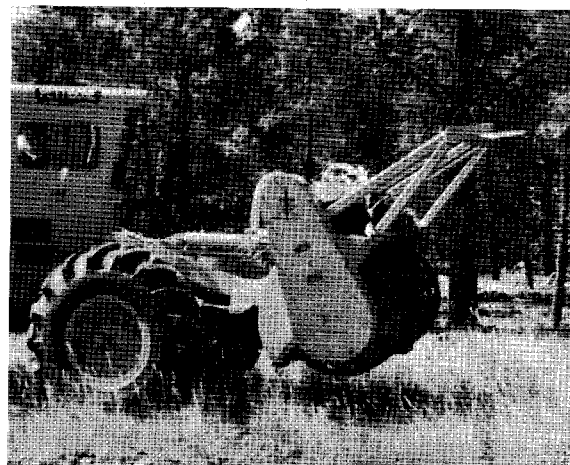
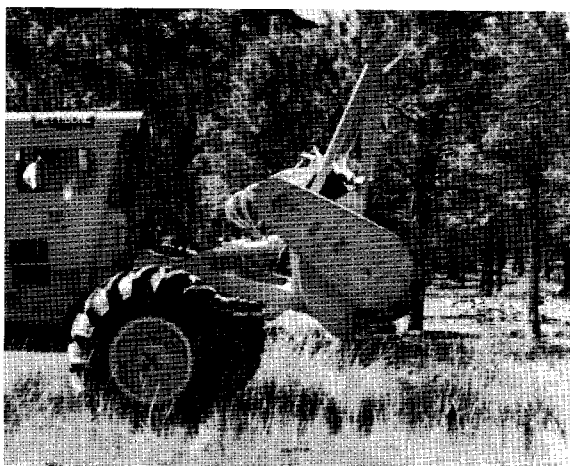
The rotor carriage assembly can be rotated by hydraulic cylinders to vary the distance by which the push bar leads the rotating flails (figs. 19 and 20). The machine was operated in the thick stand with the push bar leading the flails by the maximum amount. The result was bending the stems and actually dozing them over before the flails engaged them. <sup>1/</sup>

Rotor speed dropped when encountering multiple stems and the machine did not appear to have sufficient power for the rotor to recover speed while still engaging stems. This operation differed greatly from juniper stand treatment and pile reduction in that loading on the rotor was continuous while the machine moved forward. Clumps, single trees, and piles permit speed recovery because the load is not continuous.

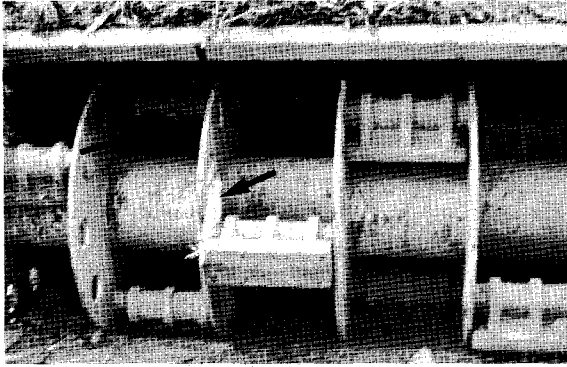
**Figure 21. Flail jammed by a chunk of wood.**

Observation of the rotor after the operation revealed that a number of flails were jammed with wood debris between the flail and the rotor disk (fig. 21). Inefficient treatment and a drop in rpm would result from this jamming. The debris might be thrown free if rpm were kept high, but this could not be determined.

Design of the flails on the reduction head is such that debris builds up on flail surfaces and wedges between flail and rotor drum disks. This causes the rotor to become unbalanced and flails to occasionally jam. This problem did not appear to measurably affect machine production rate, but the rotor unbalance may cause machine maintenance problems and mechanical damage could result, if not corrected.

1. Add air conditioning in the cab.
2. Reconsider the design of machine hydraulic systems to determine cause of excessive pressures in rotor drive components.
3. Redesign radiator to prevent dust accumulation and clogging.
4. Redesign of flails to prevent debris buildup and jamming.
5. Add gauges in the cab to monitor rotor speed and hydraulic oil temperature.
6. Evaluate total horsepower requirement.
