## Moving Small Mountains—Vesuvius Dam Rehab

—Susan L. Peterson, P.E., regional dams engineer, Eastern Region, Bedford, IN

**M**ajor developments below Vesuvius Lake dam in Ohio, US, led to the reclassification of the 70-year old dam to high hazard status. Sue Peterson oversaw the rehabilitation work undertaken to bring the dam up to current standards

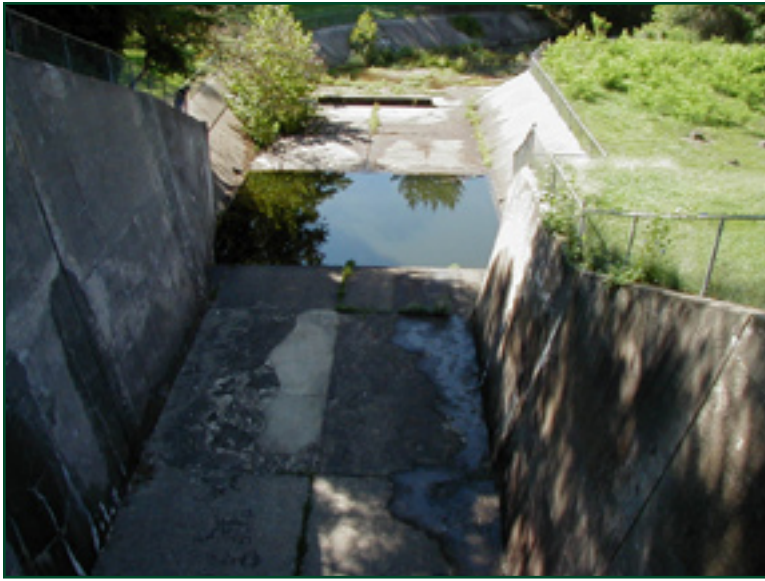
Much has changed in this part of Ohio since 1935. The dam is located about 16km from the Ohio river and two other states; Kentucky and West Virginia. It is within an hour's drive of about half a million people. Major development has occurred downstream of the dam, including the construction of houses, a major highway and a public school. These developments led to the reclassification of the dam to a high hazard status, and it was identified in a 1990 State of Ohio Department of Natural Resources report as being severely undersized. It would pass or store approximately 37% of the design storm volume. The concrete spillway has been patched and grouted a few times over the years (figure 1).

Figure 1 — Stilling basin of spillway before new concrete is installed.

In 1993, an engineering firm was hired to develop alternatives for the rehabilitation of the dam to bring it up to current standards. The selected alternative included providing overtopping protection of the dam by installing roller compacted concrete (RCC) over the whole dam and installing 30cm concrete overlays of the spillway vertical walls and replacement of the floor and sloped walls of the spillway.

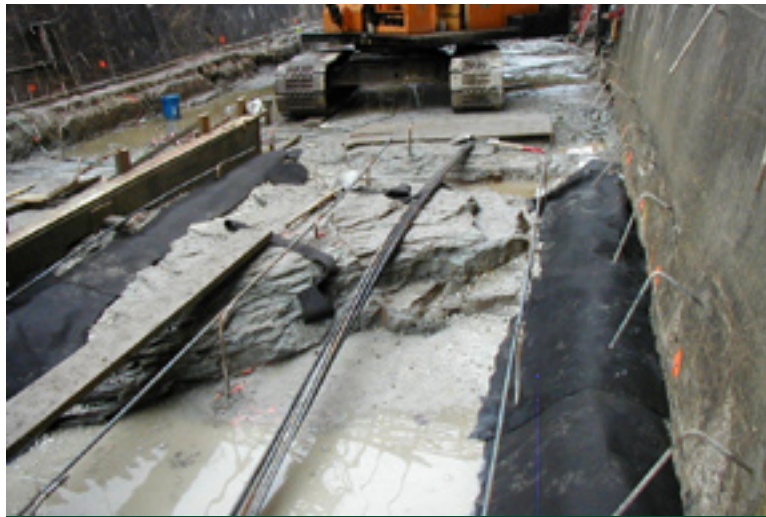
plane and is 3m thick, while the siltstone has soft to moderately hard bedding planes and appears in thin layers. When the soil adjacent to the dam side of the cellular wall was removed, there was very little fracturing of the sandstone and it was suitable for the foundation of the new cellular wall face (figure 2).

Figure 2—Exposed bedrock under the spillway floor with grouted anchor bars installed.

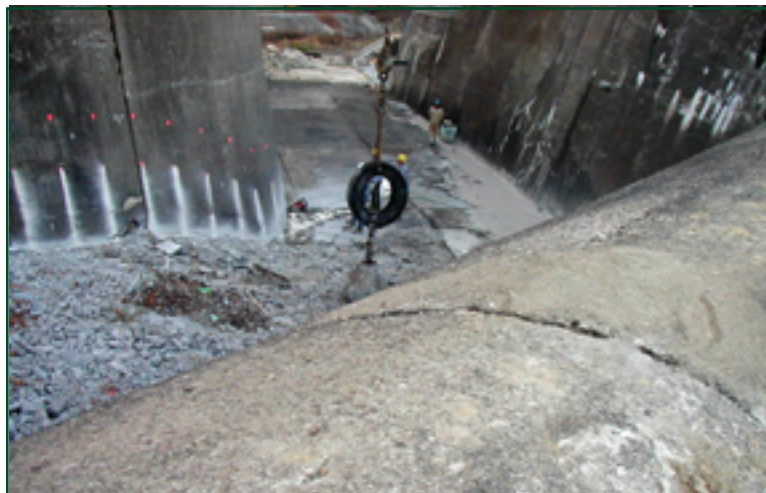
Figure 3—Wrecking ball on crane used to break up the spillway floor.

Floor sections were removed and replaced before the walls' overlays. The existing concrete in the floor of the spillway was removed along its entire length, with the exception of the stilling basin, which was left in place and overlaid with new concrete like the spillway walls. At the junction of the wall with the floor a 7.6cm saw cut was made. The original plans showed the removal of the chute floor required very little extra excavation. Once excavation of the floor began, the depth to bedrock to anchor the new floor was 0.3–2.1m. The void created by removing the old concrete and the loose material underneath was filled by the new concrete, which resulted in substantial overruns in concrete quantities. All foundation surfaces were pressure washed before the placement of new concrete (figure 3).

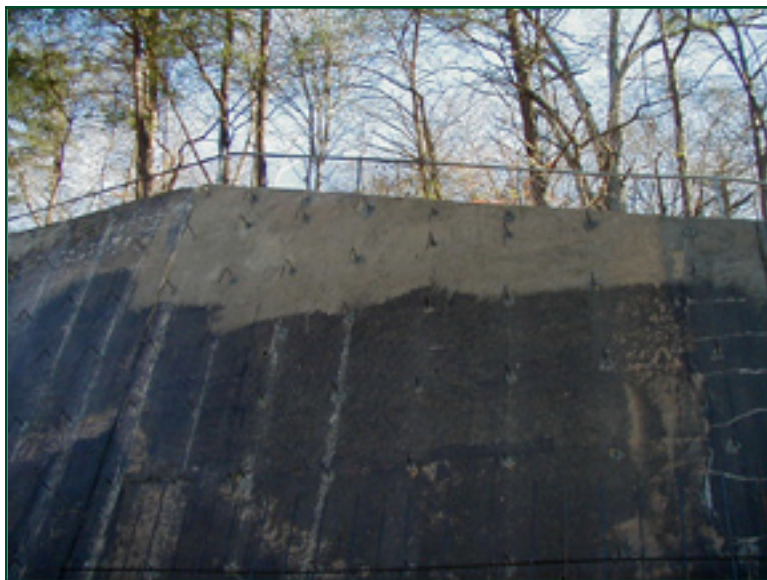
Figure 4—Grouted anchor bars installed in old spillway walls.

The reinforcement of the new concrete wall overlays and chute floor replacement incorporated grouted anchor bars (#4, #6 and #11), reinforcing bars and plain dowel bars. The new 0.3m wall overlays were anchored to the existing walls by drilling holes in the old concrete and #4 or #6 grouted anchor bars (depending on location in spillway) were installed every 0.9m on centre. The anchor bars were embedded at least 17cm on the right spillway wall and 0.3m into existing concrete and rock on the left wall. Attached to the grouted anchor bars was a combination of bars that formed a grid to reinforce the walls and floor of the spillway. The #6 anchor bars, reinforcing bars and plain dowel bars were installed in this grid pattern, with the opening between bars 0.3m each way. The bars were required to be embedded in a minimum of 5cm of concrete (figure 4).

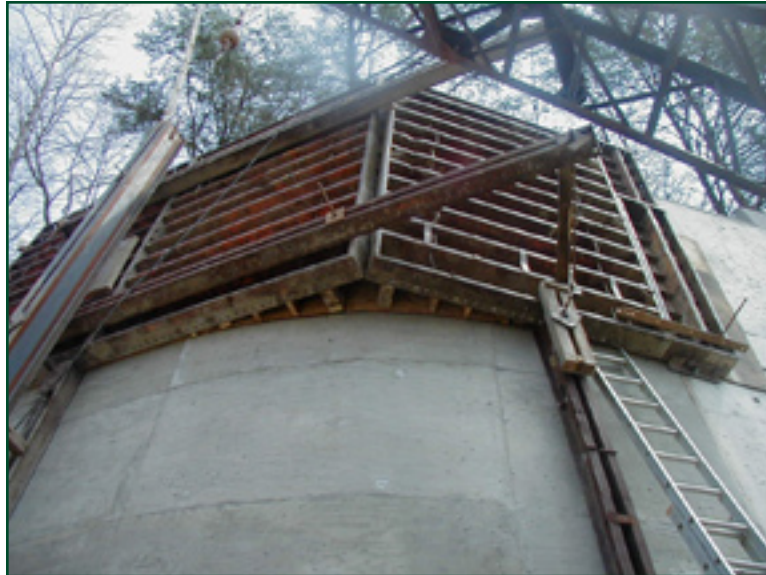
Figure 5—Forming a curved section of spillway wall.

Construction joints were made every 6.1m in the floor slabs. Contraction joints on the concrete overlay on the walls matched the joints on the existing walls and 23cm PVC water stops were installed at all joints in the walls and floor slabs (figures 5, 6, and 7).

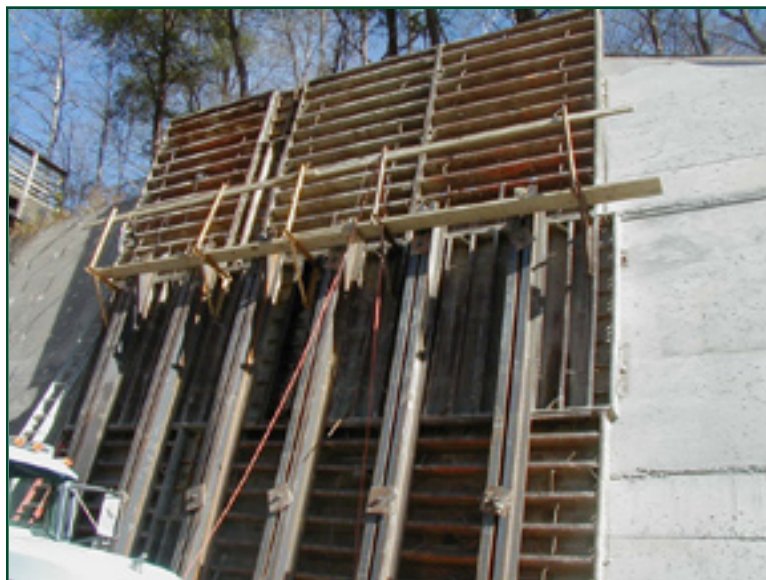
Figure 6—Steel forms used to form spillway walls.

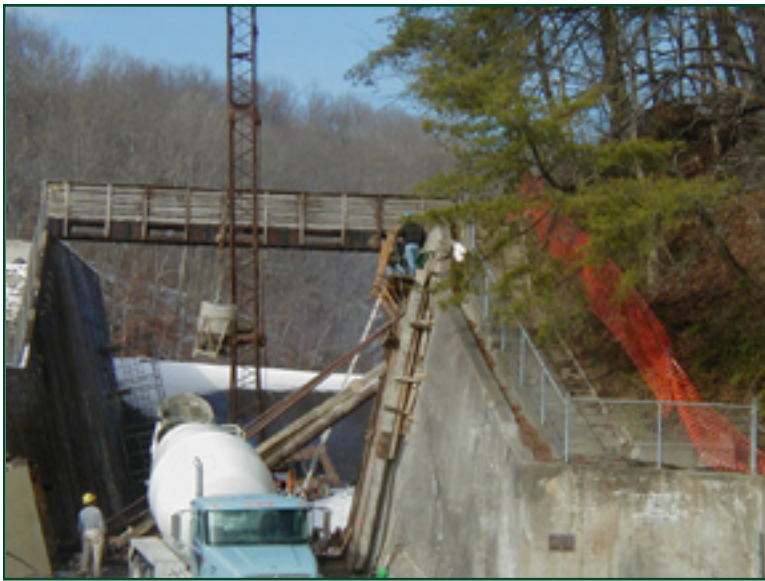
Figure 7—Placement of new concrete overlays of spillway walls using a drop bucket and crane.

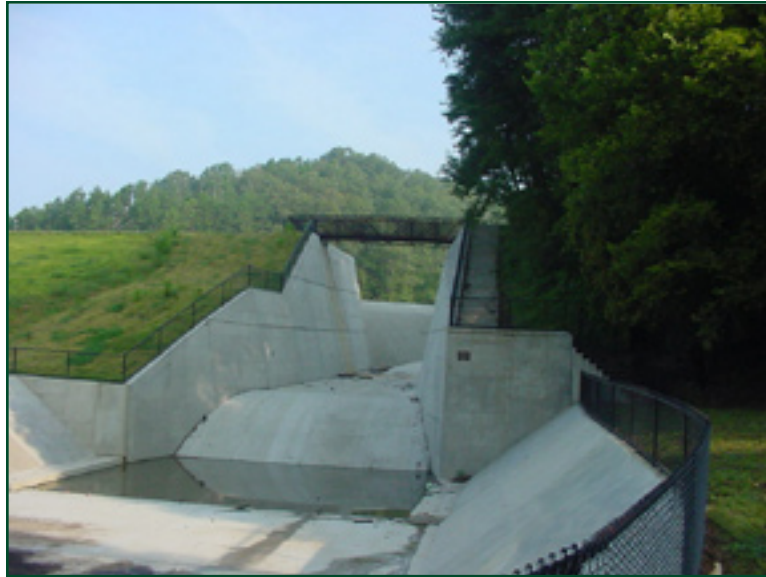
Figure 8—Finished spillway with new trail bridge and fencing installed.

Their costs were estimated at the 76m<sup>3</sup> per day and had a significant overrun by the small daily production. All the concrete pours were adequately formed, vibrated and finished, but the contractor was using old steel forms that had to be moved for each section of wall overlay which took extra time and manpower and cut down production rates. The project, although it took longer than anticipated, was very successful and completed professionally by the contractor (figures 8 and 9).

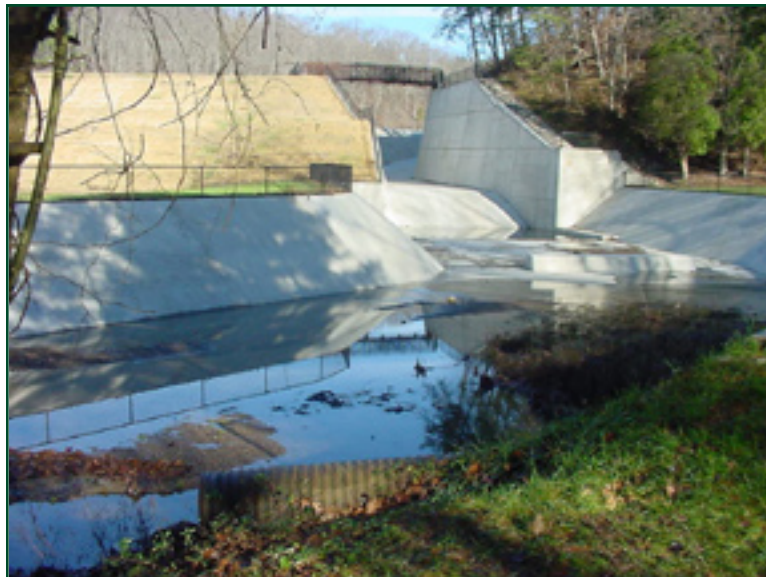
Figure 9—Finished spillway including new stilling basin and partial wier in outlet of spillway.
