**Underwater Repair of Bridge Footing**

**Stabilization of the Foundation for Bridge Footing**

## UNDERWATER REPAIR OF BRIDGE FOOTING

## STABILIZATION OF THE FOUNDATION FOR BRIDGE FOOTING

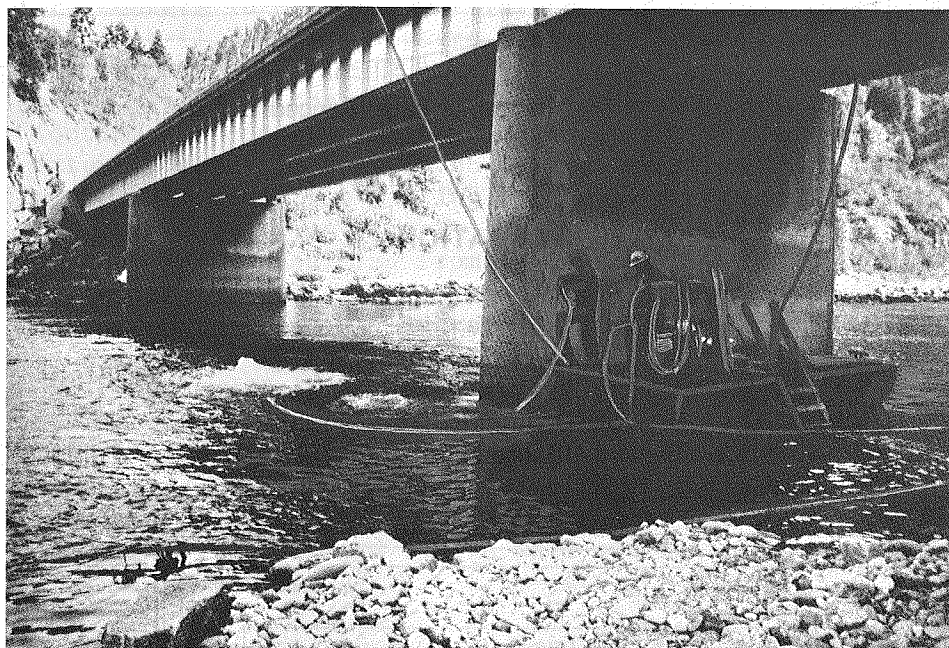
*Figure 1. Barge used as work platform for divers.*

The proposed method required two divers for underwater work, and a "dryland" crew consisting of two diver helpers and three laborers, plus a foreman and a superintendent. A barge was used to store the divers' equipment and as a work platform for the divers' helpers (fig. 1). The work consisted of:

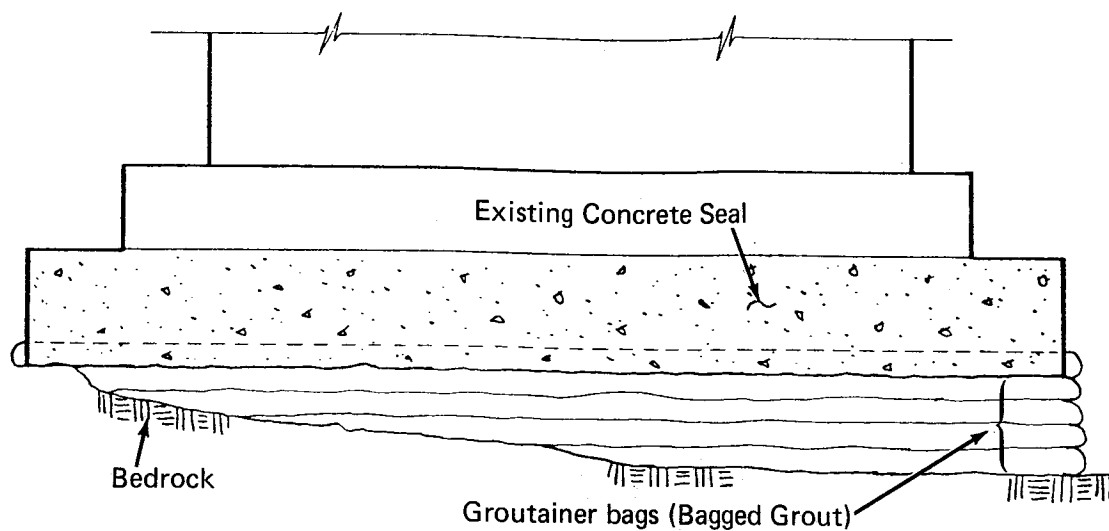
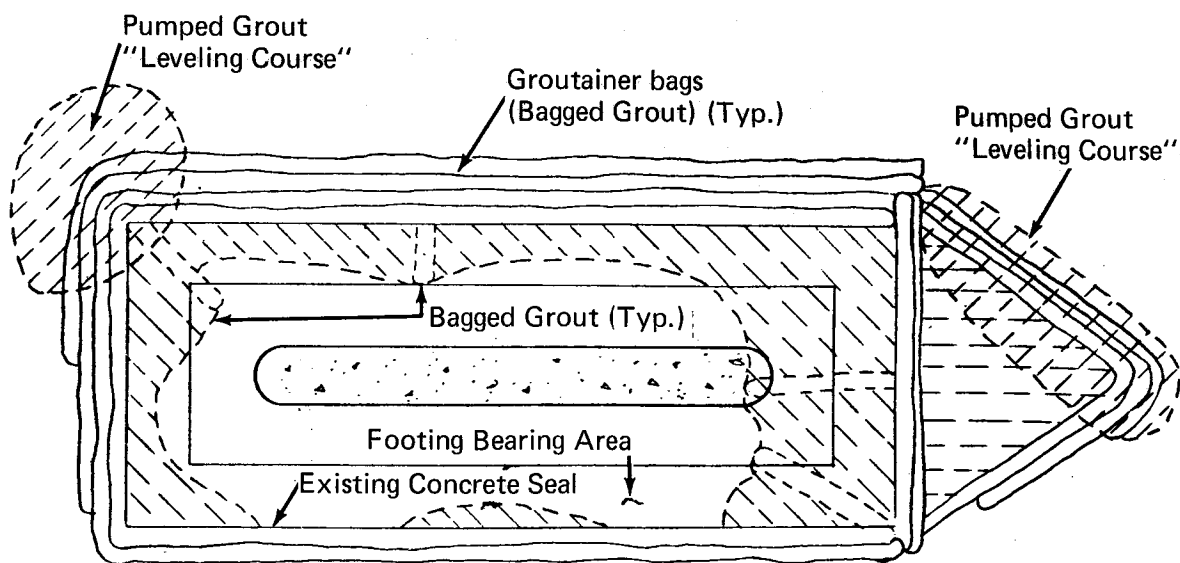
Figure 2. Plan for excavation.

The underwater inspection revealed scour depths of 2 to 2.5 feet (0.61 to 0.76 meters) along the eastern end of the plain concrete seal. Along most of the 35-foot (10.7 meter) length, the northern edge of the seal had scour which varied from 2 to 3 feet (0.61 to 0.91 meters) deep and extended as far as 5 feet (1.5 meters) under the seal. The western end was undermined from 0 to 2 feet (0 to 0.61 meters) deep. The remaining south side of the seal showed little or no scour.

The excavating consisted of removing all loose material from the streambed in the area under the footing seal and within the proposed perimeter of the bagged grout (fig. 2). Material up to 6 inches (15 cm) in diameter was removed by using "airlifts" handled by the divers. Airlifts are metal tubes varying from 4 to 10 inches (10 to 25 cm) in diameter that move material by compressed air forced through them, creating a suction at the bottom. The clear granular nature of the material involved made it possible to deposit this material in the riverbed without exceeding the contract turbidity requirements. Material larger than 6 inches (15 cm) was either moved by hand or by a backhoe operating from the bridge deck. The backhoe

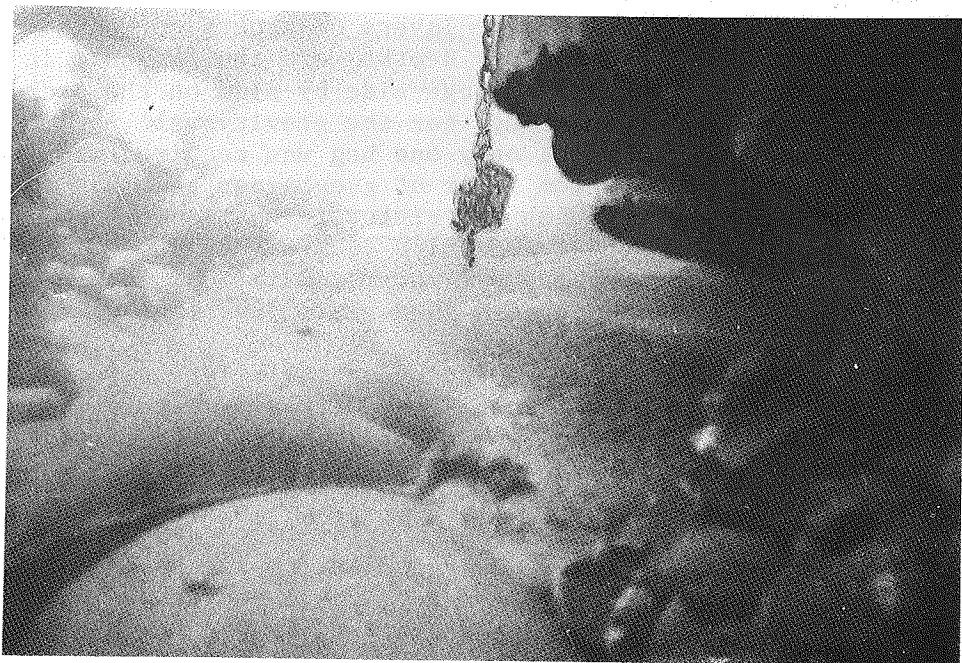
*Figure 3. One layer of grout bags and grout was pumped into this portion of the area under the footing.*

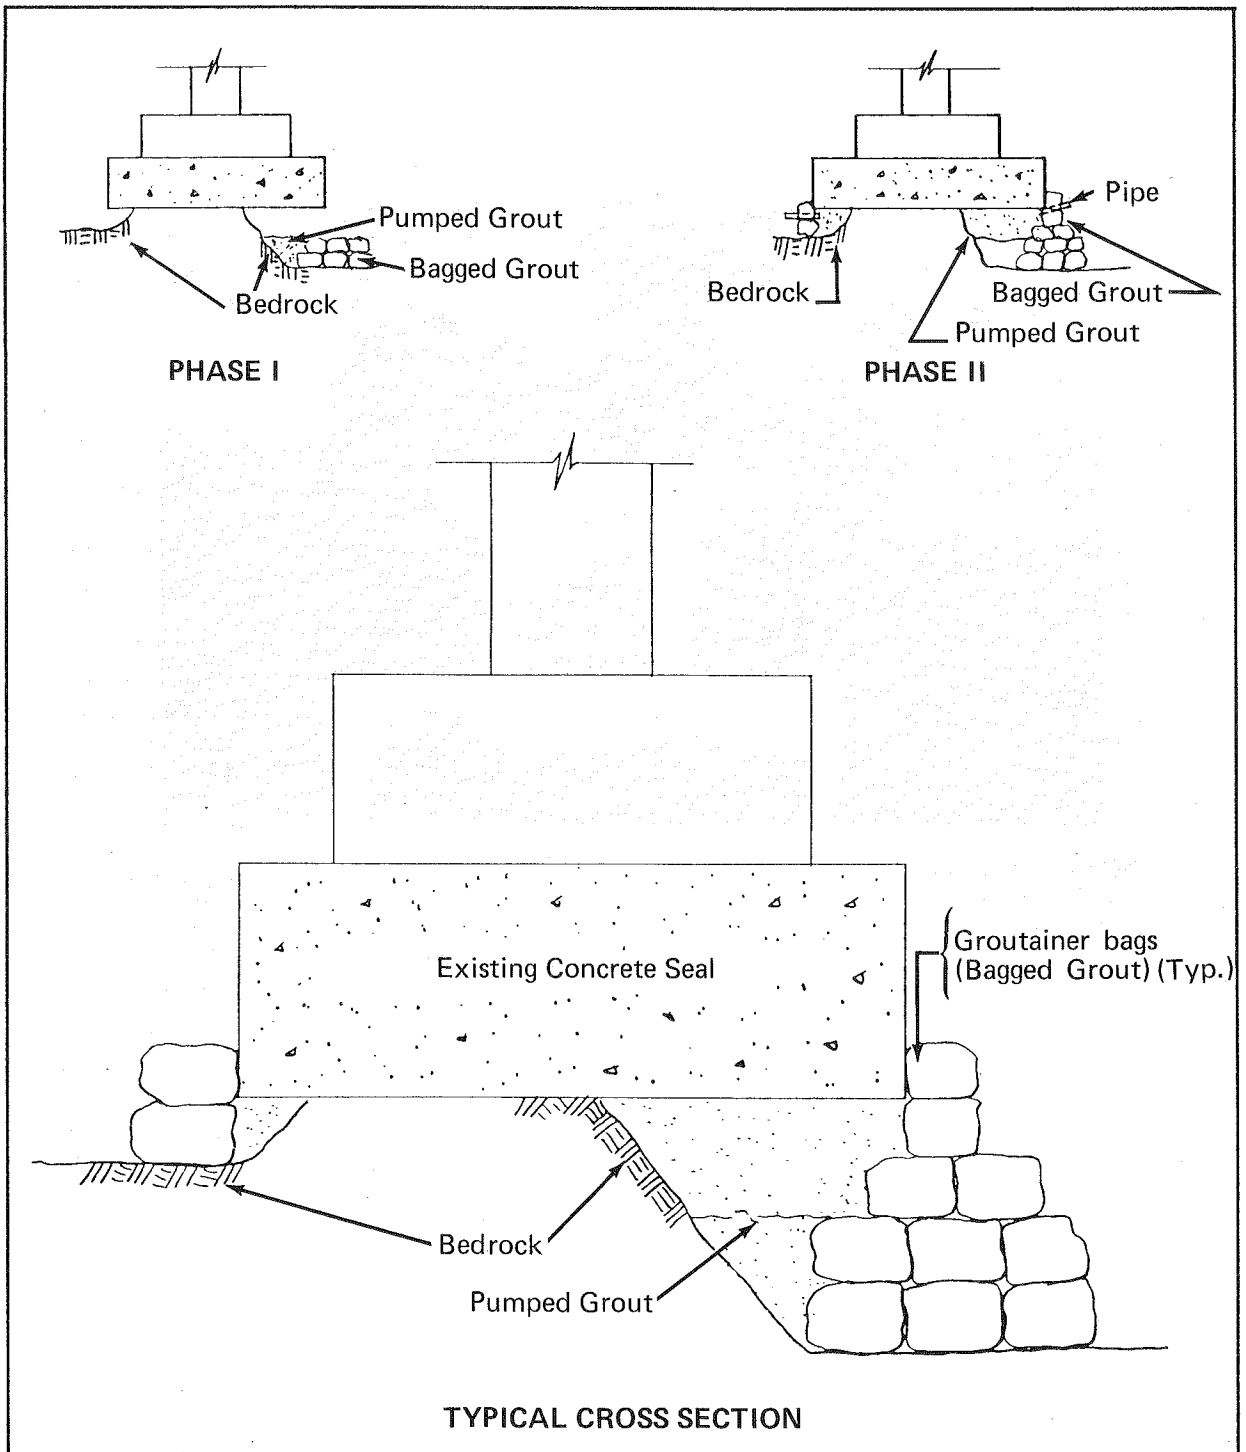
Figure 4. Placement of bags to form a lip between the wall and existing concrete sill.

The size of the cavity resulting from the excavation caused concern about the possibility of the pier shifting or collapsing due to excessive loss of bearing area under the footing. Therefore, it was decided to divide the cavity into six parts. Each part was excavated, a bag wall built, and the bags and cavity pumped full of grout before proceeding to the next part (fig. 3), as each layer of bags was completed. The top layer of bags was placed so as to form a lip between the wall and existing concrete sill. Pipes were inserted into the silled cavity through the wall before the last layer of bags was placed. The pipes were used to allow the trapped water to escape as the cavity, formed by the wall and bottom of existing sill, was filled with grout (fig. 4).

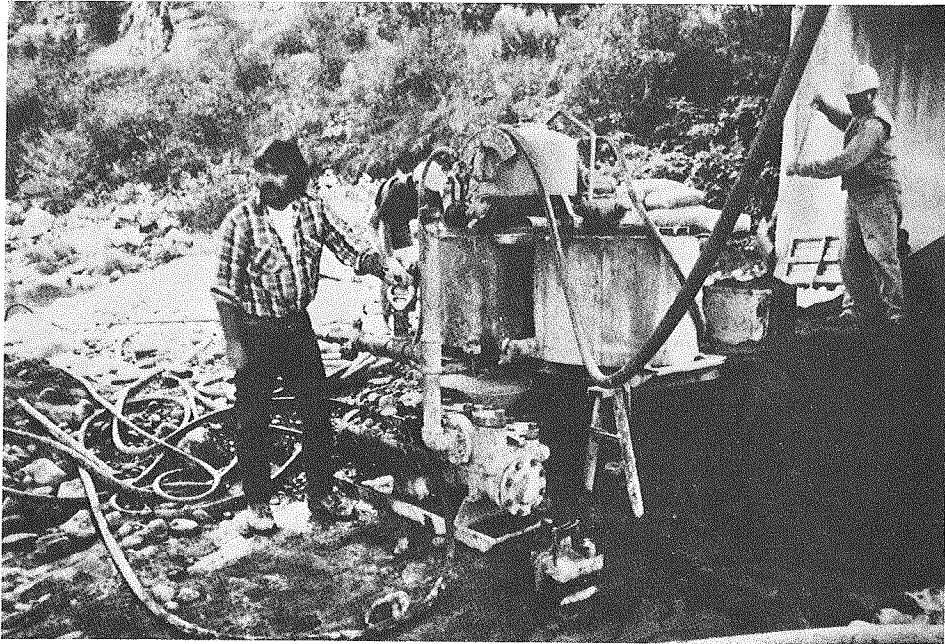
*Figure 5. Grout mixers and pump operated by an air compressor.*

The grout was composed of cement, sand, and an additive called "*Interaid*" which acted as a pumping lubricant. The grout was mixed by an air-operated mixer in 6 cubic-foot (0.17 cubic meter) batches (absolute volume) and pumped through 1-1/2-inch (3.8 cm) diameter hoses to the footing area. (fig. 5). The mix design consisted of 3 bags Type II cement, 7 cu. ft. (0.2 cubic meter) of sand, 2 pounds 10 ounces (1.2 kg) of *Interaid*, and 16 gallons (60.6 liters) of water. Test cubes taken from the grout consistently showed compressive strengths in excess of 3,500 psi (24,131 kilopascals) for 7-day and 7,000 psi (48,263 kilopascals) for 28-day tests.

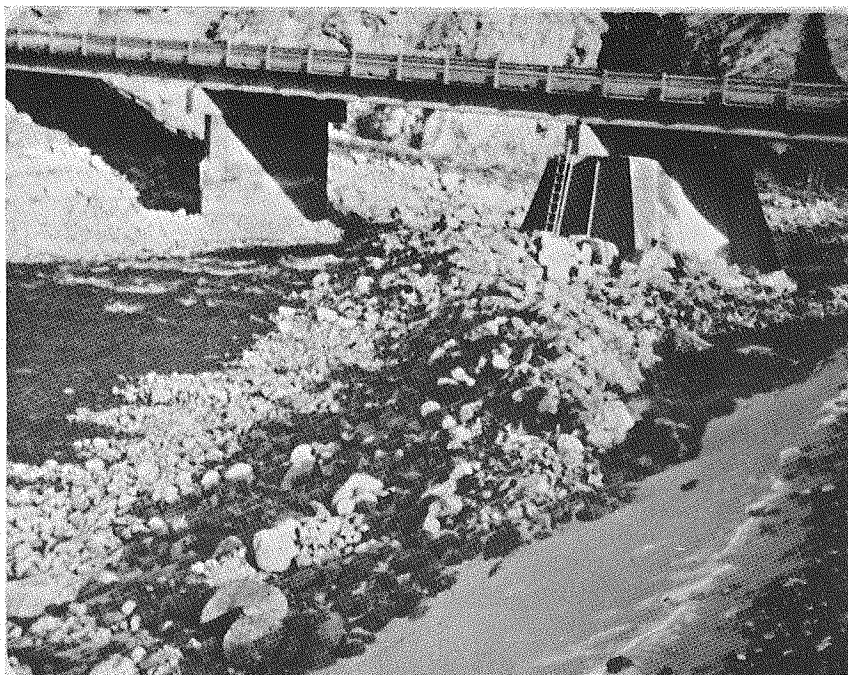
*Figure 1. Enclosure built for men to work.*

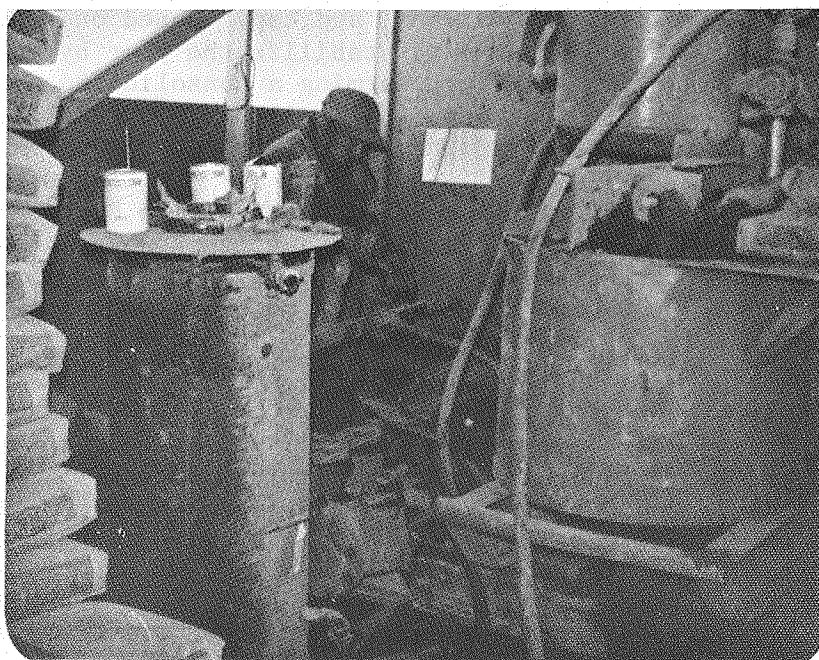
*Figure 2. Grout pump and water heater.*

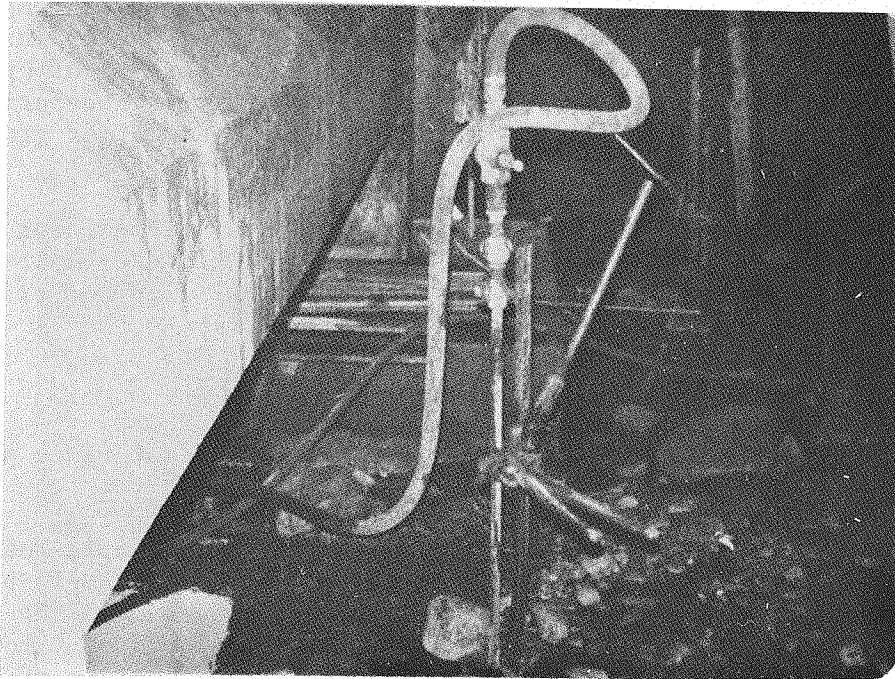
*Figure 3. Pumping grout through 3/4-inch steel pipes.*

The first operation was to drive 3/4-inch (1.9 cm) steel pipes vertically at about 3 feet (0.91 m) outside of the existing footings. The pipes were placed on 4-foot (1.2 m) centers, and were driven 3 to 5 feet (0.91 to 1.52 m) into the native material. Grout was pumped through these pipes until it surfaced (see Figures 2, 3, and 4). This procedure sealed the top area. A star drill was used to core through the grout, and steel casing was driven in the holes. The steel pipes were then driven inside the

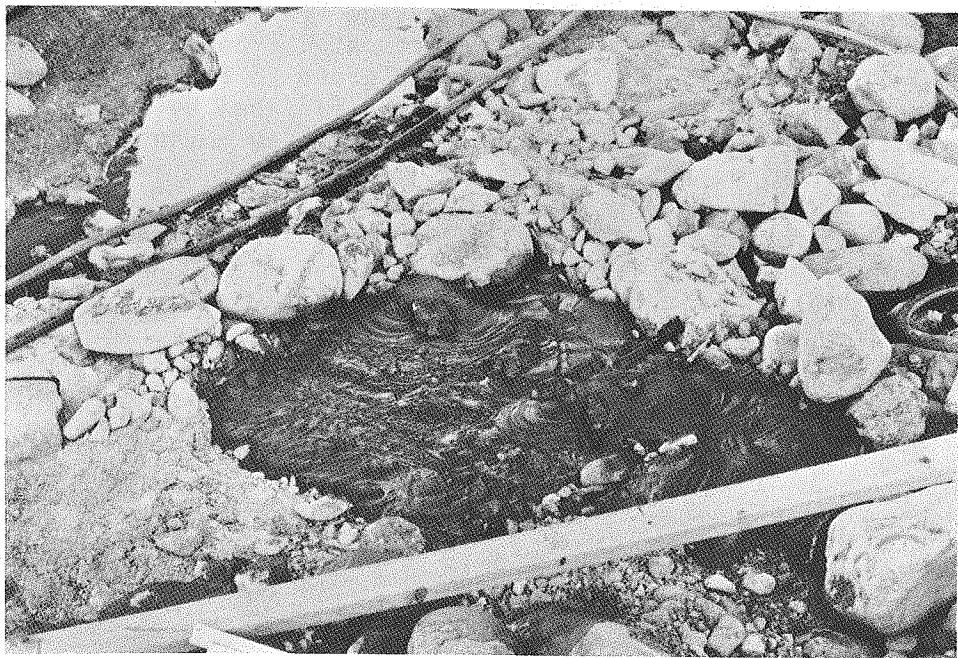
*Figure 4. Grout was pumped until it came to surface.*

casing to a depth of 10 feet (3.05 m) and grout was pumped to complete the consolidation of a mass 20 x 39 x 10 feet (6.1 x 11.9 x 3.0 m) in width, length, and depth. About 80 cubic yards (61.2 cubic meters) of grout were used. Special care was necessary during the final pumping operations directly under the existing footing, because a small amount of grout pressure could have raised the entire pier.

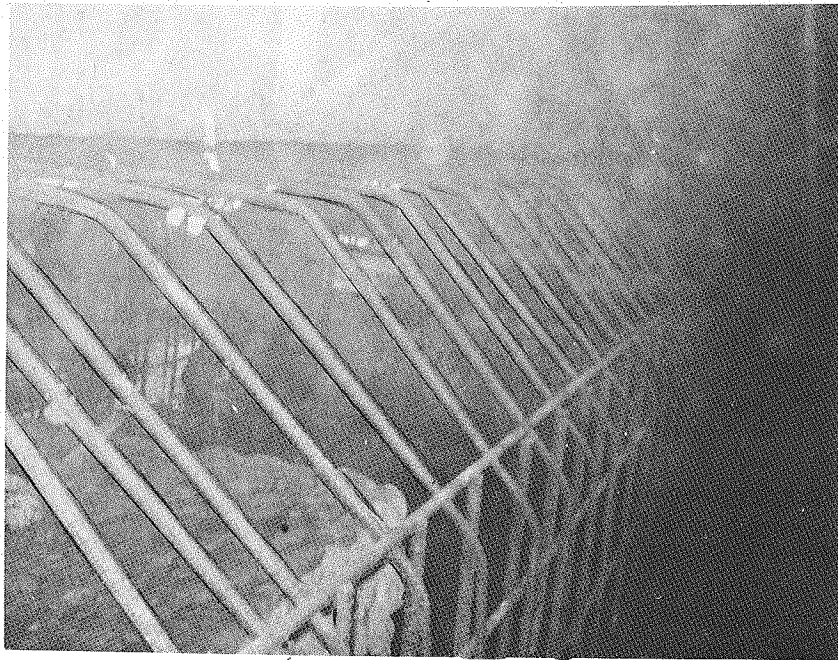
*Figure 5. Reinforcing steel placed for PAC footing.*

The last step of the repairs was to encase the existing footing of the pier with concrete. The original contract specified standard cast-in-place reinforced concrete. Because of the freezing temperature and the long distance to any concrete plant, the contractor requested and was allowed to use Preplaced Aggregate Concrete (PAC) (Fig. 5). PAC consists of preplacing coarse aggregate of 1/2- to 1-1/2-inch (1.3 to 3.8 cm), as shown in Figure 6, and then pumping grout (sand-cement) into the aggregate to form concrete (Fig. 7). The compressive strength of the cylinders made from PAC ranged between 5,200 psi to 5,590 psi (35,852 to 38,541 kilopascals) at 28 days.

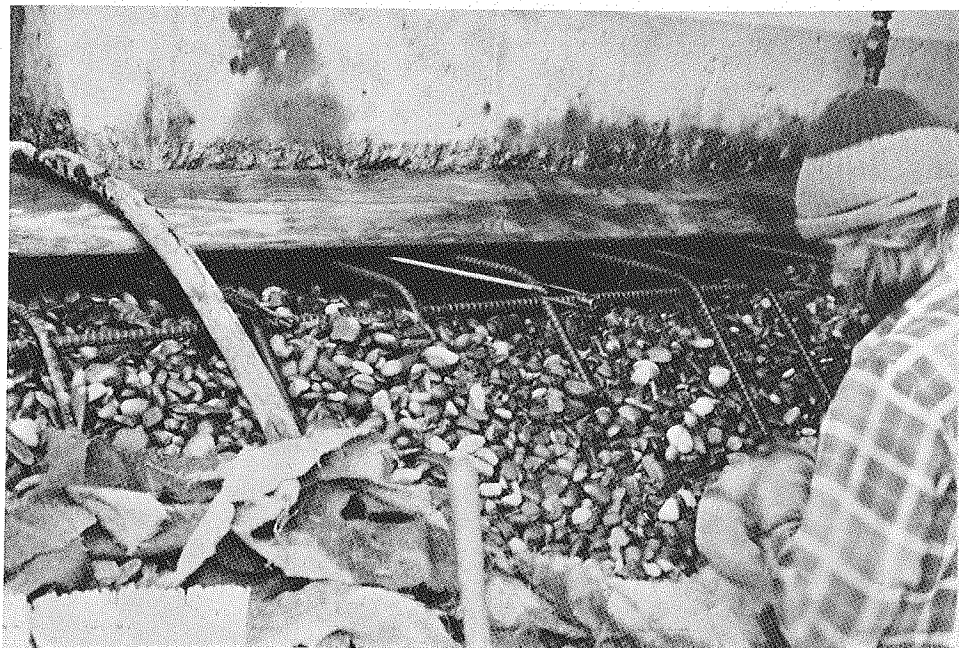
*Figure 6. Placing coarse aggregate in the footing.*

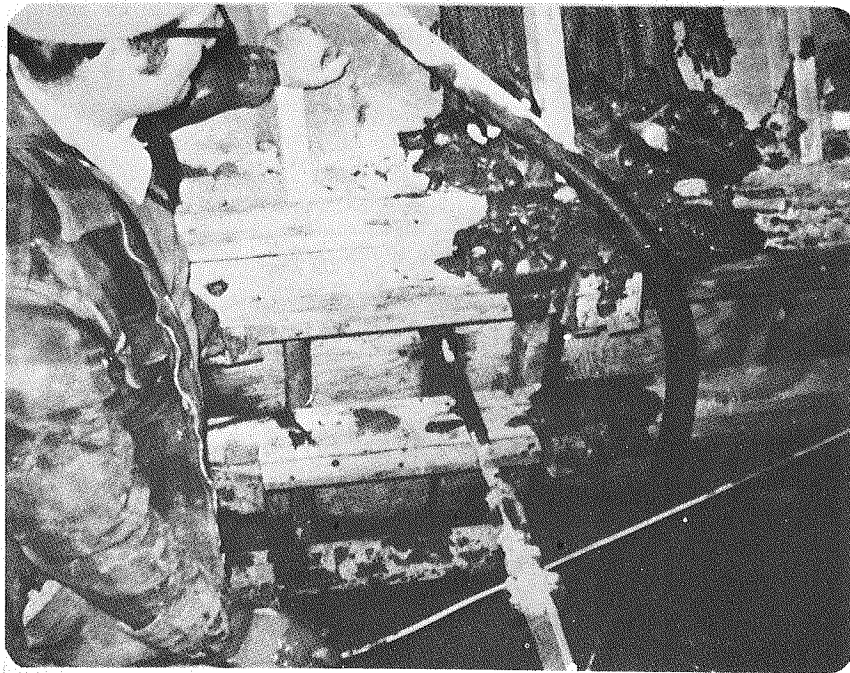
*Figure 7. Pumping grout into the coarse aggregate.*

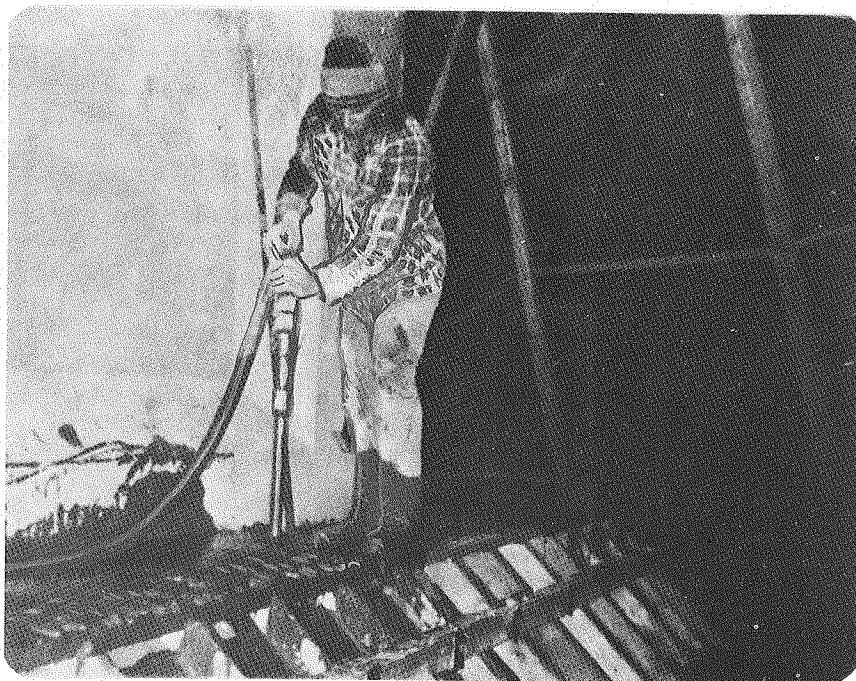
*Figure 8. Final pumping of grout to eliminate air pockets.*

One problem with PAC is that the forms must be "watertight" or the grout will not fill all the voids. Pumping starts at the bottom and proceeds to the top (Fig. 8). It took 12 hours to pump grout to form 48 cubic yards (36.7 cu. meters) of PAC. The top of PAC was finished by striking the top surface similar to cast-in-place concrete. Very few voids were found when the forms were stripped.

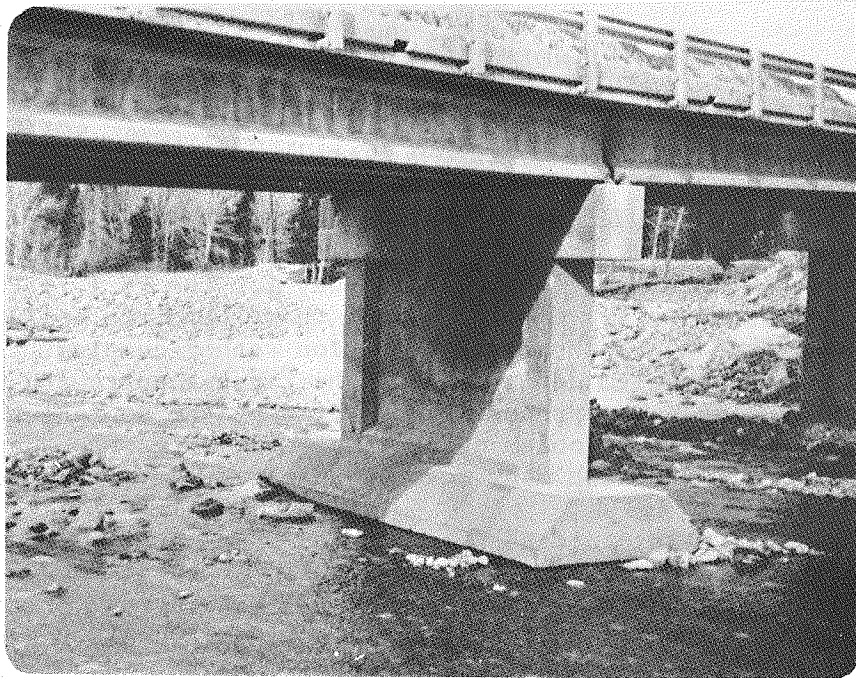
*Figure 9. Finished product.*

The cost of the project was \$50,000, but the results achieved by consolidating the native material with pumped grout, and using PAC to enlarge the pier footing, will provide a satisfactory and long-lasting product (Fig. 9).
