2021 CALDOR FIRE

CA-ENF-023040

Burned Area Emergency Response (BAER)

Assessment Report Summary

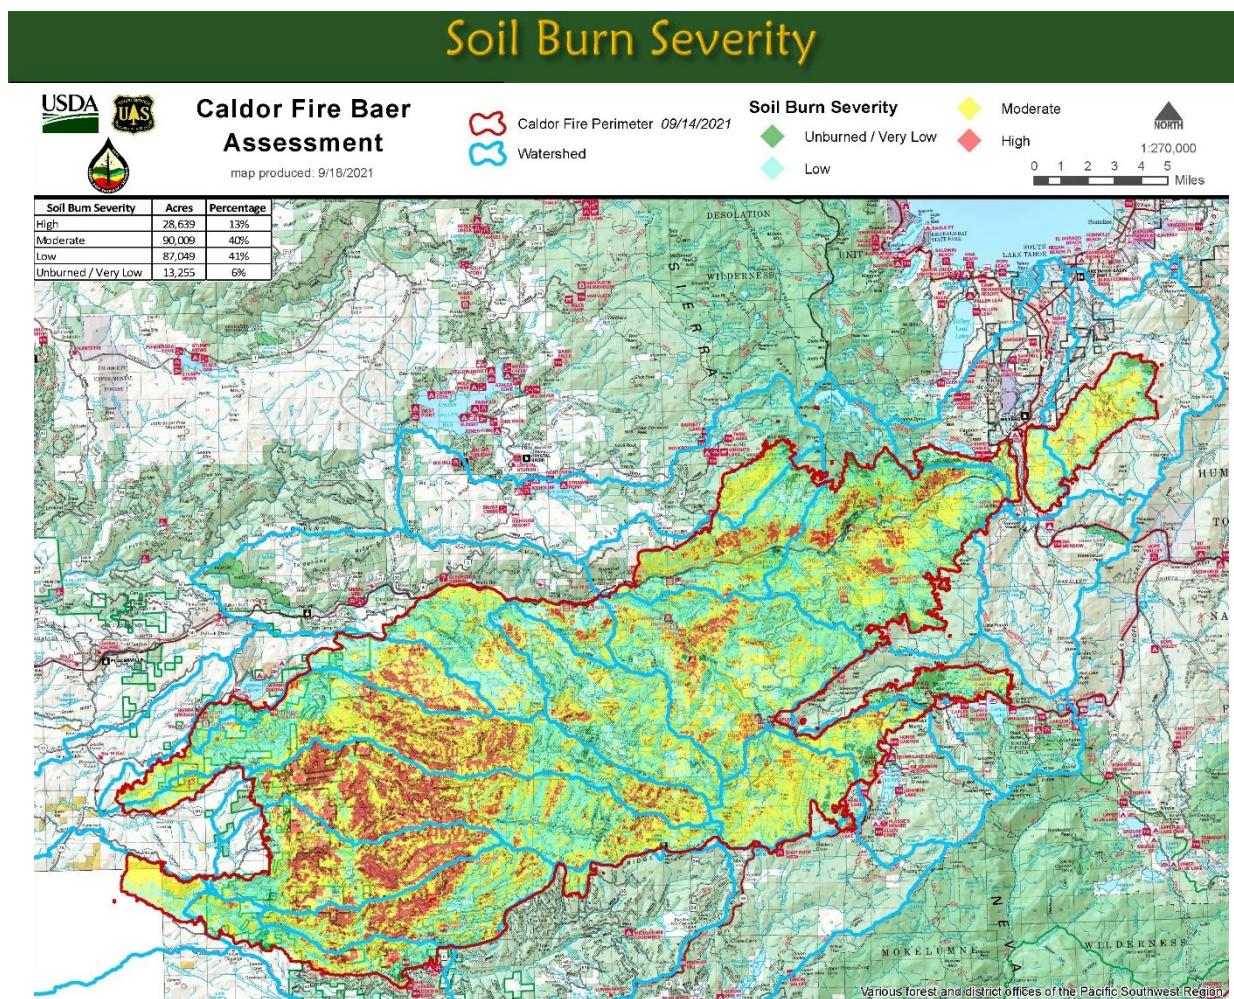
Figure 2. Soil Burn Severity Map

Primary soil characteristics considered in soil burn severity classification are forest floor cover, ash color, integrity of roots, integrity of structure, and water repellency. Water repellent soils have reduced infiltration which results in increased runoff. Areas of low and unburned SBS have minimal effects to soil properties, and therefore, little to no post-fire effects. While moderate SBS indicates that some soil properties have been affected and the duff and litter layer that acts as a sponge to absorb precipitation has mostly been consumed. And high SBS areas have significant alterations to soil properties such as complete consumption of litter and duff, loss of root viability and changes to soil structure that often drive substantial watershed response including increased erosion and runoff following precipitation events. The team conducted its field verification surveys to adjust the initial satellite data to create a final SBS map for the Caldor burned area (See Figure 2).

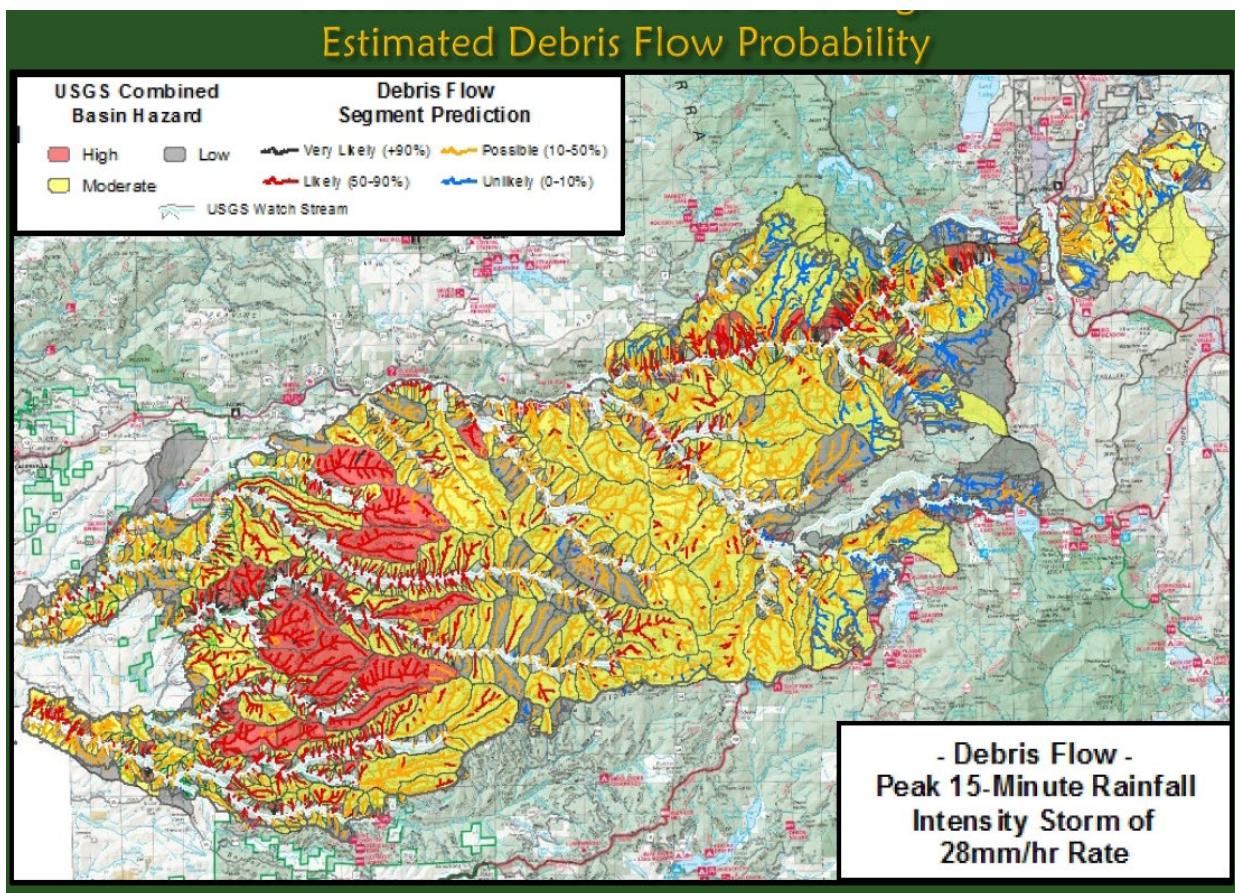
Figure 3. USGS Debris Flow Modeling Hazards.

The US Geological Survey (USGS) - Landslide Hazards Program modeled the probability and potential volumes of debris flows in the burned area. Their ongoing research has developed empirical models for forecasting the probability and the likely volume of such debris flow events. The USGS models integrates geospatial data related to basin morphometry (hill slope, size), soil burn severity, soil properties, and rainfall characteristics to estimate the probability and volume of debris flows that may occur in response to a local design storm (Staley et al., 2016). Estimates of probability, volume, and combined hazard are based upon a design storm with a peak 15-minute rainfall intensity of 12 – 40 millimeters per hour (mm/h) rate (0.47 – 1.57 inches/hr).

The USGS provides estimates that can be used to guide the initial establishment of rainfall intensity-duration thresholds for storm peak intensities of 15-, 30-, and 60-minute durations. With larger fires there is a potential for a gradient of precipitation due to the various microclimates associated with elevation and rain-shadow effects. Therefore, we use site specific storm intensities from Atlas 14 to evaluate debris flow modeled responses for the various Critical Values. **Figure 3** displays the debris flow model for the Caldor fire area.

For the Caldor Fire we selected a 1-year, peak 15-minute rainfall intensity of 28 millimeters per hour (mm/h) rate to visually present debris flow potential and volume, for the following reasons:

1. This storm intensity is consistent with the NOAA Atlas 14, Point Precipitation Frequency Data, which is a mid-elevation point within the fire area (USGS / NOAA Atlas 14, 2021); and is generally representative of the Atlas 14 value across the fire, ranging from 25 to 31 millimeters per hour (mm/h);
2. A 28 millimeters per hour intensity matches the USGS estimate for a 15- minute duration, which they described as follows, "most of the burn area requires rainfall rates greater than 28 mm/h to exceed a 50% likelihood of debris-flow occurrence".
3. And, this storm intensity has a geologic response that is generally consistent with debris and sediment identified during our on the ground assessment.

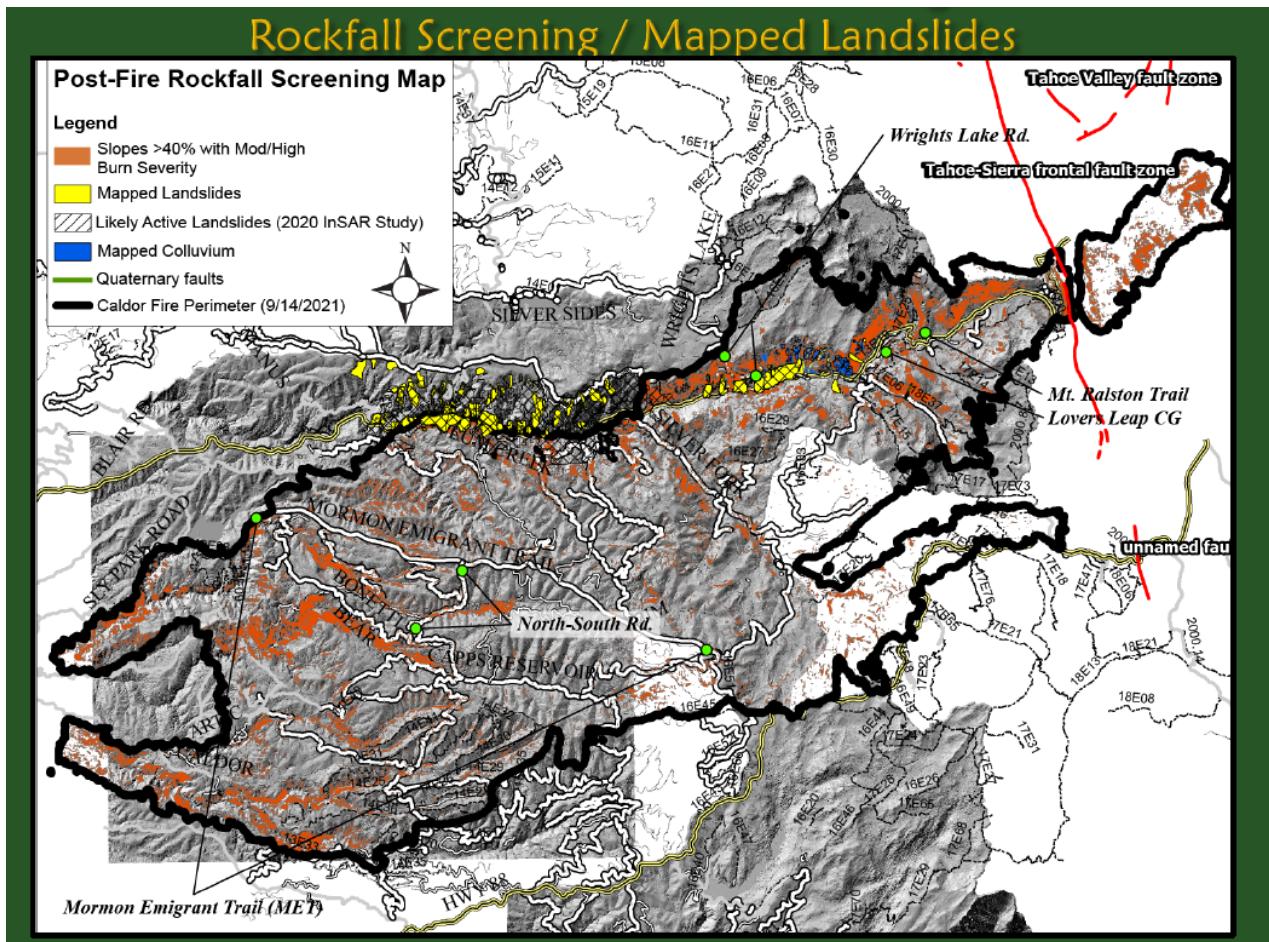
Figure 4. Post-Fire Rockfall Screening Map

We used LiDAR data to generate slope maps and identified VARs downslope of areas $\geq 40\%$ which experienced moderate to high soil burn severity. We overlaid mapped landslides, faults, and colluvial slopes to identify general areas of slope movement or potential movement. Figure 4 displays the rockfall potential assessment.

The assessment of rockfall at a landscape scale was guided by experience to evaluate this geologic hazard methodically and consistently within the knowledge currently available on this phenomenon (Santi et al., 2013; De Graff and Gallegos, 2012). To assess locations for rockfall we performed field surveys and prepared a map showing the road segments and developed recreation situated downslope from areas affected by moderate or higher soil burn severity on slopes inclined at $\geq 40\%$. Field survey consisted traveling many of these roads and developed recreation sites and observing the size and number of rocks which had rolled onto the road during or since the fire. This information was used to establish the rockfall hazard.

It is important to note that local data (extent of glaciation, rockfall frequency, colluvial or talus slopes) influences both the probability and volume of rockfall. For example, Lovers Leap Campground is located at the base of a rockfall talus slope and runout zone. The fire burned many of the trees that are adding to the stability of the slope. The post-fire rockfall hazard will be exacerbated until substantial blowdown has occurred and the slope restabilizes.

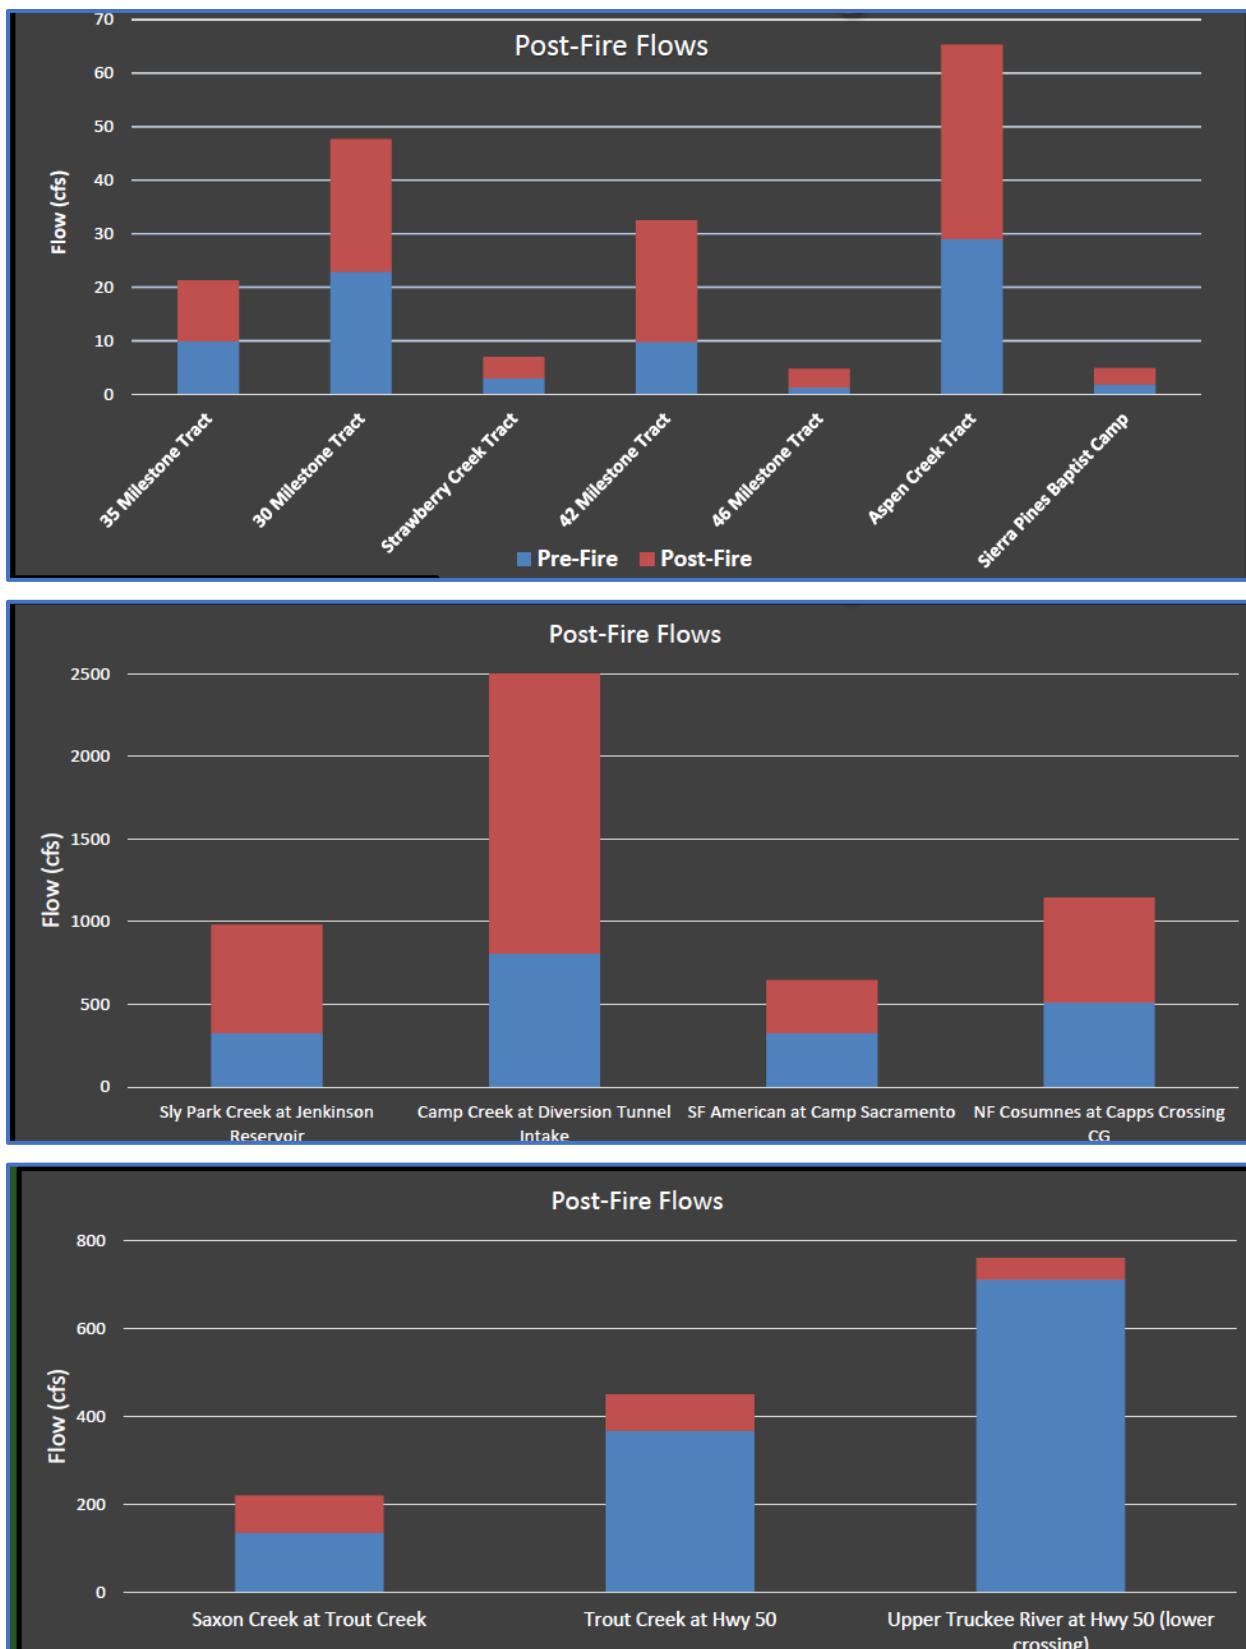
Figures 6, 7, 8. Post Fire Flows; (Blue=Pre-Fire Flows) (Red=Post-Fire Flows)

Estimated Hydrologic Response: Hydrologic modeling showed highly-variable increases in post-fire runoff, with roughly half of pour points (certain specific areas identified within the burned area) having high-very high flow increases and half having low-moderate increases in flow. Twenty-nine pour points were modeled for watershed analysis. An additional 11 pour points were modeled for the engineering specialists to determine increased flows at road stream crossings for purposes of determining if treatments were needed. Of the 40 pour points modeled for a 2-year 6-hour storm event, 10 of them showed very high increases in bulked post-fire runoff and 14 showed high increases in bulked post-fire runoff (See Figure 5). These very large runoff responses have the potential to impact life, safety, and property on Forest Service managed lands (particularly roads), pose risk to life and safety in areas under special use permit (recreation residences and organization camps), and affect water quality downstream. Water quality is of particular concern at two locations: Jenkinson Reservoir and Lake Tahoe (See Figures 6,7).

Sly Park Creek and Camp Creek feed Jenkinson Reservoir, which is a domestic water supply utilized by El Dorado Irrigation District (EID). Modeling indicated very high increases in bulked post-fire runoff for both these pour points. In addition, ERMiT modeling indicated a high erosion rate in these watersheds, likely due to loamy soil types that stay well-suspended and elevations subject to rain events (versus higher elevations which are more snow dominated).

The fire burned upstream of Lake Tahoe in the Upper Truckee River and Trout Creek watersheds. Pour points in the Lake Tahoe Basin do not show substantial increases in flow. Although increased flow is not a large concern in the Lake Tahoe Basin, there is a concern about impacts of increased sediment inputs and ash reaching Lake Tahoe, as Lake Tahoe is an Outstanding National Resource Water (ONRW). Sediment and ash inputs are anticipated to be partly moderated by Trout Creek flowing into Upper Truckee Marsh, and the Upper Truckee River having had meadow restoration which connects it to its historic floodplain upstream of the lake.
