Monroe Canyon Fire Burned Area Summary

Burned Area Report

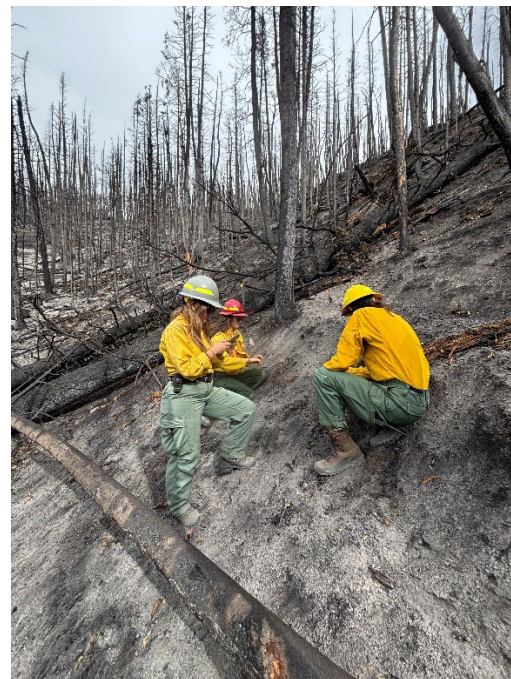
Figure 1: BAER Team member assessing soil burn severity in Monroe Canyon

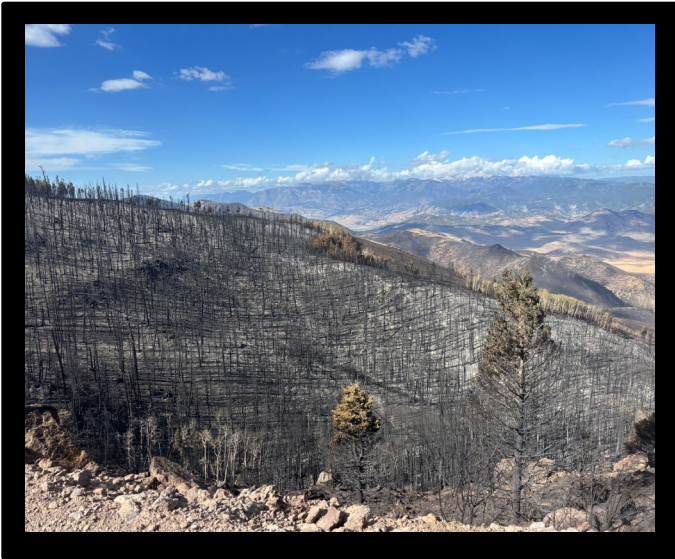
Mapped and validated SBS for the burned area is High (10%), Moderate (38%), Low (31%), and Very Low/Unburned (21%) (see map on page 7). Soil burn severity within the Monroe Canyon burn scar was driven by vegetation types found in the area. The mixed conifer and aspen stands experienced moderate and high intensity due to fuel and weather conditions. Areas within the shrub and grasslands were all dominated by fine fuels that burned quickly resulting in predominately very low and low SBS.

Figure 2: Moderate and high soil burn severity in Monroe Canyon.

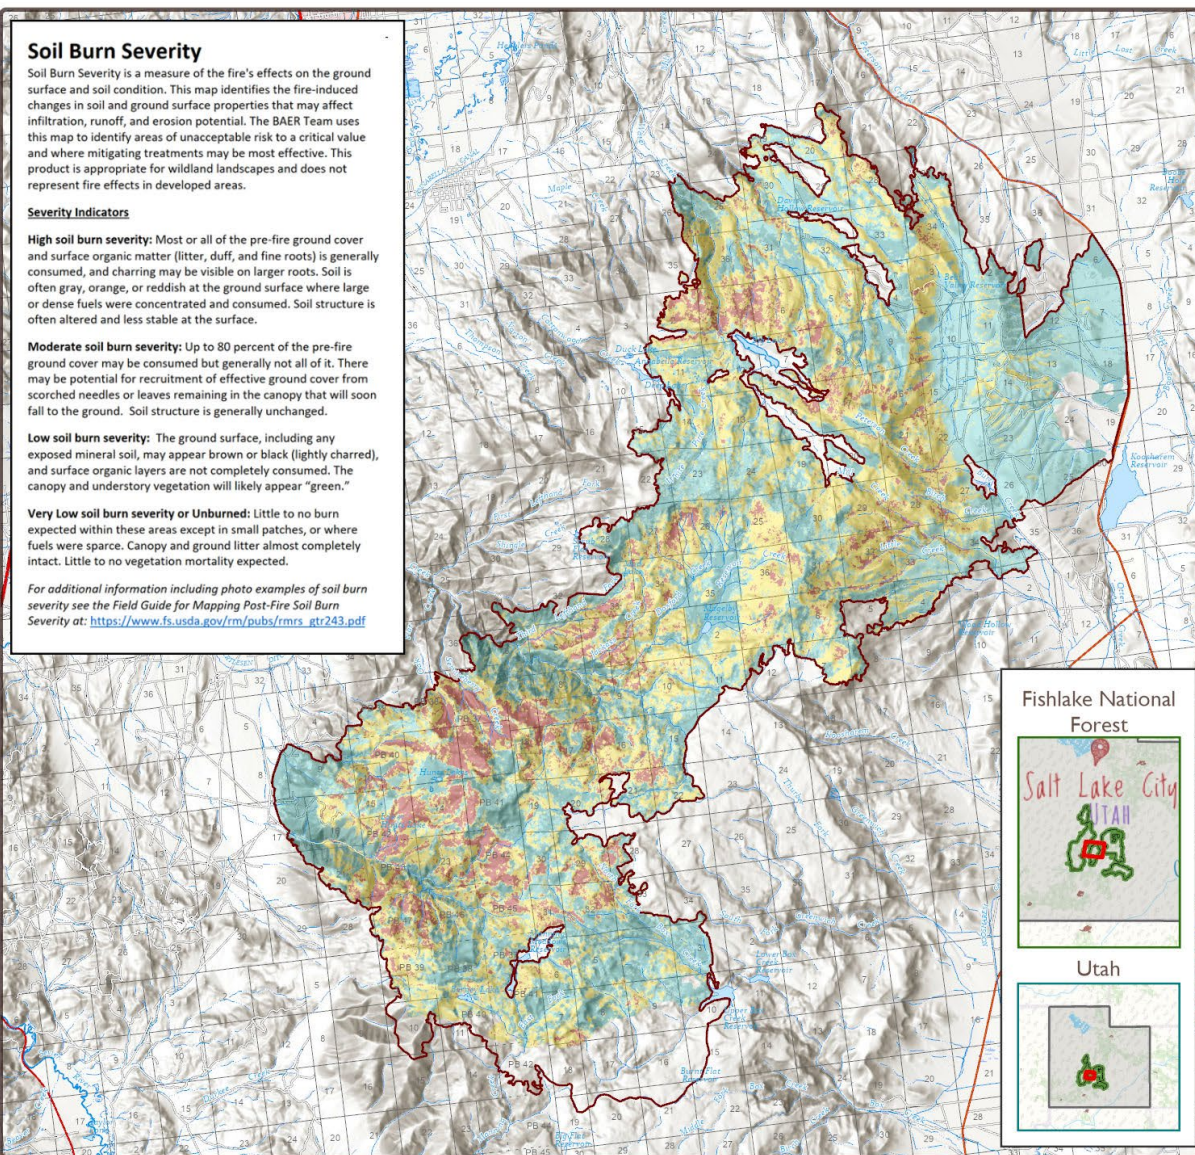
Soil Burn Severity Burned Area Emergency Response (BAER)

Soil Burn Severity	Acres	% Burned
High	6,847	10%
Moderate	26,375	38%
Low	21,141	31%
Very Low or Unburned	14,161	21%
Assessment Area	68,524 acres	
Burn Boundary 8/9/2025

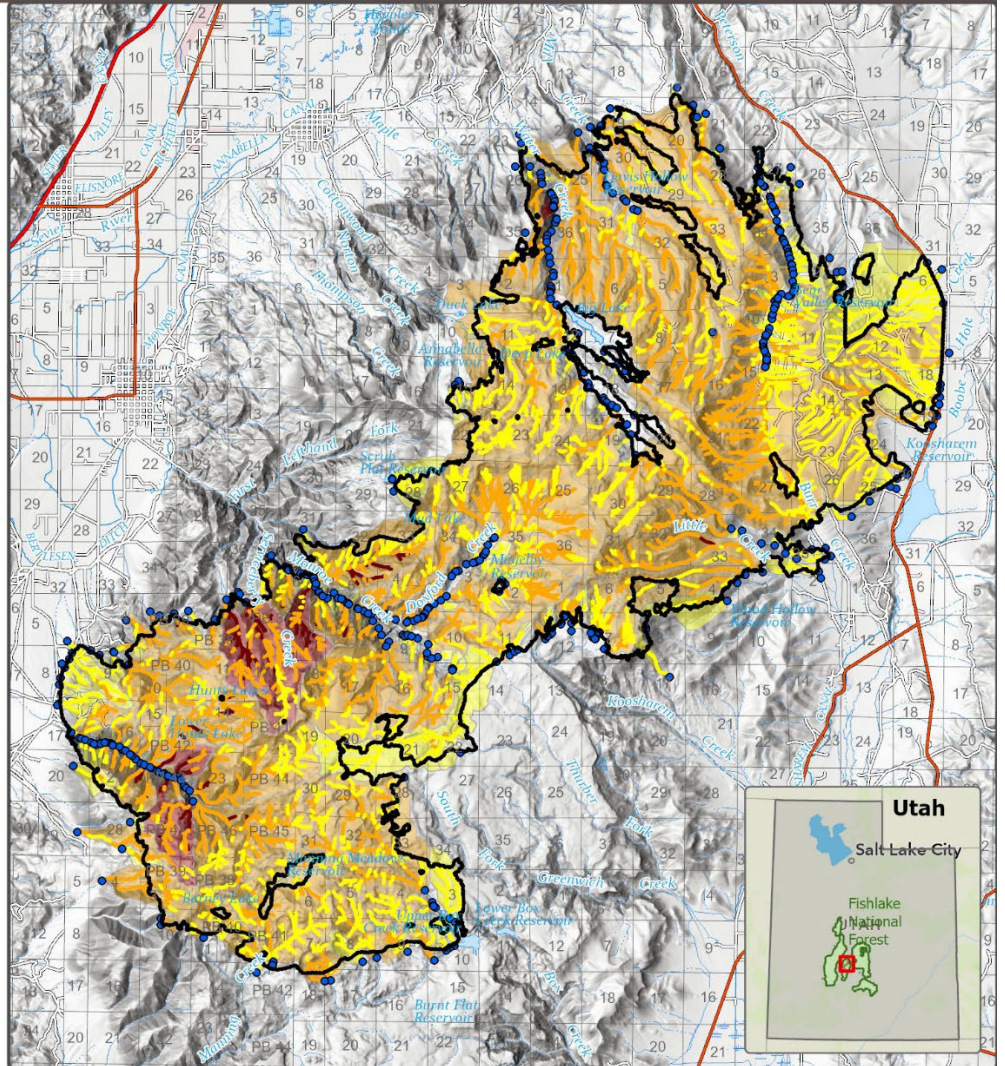
**USGS Debris Flow Combined Hazard
 Burned Area Emergency Response (BAER)**

flood event. The Monroe Canyon and Water Canyon Creek subwatersheds have modeled post fire flow increases of 219% and 417% respectively. The volume of these runoff events will be further bulked with sediment, rocks, and floatable debris. Based on the modeling of the 1-2-year precipitation event, USGS estimated a likelihood of 80-100% for a debris flow occurring in Dry Canyon, the tributaries to Monroe Canyon, and some basins in Water Canyon. There is a low threshold for rainfall in these areas. These basins also had a high combined hazard rating.

**Debris Flow Combined Hazard
 (Likelihood & Volume)
 Peak 15 minute Rainfall Intensity
 Rate of 24 mm/hour**
