# Wildcat Fire Burned Area Summary

## Burned Area Report

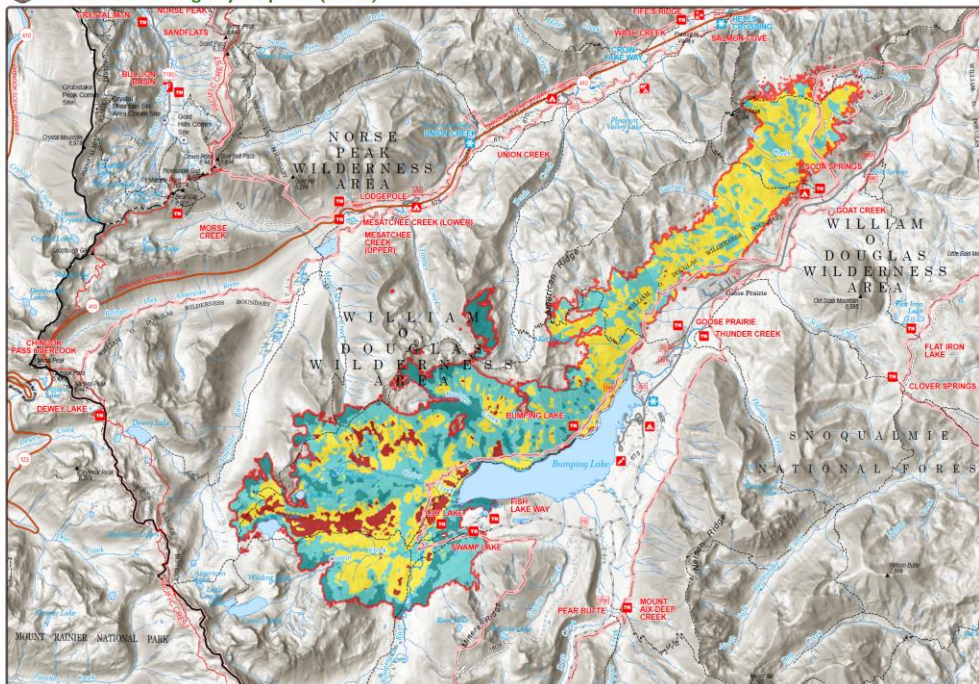
## Soil Burn Severity Burned Area Emergency Response (BAER)

Mapped and validated SBS for the burned area resulted in very low (14%), low (38%) and moderate (41%) soil burn severity. (see map on page 1). The more severe a fire's effects are on the soil, the more likely those soils will erode in subsequent rainstorms – especially in locations with steep slopes. Erosion after fires can cause tremendous damage to homes and other structures in the years after a fire.

Soil Burn Severity is a measure of the fire's effects on the ground surface and soil condition. This map identifies the fire-induced changes in soil and ground surface properties that may affect infiltration, runoff, and erosion potential. The BAER Team uses this map to identify areas of unacceptable risk to a critical value and where mitigating treatments may be most effective. This product is appropriate for wildland landscapes and does not represent fire effects in developed areas.
