# Glengarry Mine Closure Construction Report

**GLENGARRY MINE CLOSURE  
CONSTRUCTION REPORT  
CONTRACT 50-0398-3-004  
2003-2005**

**PHASE III  
NEW WORLD MINING DISTRICT  
RESPONSE AND RESTORATION PROJECT**

**MAY 2007**

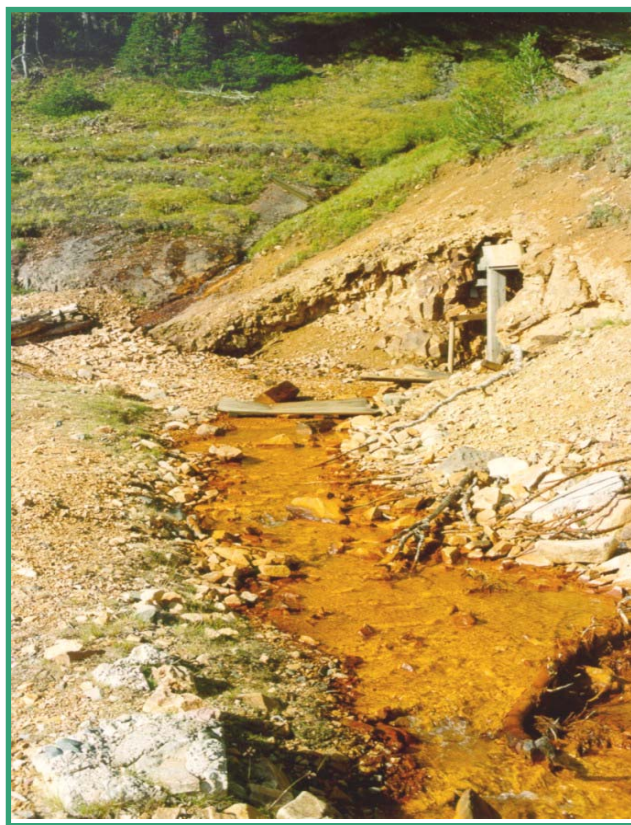
**Figure E-1. Acidic Discharge from the Glengarry Mine Adit Prior to Closure**

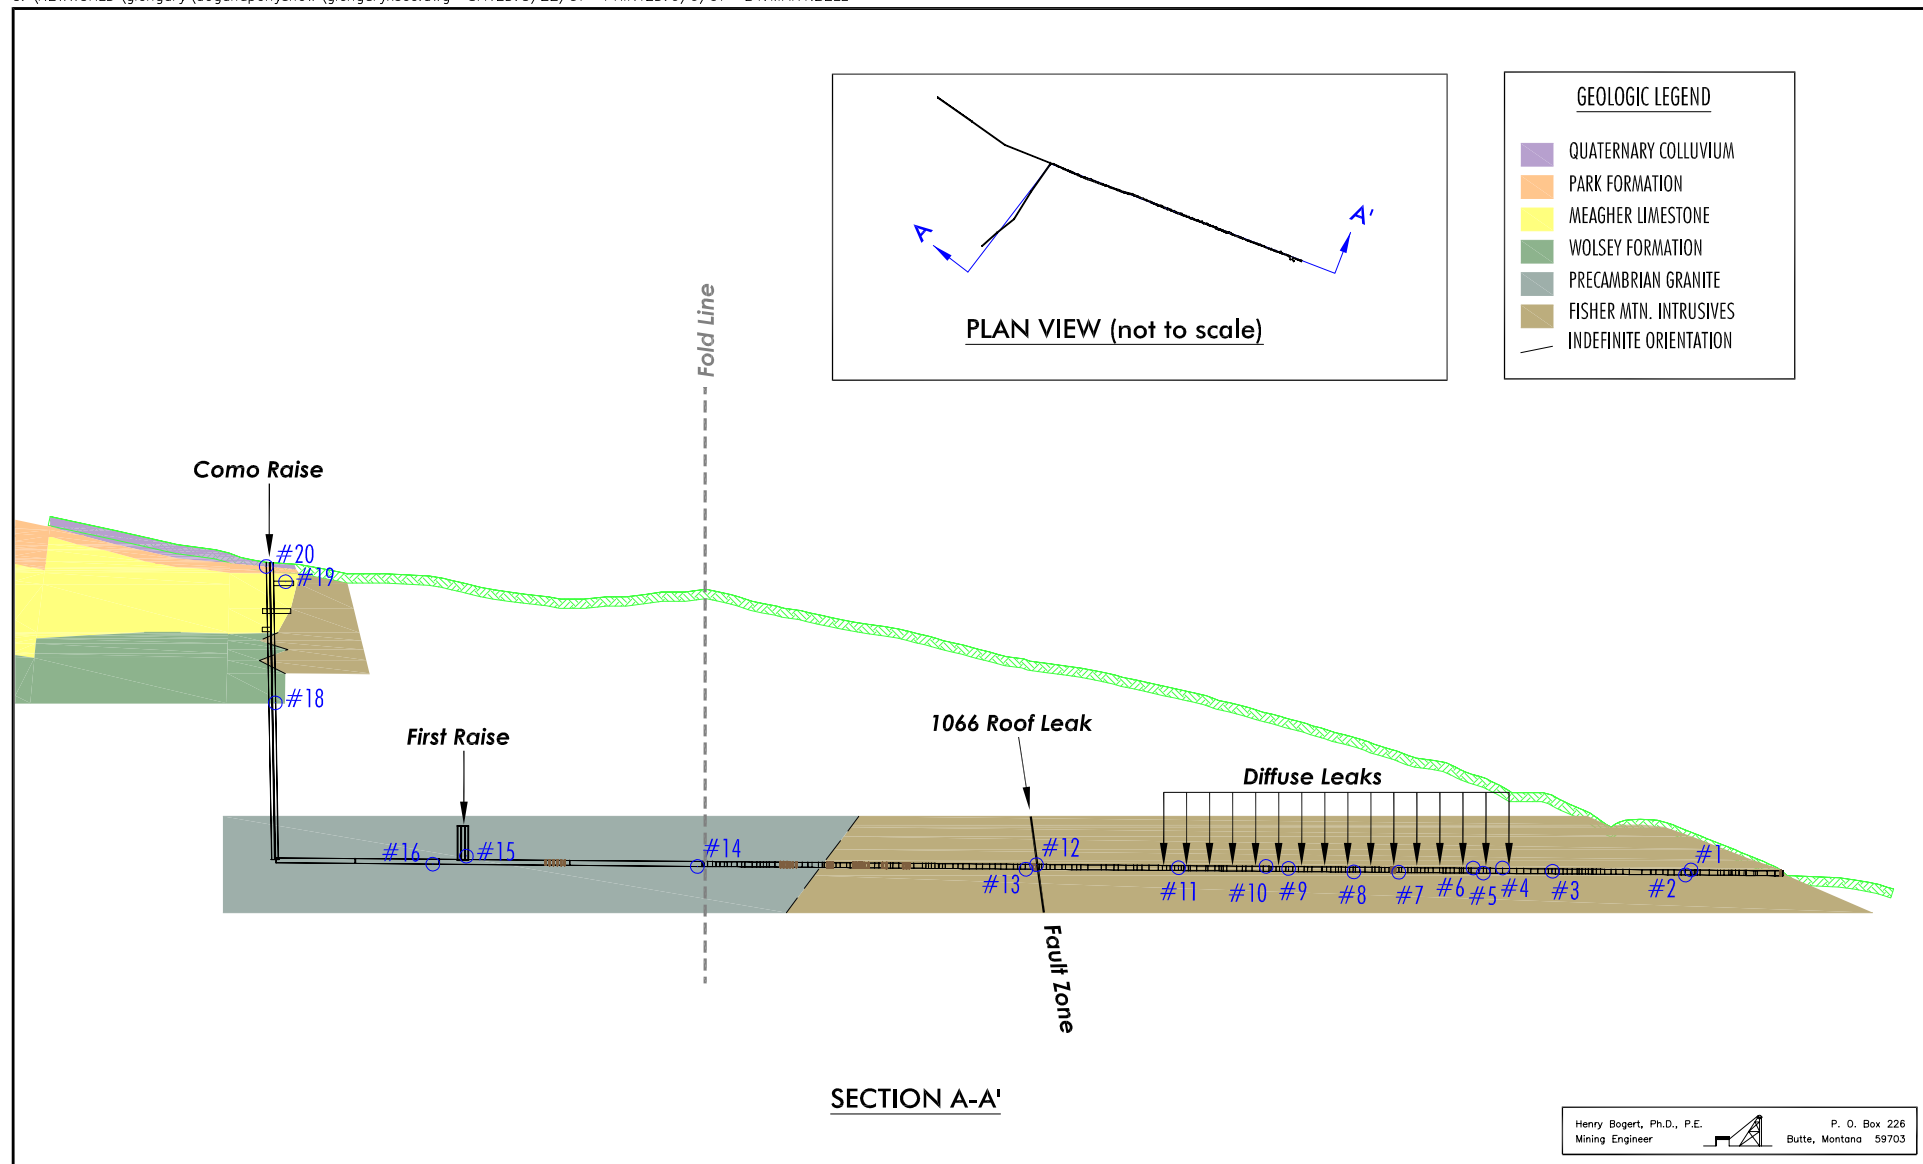
Cross-Section of the Glengarry Mine  
Showing Geology and Water Inflow  
New World Mining District  
Response and Restoration Project  
**FIGURE 3**

The following year in June 2001, the Como Raise was reopened from the surface downward to a depth of 66 meters (215 feet) where a small room with two pneumatic hoists was encountered. The rehabilitated portion of the raise crossed downward through about 1 to 2 meters (3 to 6 feet) of colluvium, 3 meters (10 feet) of Park Shale, 24 meters (80 feet) of silicified Meagher Limestone that was replaced by massive sulfide mineralization over the top 4.6 to 6.1 meters (15 to 20 feet), and about 37 meters (120 feet) into the underlying Wolsey Shale (**Figure 3**).

- 3) **1066 Roof Leak** - The 1066 roof leak (**Figure 3**, station No. 12) is associated with a fault 325 meters (1,066 feet) inward from the portal, and has a flow that varies seasonally from 9 to 49 Lpm (2.4 to 13 gpm). This flow is characterized by a pH of 4 to 5 su, 24 to 123 mg/L iron, and 0.0014 to 0.05 mg/L copper. Concentrations of aluminum (4 to 24 mg/L), arsenic (0.016 mg/L), and cadmium (0.0015 to 0.0032 mg/L), in water discharging from this structure are higher than concentrations in water discharging from the two raises.

A fourth, diffuse source, representing a collection of small, fracture-controlled roof leaks (**Figure 3**, station Nos. 1 through 11), are developed in bedrock between the portal and the 1066 roof leak. The diffuse roof leaks are dry in the winter but collectively contribute up to 57 Lpm (15 gpm) during snowmelt. These leaks exhibit a pH of 3 to 6 su, 2 to 10 mg/L iron, and 0.001 to 0.006 mg/L copper.

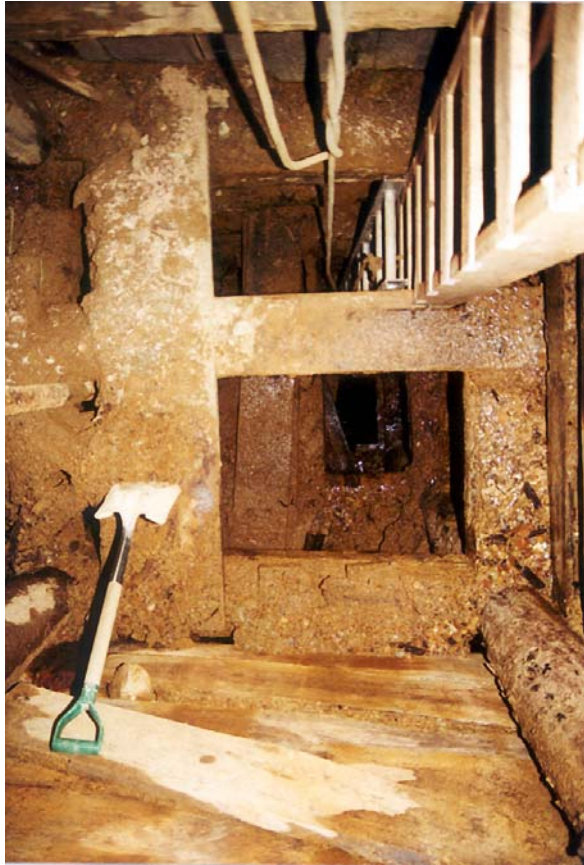
The Como Raise consists of two, 1.4-meter (4.5-feet), square-set compartments (**Figure 4**) and is offset horizontally in five places. Vertical distance between the peeled log timber sets is about 2 meters (6.5 feet). The north compartment contained ladders, landings and a timber slide; the south compartment was used as an ore pass. The ore pass was partially lined with 5-centimeter (2-inch) lacing in varying states of repair.

**Figure 4. Glengarry Mine Two Compartment Como Raise**

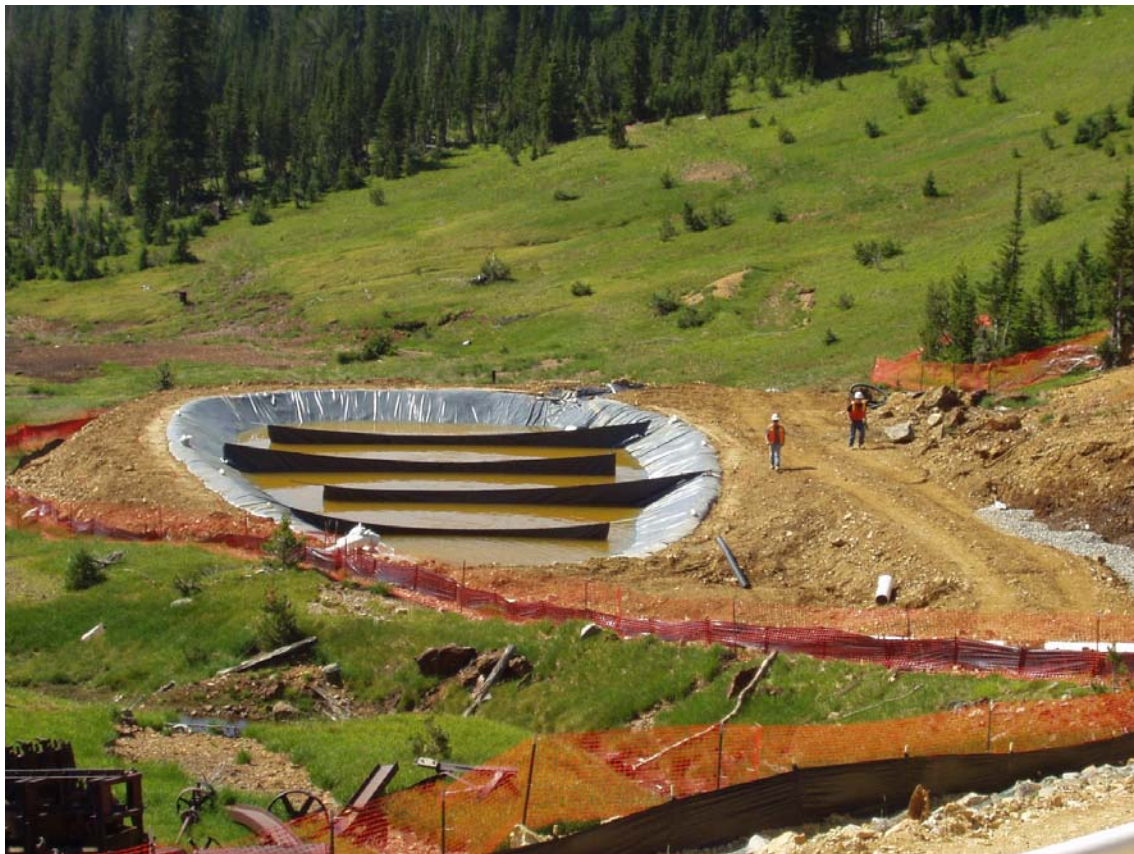
A second sediment pond (**Figure 8**) was constructed in 2003 and operated in conjunction with the primary settling pond to more effectively remove sediment before discharging to Fisher Creek during construction. The pond was designed to hold 300 cubic meters (392 cubic yards) of sediment with enough freeboard to treat water. The pond was fit to surface topography, lined with a non-woven geotextile and a polyvinyl chloride (PVC) liner. PVC baffles were constructed across the pond to lengthen the flow path through the pond and maximize settling of sediment. The site selected for pond excavation developed a wet seepage requiring the construction of an unanticipated underdrain system beneath the pond. The two ponds were connected with a 14-inch PVC discharge pipeline that fed discharge water from the upper primary sediment pond to

**Figure 8. Secondary Sediment Pond at the Glengarry Mine Site**

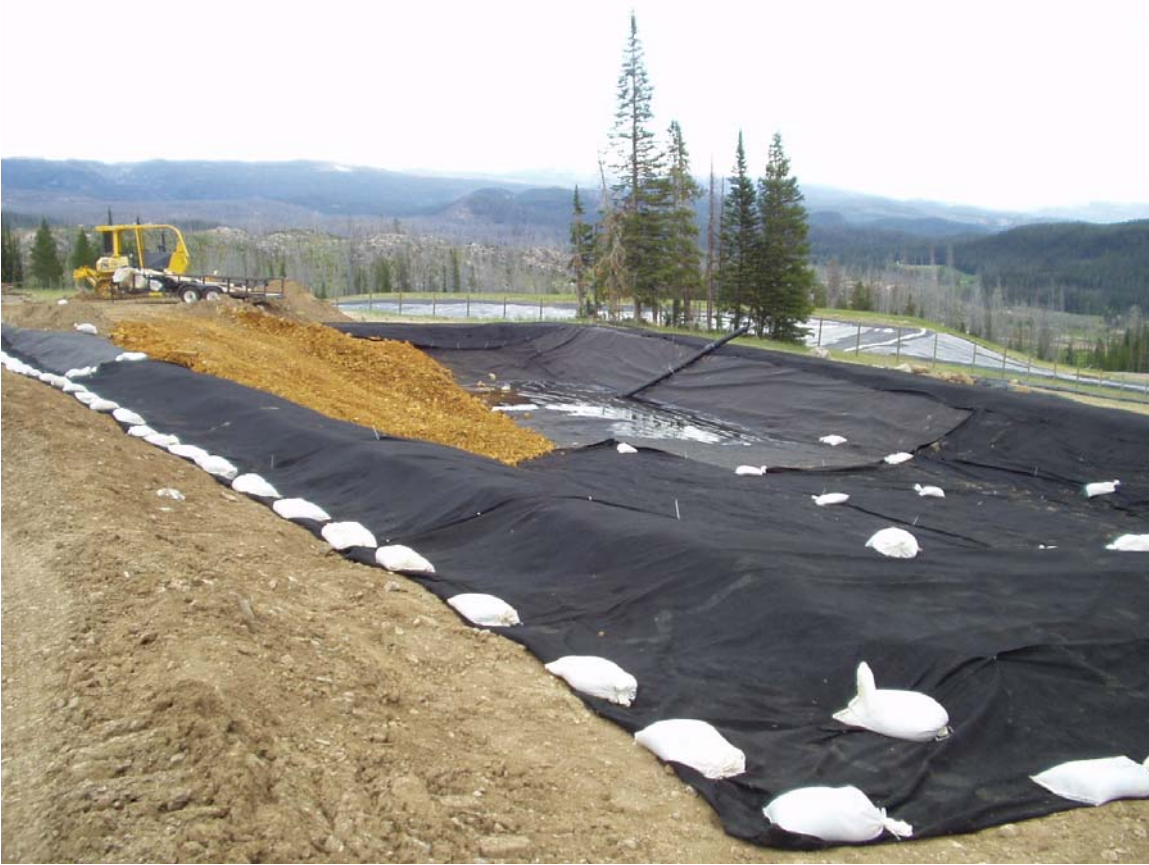
**Figure 9. Muck Storage Pad at the New World Waste Repository**

In all, 351 cubic meters (459 cubic yards) of rock and debris required mucking from the sill of the Glengarry Mine and transported to the muck storage pad. Material from the muck pad was ultimately placed in the waste repository and the muck pad removed under a separate contract.

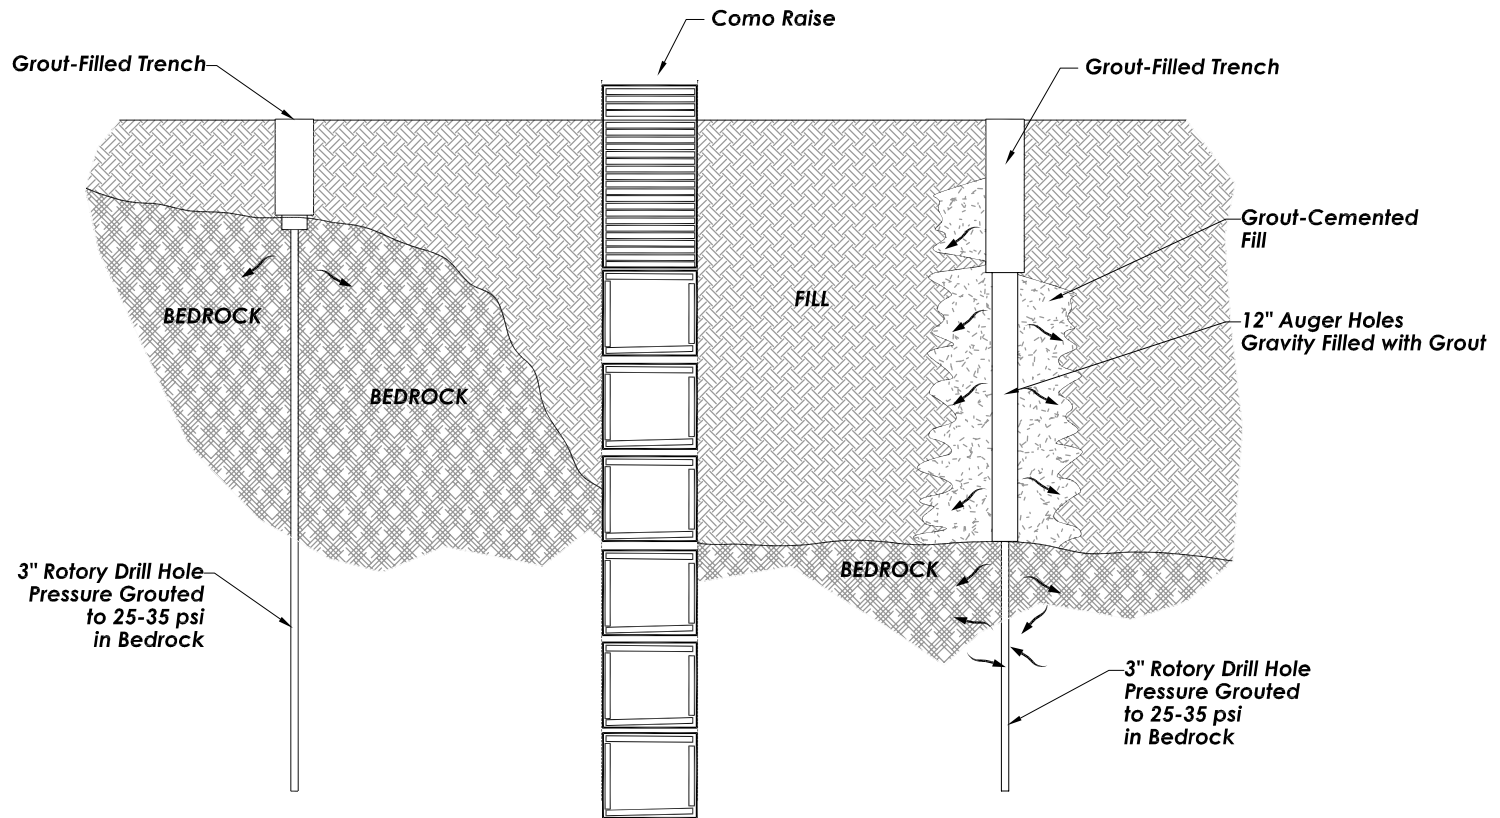
Detailed Cross-Section of the  
Como Raise Collar  
Grout Curtain  
FIGURE 11

The contract's proposed method of installing the grout curtain in shallow unconsolidated materials called for drilling 7.5-centimeter (cm) (3-inch) diameter holes through the colluvium, compacted backfill, and fractured, near-surface bedrock, and then using permeation grouting or jet grouting to construct the shallow portion of the grout curtain. The nature of the clay-rich colluvium and compacted backfill prohibited use of these grouting techniques, which resulted in a considerably different program for construction of the shallow portion of the grout curtain. This program is described below and illustrated in **Figure 11**.

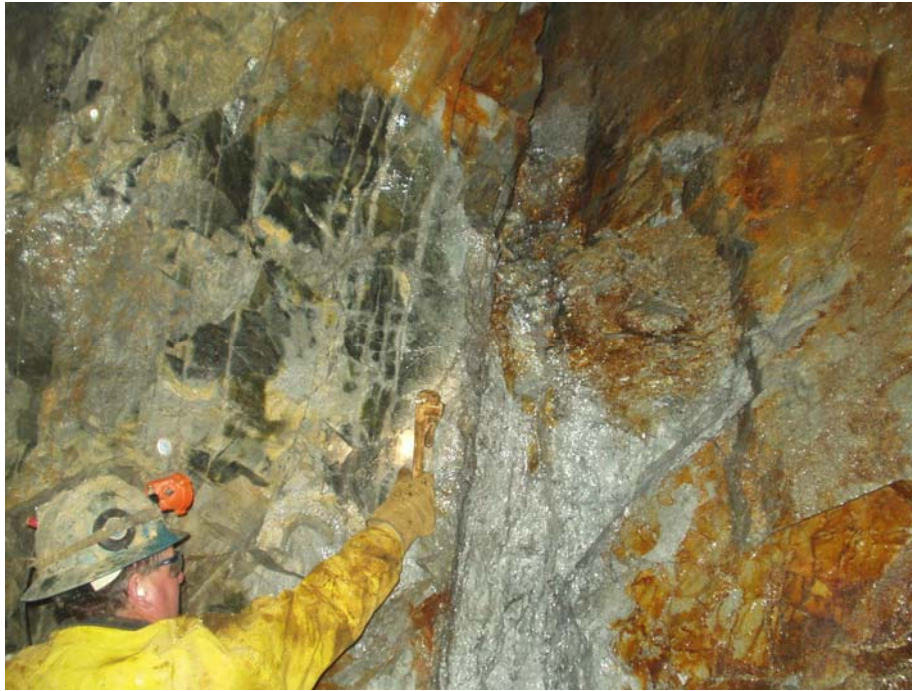
The zone of rock in the drift making water in the 1066 roof leak area was timbered, lagged and heavily covered with ferricrete stalactites when the workings were opened for assessment in 2000. Historical mapping of the Glengarry by DNRC and Kennecott in the mid-1970s (Kennecott, 1973; DNRC, 1974) had mapped the zone as a Tertiary porphyry dike that cut the adit at a very oblique angle trending N 35 W. The initial design called for drilling this water-bearing structure and placing an impermeable grout curtain around the drift from two drill stations, one either side of the structure. During rehabilitation for plug construction in 2003, rib lagging was removed from the timber sets through the 1066 zone, and the rock was scaled to expose bedrock through zone. The water-bearing interval was observed to be a fault that crossed the adit at about right angles (strike N 20 E, dip 73° east; drift trends N 60 W) rather

than the originally reported obliquely-oriented dike (**Figure 15**). Because of the different type of structure (fault versus dike) and its different orientation, the initial plan for drilling the zone was changed to construct one drill station in the drift about 24 meters (80 feet) toward the portal from the 1066 fault, or about 300 meters (984 feet) inward from the portal. The drill station was cut on both sides of the adit to drill the structure at right angles to the drift.

**Figure 15. Glengarry Mine 1066 Fault Zone in Altered Fisher Mountain Intrusive**

- The plans for drilling and grouting the 1066 roof leak changed after the timbers were stripped from the leaking zone, as the initially suspected dike turned out to be a fault that was oriented differently than believed from historical accounts. Because of this, one of the two original drill stations planned was deleted, and a larger drill station was constructed to drill the 1066 fault. As this drill station was much larger, the site was no longer suitable as a plug station so a new Plug Station #4 was constructed between the drill station and the 1066 fault. No modification was needed to the contract for this change as the work for the deleted drill station was traded for construction of the larger drill station. Additional work was required to clear timbers and muck from the 1066 zone than originally planned (in original contract as unit costs, part of Modification #3). Because the fault zone had stopped vertically and laterally upward into the back of the mine, a bulkhead was needed to allow completion of a grout curtain around the fault (part of Modification #4).

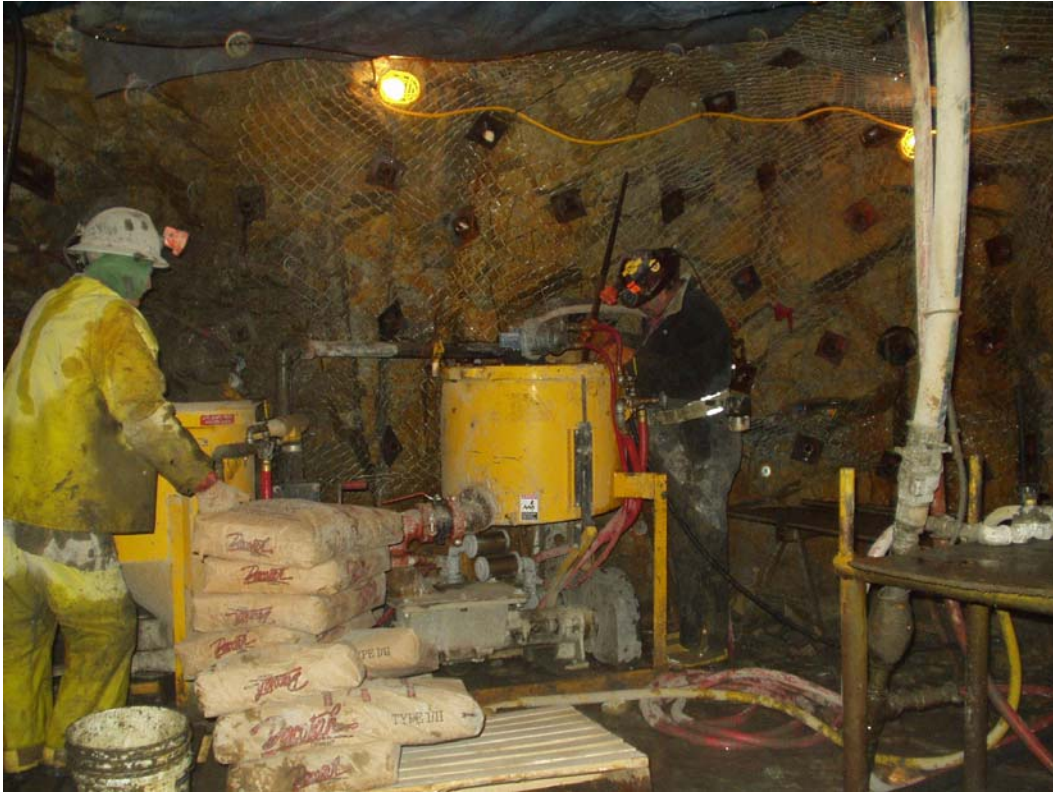
Primary and secondary holes were initially grouted with microfine grout in order to force fine grout out into distal fractures and were then finished with Portland cement grout (**Figure 17**). All holes were grouted to refusal (no grout take for 20 minutes at 150 psi). Primary holes took 1,243 gallons of grout (166 cubic feet) using 4.28 dry tons of grout (5 sacks of grout per cubic yard of mix). Secondary holes took 1333 gallons of grout (178 cubic feet) using 2.74 tons of grout. Grout for secondary holes was much less viscous (2.5 to 3 grout sacks per cubic yard of mix). All holes were shut in using pump-through valves after completion of pressure grouting. During grouting of the fault zone, flow at the cemented bulkhead went from 19 Lpm (5 gpm) on October 22 to less than 0.5 gpm on October 28. Grouting of secondary hole S4 on the second to last day of active grouting shut off almost all flow from the bulkhead fracture leaks. Flow at the portal for the same period was reduced from 189 to 103 Lpm (50 to 27.3 gpm).

**Figure 17. Grouting the 1066 Fault Zone**

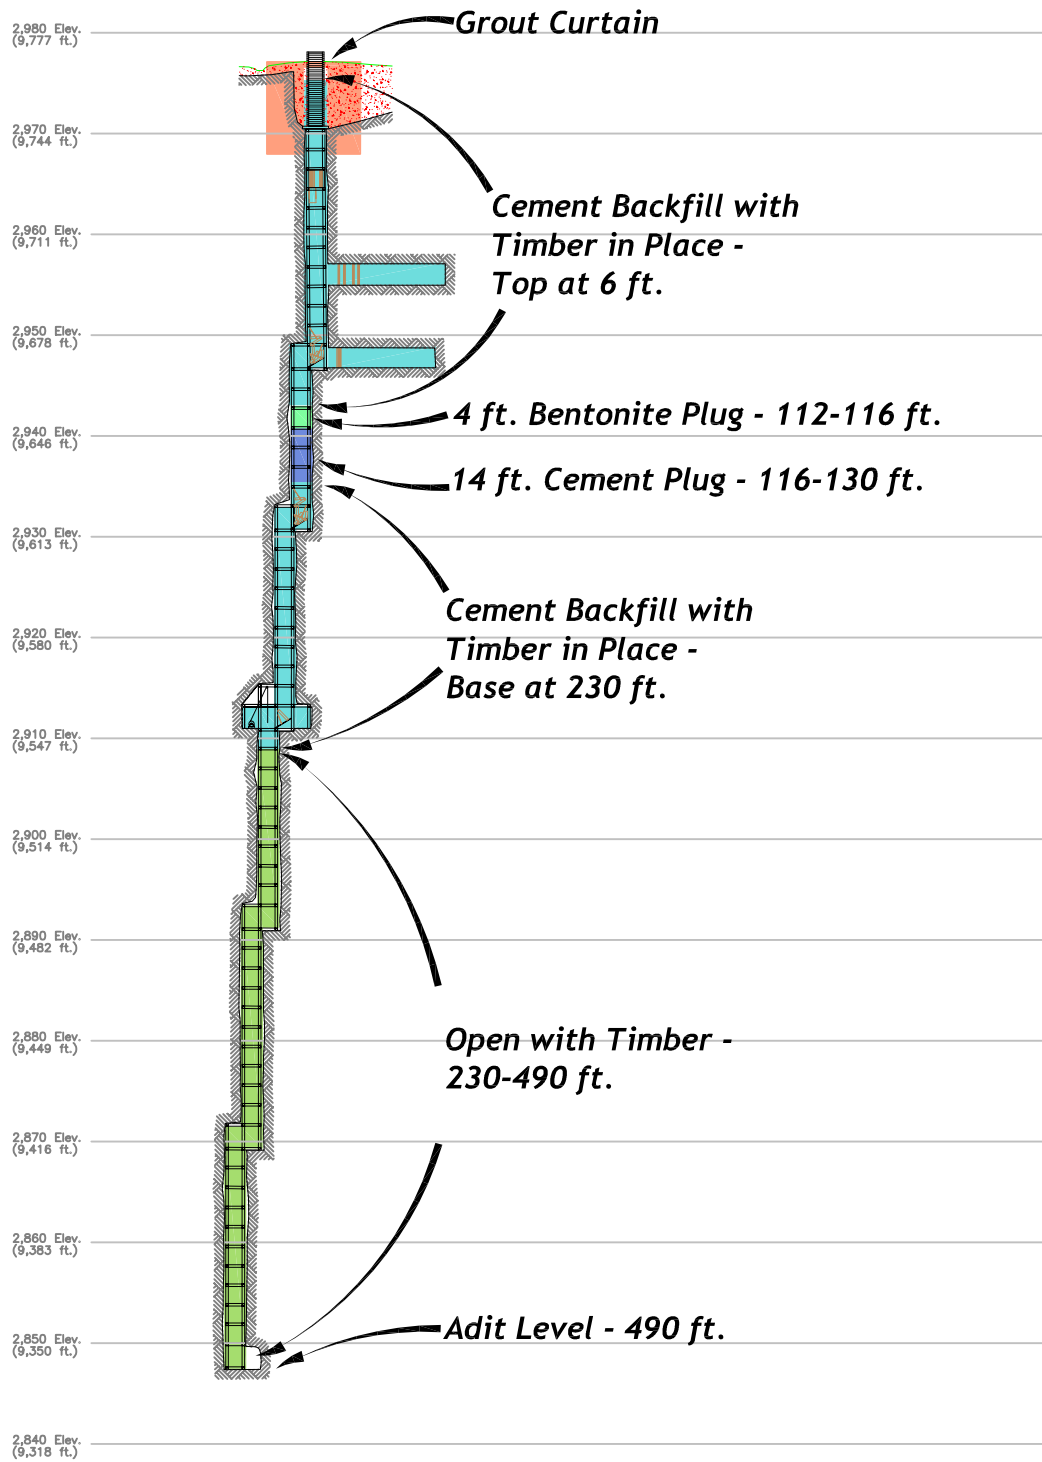
chosen to place the plug in the relatively impermeable Wolsey Shale Formation and below any water producing intervals in the overlying Meagher Limestone. This new location was also selected to avoid offsets in the raise (**Figure 18**) and to site the watertight plug in a portion of the raise with a minimum amount of rock fill debris between the lagging and the ribs, and in an interval in which the lagging was largely broken or rotted away.

Concrete was initially placed on the bulkhead from a continuous, 15 cubic meter (20 cubic yard) per hour batch plant at the surface (**Figure 20**). Cement was pumped from the batch plant via a push-piston pump through a 10.2-centimeters (4-inch) high-pressure flexible hose to a 15-centimeter (6-inch) HDPE tremi pipe for delivery down the raise. The HDPE pipe was cut off in stages as cement levels were advanced up the raise during backfilling. The first lift of cement was poured on August 17 and was about 1-meter (3.3-feet) thick (9.9 cubic yards). This first lift was allowed to set for 24 hours. The second and third lifts (August 18 and 19) were about 3.2-meters (10.5-feet) thick (31.3 and 30.7 cubic yards, respectively) and were also allowed to set up for 24 hours between pours. The raise was backfilled in two successive pours on August 24 and 27 and consisted of 78.8 and 82 cubic yards of placed concrete (**Figure 21**). These two pours brought the level of the backfill to the bottom of the watertight plug site, about 39 meters (128 feet) below the raise collar (**Figure 18**).

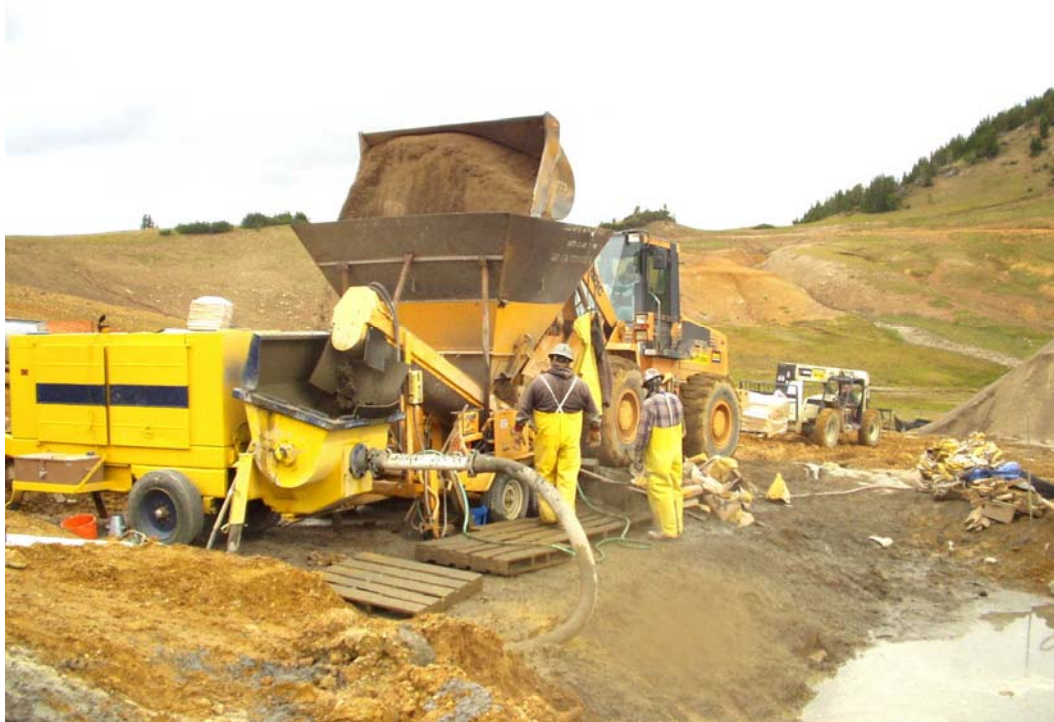
**Figure 20. Continuous 15 Cubic Meter/Hour Concrete Batch Plant at the Como Raise**

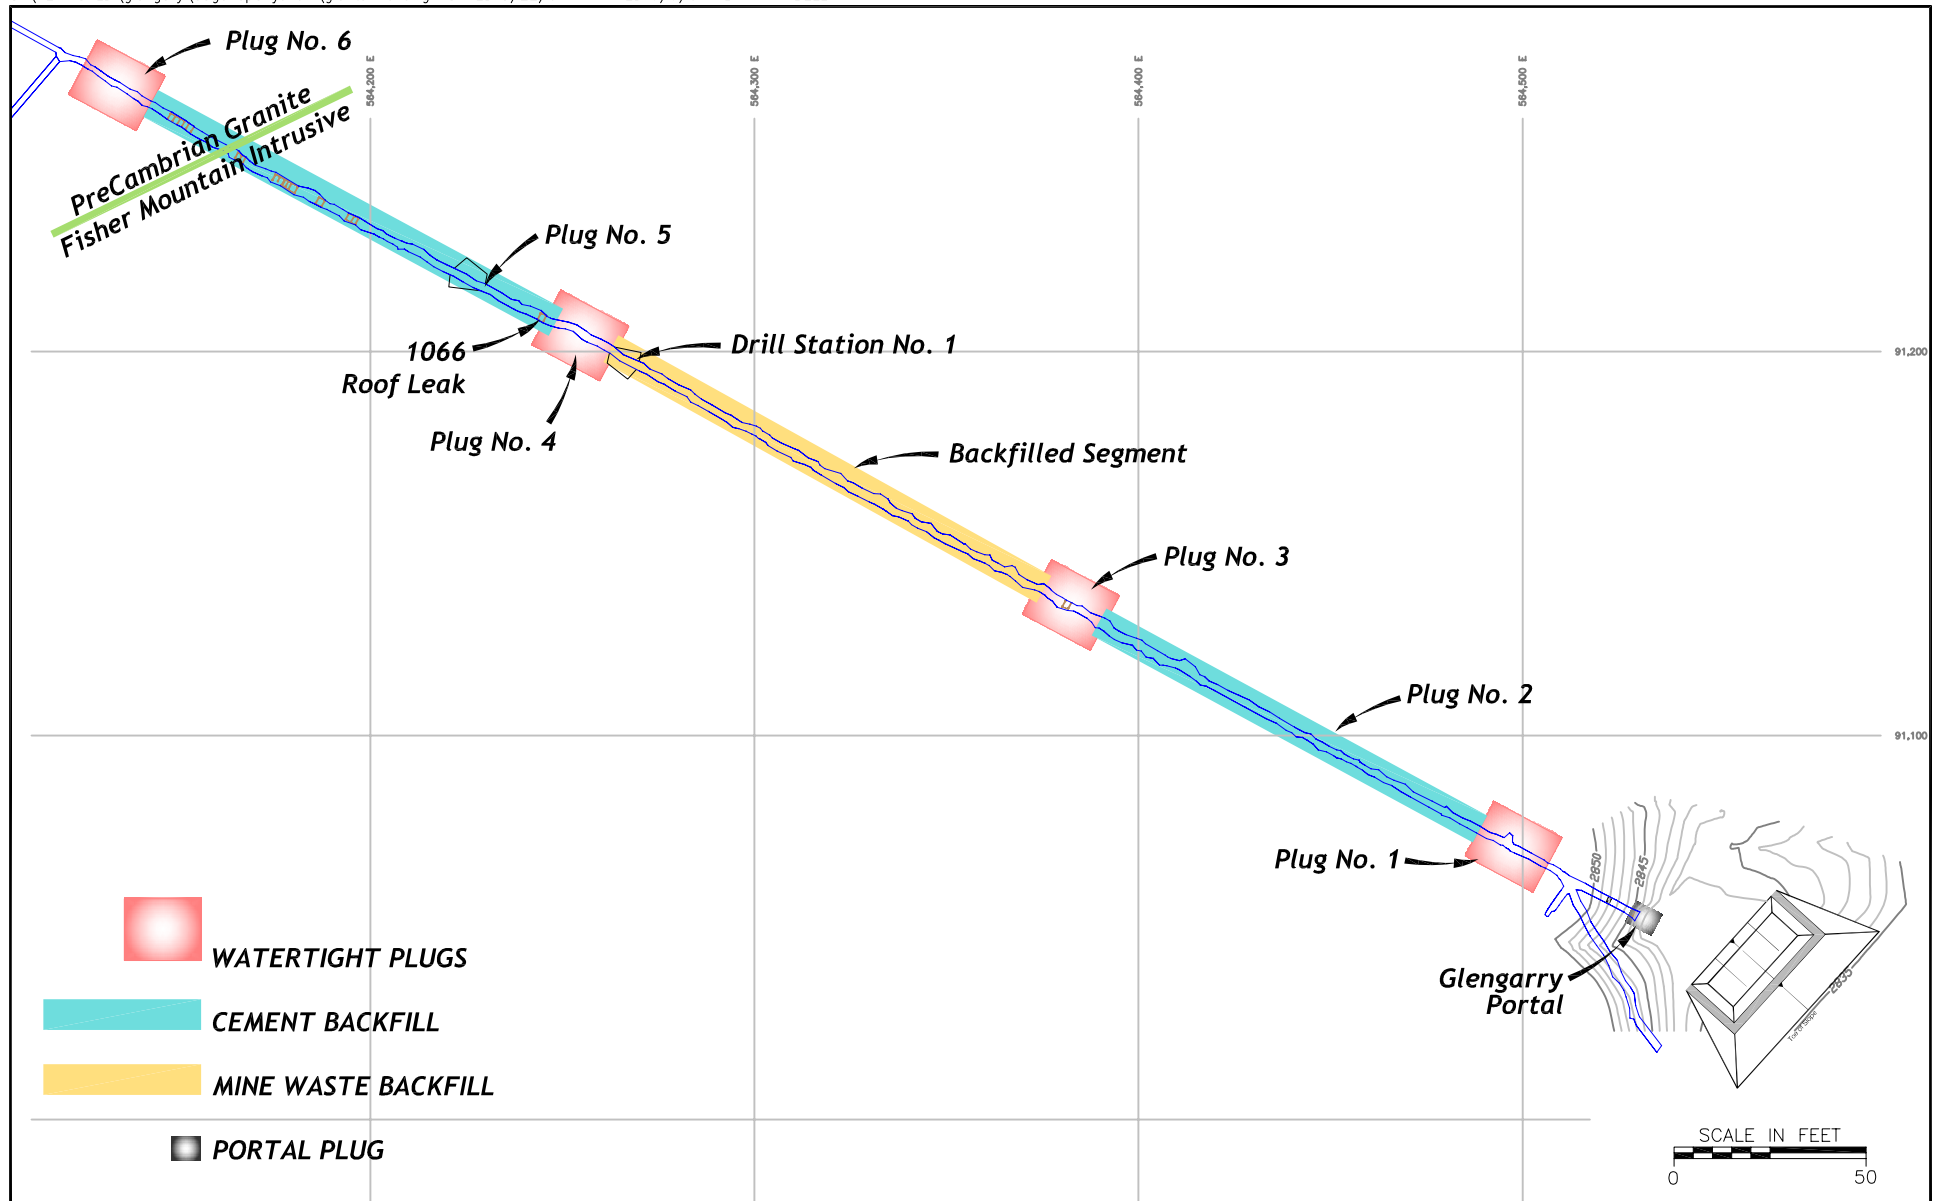
Plan Map of Adit Plugs  
and Backfill Segments  
New World Mining District  
Response and Restoration Project  
FIGURE 24

Two segments of the workings between Plug Nos. 4 and 6 and Plug Nos. 1 and 3 (**Figure 24**) were filled from Drill Station Nos. 2 and 5 with long, cemented-fill plugs. These long plugs were designed to provide a structural fill for ground support around and between the watertight plugs in the event the workings collapse. Segments were filled by connecting a 3-inch HDPE pipe to the bottom of a 3-inch drill hole casing, running the pipe along the drift, and pouring cement on the sill of the workings between short wooden stop dams. In this manner, the long plugs were filled for most the plug interval to within 30 to 45 centimeters (12 to 18 inches) of the back (**Figure 28**). Plug Nos. 5 and 2 were poured in 2004 and 2005, respectively.

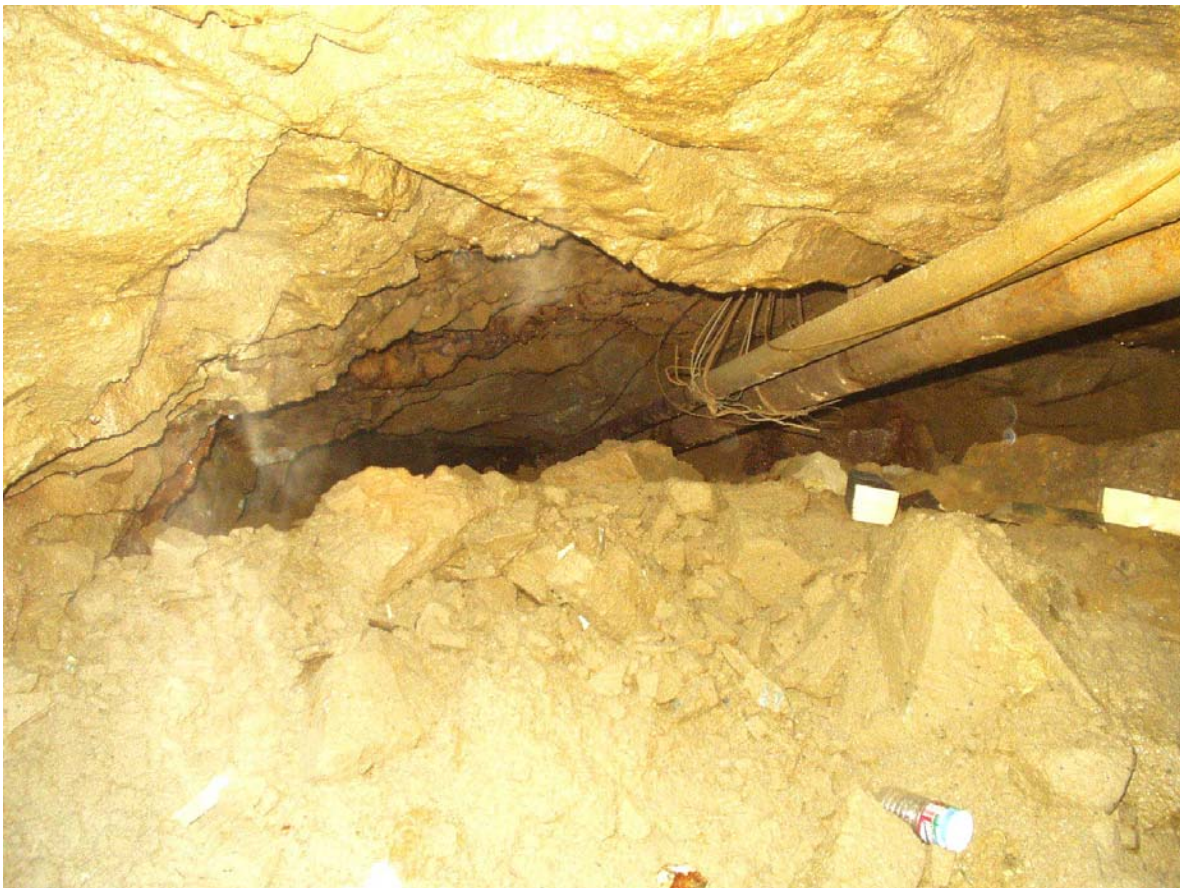
**Figure 29. Waste Rock Backfilled Segment**

One 178-meter (584-feet) segment of the workings between Plug Nos. 3 and 4 (**Figure 29**) was filled with rock generated from drill station construction to act as a structural fill. In all, about 900 cubic meters (1,177 cubic yards) of rock was used to fill this interval. This backfilled section was completed between October 6 and 11, 2004.

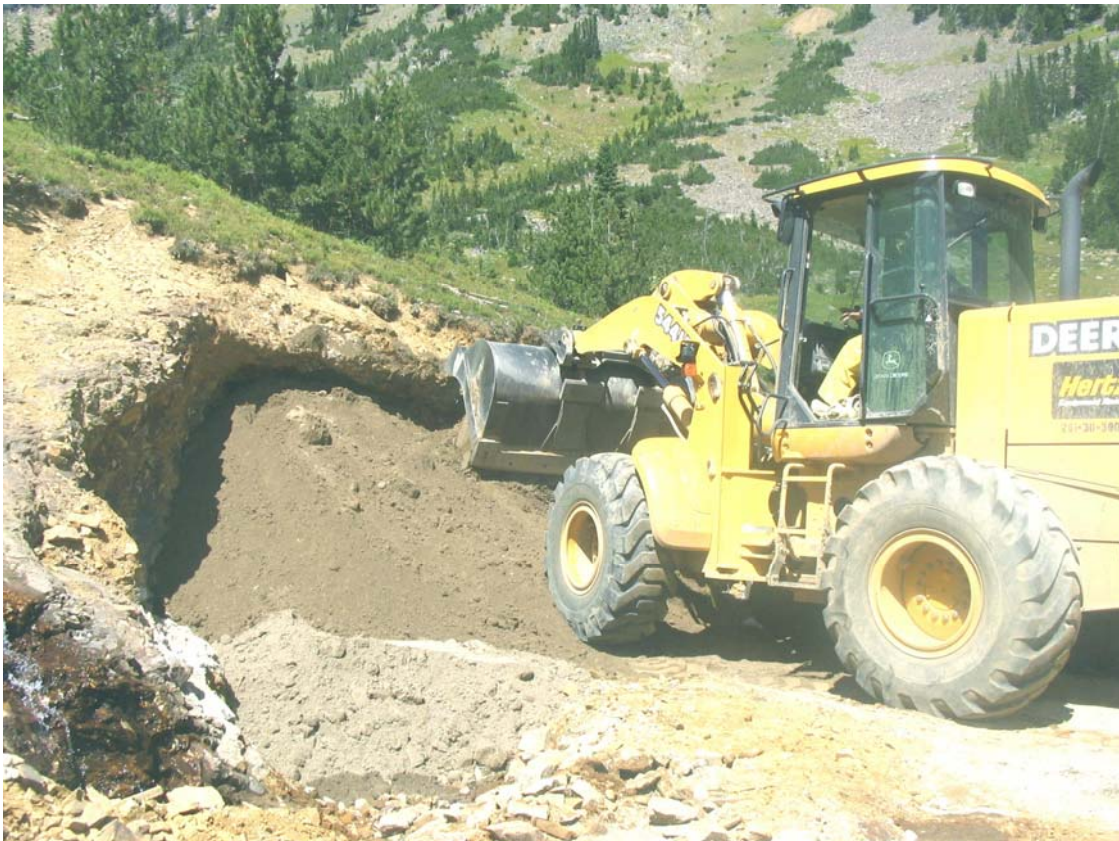
A portal plug was constructed to allow for final surface revegetation of the portal pad site as additional work (Modification #15) to the contract (**Figure 30**). The sill in the portal area from 3.7 meters (12 feet) outside of the brow to 7 meters (23 feet) inside of the brow was covered with a 30- to 46-centimeter (12- to 18-inch) thick layer of rounded cobbles to act as a drainage layer. The cobbles were covered with 1.3-centimeter (0.5-inch) thick non-woven geotextile fabric and the portal backfilled with leftover cement aggregate (3/8-inch minus) and compacted with a mucker or loader bucket. The toe area of the backfill was wet but no flow was observed from the former adit. In all, 6.9 cubic meters (9 cubic yards) of cobbles and 34 cubic meters (45 cubic yards) of aggregate were used in the Glengarry portal closure.

**Figure 30. Backfilled Adit Portal Plug**

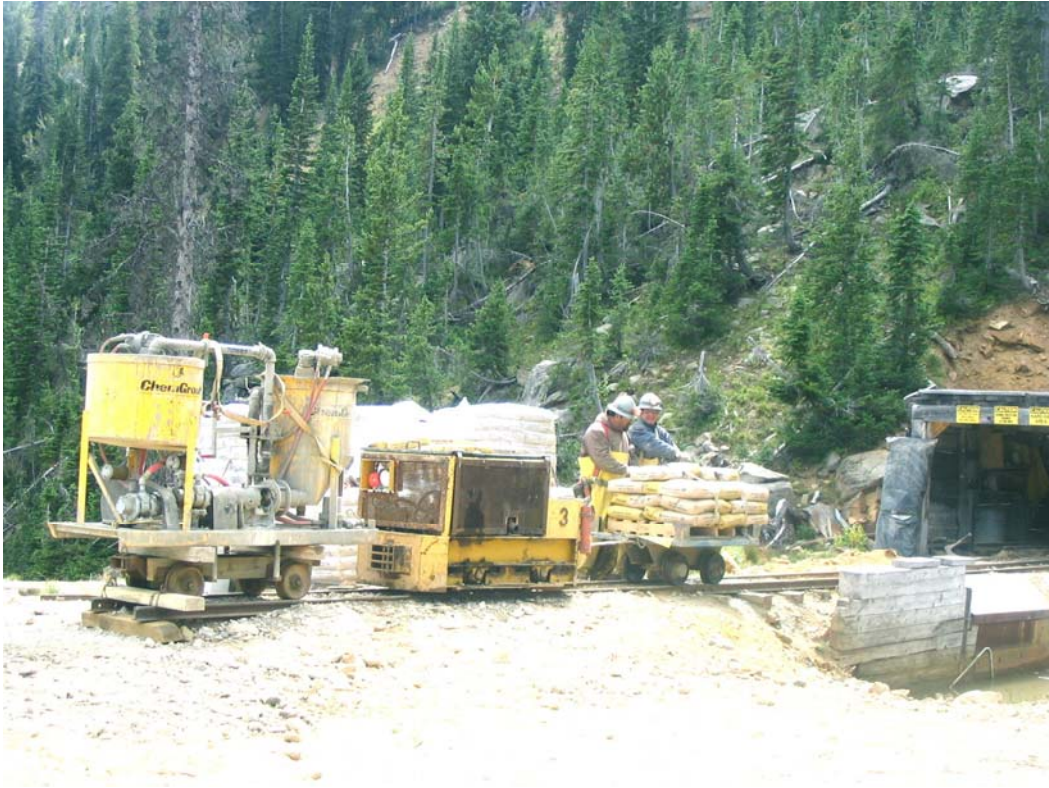
On July 25, 2005, HBI undertook underground rehabilitation of the Gold Dust workings by clearing caves along the railroad track that was still useable in the mine, resetting the track gauge, reestablishing ventilation, repairing electrical utilities, and setting underground pumps for grouting. A locomotive, timber car and ventilation fan were mobilized to the site to assist with grouting work (**Figure 31**).

**Figure 31. Gold Dust Adit Rehabilitation**
