Construction Report

McLaren Adit Closure, Road Reclamation, and Revegetation Contract

Contract AG-0398-C-10-0023
2010-2011

New World Mining District
Response and Restoration Project

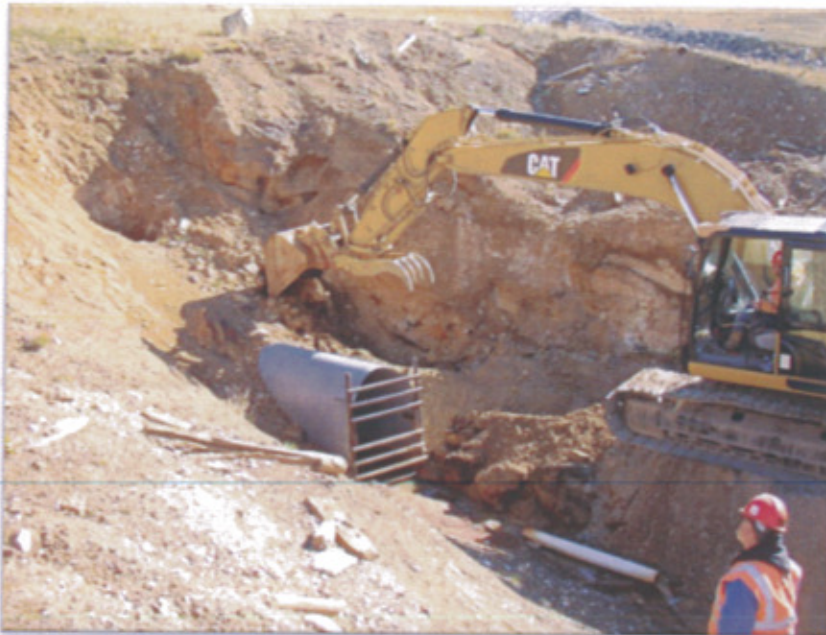
Owing to the late issuance of the Notice to Proceed, the Contractor and COR decided to limit the work during 2010 to the McLaren Adit closure. The Contractor mobilized to the site on September 9, 2010. Debris which had fallen from the roof of the adit was impounding a small amount of water. The Contractor commenced with pumping this impounded water to the existing rock-lined channel. Following dewatering, the Contractor removed an existing 20 ft by 5 ft culvert which was serving as access into the adit, and cleaned the portal area of loose debris (Photograph 1).

Photograph 1 – Stabilizing McLaren Adit prior to Entry

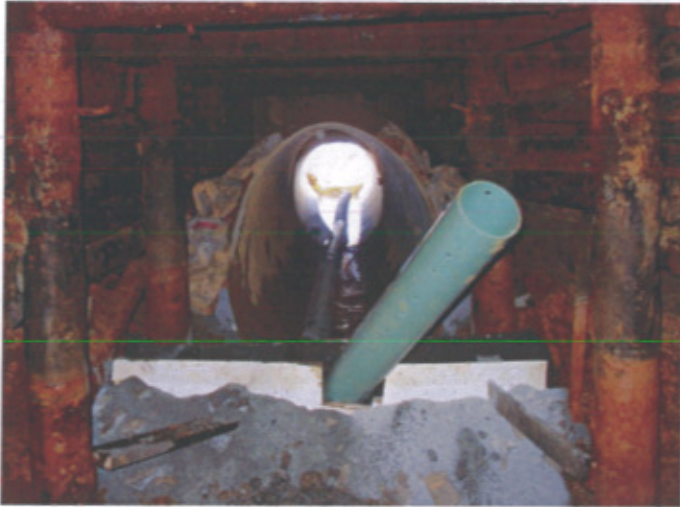
Photograph 2 – Concrete crib wall inside the McLaren Adit

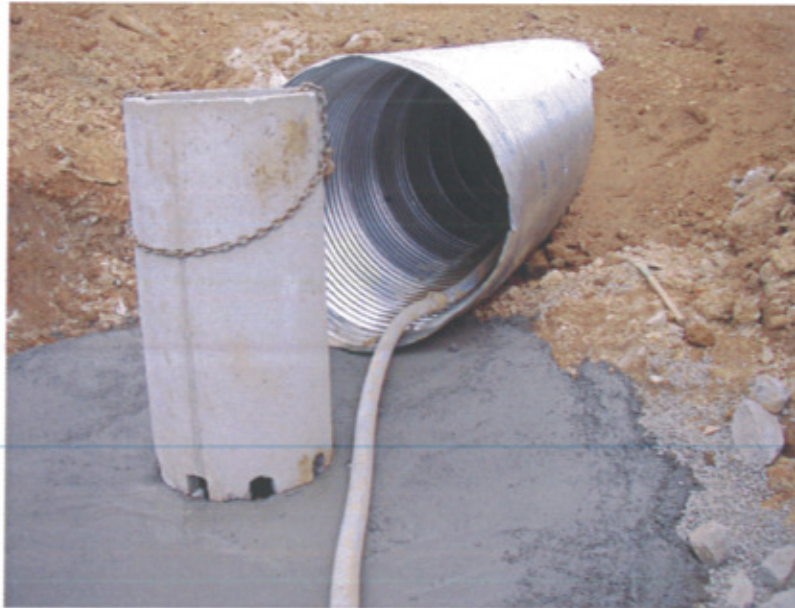
Photograph 3 – Riser and Concrete Pad – McLaren Adit Water Collection System

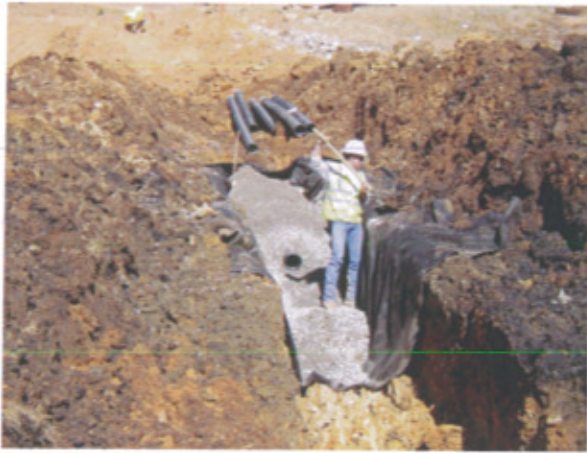
Photograph 4 – McLaren Adit Water Discharge Line

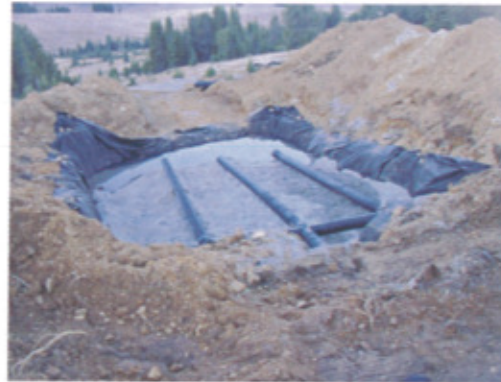
The infiltration gallery is a 30 ft x 30 ft x 5 ft excavation lined with non-woven geotextile and backfilled with 2 ft of $\frac{3}{4}$ in washed gravel. The 8 in solid line transitioned to three 8 in perforated lines at the infiltration gallery which disperses the adit water much as a septic drain field is designed to do (Photograph 5).

Photograph 5 – McLaren Adit Infiltration Gallery

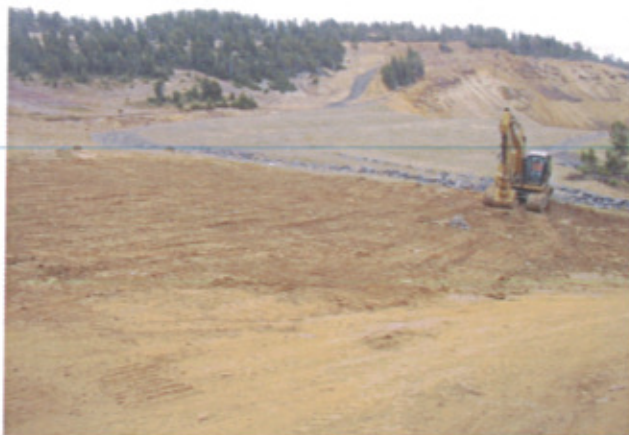
To complete the work for the year, the McLaren Adit portal area was backfilled with clean borrow material and graded to tie into the adjacent topography. The discharge line and infiltration gallery were covered with 4 ft of soil and the sites graded.

Photograph 6 – McLaren Adit Backfilled and Regraded

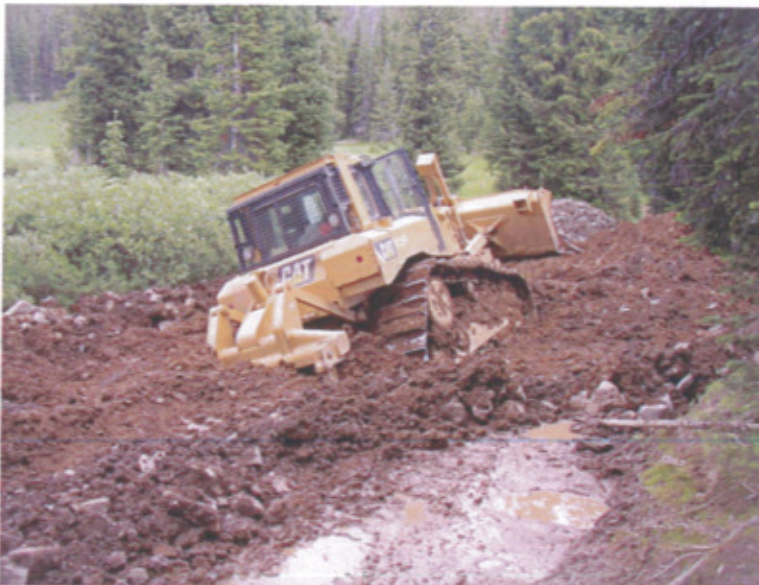
Photograph 7 – Unstable Road Subgrade (Lake Abundance Road)

locations with areas of standing water and abundant groundwater seeps. After one pass by the haul trucks the road surface was severely rutted and soon became impassable. Both a haul truck and one of the D6 dozers became mired in a particularly soft area. The Contractor and COR decided to pull off the *Lake Abundance Road* until ground conditions improved. The Contractor transferred the Lake Abundance crew to the *McLaren View Road* where they installed 2 new culverts and constructed a 100 ft x 200 ft parking area for vehicles and trailers.

The COR and Contractor discussed options for stabilizing the soft areas along the *Lake Abundance Road*. The use of geogrid as a reinforcing underlayment was explored but quickly abandoned as being too expensive. It was decided to use coarse rock, of which there was an ample supply in the staging area, and non-woven geotextile fabric as subgrade support to bridge over the soft sections. The Contractor resumed work on the *Lake Abundance Road* on September 10, 2011. Three sections of the road received subgrade stabilization. Soft road materials were excavated from the road prism and set aside. A layer of non-woven geotextile was placed over the excavated section and covered with a minimum 18 in of 5 in minus rock.

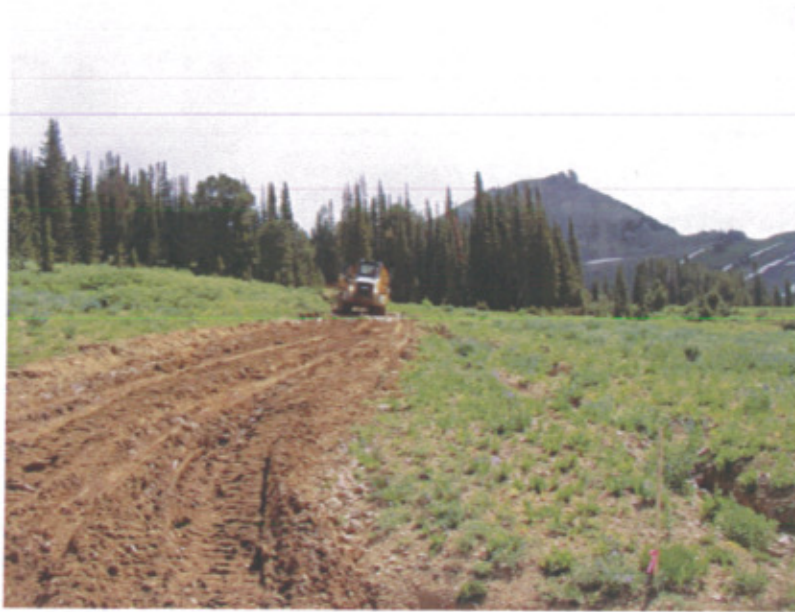
Photograph 8 – Unstable Sub-Grade along the Lake Abundance Road

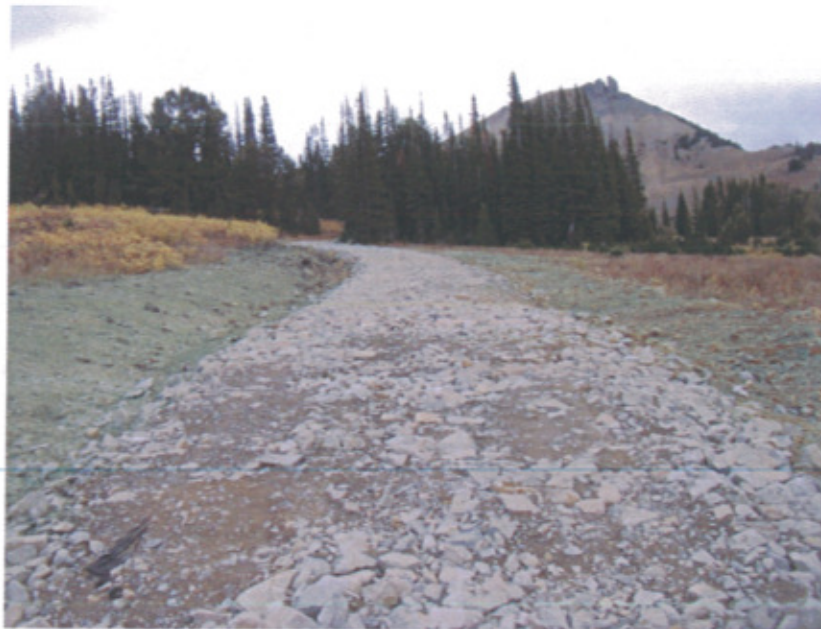
Photograph 9 – Same Section of Road after Stabilization

Approximately 2,000 ft of roadway was stabilized using this technique. The cost to the project was an additional \$45,600.

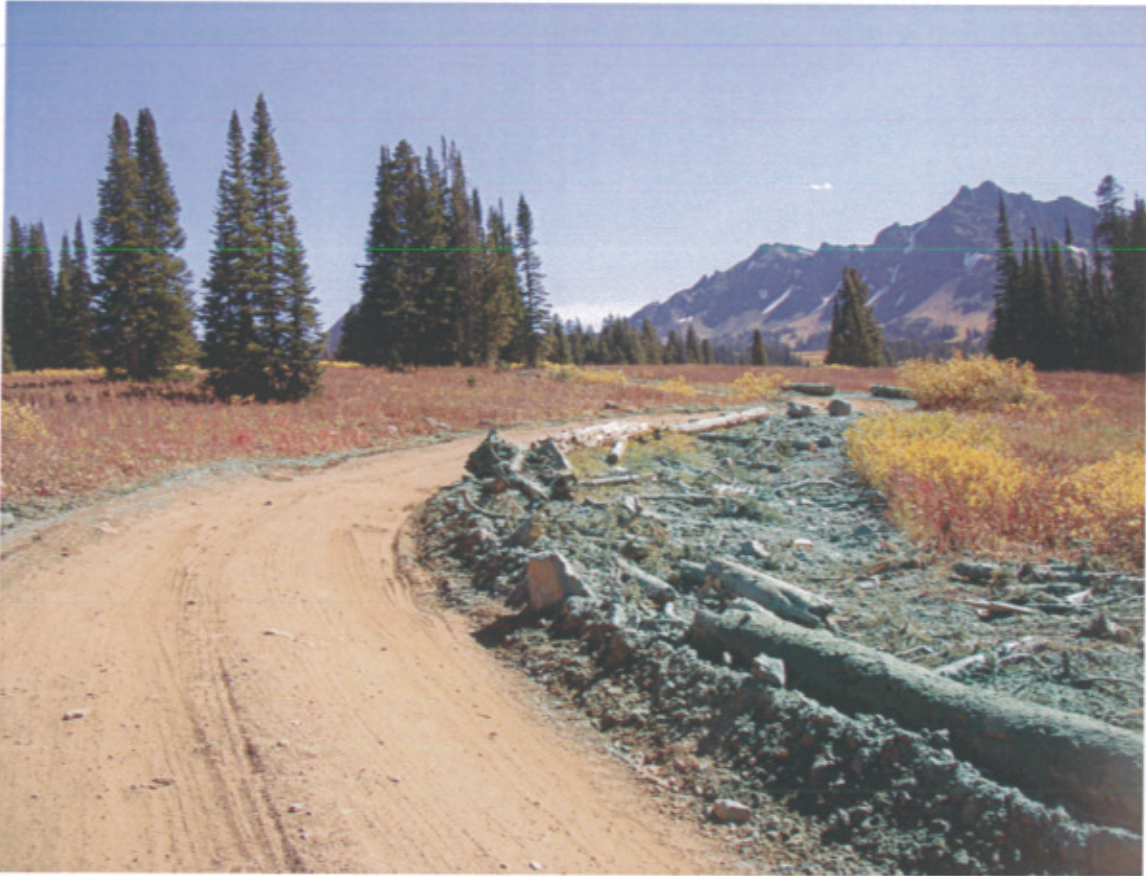
Culverts, run-off ditches, and armored fords were also installed at strategic locations along the 3.3 mi length of the *Lake Abundance Road*. The Contractor also defined the primary roadway to a single vehicle width and reclaimed sections where multiple pathways had been developed over the years (Photograph 10).

Photograph 10 – Section of Lake Abundance Road Reclaimed to Single Lane

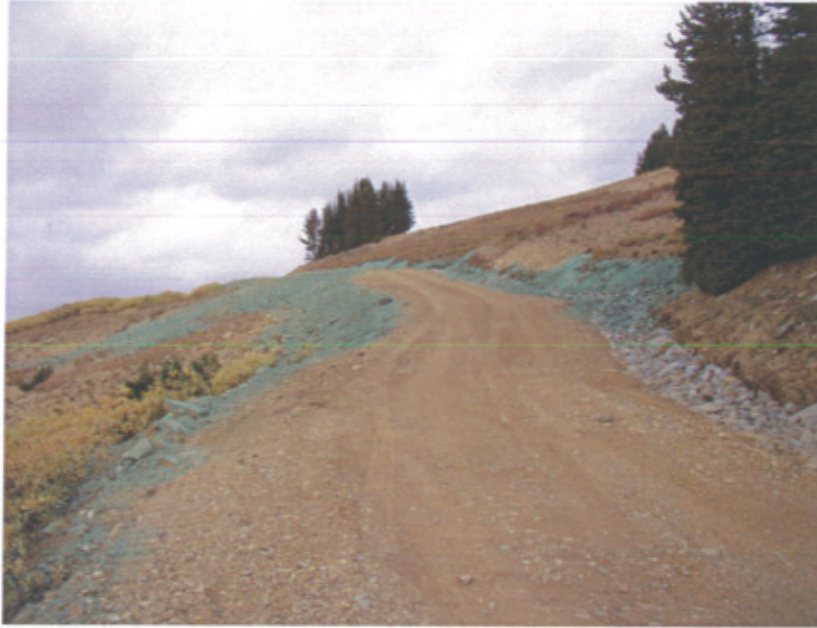
Photograph 11 – Armored Ditch along the Daisy Pass County Road

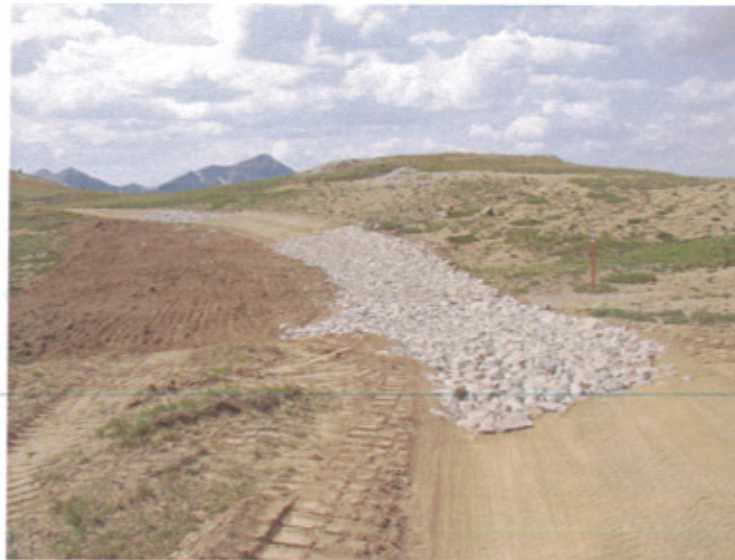
Photograph 12 – Belly Fill along the Scotch Bonnet Road

Additional coarse rock armoring was also placed along sections of the *Scotch Bonnet Road* in sections where snow remained late into the summer. The roadbed through these areas was soft and often rutted from vehicle traffic, and the coarse rock “belly fills” will help maintain a stable and trafficable surface.

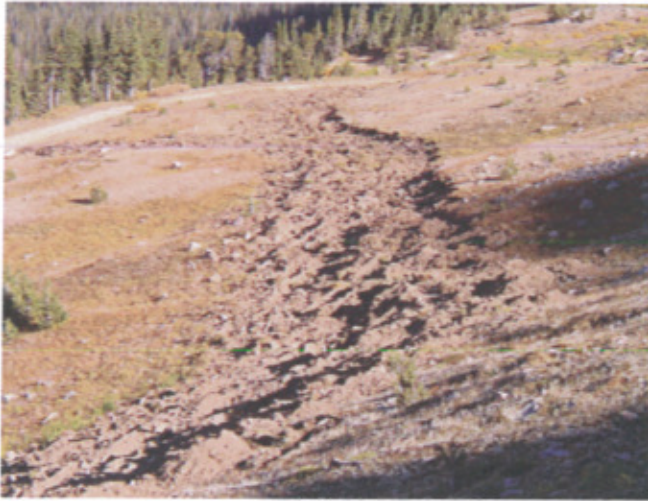
The Contractor reclaimed approximately 1,500 ft of the *Upper Henderson Road* (Photograph 13) starting from its intersection with the *Henderson Mountain Road*. The remaining 800 ft of the road traversed a steep and unstable hillside and was already sloughing from snow slides and slope creep. The COR decided

Photograph 13 – Reclaimed section of the *Upper Henderson Mtn. Road*

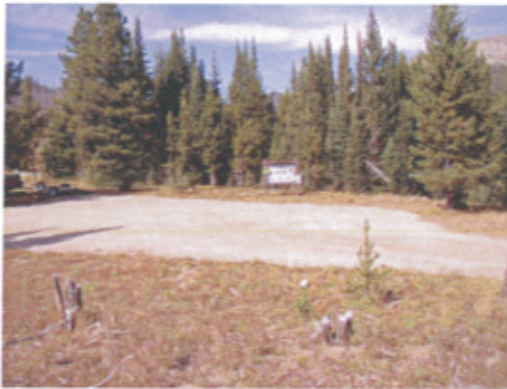
At the *Lady of the Lake Trailhead Spur Road*, $\frac{3}{4}$ in crushed gravel was placed and compacted on the road and on a small parking area. (Photograph 15)

Photograph 15 – *Lady of the Lake Trailhead*

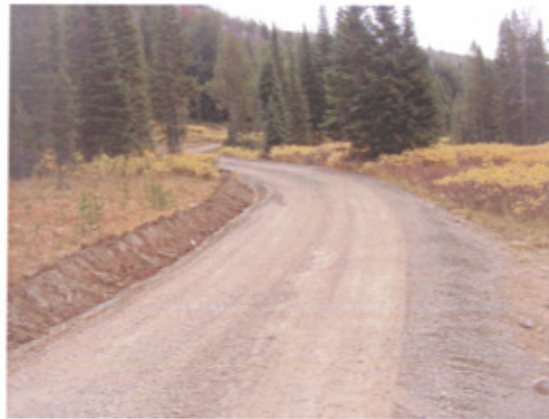
Several 100 ft sections of the heavily trafficked *Lulu Pass County Road* received up to 12 in of road base in areas where the running surface was soft and unstable. Side ditches were also cleaned and reestablished, and the road graded (Photograph 14).

Photograph 14 – *Lulu Pass County Road*

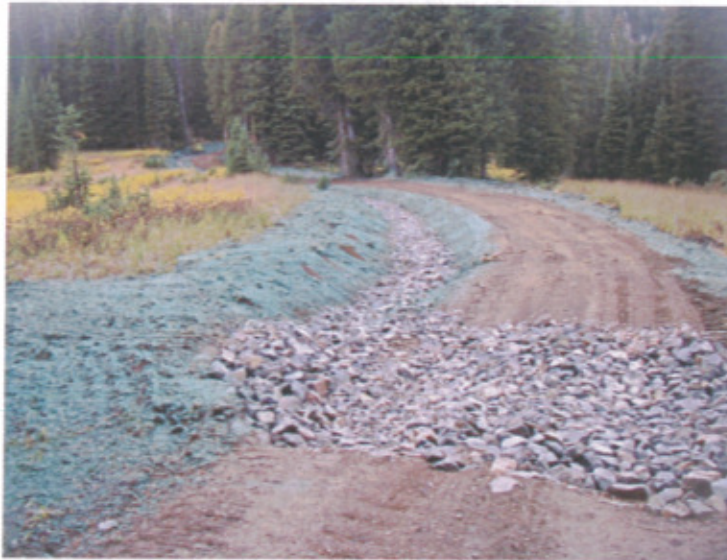
The *Miller Creek Road* required armored side ditches and subgrade stabilization over what was estimated in the contract due to extensive surface water discharge and poor ground conditions. There was near surface groundwater and numerous water seeps along a 0.5 mi section of the road starting at the Miller Creek crossing. The seeps and groundwater softened the road subgrade, and in places discharged onto the road creating a soft road surface. The COR directed the Contractor to place geotextile fabric and

coarse rock in locations requiring stabilization, and rock armor in side ditches in areas of obvious water discharge (Photograph 16).

Photograph 16 – Water Management along the Miller Creek Road

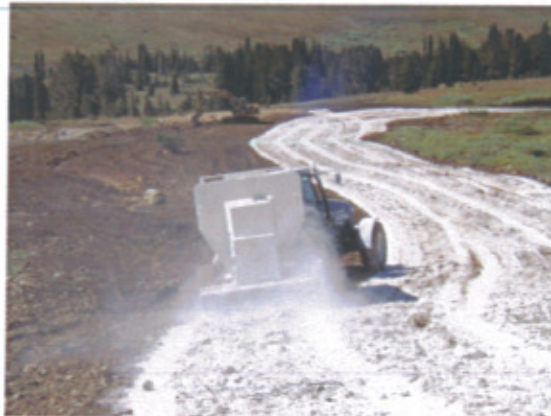
Photograph 17 – Spreading Lime below the McLaren Adit

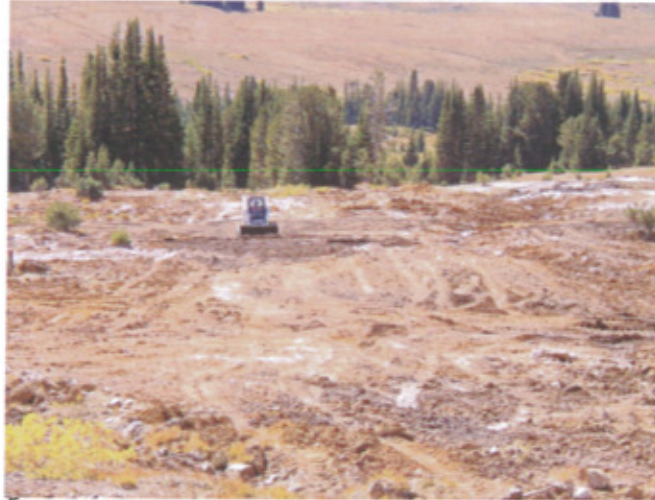
Photograph 18 – Applying Compost below the McLaren Adit

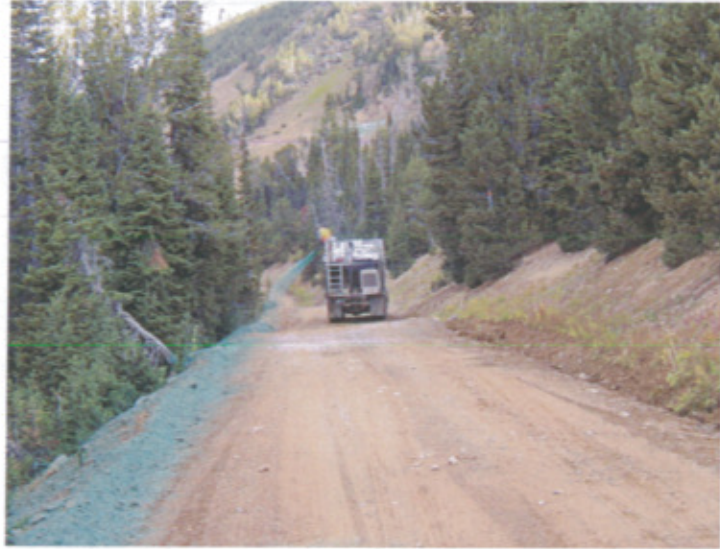
Photograph 20 – Hydroseeding along the *Daisy Pass County Road*

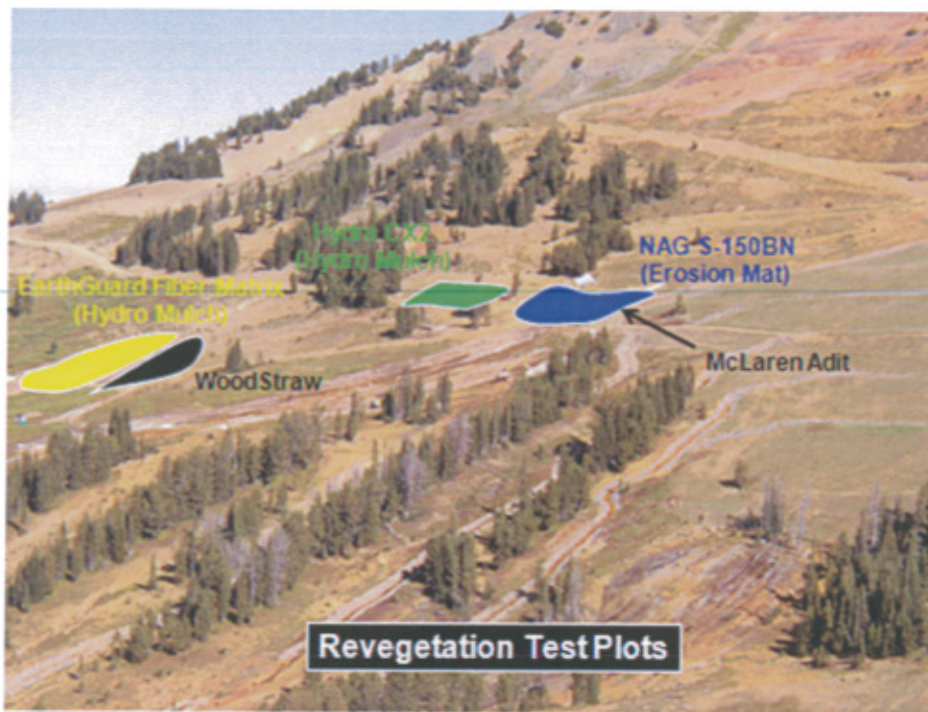
The areas were treated with the following: North American Green’s S-150 BN erosion mat, EarthGuard Fiber Matrix, Wood Straw, and North American Green’s HydraCX². North American Green’s S-150 BN is the erosion mat specified in the contract, and WoodStraw is a 100% wood product, chipped into 4 in x 1/8 in ‘straws’ which are broadcast over the soil surface. EarthGuard and HydraCX² are proprietary products applied by a hydro seeder and which form a physical barrier over the soil surface. Photograph 21 shows the location of the test plots in relation to the McLaren Adit.

Photograph 21 – Erosion Protection and Revegetation Test Plots (McLaren Adit area)
