**CONSTRUCTION REPORT  
McLAREN PIT RESPONSE ACTION  
CONTRACT 50-0398-2-001  
2002-2004  
NEW WORLD MINING DISTRICT  
RESPONSE AND RESTORATION PROJECT**

**USDA Forest Service  
Gallatin National Forest  
Bozeman, Montana**

**July 2006**

**FINAL CONSTRUCTION REPORT**

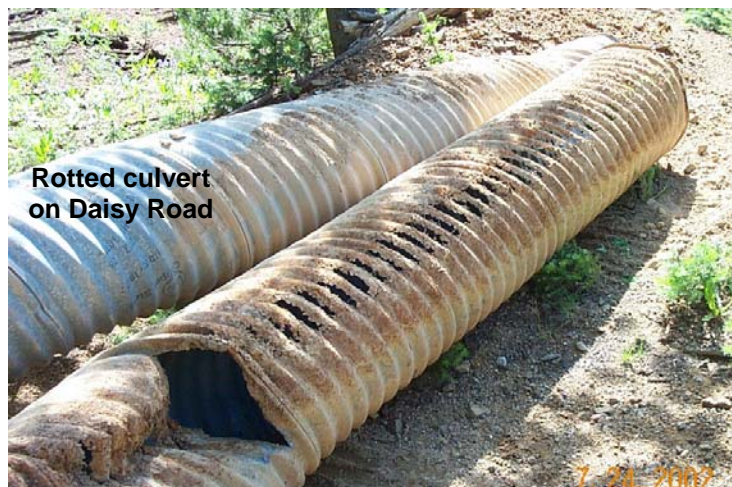
The contractor inspection crew found a culvert at MP 2.9, Daisy Pass Road, which had rotted out completely. Replacement of the culvert was not the contractor’s responsibility because this was a preexisting condition. The COR directed URS to replace the culvert with a government furnished 24 inch corrugated metal pipe (CMP) with Modification 1 (Mod 1). Heavy riprap haul to McLaren Pit commenced July 30.

**Rotted culvert  
on Daisy Road**

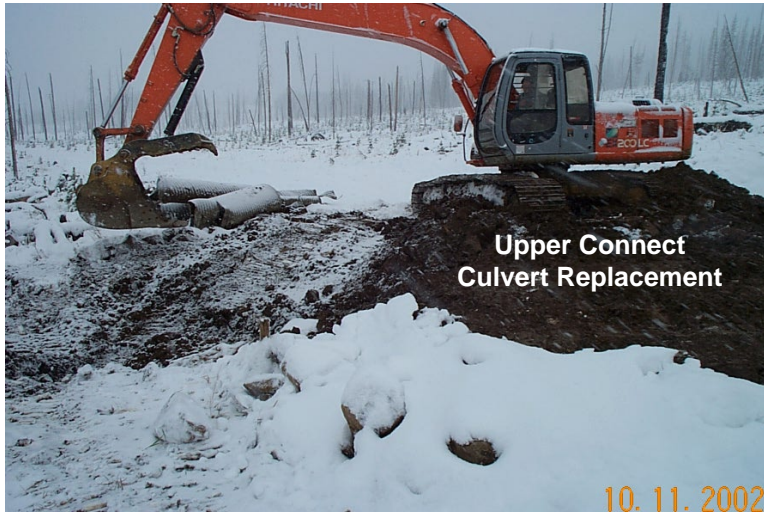
During hauling of riprap, two arch culverts on the Upper Connect Road, Sta. 0+990 and 1+064, and one culvert at the Lulu/Connect intersection, were partially smashed by the heavy loads. The Lulu/Connect intersection culvert was replaced on September 19. The

arch culverts on Upper Connect were replaced on October 11, 2002, during 2002 demobilization under blizzard conditions. Due to the snow conditions, the installations were marginal and the contractor was advised the culverts would be monitored in 2003, and may need to be re-installed. The culverts held up under haul in 2003, and did not need to be re-installed.

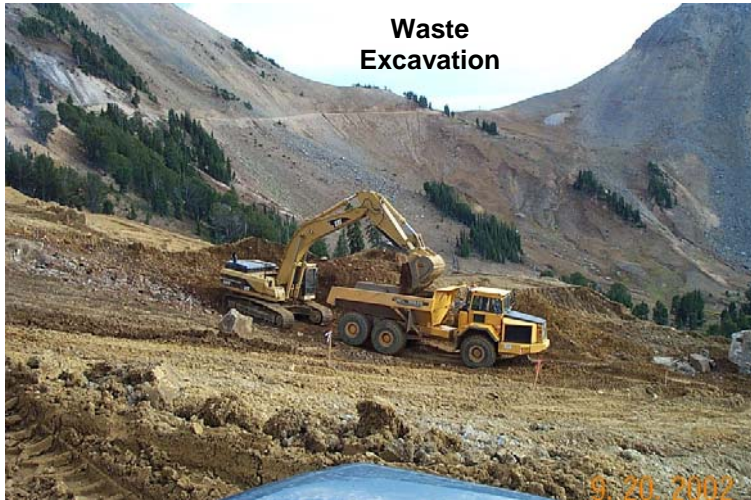
In late August, 2002, the contractor encountered wet waste rock mixed with clay in the lower center portion of the pit. Moisture contents ranged from 17% to 22%, with the optimum moisture for compaction at 11%. This wet zone was not anticipated in the design. If the waste rock from the lower portion of the pit all remained wet, as much as 14,000 m<sup>3</sup> of waste rock could have been affected, causing significant problems with achieving compaction of the waste. The COR requested URS to prepare a proposal to

amend the wet waste rock with calcium oxide (lime) to improve compaction characteristics. The COR estimated costs for amending the waste rock to run as high as \$150,000 if the wet zones were extensive in the excavation. The project manager attempted for several weeks to find a source for calcium oxide and the equipment needed to incorporate the lime into the waste rock without success.

One trial load was placed in the waste embankment zone and rolled into the waste, showing some benefit for compaction. By the second week of September, the clay content of the waste rock seemed to be reduced. Several point sources of subsurface water were diverted from the waste rock excavation area, reducing the moisture content of the waste rock being placed. By mixing the wet waste rock with dryer underlying material in the waste placement area, the contractor was able to meet compaction requirements the rest of September.

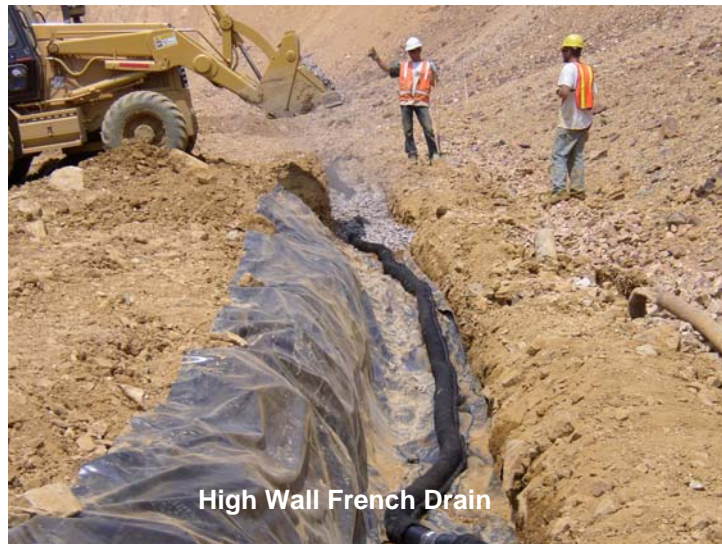
If the seeps were not treated, subgrade finish for the liner would have been difficult at best, or possibly not achievable. The COR also had concerns about the affects of the groundwater on the long term stability of the waste rock. It was decided to install a permanent subdrain system to collect the water from the seeps and transport the water northwest to the run-off channels below the pit. The COR and URS project manager

designed a system using a french drain at the high wall at sumps at the three rock point sources, and transporting the water to runoff channels in 4 inch PVC flex pipe (Mod 6). The work on the subdrain system started July 23 and was completed on July 29, 2003.
