## CHAPTER 2. THE GOLD DUST MINE (24PA874)

## **Physical Remains at the Gold Dust Mine.**

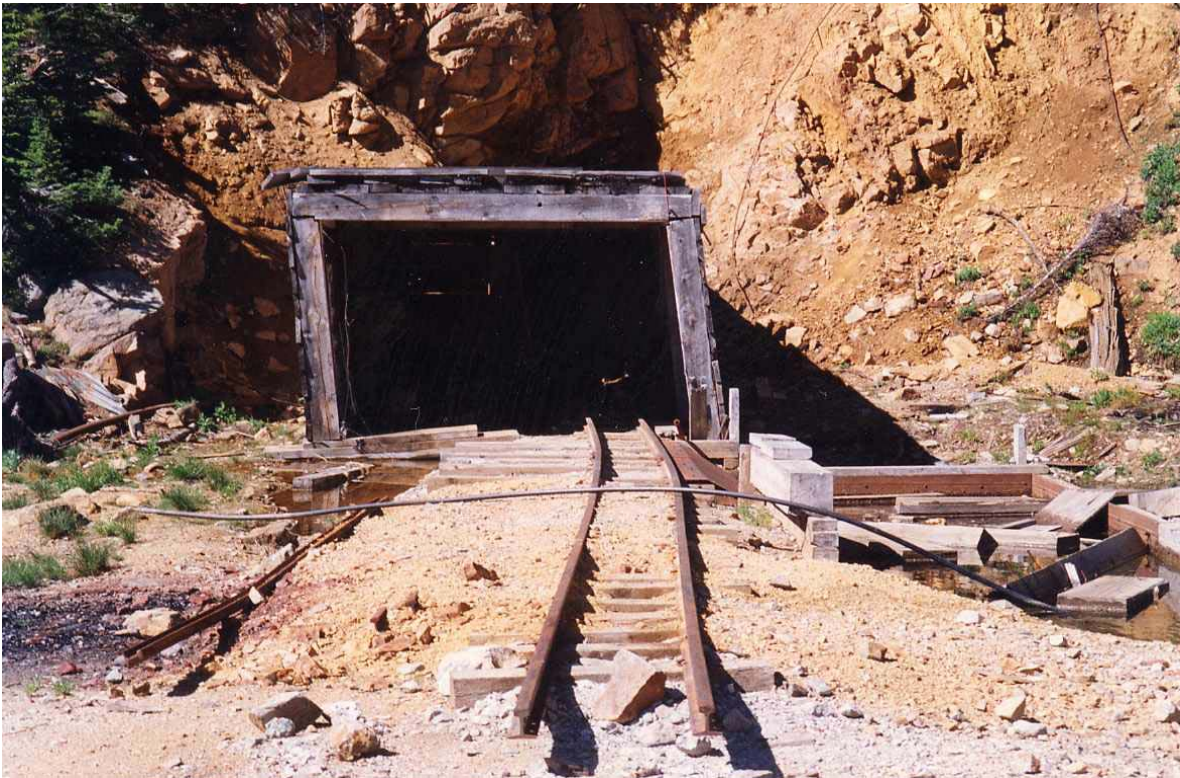
Feature 1, the Gold Dust Adit, is 8.2 feet in diameter at the portal. Two sets of ore car tracks extend 60 feet north and 30 feet northeast from adit portal to the waste rock dump (Feature 2). The adit was driven between 1920 and 1925 and drifts to the southwest for about 2,300 feet. No production is recorded from the adit. Mules were reportedly used to draw the muck (waste rock) out of the adit. Figure 2-2 is a photograph of the adit as it appeared in 2001. A cable associated with the upper portion of the aerial tramway system is located 32 feet west of the adit. During Crown Butte Mining's exploration work in the 1990s, the partially collapsed portal was cleaned up and a shed was re-constructed around the entrance (Fredlund, et al.1990; Fredlund 1992).

Figure 2-2. Feature 1, Gold Dust Adit, (after rehabilitation in the 1990s).

After discovery of the Homestake Breccia Pipe in 1990 by surface drilling, Crown Butte Mine executed an underground drilling program from the Gold Dust Adit to delineate mineralization in the lower portion of the pipe by drilling angle holes from four drill stations. The portal and underground workings were rehabilitated to gain access to the drill stations. The mine was mapped geologically during the rehabilitation work. Approximately 34,000 feet of drilling was conducted to formulate this map. The elusive ore body, estimated at about \$1.8 billion in 1991, proved to be located at the same level as the Gold Dust Adit, which had been stopped about 250 feet short of the prize. The portal was closed with a series of timber sets and a locking steel gate in 1991 (Noranda 1991; Kirk 2002).

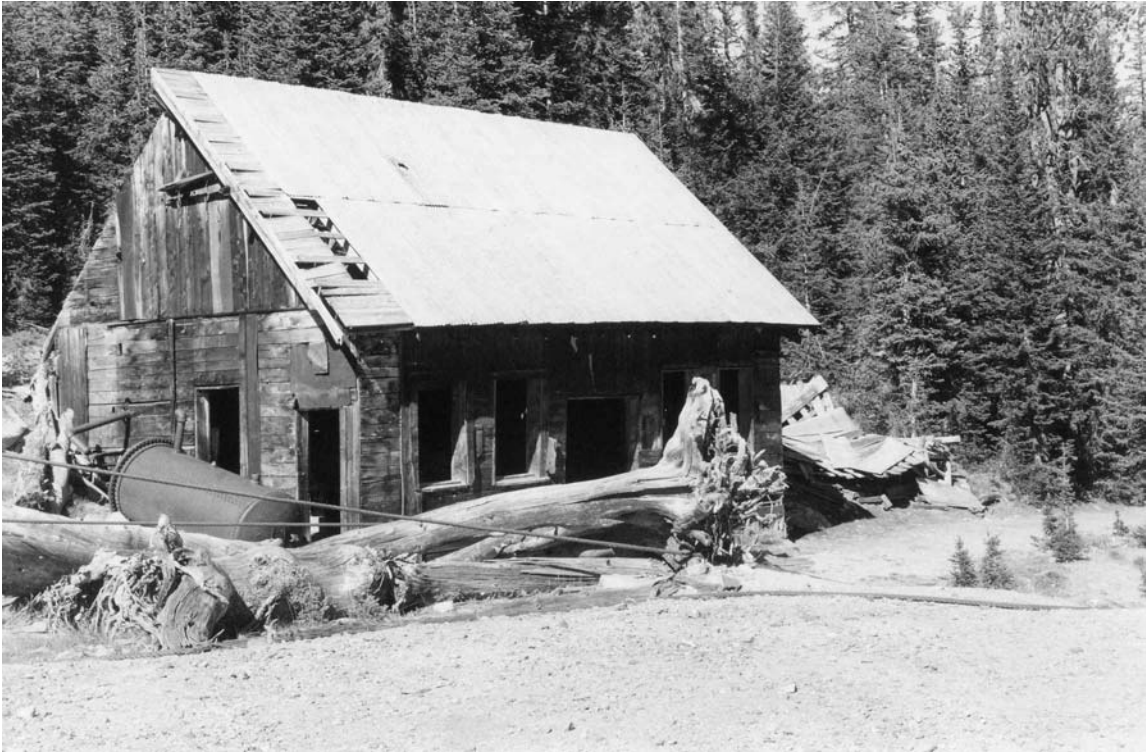
Feature 3 is a wood frame compressor house that has a steeply pitched gable roof. This structure was intact in 1990, but had mostly collapsed in the spring of 2001. Figures 2-3 and 2-4 are photographs of the compressor house as it appeared in 1990, while Figure 2-5 shows the structure as it looked in 2001. The following description was made in 1990:

Figures 2-3. Photograph of the compressor house (1990 GCM file photo).

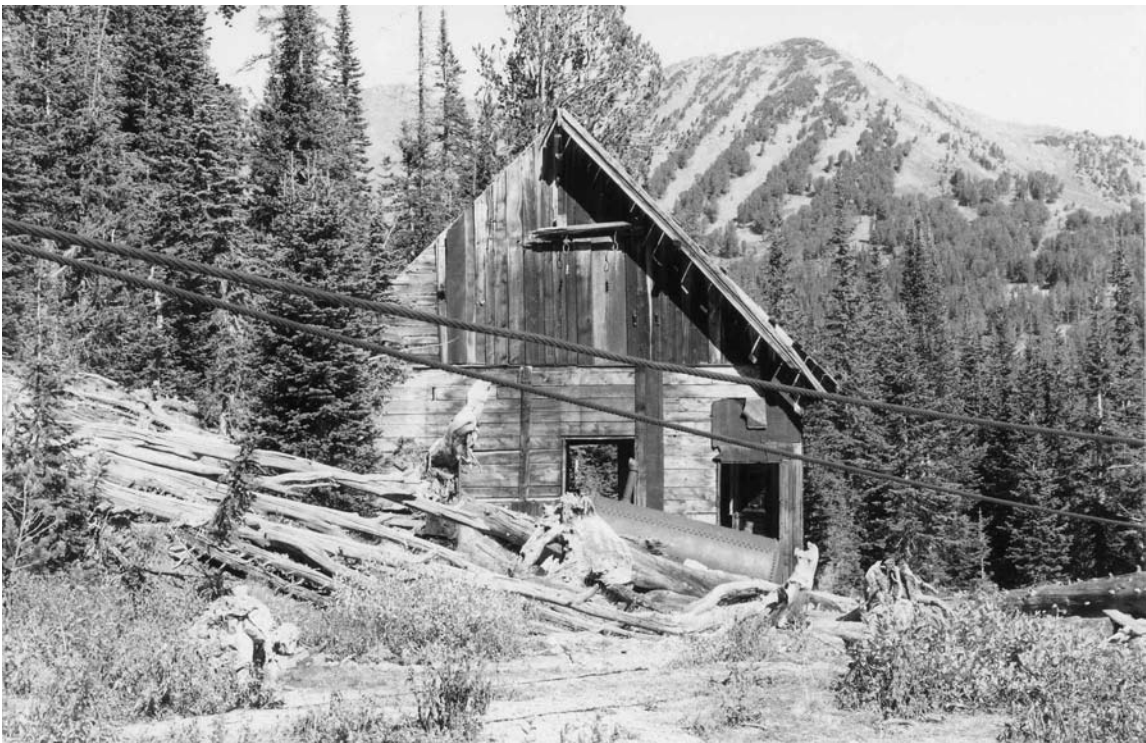
Figure 2-4. Photograph of the compressor house (1990 GCM file photo). Note tram cables and compressor tank.

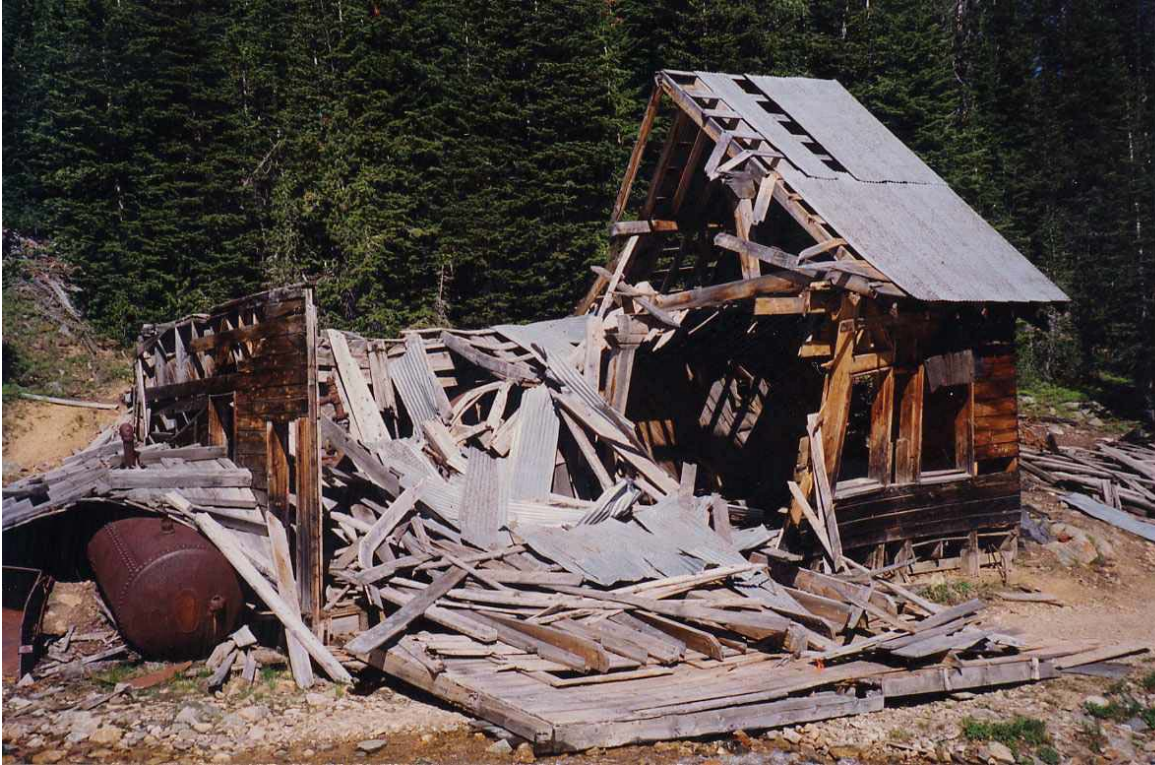
Figure 2-5. Feature 3, Compressor house, as it collapsed in the spring of 2001.

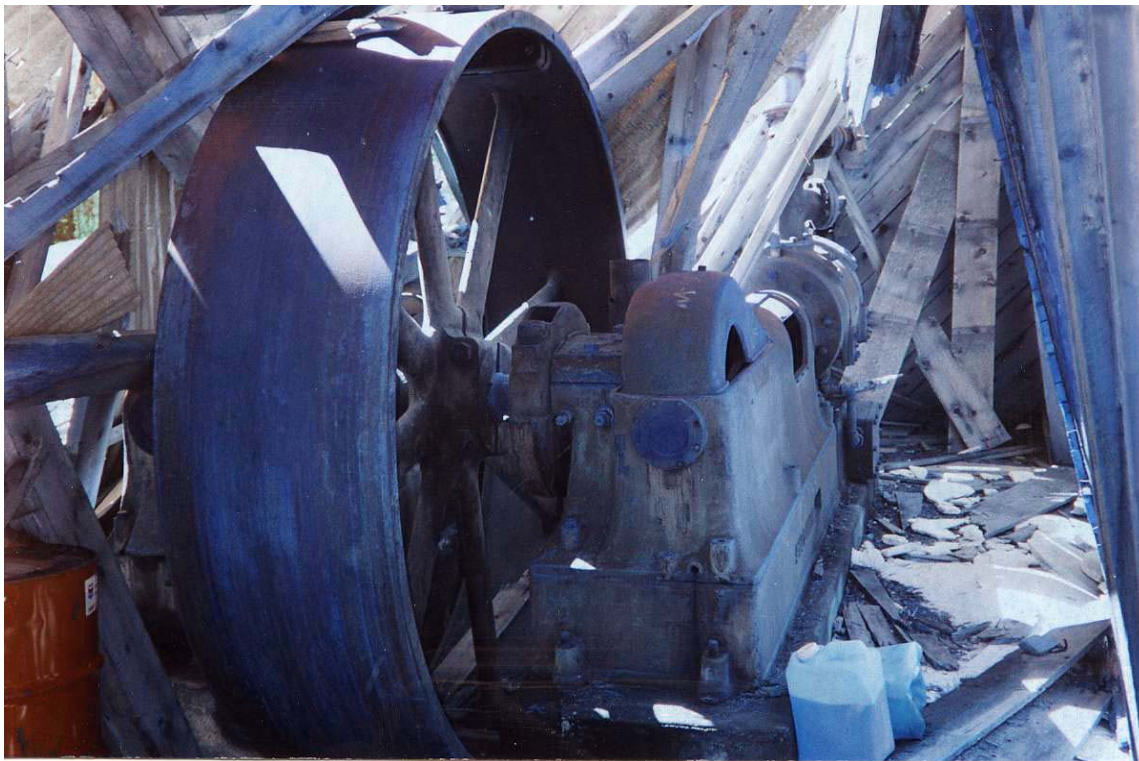
The Sullivan compressor (Figure 2-6) is intact in the building. It is an electrically powered compressor as indicated by the large flywheel and type of foundation and mounting (Hoffman 2002). A riveted iron air tank is also located adjacent to the building.

Figure 2-6. The Sullivan compressor is still intact in the compressor building (Feature 3).

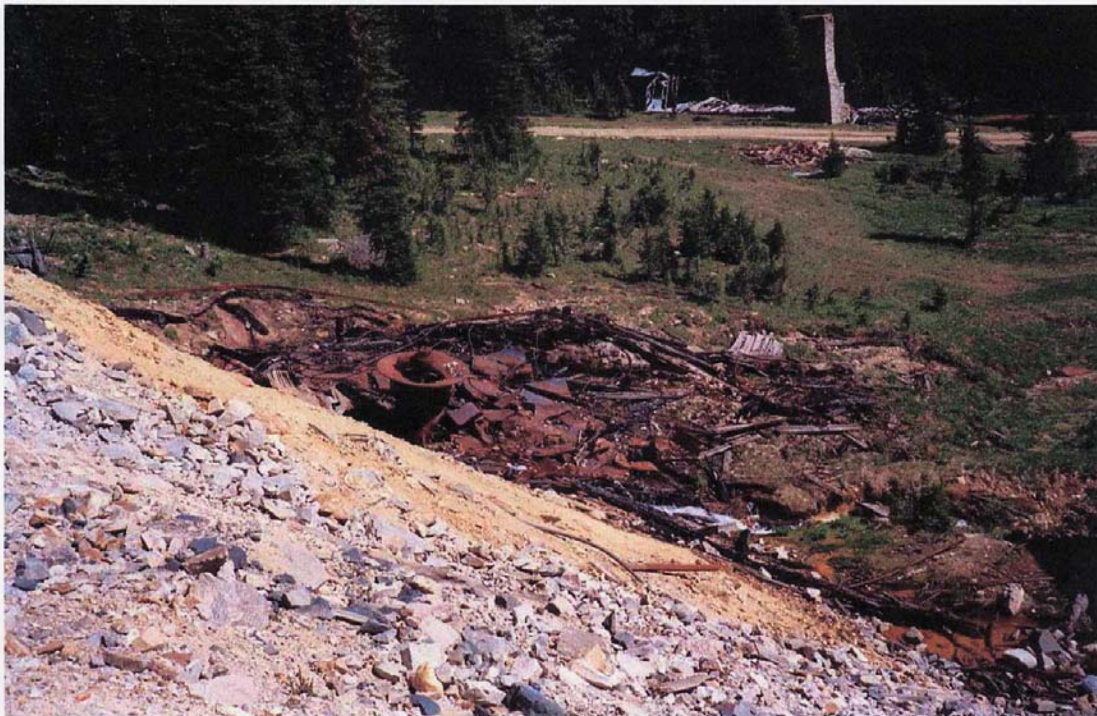
Feature 5 is an ore discharge terminal for the upper aerial tramway bringing ore from the Homestake Mine (Figure 2-7). It was completely collapsed in 1990, and has burned since then. Here, ore from the Homestake was unloaded from the tram cars and run through an Allis Chalmers gyratory crusher (Figure 2-8), probably so it would blend or load better in the ore bin. The mechanism of ore transfer from this discharge terminal to Feature 6, the ore bin and lower tram loading terminal, is unknown. This 72 x 40 foot structure had log and wood beam construction with a wood foundation, corrugated tin roof and board siding. Tram cables from the Homestake Mine lead to the building.

Figure 2-7. Collapsed discharge terminal for the aerial tramway from the Homestake Mine. The Gyratory Crusher is visible in the debris. The long pieces of metal are tram cable guides. The chimney at Feature 13a is seen in the background.

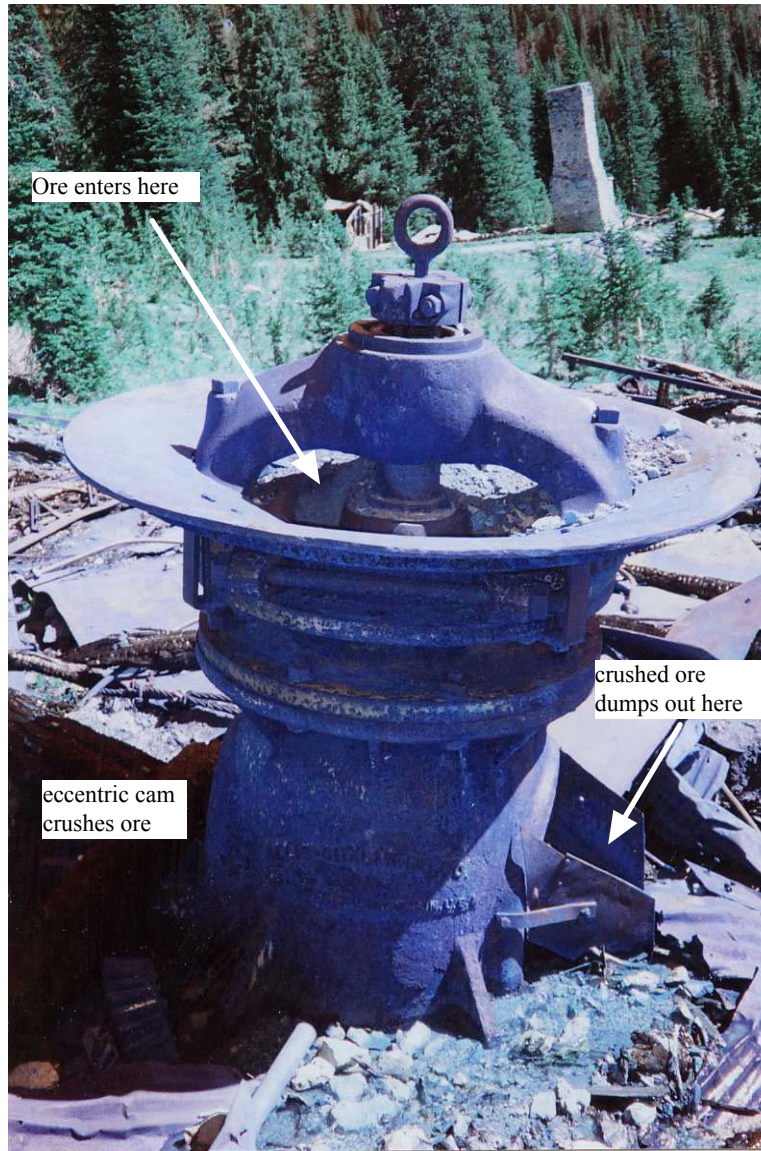
Figure 2-8. Allis Chalmers gyratory crusher at the load-out terminal of the Homestake to Gold Dust Tramway (Feature 5).

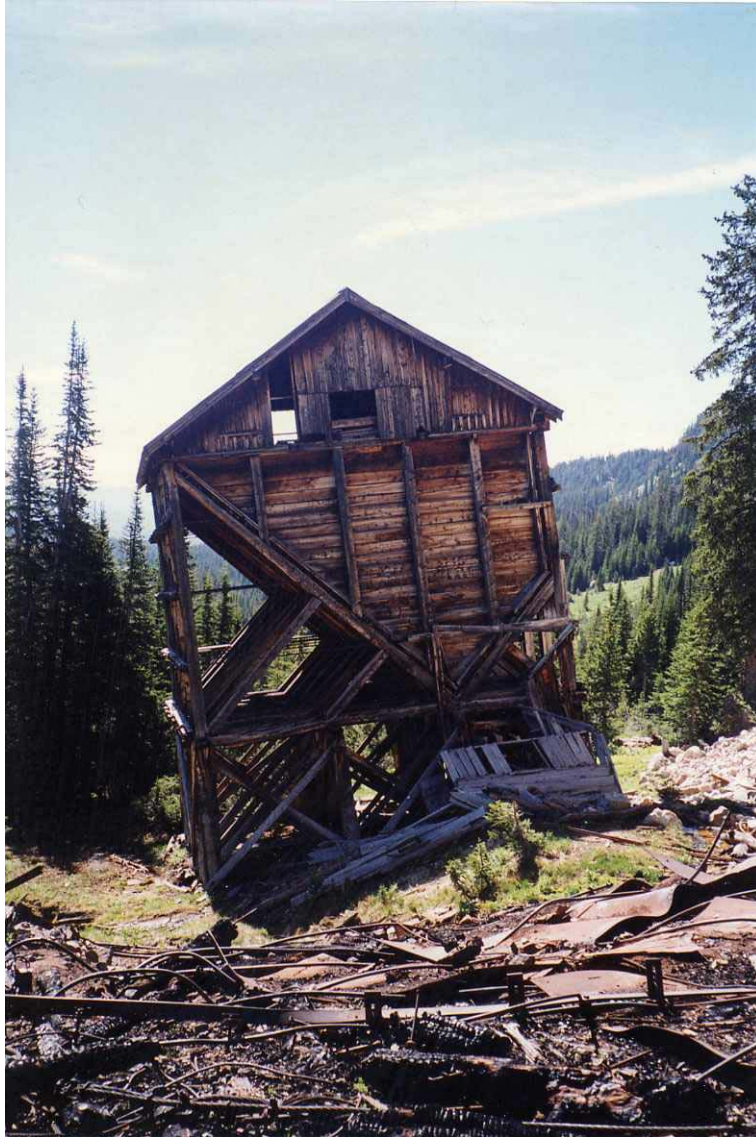
Feature 6 is a wood frame ore bin and loading terminal for the lower tram (Figures 2-9 and 2-10). The 36 x 34 foot structure is oriented northwest and southeast. It is located 42 feet east of Feature 5, at the base of the waste rock dump. It has a log foundation with wood frame superstructure. The gable roof is sheathed in corrugated metal and is sided with boards. There is a wood ore chute on the south side. The remains of a small shed-roof structure that had vertical and horizontal board and batten siding are located on the southwest corner. Wood on the ore bin appears to be tongue and groove. The storage bin gable-ends are constructed from vertical board and batten with vents. Metal struts add support to the wood trusses. Vertical board and batten siding is bolted to the foundation on the north wall. The tram cables for the lower tram enter on the east side of the structure. Here the tram cars passed beneath the ore chute for loading. It is not clear how

Homestake ore was transferred from the discharge terminal (Feature 5) to this ore bin. This was accomplished with a conveyor, through a small doorway on the upper west story. Rollers to support the conveyor are visible in the upper west window. As with all mining operations, gravity is the main source of energy for moving ore, and the method of transfer is usually apparent by the relative elevation of the facilities. In this case, the trestle may not have been completed, or may have totally deteriorated. The lower tram sheave wheels, guides and a bucket were still intact in the structure in 1990. The structure is now leaning noticeably as of 2001.

Figure 2-9. Feature 6, ore bin and loading terminal for the lower tramway segment (2001 photo). The remains of Feature 5, the discharge terminal for the upper tram, are in the foreground (note tram cables and cable guides amid the debris).

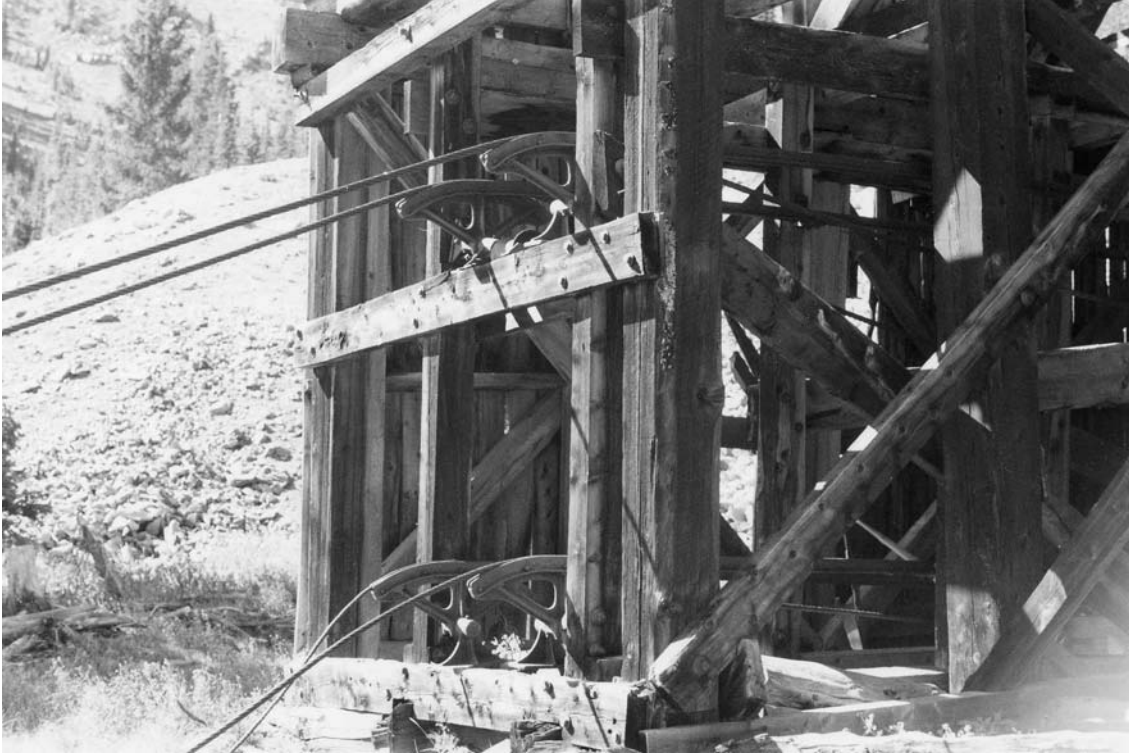
Figure 2-10. Feature 6, Gold Dust ore bin and loading terminal for the lower tramway segment (GCM 1990 file photo). This is the east side of the structure showing the Lawson style terminal where empty cars arrived upside-down on the bottom stationary cable-track, invert and are loaded, then proceed down the line to the smelter.

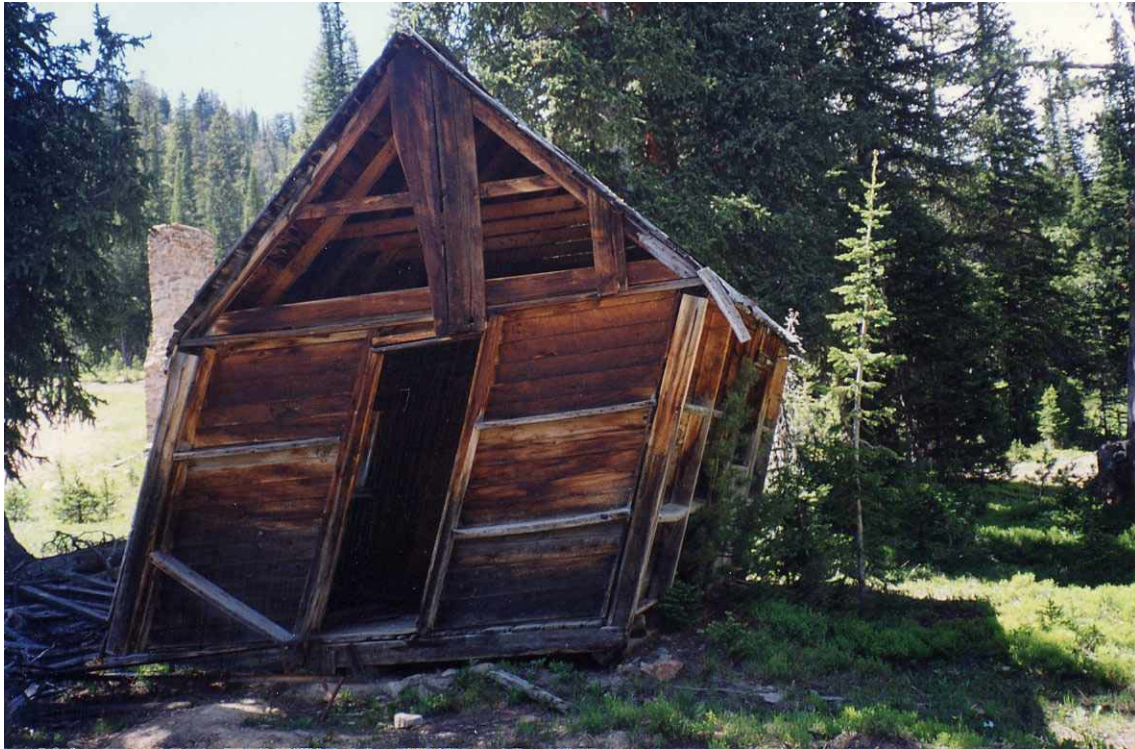
Feature 8 is a wood-frame 13 x 19 foot craftsman-style residence, oriented northeast and southwest, with the facade facing southeast (Figure 2-11). The gable roof is sheathed in corrugated metal. The entry is central to the facade. The siding has been stripped off the facade, while the walls and rear facade have portions of original vertical board and batten siding intact. Windows are located on the north and south walls. The remains of a 6.5 x 19 foot shed addition are attached to the south side.

Figure 2-11. Feature 8. One of the few standing structures remaining at the site, this cabin shows pronounced effects of snow loading and deterioration.

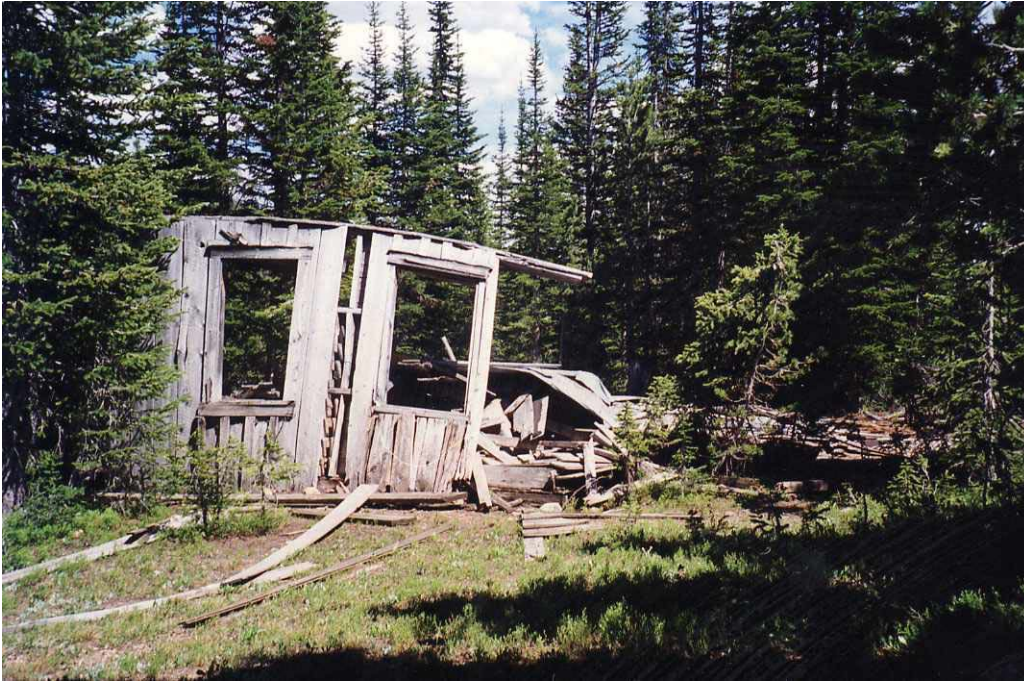
Feature 10 is a wood framed, three-room structure that measures about 16 x 26 feet with the facade facing southeast (Figure 2-12). The roof is missing and the north wall is collapsed with other walls buckling. The structure has a wood foundation and vertical board and batten siding. The roof probably collapsed into the interior, since there is considerable debris. The building appears to have had a corrugated metal roof. Windows are located on the south and west walls. The entry is central to the facade and is flanked by two windows. Debris indicates that there may have once been a wood-decked porch on the facade.

Figure 2-12. Feature 10 remains.

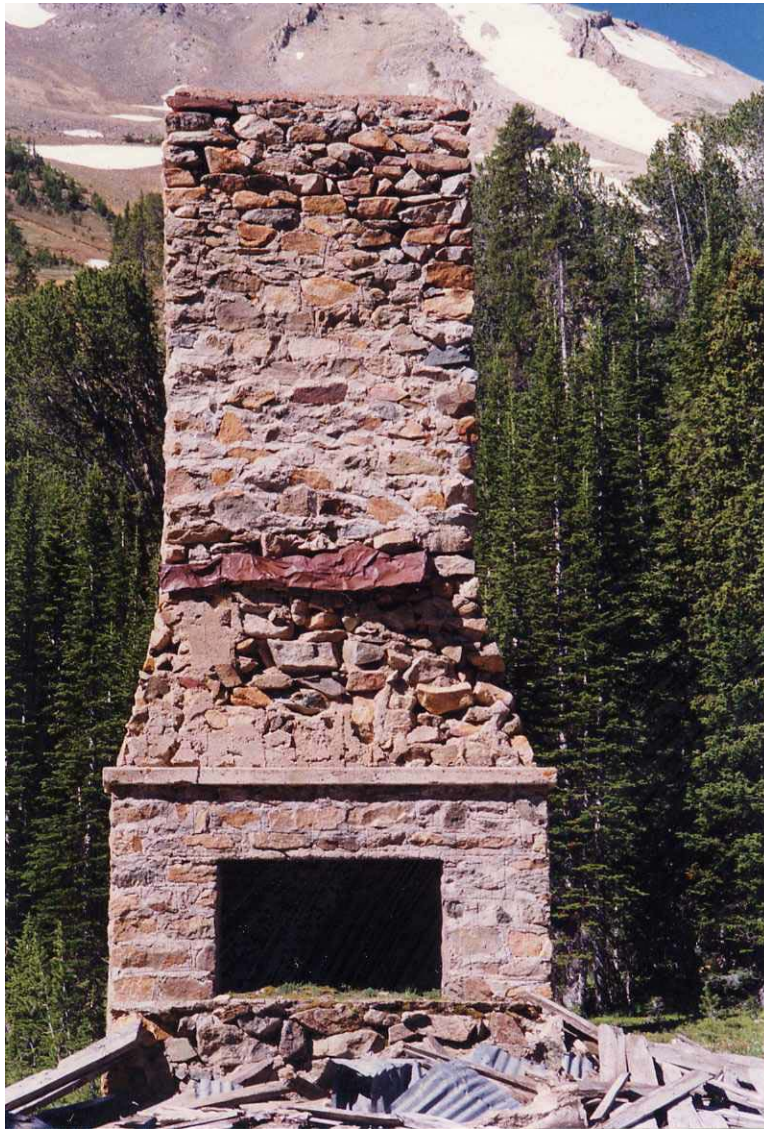
Feature 13a was described in 1990 as “a 32.8 x 65 foot wood-frame building with a wood foundation set on concrete footings and a gabled-roof with corrugated metal sheathing” (Fredlund et al. 1990). It has since collapsed and a good deal of the construction material has been removed. It is located 19 feet south of Feature 12 and is oriented northwest and southeast. An impressive rubble stone and mortar chimney located at the southwest side of the feature is the only standing portion of the structure (Figures 2-13, 2-14). The function of this large structure has not been identified. It may have been the mine superintendent’s residence and office, or had an industrial use, but definitive interpretation is difficult due to the absence of artifacts and materials. Its concrete footing suggest greater permanence and sturdiness of design when compared to the typical residence structures at the site. Feature 13b is a (collapsed) shed roof addition to Feature 13a. It is 7 x 10 feet and is of wood frame construction. It had an addition attached to the northwest wall and had a corrugated metal roof. The walls had vertical board and batten siding. The entry is left of center on the facade (southeast) with a window on the rear facade (northwest).

Figure 2-13. Large rubblestone and mortar chimney at Feature 13a.

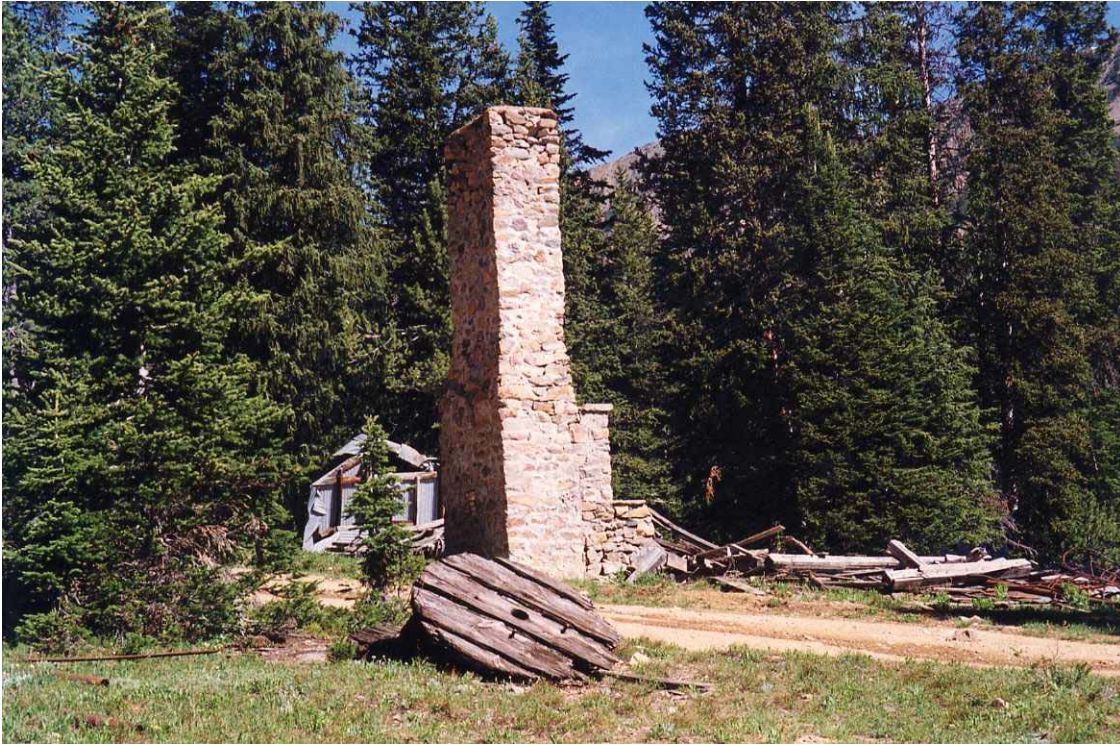
Figure 2-14. The rubble and mortar chimney at Feature 13a, looking north. Note tram cable spool in foreground.
