**CONSTRUCTION REPORT  
SELECTIVE SOURCE RESPONSE ACTION  
CONTRACT 50-0398-1-11003  
2001-2002  
NEW WORLD MINING DISTRICT  
RESPONSE AND RESTORATION PROJECT**

**USDA Forest Service  
Gallatin National Forest  
Bozeman, Montana**

**June 2006**

**FINAL CONSTRUCTION REPORT**  
**SELECTIVE SOURCE RESPONSE ACTION**  
**NEW WORLD MINE RECLAMATION PHASE I**  
**CONTRACT 50-0398-1-11003**

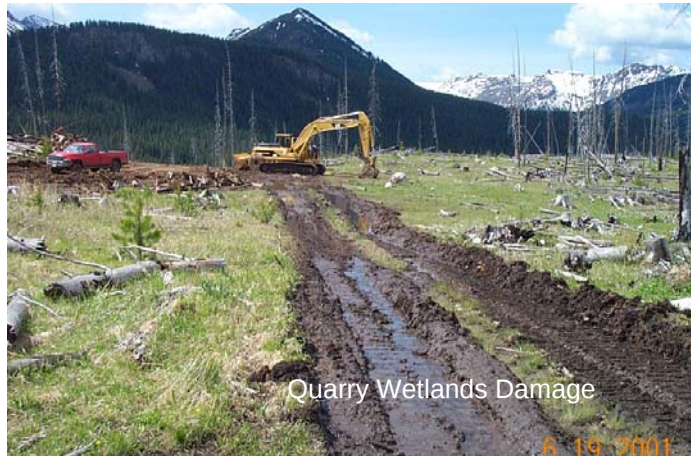
Due to the damage the subcontractor caused to the quarry access road, the contractor was authorized to build a temporary access road for about 100 m. This access road was then reclaimed and revegetated when rock haul was completed.

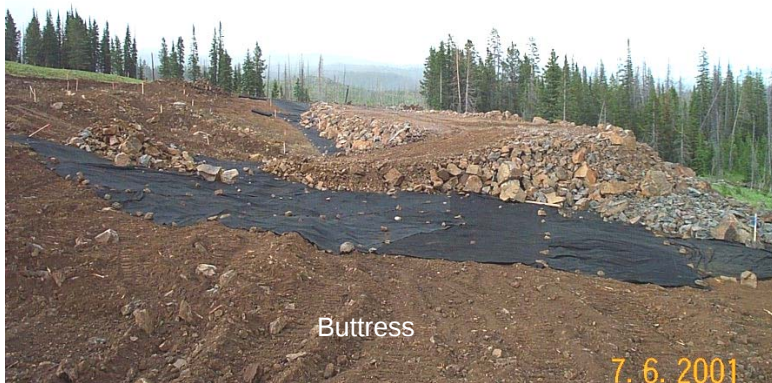
The geotextile initially furnished to the project did not comply with the specified GT-1 geotextile. It was determined the geotextile furnished to the project (Type II-A) would suffice for the buttress/subgrade interface, but would not be suitable for use in the repository liner system.

The buttress construction proceeded to near completion on July 17, when the contractor's survey indicated the buttress was at design grade. The government performed a Q/A spot check survey, which revealed the buttress

subgrade and finish elevations were 1m to 1.5m high in the middle 60m of the buttress. There apparently had been an error in marking the construction control stakes in this area. After conferring with the designers, the contractor was given the option of removing the buttress rock, excavating the subgrade to the design elevations, and replacing the buttress; or leaving the buttress at the constructed grades and not including the buttress rock above design elevations in the final pay quantities for buttress rock. The contractor opted for the second option with the provision that the depth of the toe drain would be between 1m and 2m (designed for 1m) with a minimum grade toward the sump of 1% (WO J). The actual depth of the toe drain in the section averaged 1.4m. The contractor subsequently placed about 1700m<sup>3</sup> of rock for which there was no payment. This change in the buttress elevation increased the capacity of the repository by an estimated 10,000m<sup>3</sup>.

The contractor was authorized to use the Type II-A geotextile under the buttress (WO G).

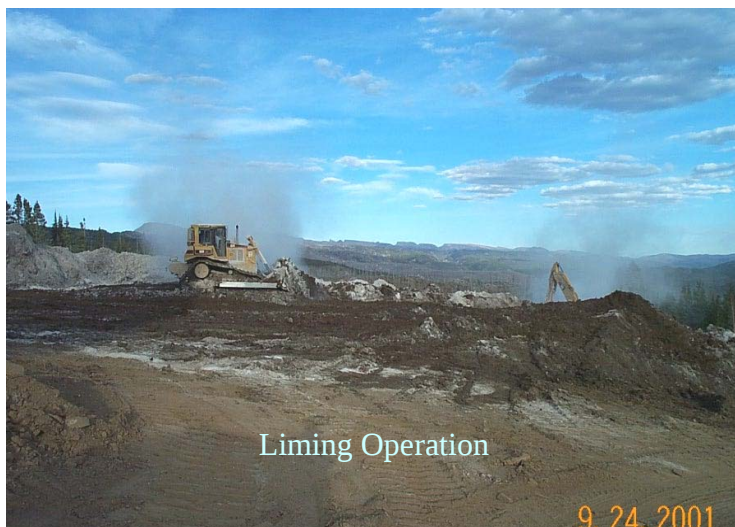
Liming Operation

All went well until September 6 when both the superintendent and the Q/C manager left the project for Colorado, leaving an acting superintendent and an acting Q/C manager. On September 6 the first of several rain events occurred that slowed waste haul and placement operations. The contractor shutdown operations for a day to let conditions dry and improve.

On September 9, operations resumed even though afternoon thunder showers were occurring nearly daily. Slimes being placed from Rommel were wetter than previously, and the surface of the waste rock in the repository was too wet for adequate compaction. The acting superintendent was advised the material was obviously not meeting compaction requirements, compaction tests were not being taken, and that lime needed to be applied to the slimes from Rommel. The project superintendent and project Q/C manager returned to the site on September 18. They immediately undertook stirring and applying lime to dry the waste in the repository. Liming and drying proceeded to the point where compaction was effective. Compaction testing resumed, with waste rock compaction brought into compliance about September 25.

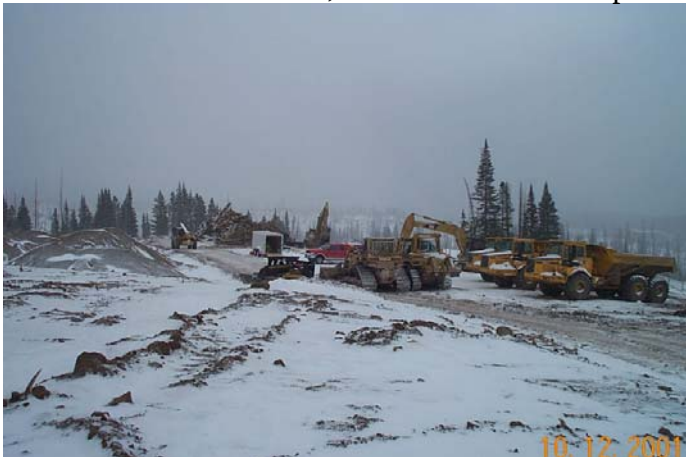
The top liner deployment began late on October 9 after the liner subcontractor crew arrived during the first of several snow events. After the snow melted the liner crew was able to place most of the permanent top cover liner system. Another snow event started October 11 and continued until the morning of October 13. The contractor attempted to clear snow from the deck, face and toe of the repository with equipment, snow blowers,

and snow shovels. Another snow storm started late on October 13 and continued through October 14. These storms prevented placing the temporary liner in accordance with specifications. On October 15, with continuing intermittent snow flurries forecast, the contractor and the government decided to winterize the repository as best as possible (WO O).

The winterization process agreed upon was to place the temporary liner on the deck and west face after removing as much snow as possible. Testing of the liner was foregone because moisture and temperature limitations were not being met. The liner seams were fusion welded where moisture would allow welding. Other areas along the crest were tack welded and/or extrusion welded. To anchor the bottom of the permanent liner already placed but not welded to the bottom liner, a layer of sand was placed at the interface, geocomposite covered the sand and operations cover soil was placed to a depth of about 3m. The temporary cover/bottom liner interface was anchored with an earth berm. Berms 600mm deep and 4m wide were placed along the crest of the deck to prevent the temporary liner from billowing in winter winds. Various temporary diversion ditches were built to lead water away from the repository cover. The fencing around the repository was completed except for two sections needed for access to complete the repository. These fence sections received temporary fencing. All major work on other

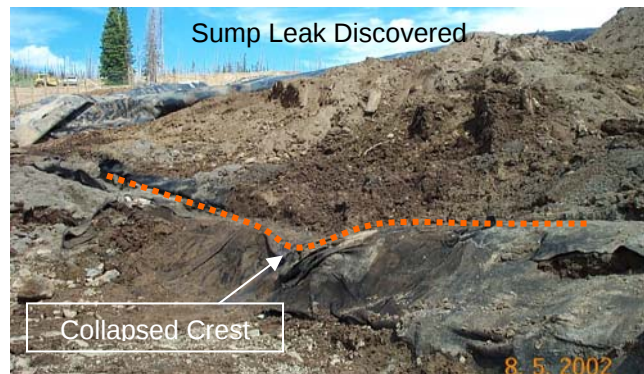
The contractor uncovered the top/bottom liner interface at this location using a smooth bit on an excavator and hand labor. It was discovered that the sump crest had caved inward and slumped down some 30 inches. This would be the same level as the recorded leak.

Apparently the equipment had damaged the structure in the previous fall not by direct contact but by pushing a load of soil toward the structure which then caused the sump crest to collapse inward toward the drain gravel fill. The contractor proceeded to expose the damaged area, peel back the top liner, excavate inside and outside the bottom liner to check for damage, then rebuild the liner support on the outside as well as replace the drain gravel fill. The top and bottom liners were repaired, tested, and welded together. An extra layer of top temporary liner was then welded onto this interface to give added protection to the corner.

berms were removed from the west and south crest of the deck, revealing severe damage to the temporary liner placed the previous year. This area received a second layer of liner welded to the top liner rather than attempt to identify and patch the damaged liner. The diversion berm cover on the west interface was welded on both sides and to the bottom liner to assure a tight seal, rather than the designed sandbag anchor. The contractor elected to weld the full perimeter of the top/bottom interface rather than the lap and cover interface as designed, although more costly. This welded perimeter provides a tighter interface seal than the lap and cover system.

The contractor proceeded to expose the perimeter of the top/bottom liner interface and check for damage. The interface was pressure washed to assist with inspection. All dimples in the liner, which could be indications of pinhole damage, were either vacuum tested or patched with an extrusion weld. The surface of the permanent top cover was carefully inspected to find and patch pinholes made by rocks during the winter. The

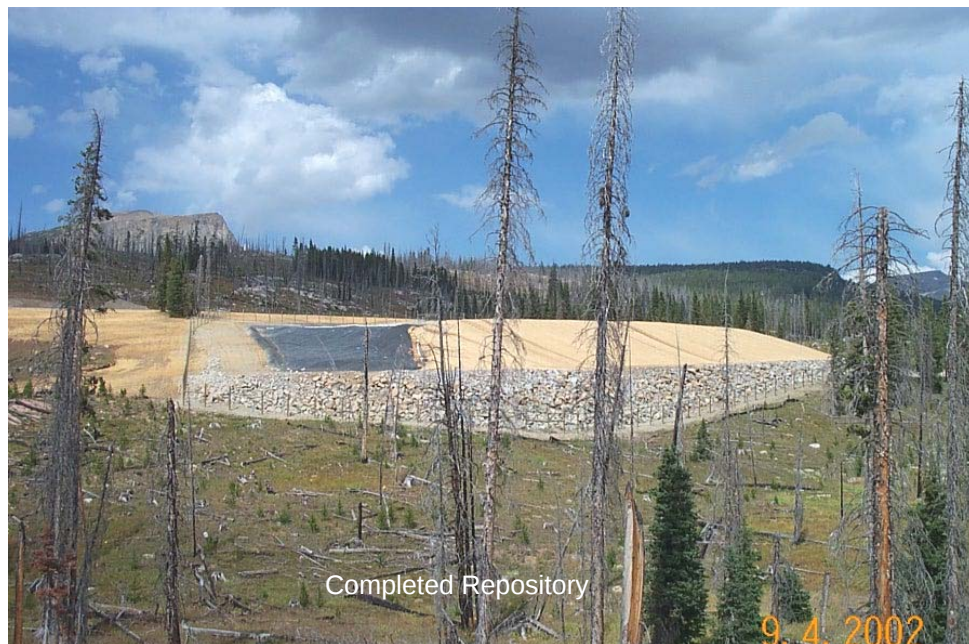
During the winter of 2001-02, it was found that the face of the repository waste had been built at about a 1:3 slope. The designed slope was 1:4. The 1:4 slope is the design slope needed for the cover soil to be stable under saturated conditions. The obvious solution to the slope error would be to remove the cover already placed, lay the waste back to the designed 1:4 slope, and replace the cover. This would be somewhat risky because it would require the waste rock to be exposed and disturbed, and most of the cover already placed would not be salvageable. Through discussions with designers and the contractor's geotechnical engineer, it was decided to place the cover soil on the permanent cover slope of 1:3, but to build the finish surface of the cover soil at 1:3.5 (Modification 9). This modification increased the cover soil and drain gravel quantities, but the contractor was not compensated for the increase because the change was caused by a construction error. Cover soil was placed and compacted over the permanent cover liner. The slopes were drill seeded, fertilized, and erosion mat placed. All other disturbed areas in the repository site were either seeded and hydromulched or drill seeded and straw mulched. Work was completed on the repository on August 31, 2002.

The repository fence partially collapsed along the toe of the buttress during the winter of 2001-02. It was determined the collapse was probably due to snow loads drifting off the buttress surface or highmarking by snowmobiles in the winter. The fence subcontractor

installed poles along the top of the wire mesh between the posts, and tied the mesh to the poles to prevent future damage (Modification 8).

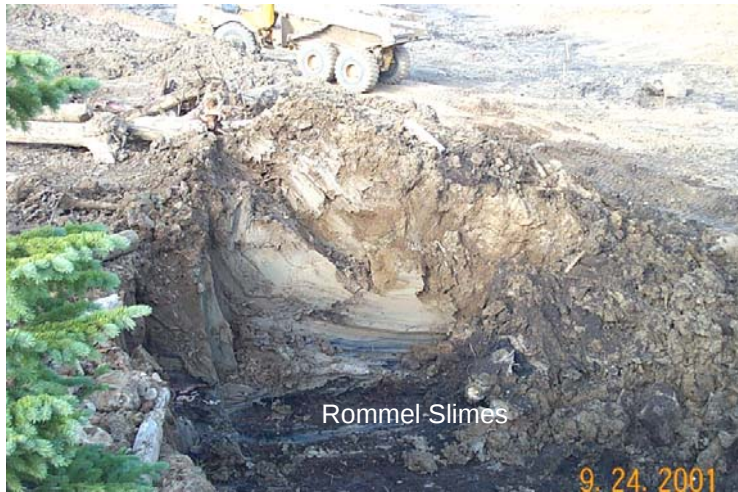
Final excavation of the lower dam revealed two structures. The initial lower dam was apparently built about 15 feet high. It is surmised that once the original tailings pond filled, the a second dam about 20 feet high was built over the original dam. This second dam partially covered slimes, making the native dam material largely unusable for final shaping of the site.

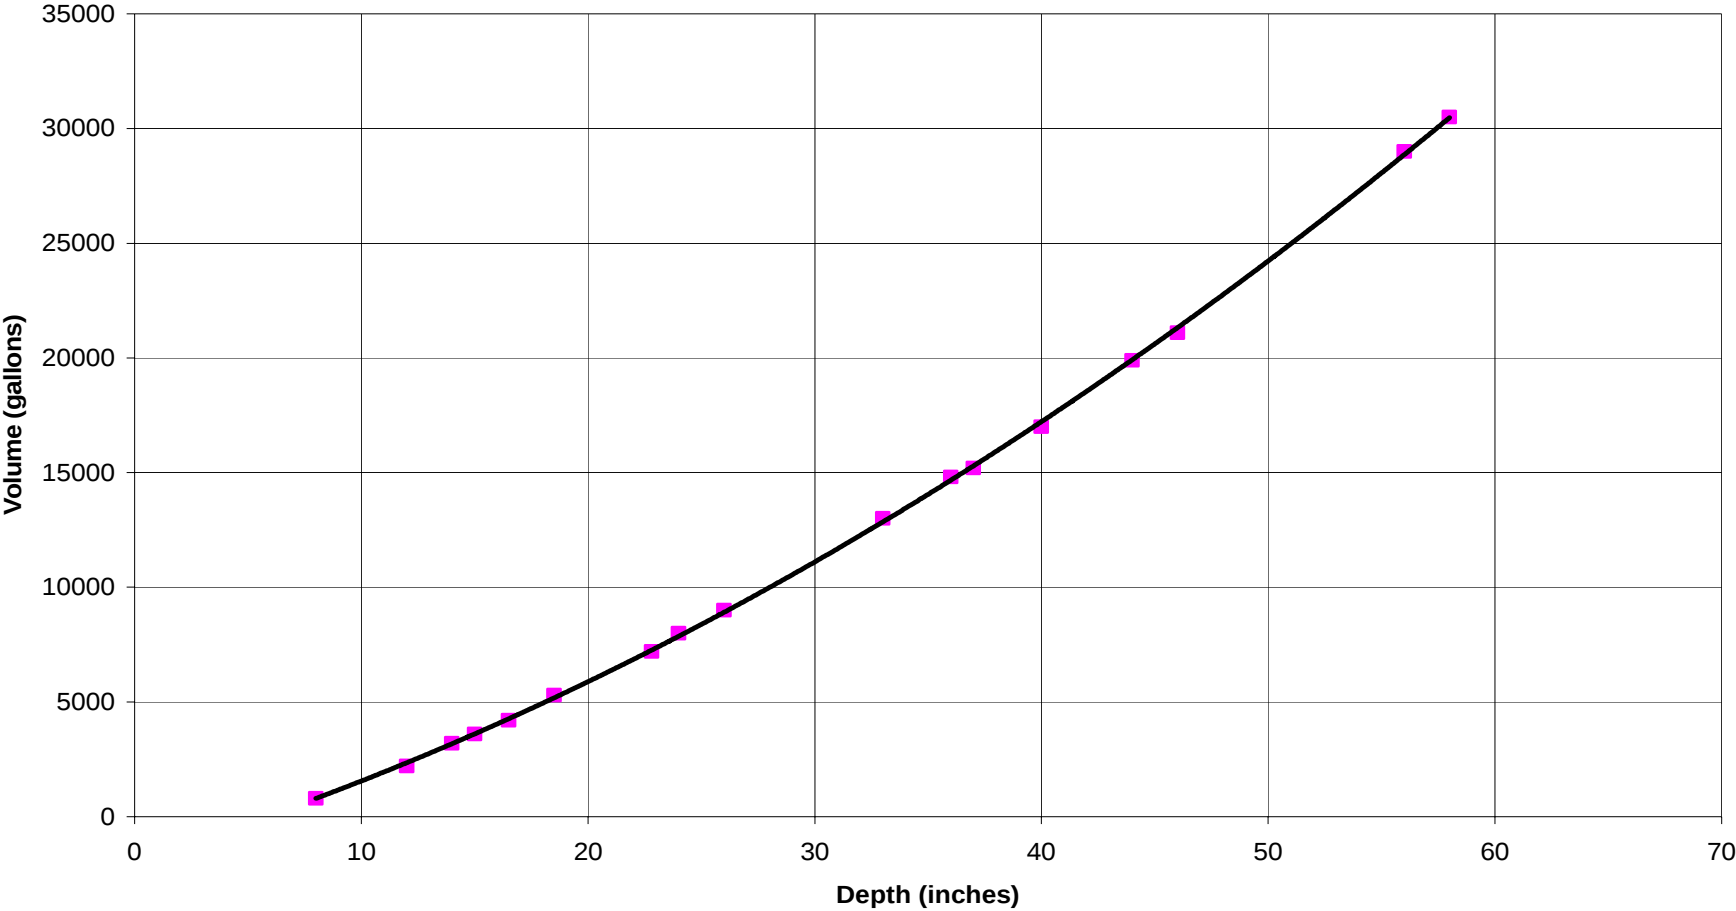
Sump Volume/Depth Relationship

The sump continued to accumulate water after the sump was repaired. After reaching a depth of 66 inches, the contractor pumped the sump during the week of August 29. During the pumping operation, water levels were monitored to establish a volume to depth relationship (Appendix D). The sump continued to accumulate water the next month, although at a slower rate than in August. On October 9, the water had reached a depth of 26.5" when the sump was pumped by the government to assure maximum capacity for the sump through the following winter. Water levels need to be monitored with periodic pumping for the next few years as water drains from the waste.
