Machine Driving of
Wooden and Steel
HIGHWAY
GUARDRAIL POSTS
under Adverse Conditions

by Charles J. Gatchell
and Edwin L. Lucas

U.S.D.A. FOREST SERVICE RESEARCH PAPER NE-212
1971

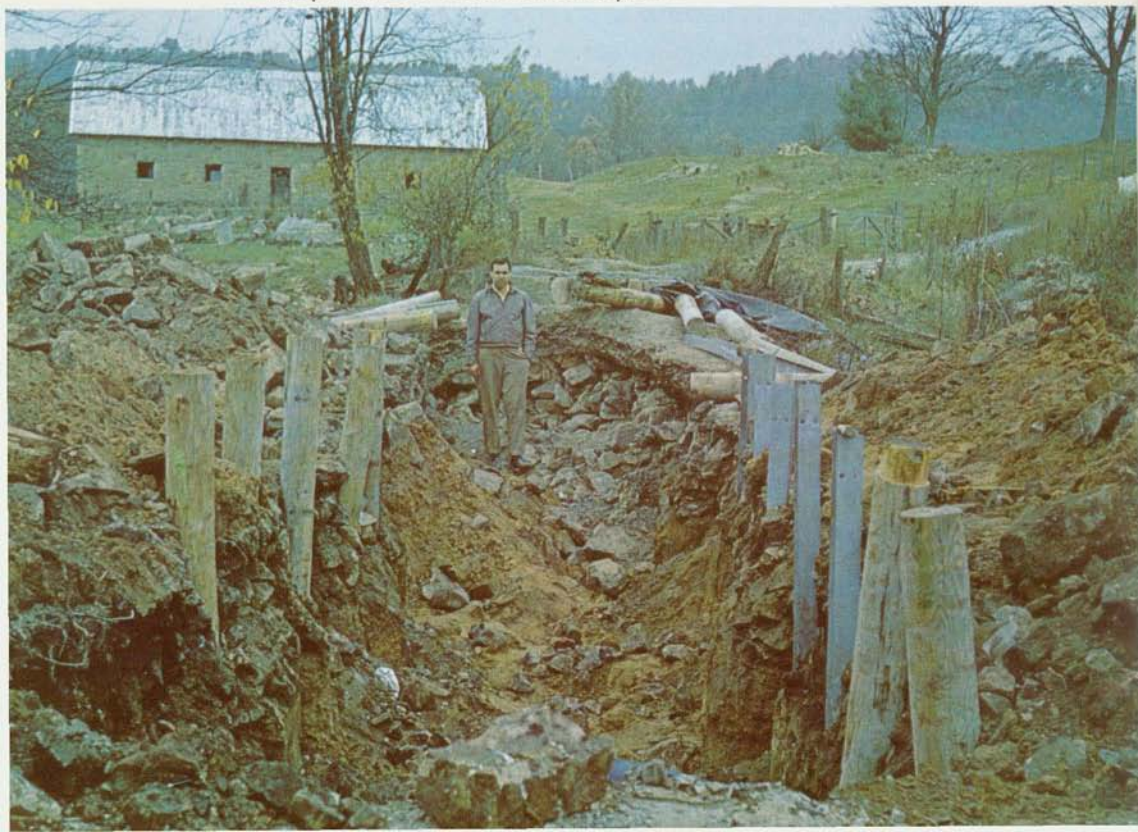
Figure 1.—Wooden and steel guardrail posts were driven into an old roadbed. A trench was excavated so the posts could be examined in place.

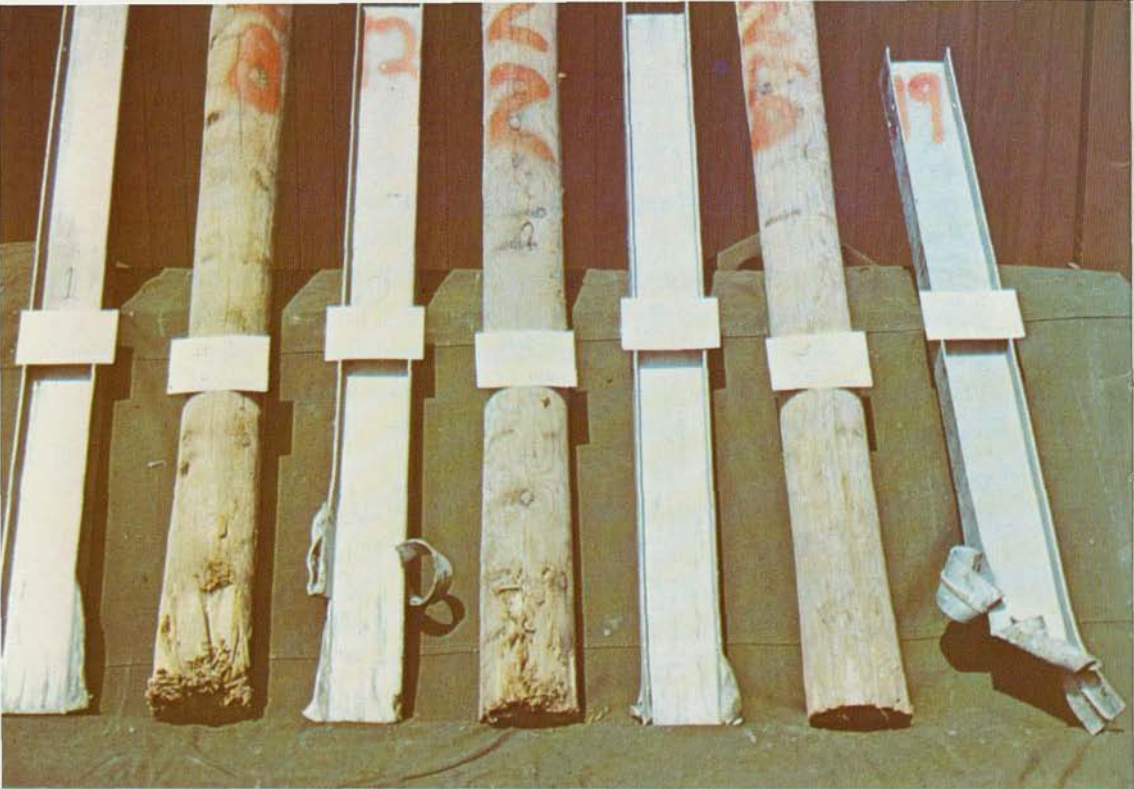
Figure 3.—The four steel posts and three wooden posts driven into the rock base of site 1. The number of blows per post with the 950-pound hammer were (from left to right): steel post 1—12 blows; wooden post 1—28 blows; steel post 2—12 blows; wooden post 2—22 blows; steel post 3—12 blows; wooden post 3—25 blows; steel post 4—19 blows.

The condition of the three wooden posts and four steel posts driven into the rock base is shown in figure 3. Wooden post 3 was undamaged, and damage to the other two wooden posts would not impair their performance. These results are consistent with our earlier driving experience, using a 1,400 pound hammer. As a general rule, when a wooden post hits an obstruction, it either stops or moves the obstruction.

The four steel posts driven into the rock base suffered light to severe damage. Steel posts 1 and 3 had only minor damage to the flanges and would probably perform adequately. Steel posts 2 and 4 would be unacceptable for guardrail support. The flanges of steel post 2 were stripped from the web. Steel post 4, which took 19 blows to get to grade, suffered separation and curling

of the flanges and curling of the web. None of the wooden or steel posts was damaged above the groundline.

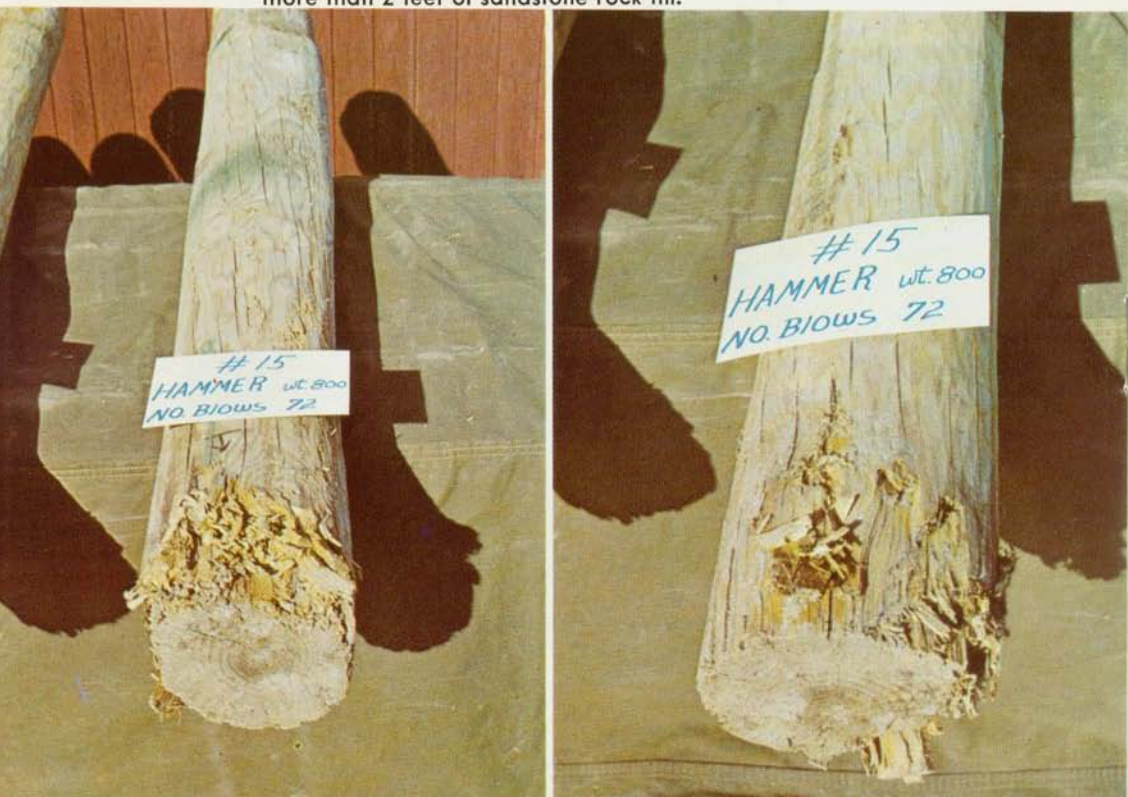
Of the 15 wooden posts driven on site II, posts 6 and 10 were significantly damaged. Damage was in the form of splits resulting from wedge-shaped rocks that had been driven into the base of the posts. We believe that wooden post 6 would have been serviceable because the damage was in that portion of the post that was completely treated with preservative. Post

Figure 6.—Two views of wooden post 15. Knots located within 4 inches of the base minimized the severity of damage that could have resulted from driving through more than 2 feet of sandstone rock fill.

10 had splits along its sides that may have penetrated to untreated wood in the center, and therefore this post was considered to be severely damaged.

The presence of knots within 3 to 12 inches of the base of a post is recommended to minimize the potential for splitting. Splits stop at the knots. Furthermore, on either side of the knot, the grain is not straight but is curved around the knots. This curving of the grain also tends to terminate splits. For example, wooden post 15 (fig. 6) required 72 blows with an 800-pound hammer to be driven into more than 2 feet of sandstone rock fill. Because knots were located about 4 inches from the base, damage to the post was superficial. The value of knots in reducing the severity of damage was observed on 11 of the 17 wooden posts driven on site II.

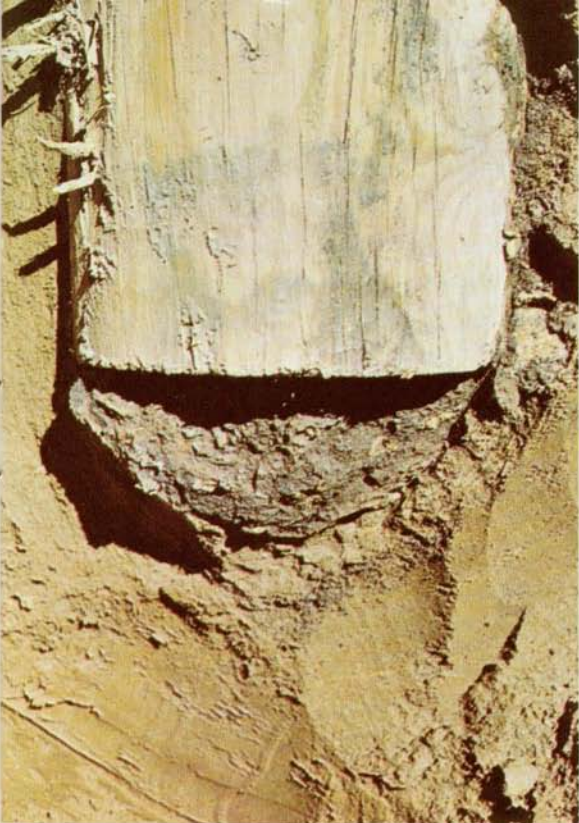
During machine driving, a flat-bottomed wooden post tends to form a cone of compressed material on its base (fig. 7). Cones were clearly visible in site II. The centers of the cones were made of limestone and shale with concentric conical layers of other materials on the outside (fig. 8). These cones were often present after the post was driven through 2 feet of sandstone rock fill. A sleeve of material from the top layers was often clearly visible around these posts. This sleeve was thickest near the groundline and tapered in toward the bottom of the post.

There are two major benefits to these cones. One is the reduction in resistance that would normally be associated with a cross-section 7 or more inches in diameter. The effect is similar to driving a pointed post.

The second major benefit is the protection the cone provides to the base of the post. The top layers generally will be composed of small pieces (1 inch or less) of topping, which do not cause damage. If a post with a cone beneath is driven onto a

Figure 7.—Cones of compressed top-layer material form at the base of flat-bottomed wooden posts. These cones reduce the resistance of the post to driving and help protect the bottoms of the post from damage.

- Wooden posts should have a blunt bottom because, as they are driven, a cone of compressed top-layer material forms at their base. This cone acts as a wedge, which reduces the energy required to drive and protects the bottom of the post from damage.
- Wooden posts should be cut so that knots are located between 3 and 12 inches from the base to minimize the severity of damage.

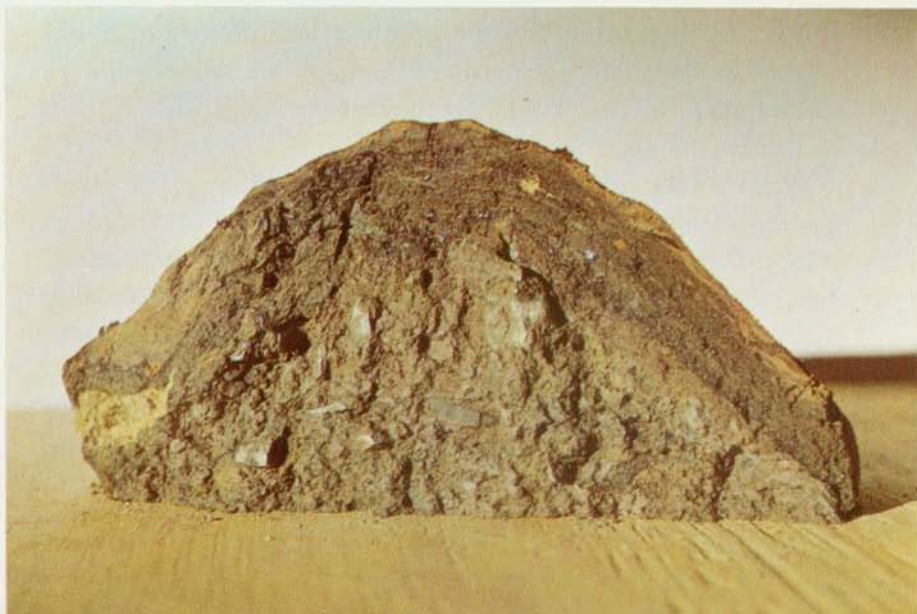
Figure 8.—Section of cone formed at the base of wooden post 16. Center of the cone is made up of limestone and shale from the top 8 inches of the site profile. In the outer inch of the cone, concentric layers of other materials can be seen.

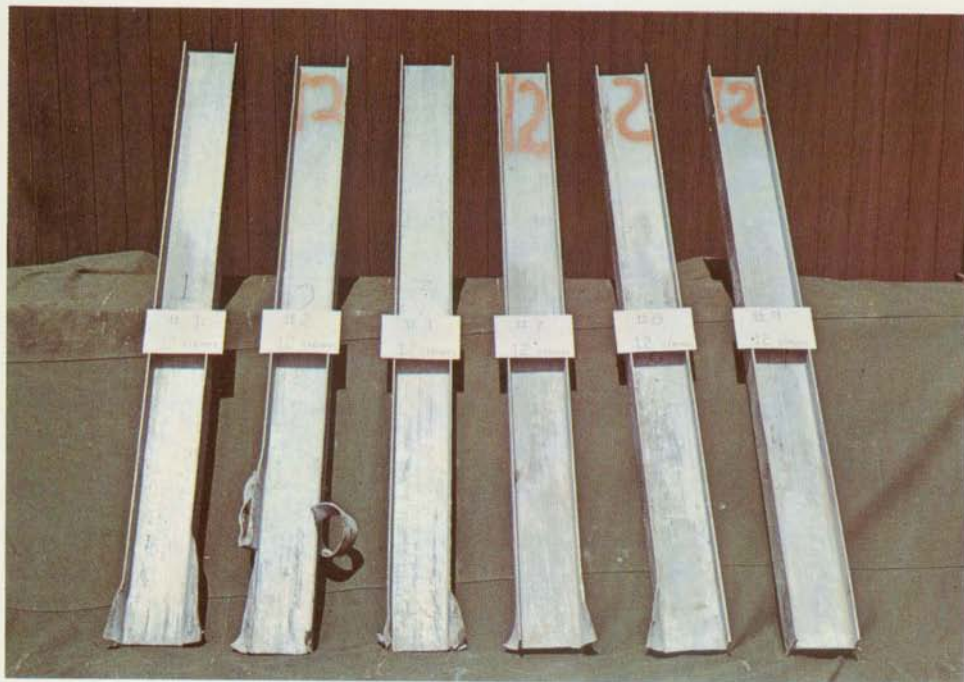
Figure 9.—Six steel posts on site 1 required 12 blows each for insertion. Damage ranged from none to severe.

Six steel posts (fig. 9) on site I each received 12 blows with a 950-pound hammer. Damage ranged from none to severe. Damage to the flanges of steel posts occurs relatively easily and is not detectable from above-ground observations of the driving action.
