# **TREATMENT EFFECTIVENESS MONITORING FOR SOUTHERN CALIFORNIA WILDFIRES: 2003 TO 2004**

## **THE CEDAR, GRAND PRIX/OLD, PIRU, and PADUA FIRES**

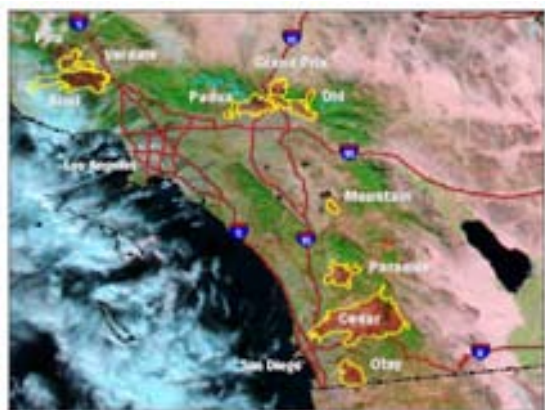
Fig. 1.1. False-color infrared MODIS scene showing fire locations, acquired November 5, 2003 (Clark et al. 2003).

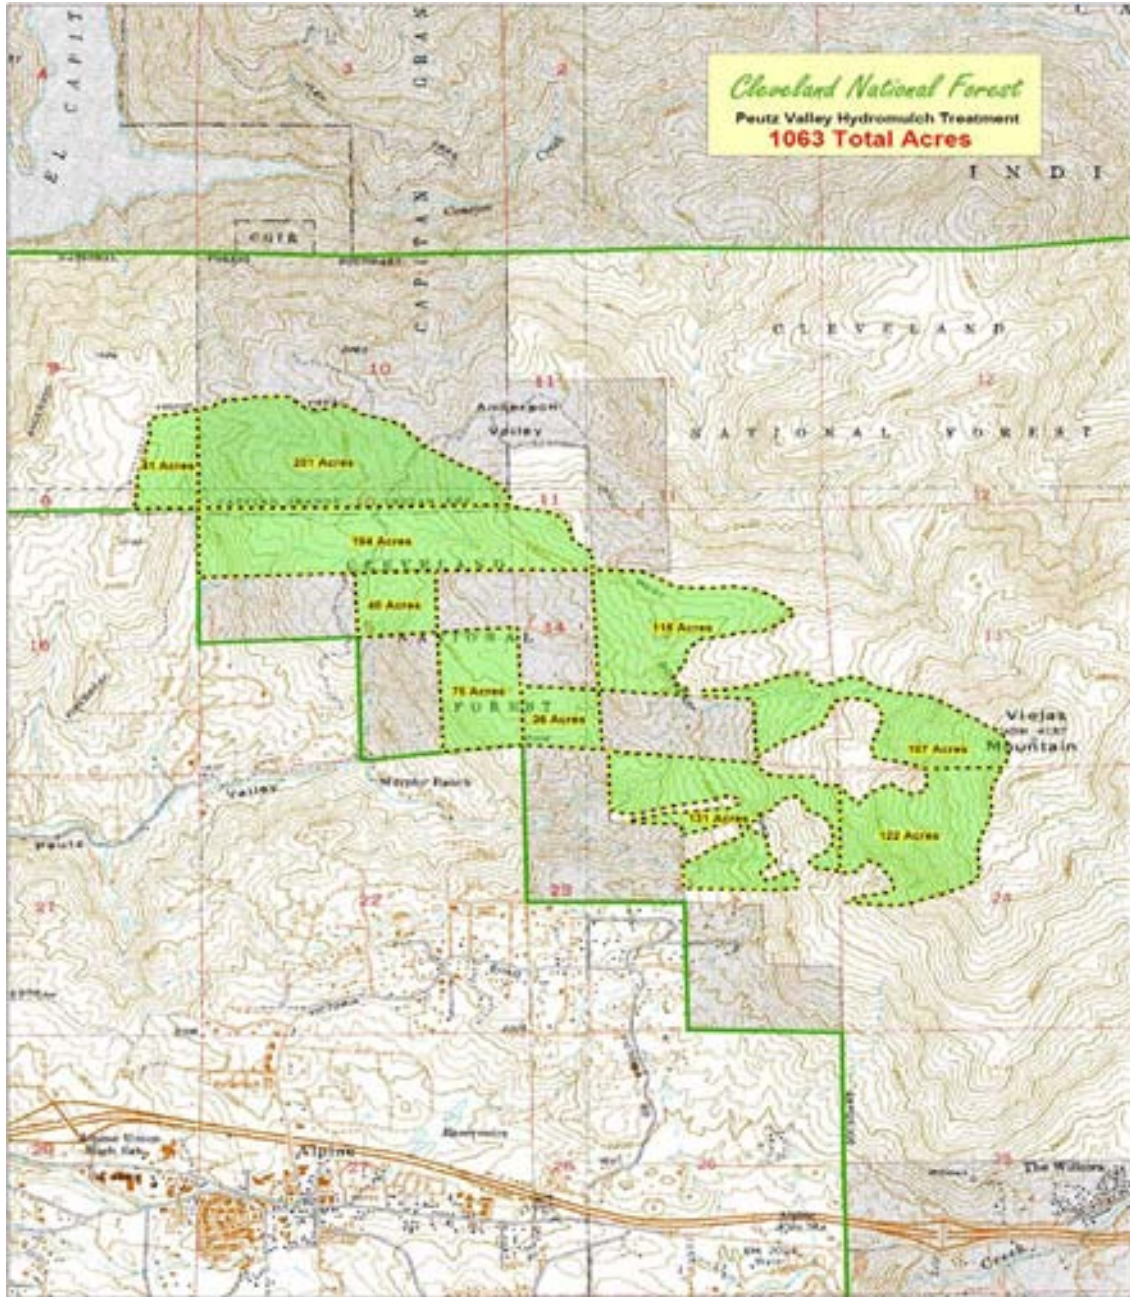
Fig. 2.4. Land treatment effectiveness monitoring sites for Cedar Fire located above Peutz Valley. Sites were located on both Capitan Grande Indian Reservation and FS responsibility lands. The 201 acres on the Capitan Grande Reservation were treated with 100% aerial hydromulching, and the Forest Service lands were treated with strip aerial hydromulching to provide 50% coverage.

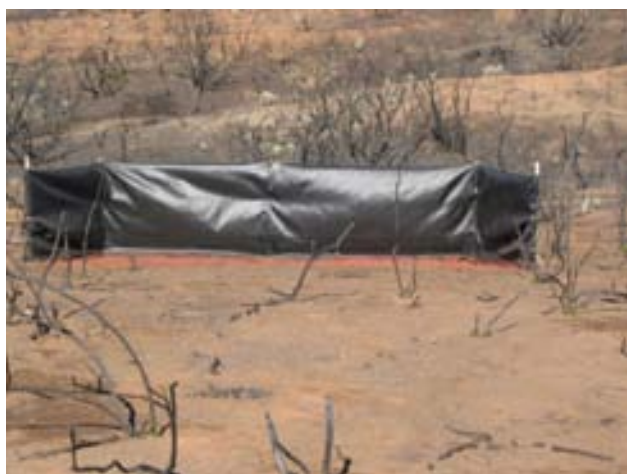
Fig. 2.5. Representative silt fence construction viewed from contributing area. Note red chalk placed at base of silt fence designating the surface boundary.

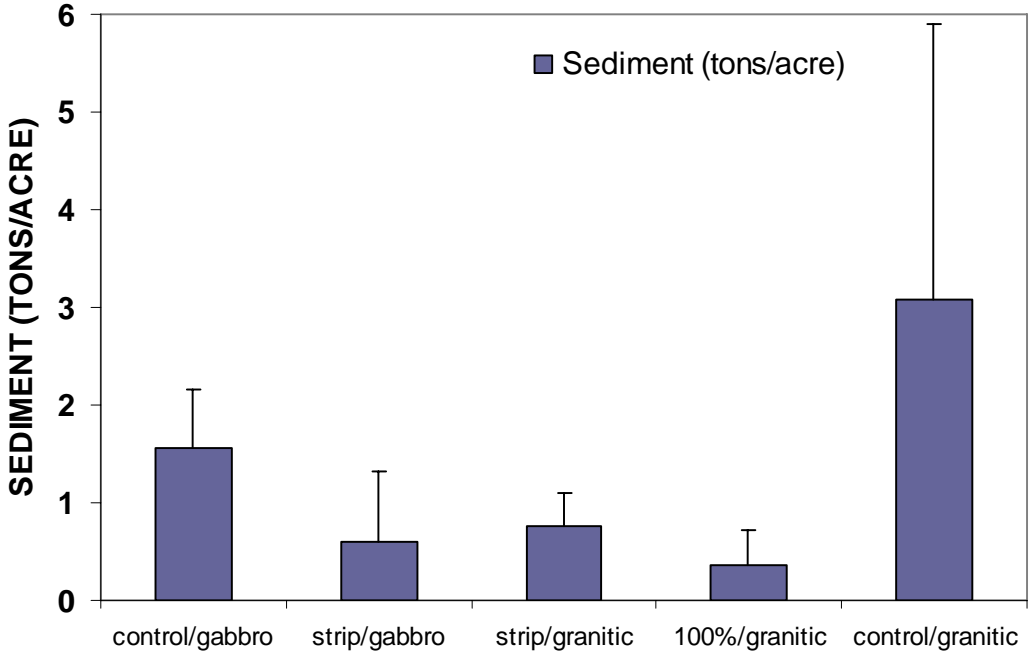
Fig. 2.6. Mean values of sediment collected Mar 2, 3 following Feb and Mar precipitation of 5.7 in. Sampling size: Control/gabbro n = 13; strip/gabbro n = 11; strip/granitic n = 10; 100% granitic n = 10; control/granitic n = 10.

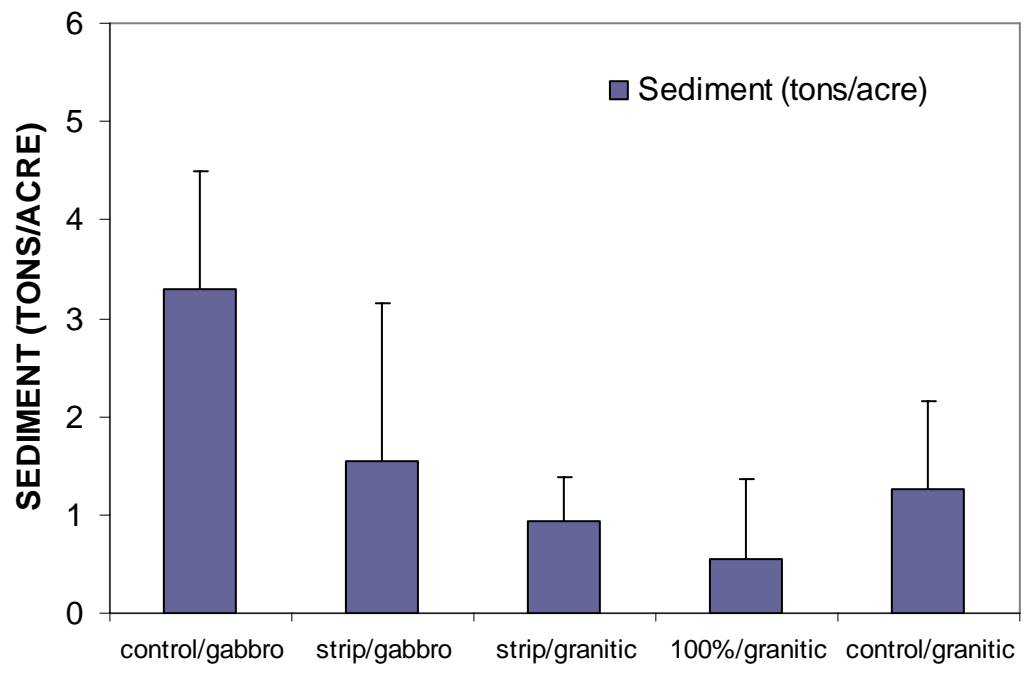
Fig. 2.7. Mean values of sediment collected Apr 13, 14 following March and April precipitation of 0.85 in.

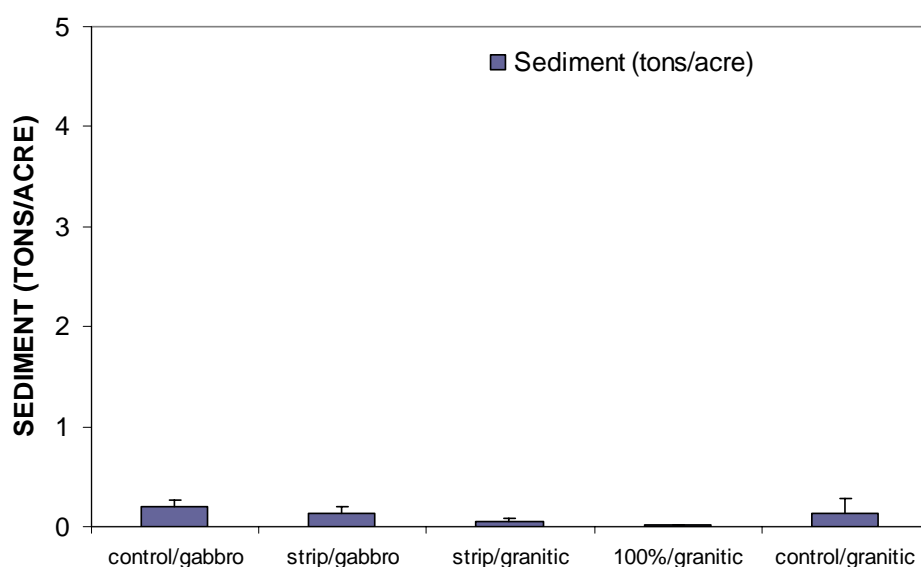
Fig. 2.8. Comparison between treatments of mean values of sediment collected on May 16 following April and May precipitation totals of 0.41 in.

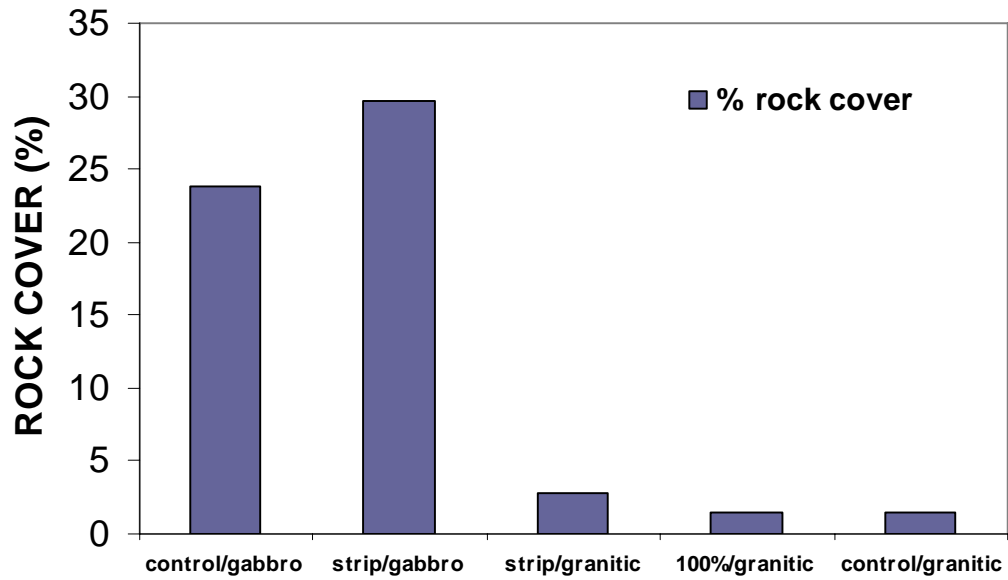
Fig. 2.10. Comparison of percent rock cover between gabbro and granitic parent material under all treatment conditions.

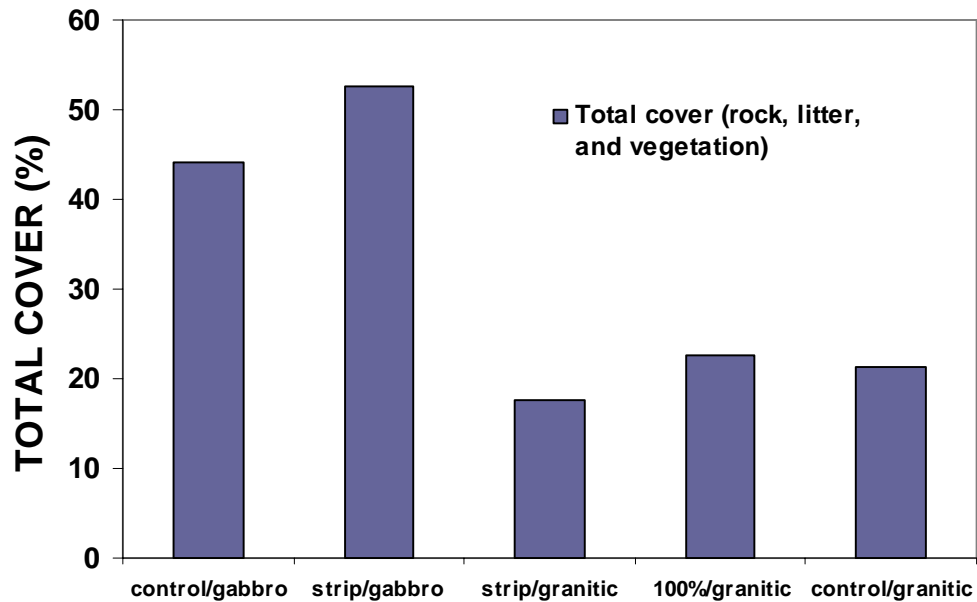
Fig. 2.11. Comparison of total cover (rock, litter, and vegetation) between gabbro and granitic parent material under all treatment conditions.

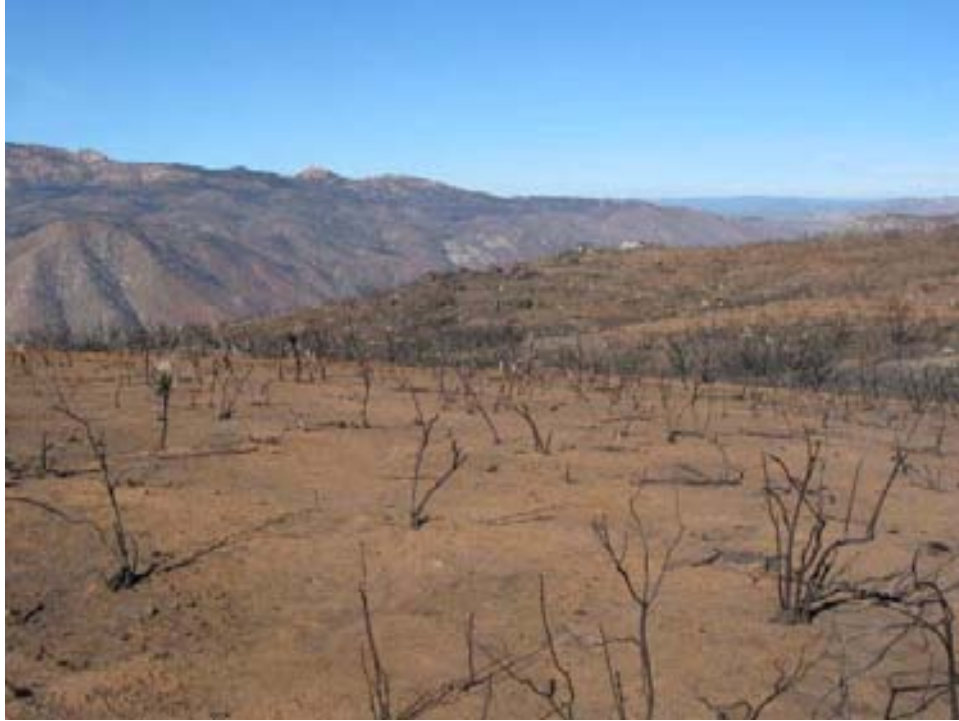
Fig. 2.13. Photo of the burned area underlain by granitic parent material taken in December 2004. There were few signs of vegetation recovery at this time.

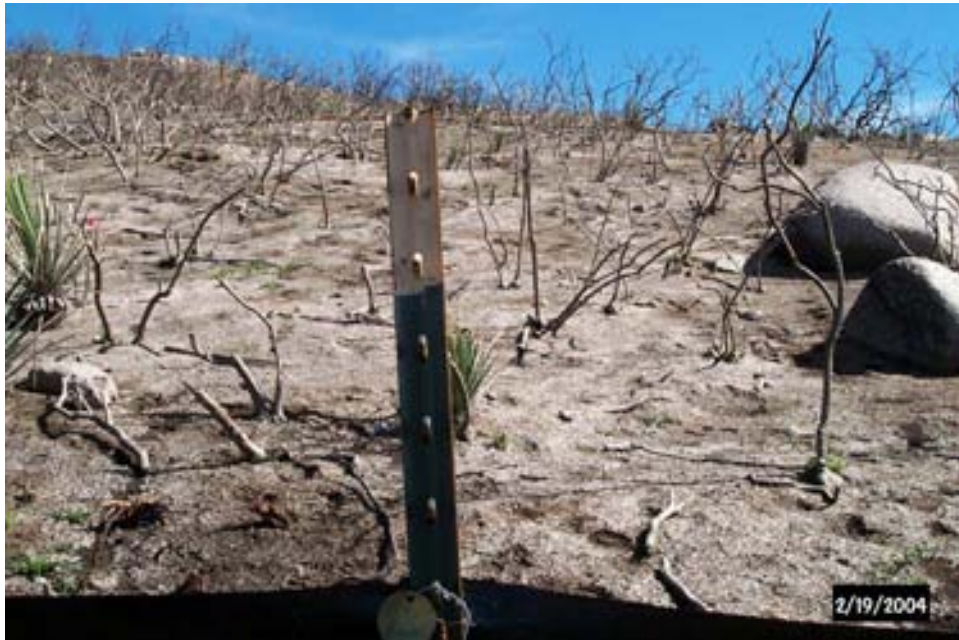
Fig. 2.14. View of contributing area of silt fence 39 (100% treatment-granitic) showing vegetation recovery on 2/19/2004. Chamise skeletons were just beginning to resprout.

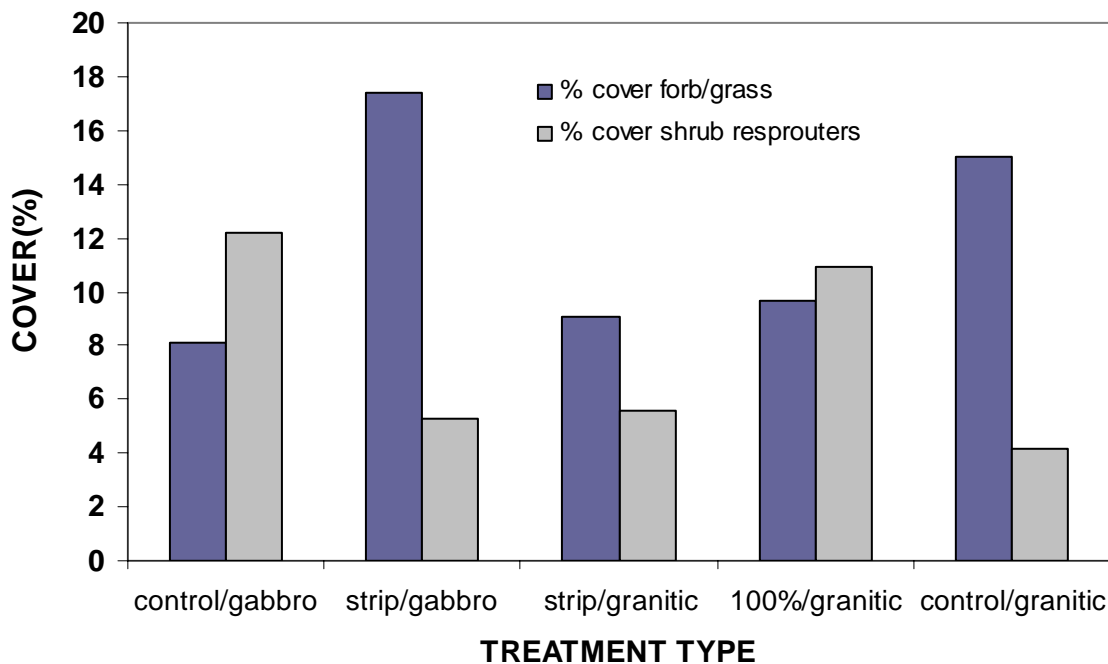
Fig. 2.16. Comparison of percent cover between forb/grass and shrub resprouter species sampled on June 7, 2004. Forbs/grasses showed a higher response to the strip treatment on gabbro which may be a result of greater moisture stored at the surface due to the hydromulch.

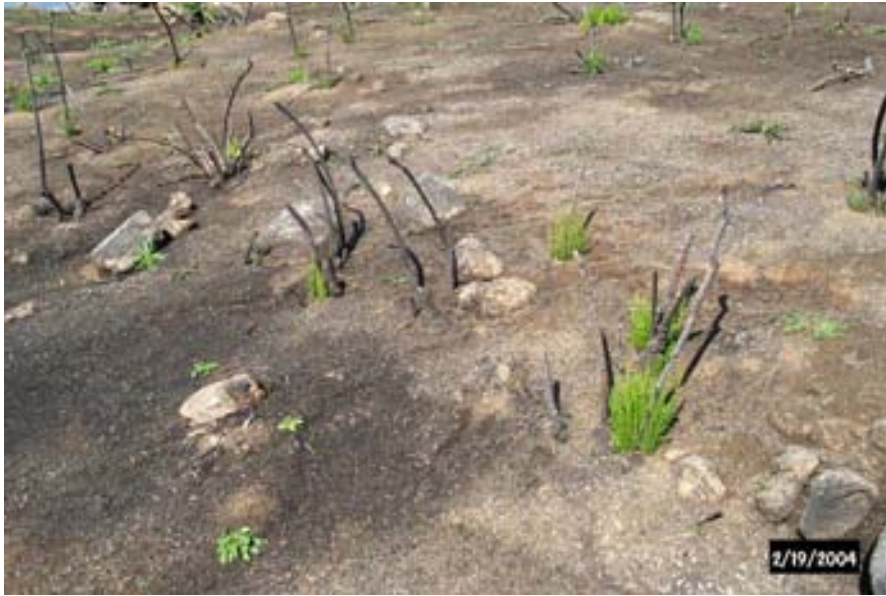
Fig. 2.17. Photo of resprouting chamise taken on 2/19/2004.

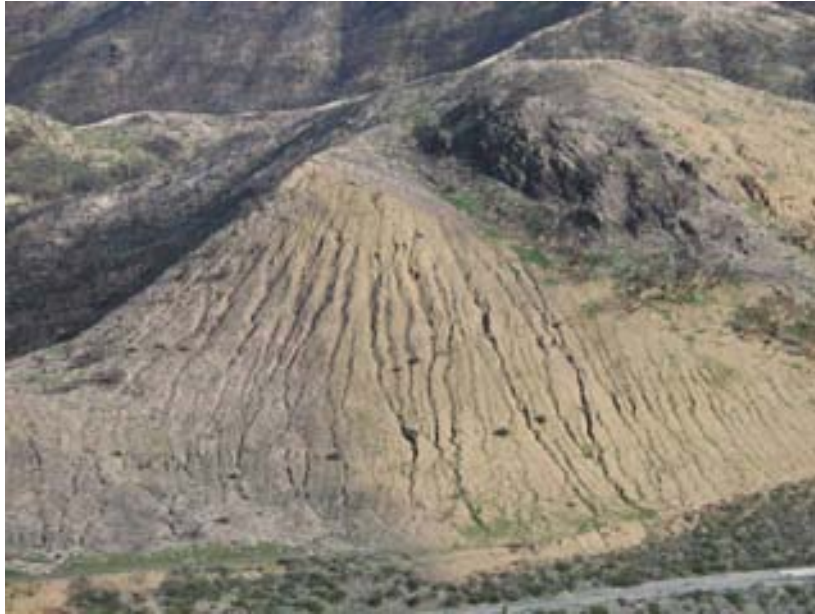
Fig. 2.21. Rilling of “100% cover hydro-mulch applied on steep (>55% slope) roadcut in the Devore area.

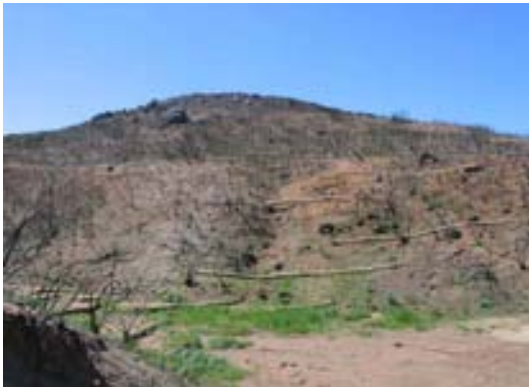
Fig. 2.23. View of fiber rolls placed in checkerboard fashion upslope to the top.

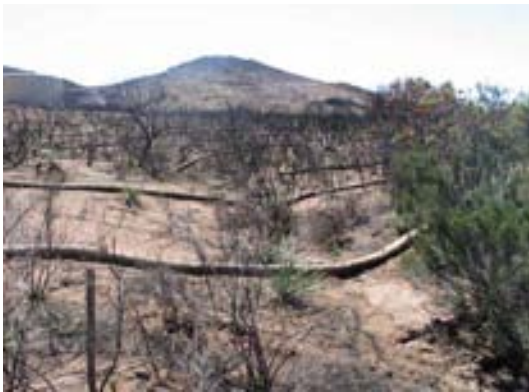
Fig. 2.24. Fiber rolls incorrectly placed across drainage.

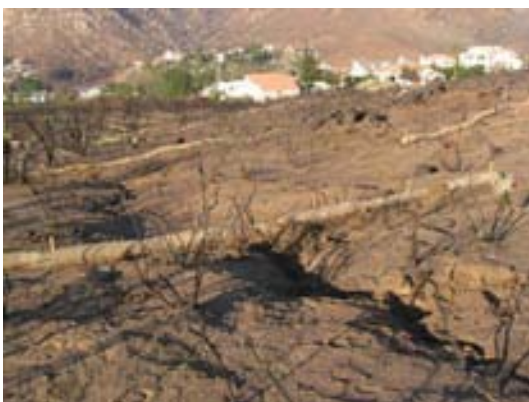
Fig. 2.25. Another view showing fiber rolls placed incorrectly. The fiber roll seen in the foreground was undercut during the Christmas Day storm. Note backfill repairs.

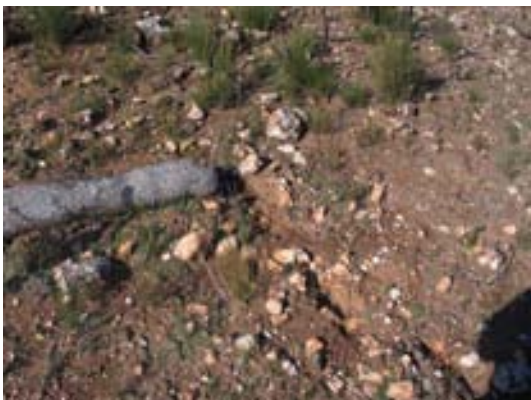
Fig. 2.26. Fiber roll incorrectly down-turned at end. A rill is beginning to form at the end where water is being channeled.

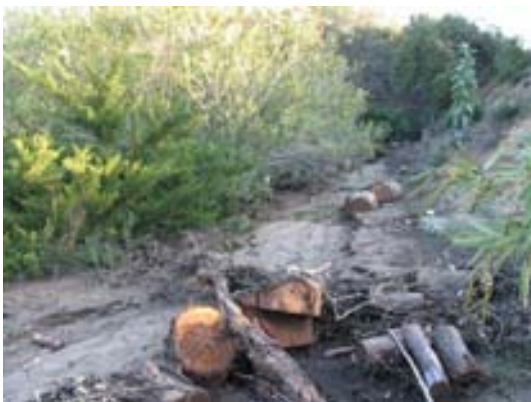
Fig. 2.27. Sediment and debris in channel that emptied onto Cathedral St.

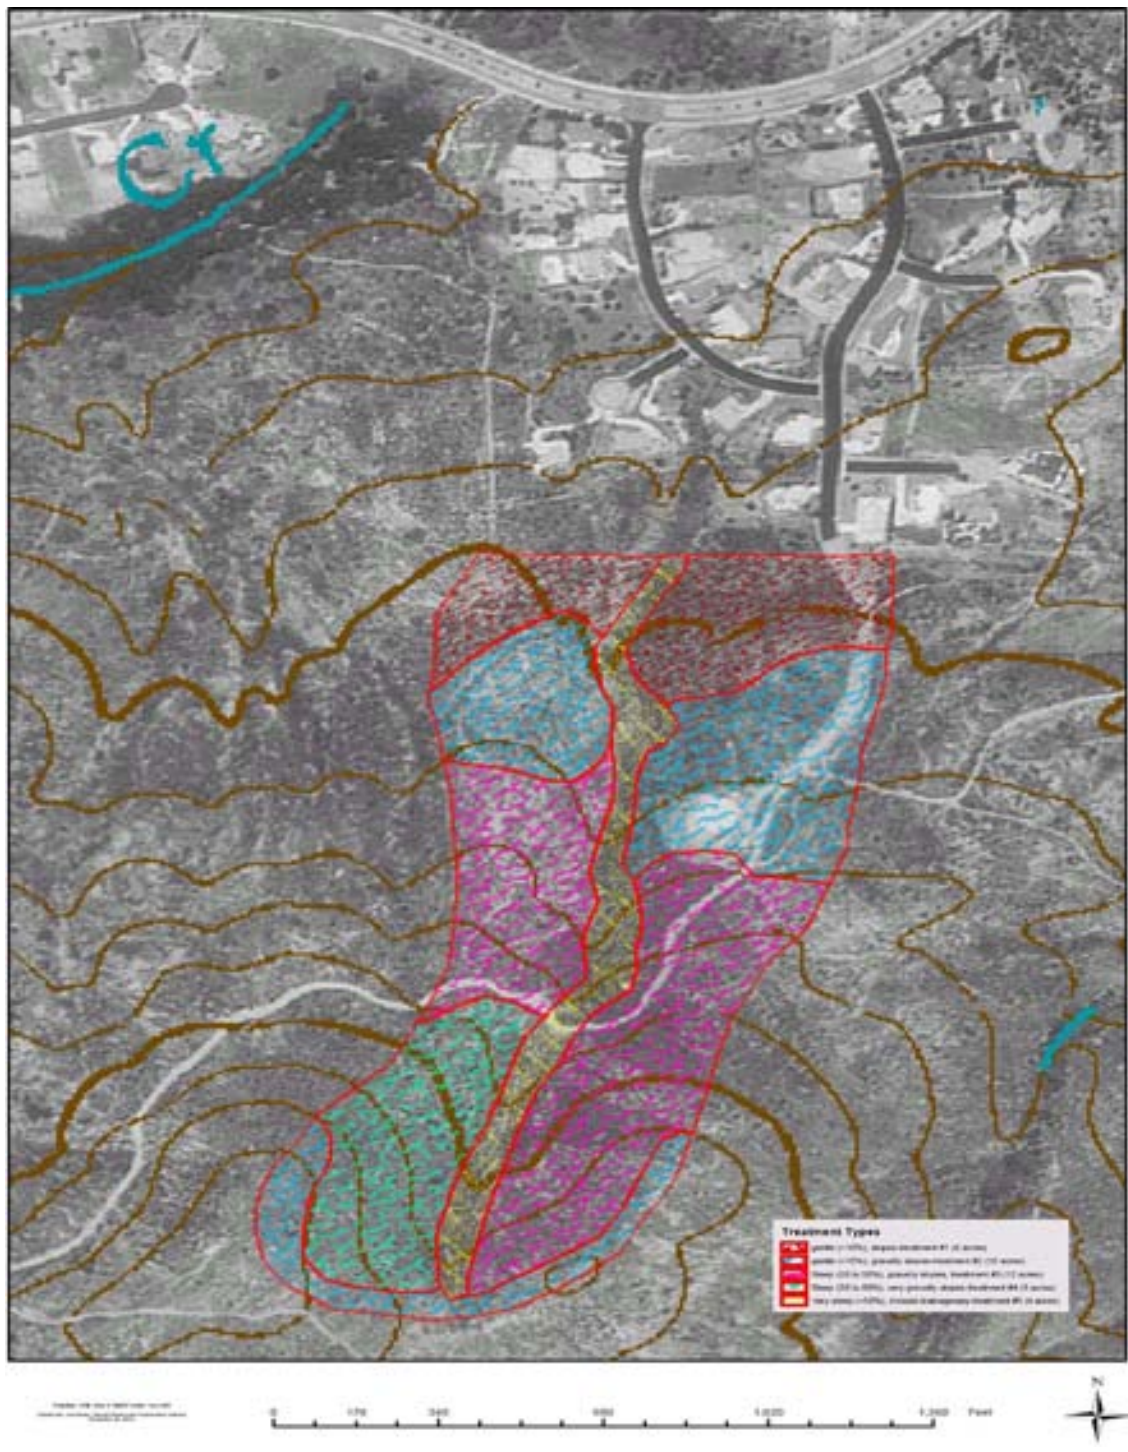
Fig. 2.32. View of 38 acre fiber roll treatment site at San Diego County Estates (Cedar Fire) in the San Vicente watershed.

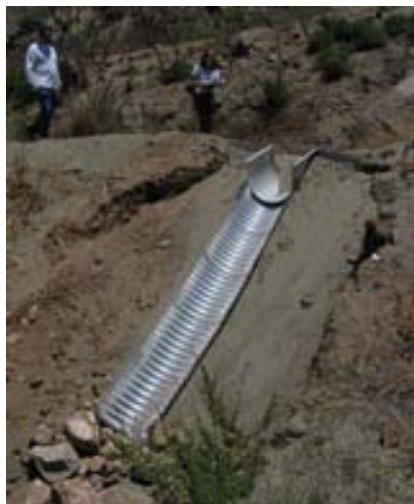
Fig. 2.33. New overside drain with extension at mile point 0.6, photo #100-0008.

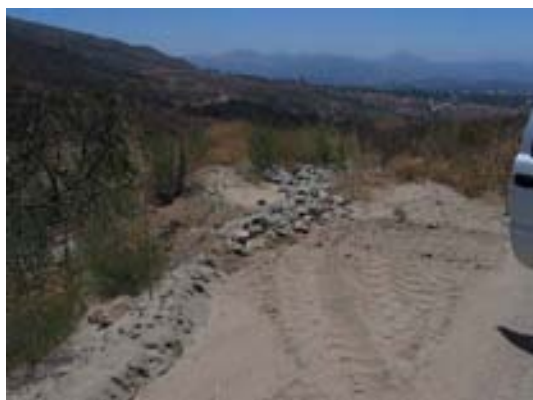
Fig. 2.34. Riprap added to existing drainage features (rolling dip and lead-off (crowing) at mile point 1.1, photo #100-0013.

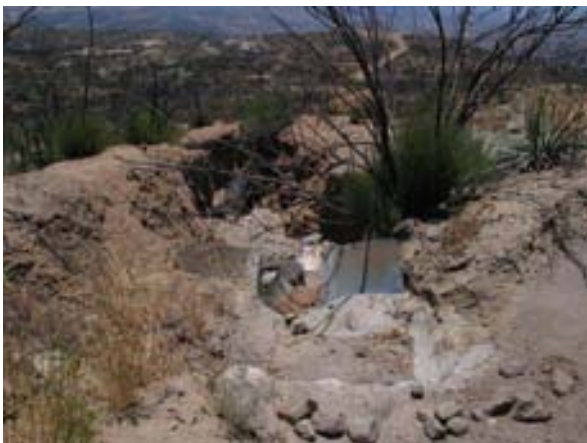
Fig. 2.36. Old overside drain located on private section of Anderson Truck Trail. Mile Point 1.7, photo #100-0018.

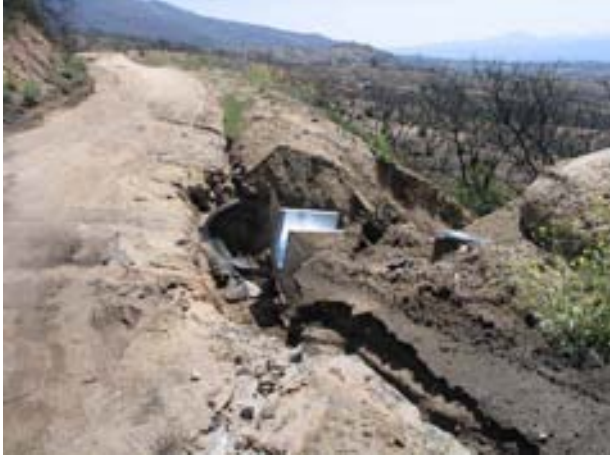
Fig. 2.37. Failure of overside drain at mile point 1.4 on Anderson Truck Trail. Photo taken on Apr 7, 2004.

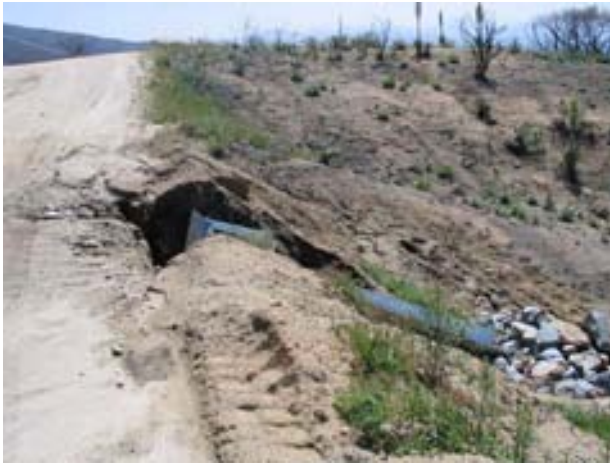
Fig. 2.38. Failure of overside drain at mile point 1.9 on Anderson Truck Trail. Photo taken on Apr 7, 2004. Note riprap below overside drain.

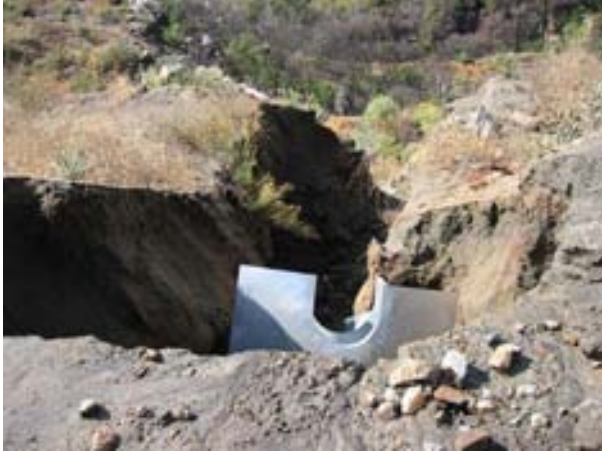
Fig. 2.39. Failure of upside drain at mile point 1.49. This failure occurred during the October, 2004 rain events.

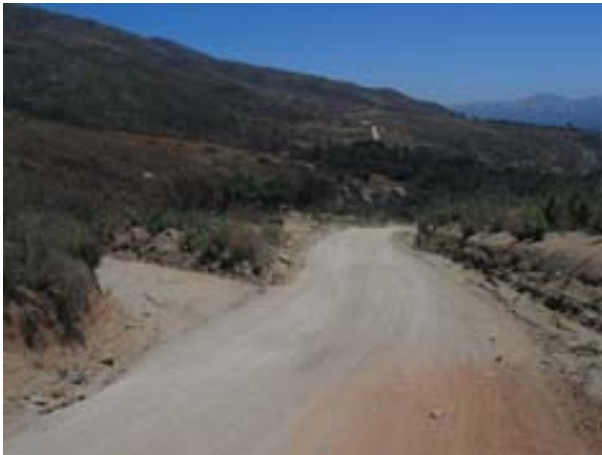
Fig. 2.40. Rolling dip with lead off installed. Dip is hard to see in photo. Mile point 0.9, photo #100-0020.

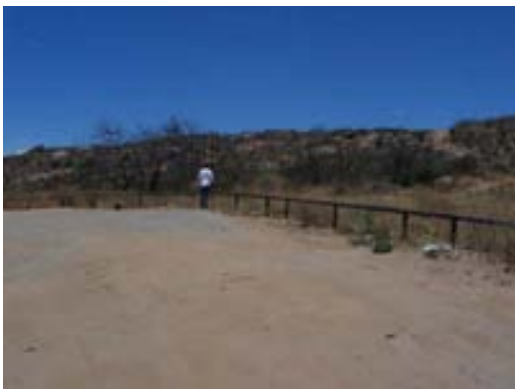
Fig. 2.44. Removable pipe barrier (OHV barriers) placed along Anderson Truck Trail. (Photo # 100-0015).

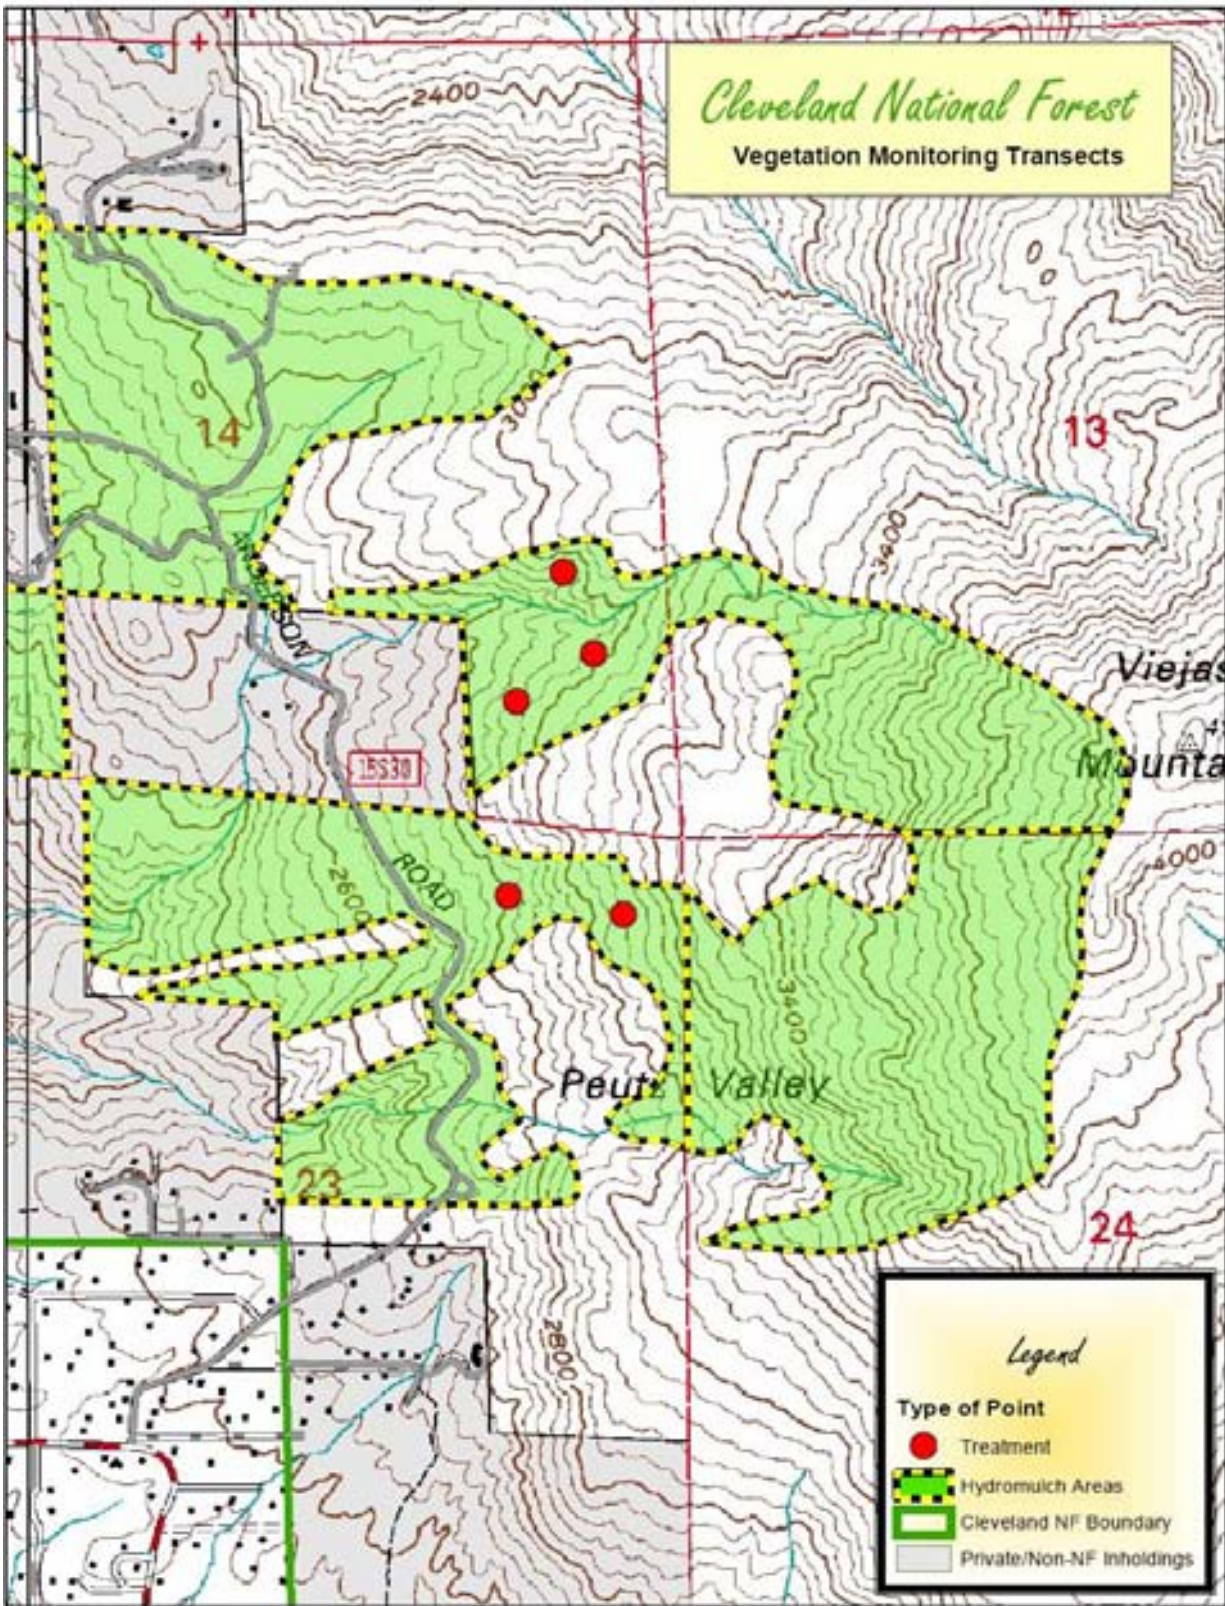
Fig. 2.45. Map showing general location of vegetation monitoring transects. Red circles designated treatment in legend are transect locations.

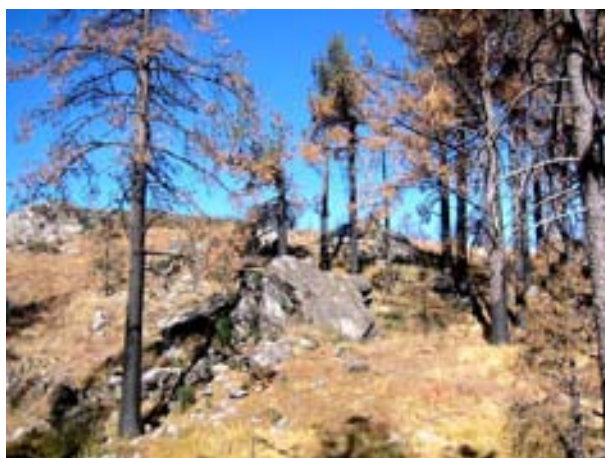
Fig. 2.46. SDi-5842 October 15, 2004

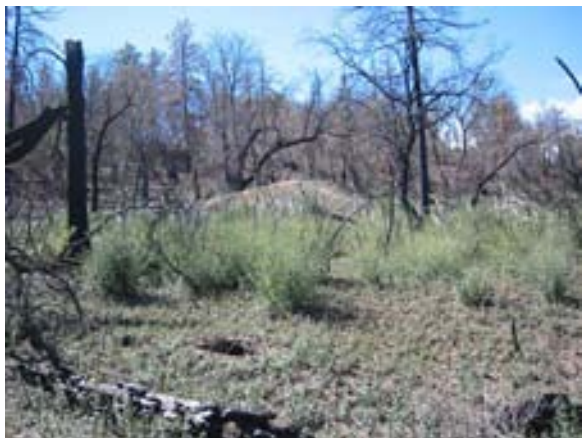
Fig. 2.49. SDi-8586H October 15, 2004 (Note tailings pile in center of frame)

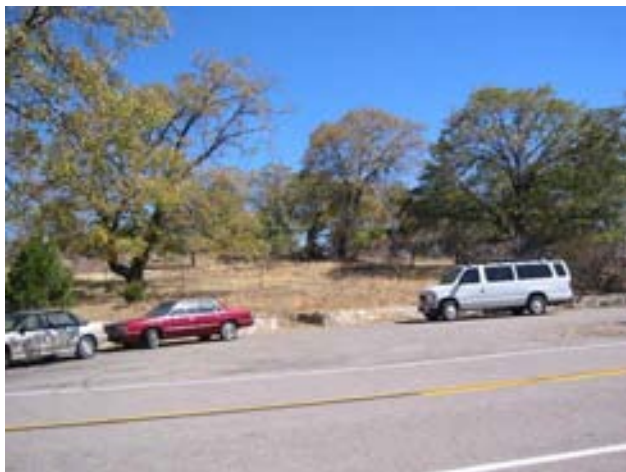
Fig. 2.51. SDi-9197 October 15, 2004

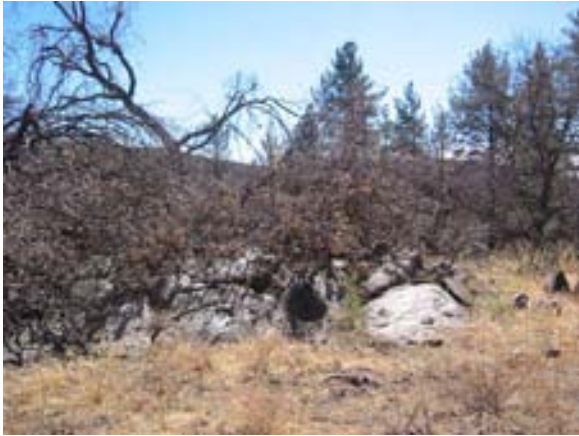
Fig. 2.53. SDi-8571 October 15, 2004

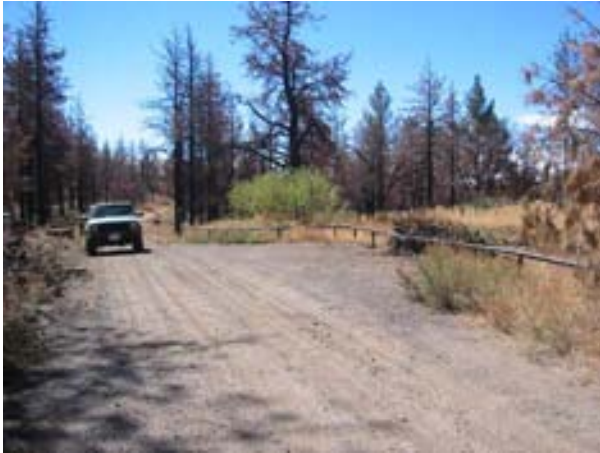
Fig. 2.55. SDi-10768 October 15, 2004 (Site is to the right of the barriers; private property gate is apparent behind vehicle)

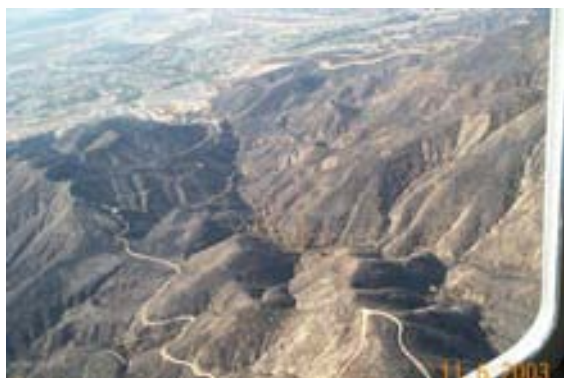
Fig. 3.1. View of steep, incised canyons of the front range of the San Bernardino Mountains.

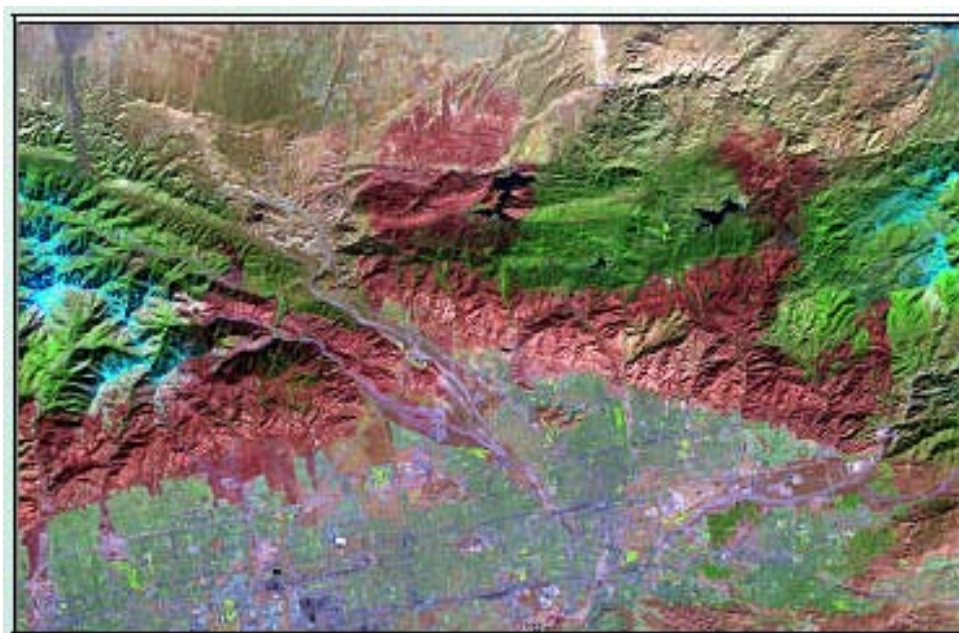
Fig. 3.2. ASTER imagery of the Grand Prix and Old Fires, acquired on November 18, 2003. The city of San Bernardino is south of the fires (Clark et al. 2003)

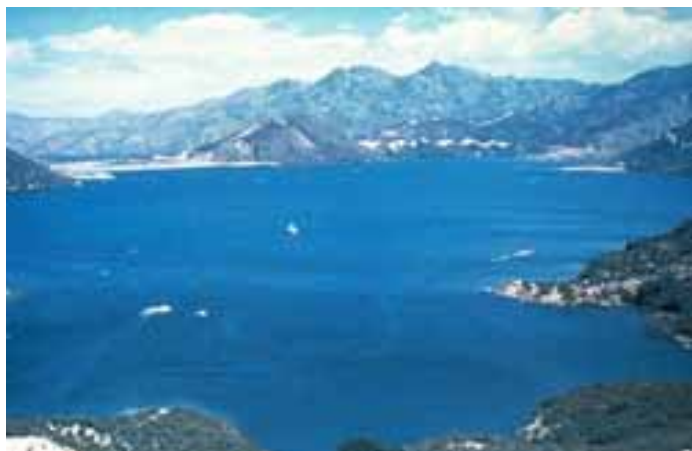
Fig. 3.5. Aerial view of Silverwood Lake (copyright California State Parks)

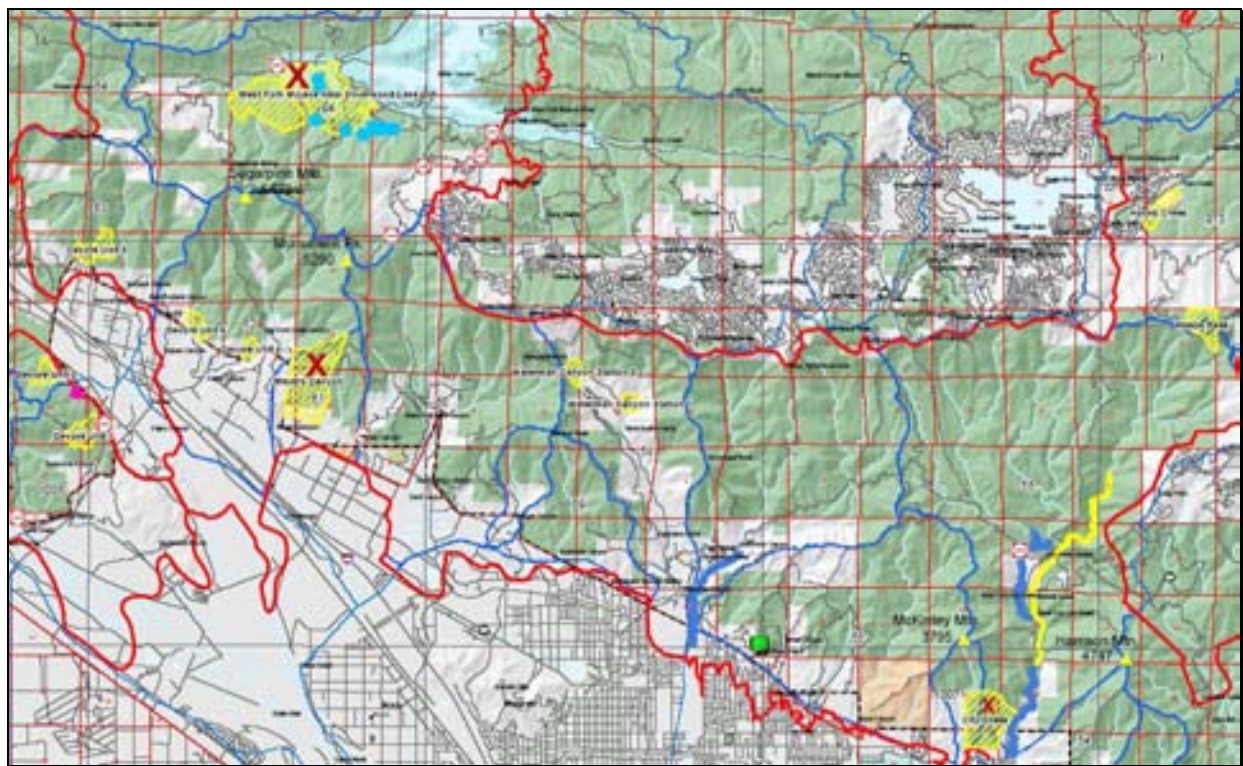
Fig. 3.6. Proposed locations of land treatment effectiveness monitoring sites for Grand Prix /Old Fire (red X's). Sites monitored were West Fork Mojave (Lake Silverwood), City Creek, and two sites in the Devore area.

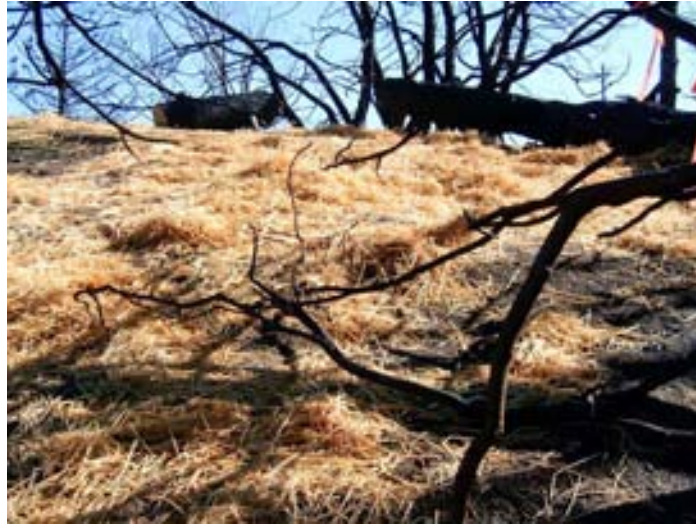
Fig. 3.21. Hooks Creek hand mulch site PP1East viewed on 12-3-2003. Note the high cover percent because of low wind conditions in area.

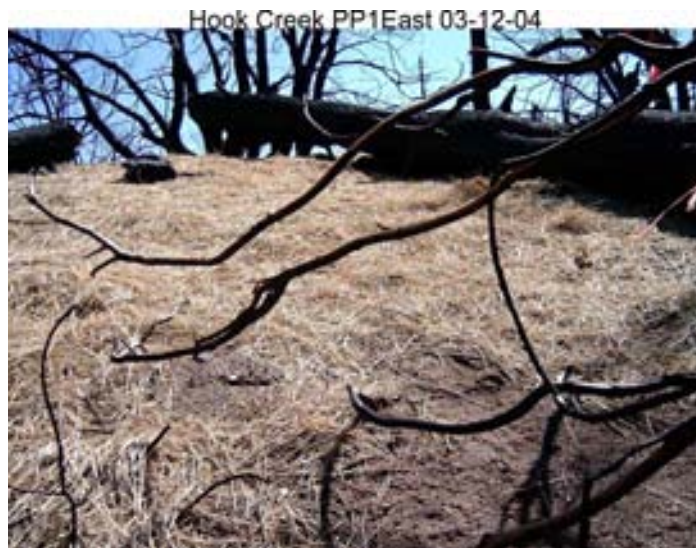
Fig. 3.22. Hooks Creek hand mulch site PP1East viewed on 3-12-2004.

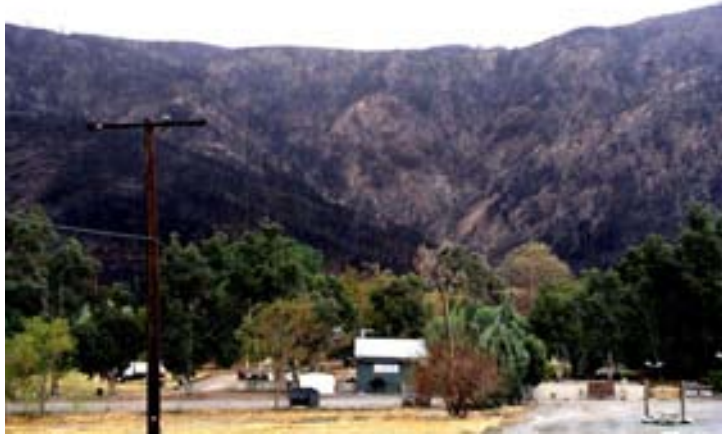
Fig. 3.44. Entrance to Deer Park Nudist Resort. Note two steep canyons immediately behind camp. Buildings of the camp extend beyond the trees to the National Forest border.

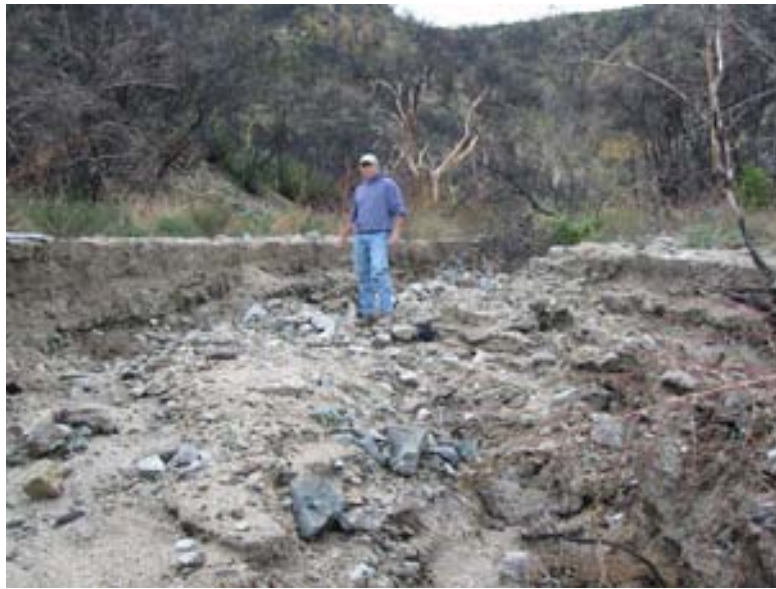
Fig. 3.59. Sediment was stored to the level of the cut banks. Sediment storage can be seen in Figs. 3.52 and 3.53. All of this material was released during the October, 2004 storm events when the check dam failed.

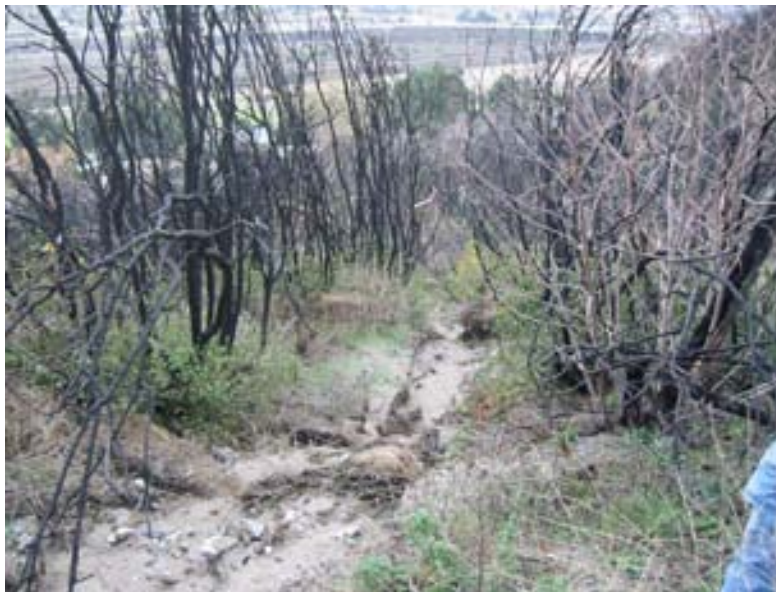
Fig. 3.60. Blowouts of side channel check dams also occurred in the October, 2004 storm events.

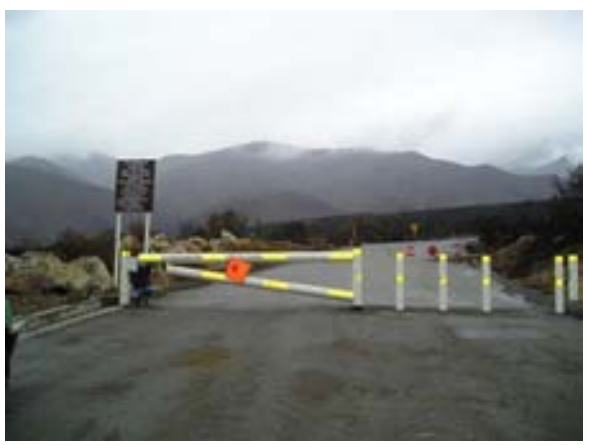
Fig. 3.61. View of new gate and warning sign located at Lower Lytle Creed Divide.

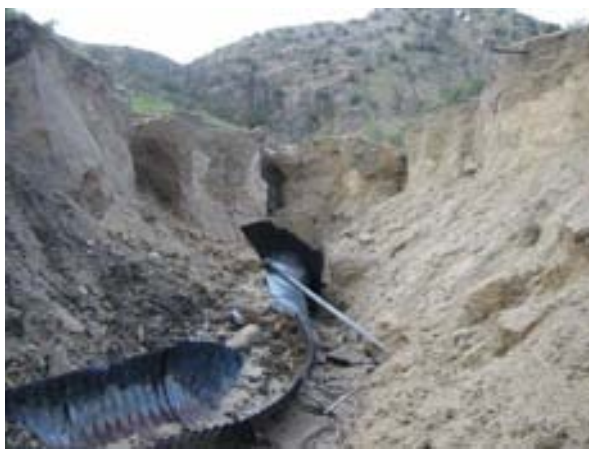
Fig. 3.62. Failure of rolling dip and upside drain along Big Tree Cucamonga #1N34. This occurred following October, 2004 storm events. Treatment was planned here but not completed before the October, 2004 rain events. Milepoint was unknown.

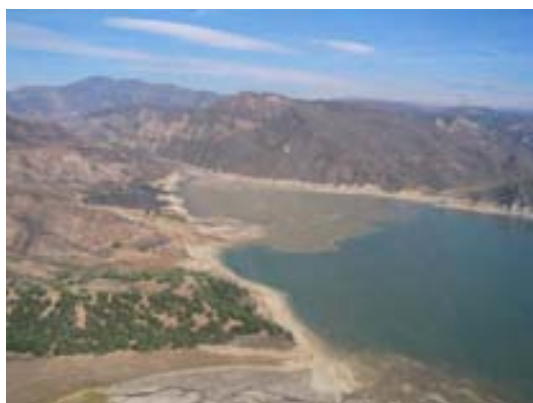
Fig. 4.1. In this view of the Lake Piru Reservoir, a plume of sediment can be seen entering at the upper end.

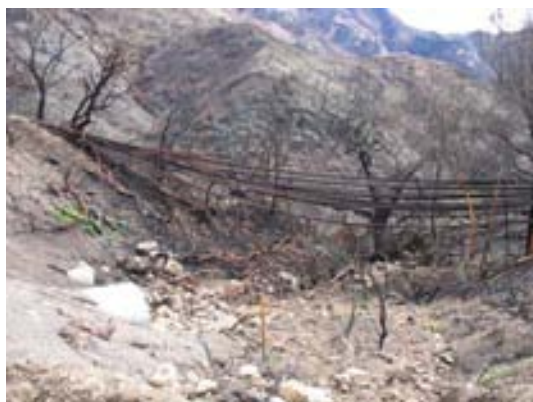
Fig. 4.2. Oil pipelines suspended across drainage in the Sespe area. The fire uncovered a vast array of functioning and non-functioning pipelines in the area. It was suggested that the pipelines be mapped and noted as working or not.

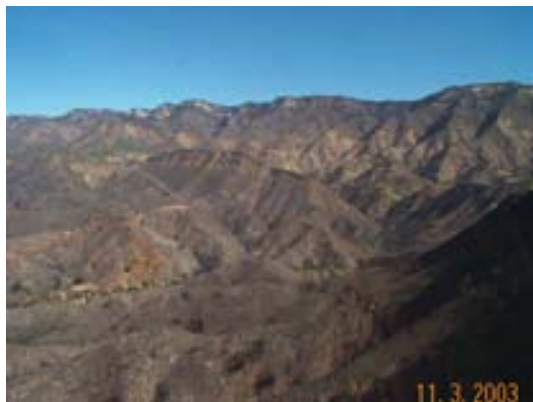
Fig. 4.3. View of steep terrain common to the Monterey and Sisquoc geologic formations found in the Piru Fire area.
