# **TREATMENT EFFECTIVENESS MONITORING FOR SOUTHERN CALIFORNIA WILDFIRES: 2003 TO 2004**

## **THE CEDAR, GRAND PRIX/OLD, PIRU, and PADUA FIRES**

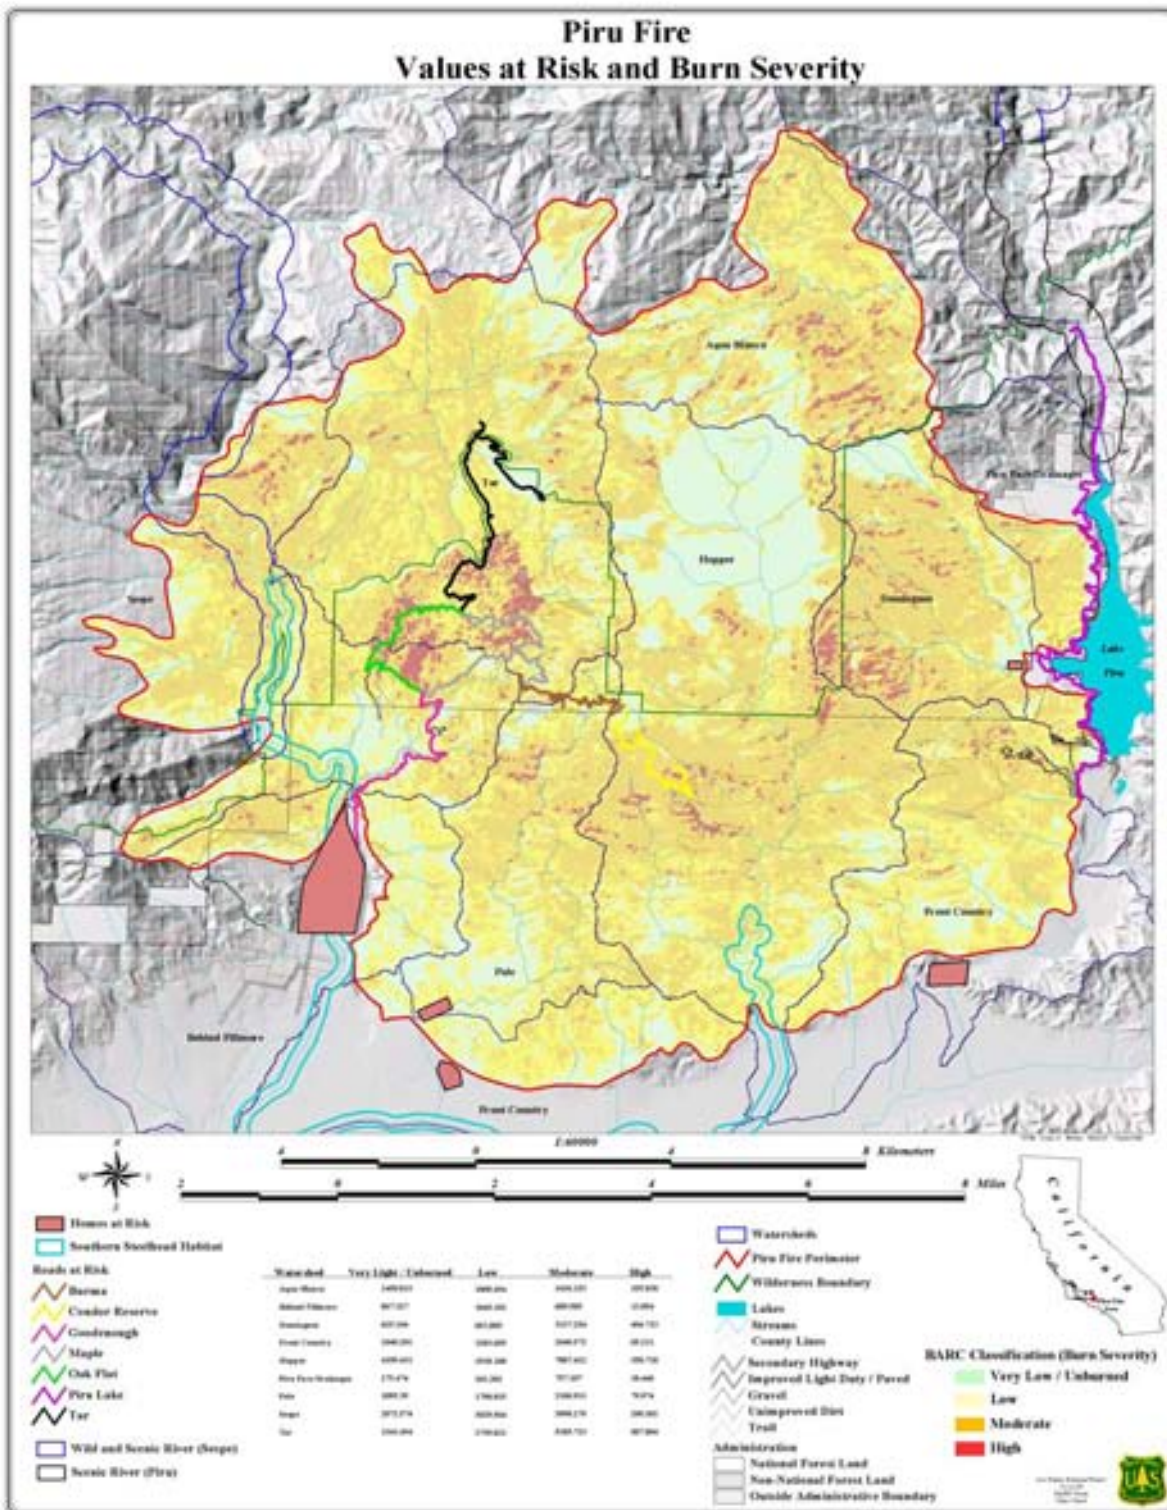
Fig. 4.4. Burn severity map of the Piru burn area.

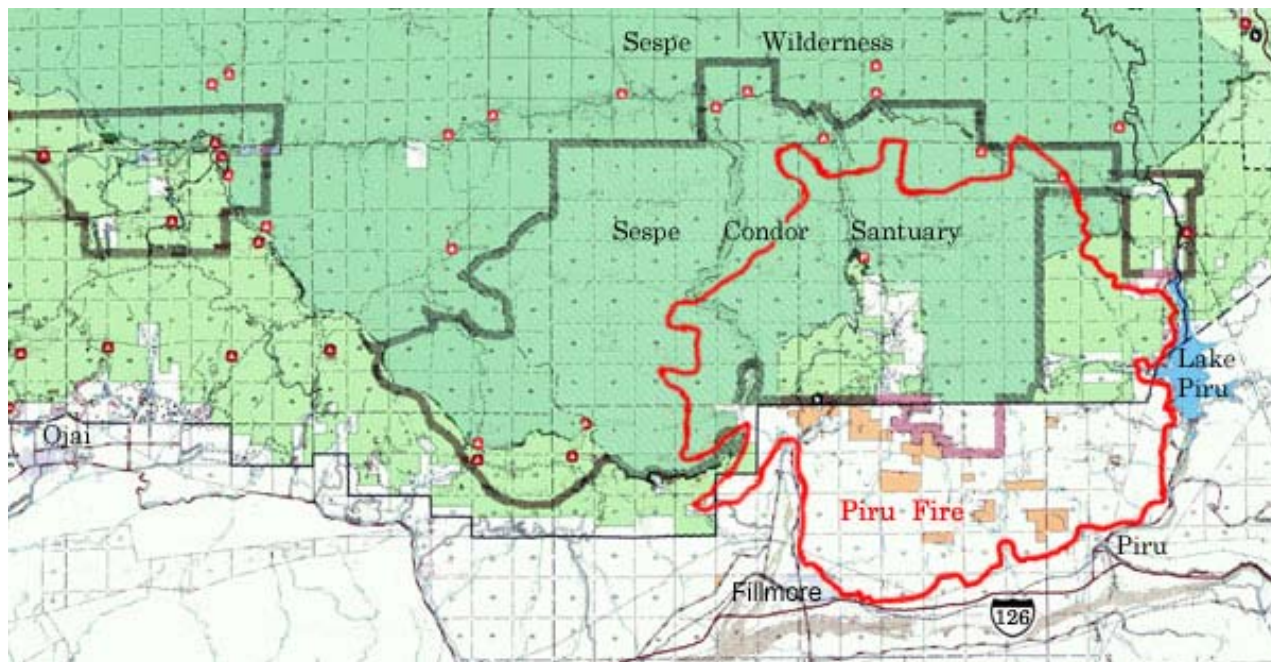
Fig. 4.5. Boundary of Piru Fire lined in red.

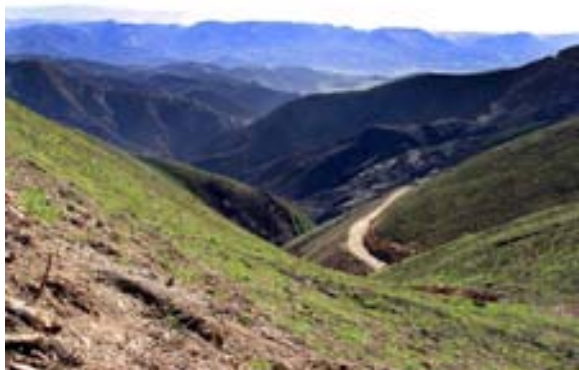
Fig. 4.6. Grass and herbaceous vegetation recovery witnessed within weeks following the Piru Fire. Photo taken on 11-21-2003.

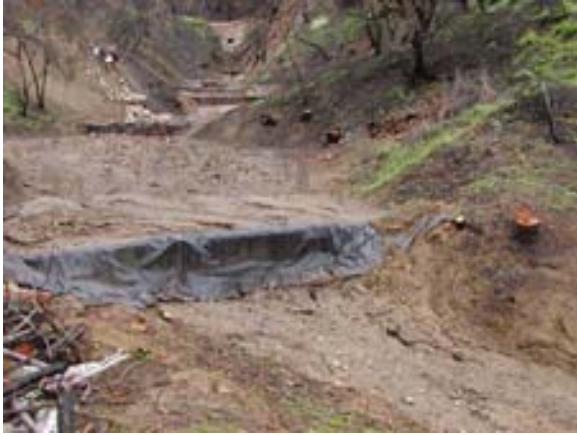
Fig. 4.13. Storage area behind dams filled to capacity.

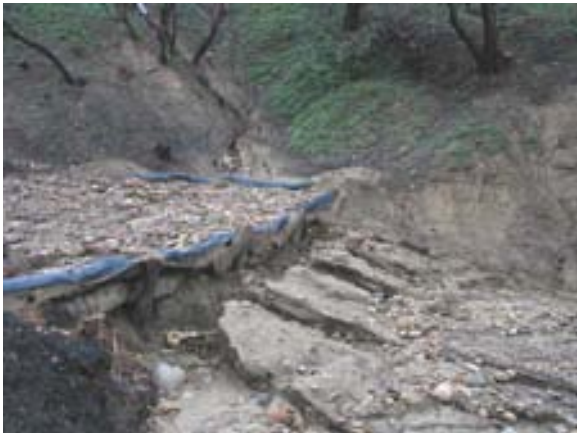
Fig. 4.14. Cutting back under the log check Dam.

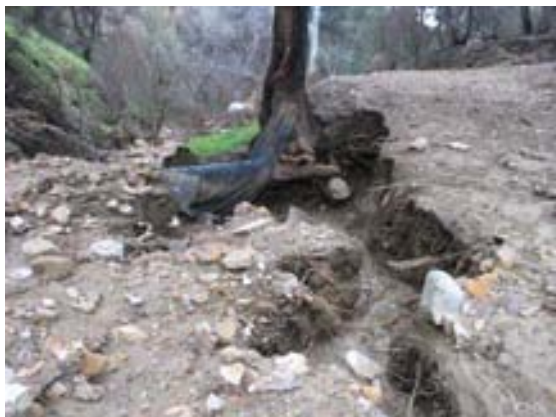
Fig. 4.15. New channel formed in newly deposited sediment causing check dam to fail at end.

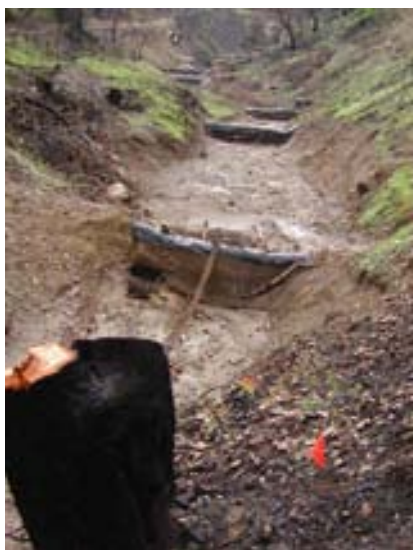
Fig. 4.16. Water flowing under structure in foreground and sediment overtopping and going around structure.

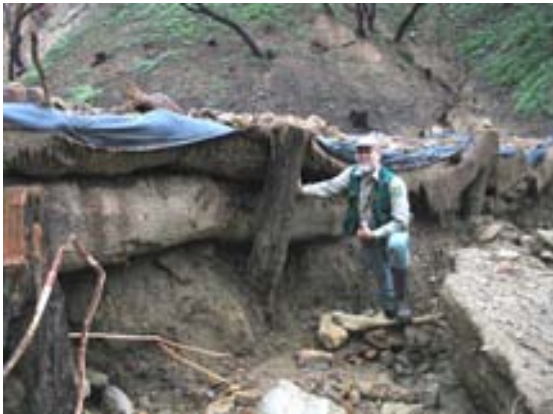
Fig. 4.19. View of log check dam being undercut. With the check dam filled to capacity with sediment, there is nothing reducing the energy of the water flow.

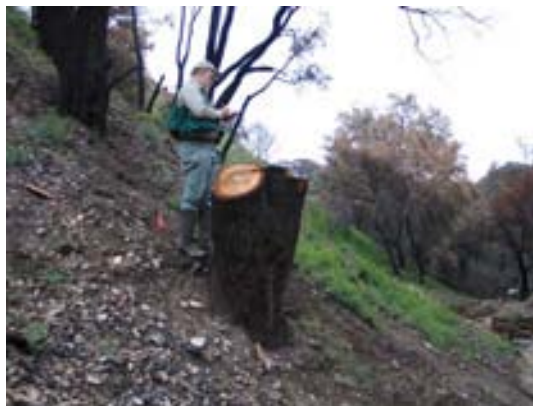
Fig. 4.20. Remaining canyon live oak stump.

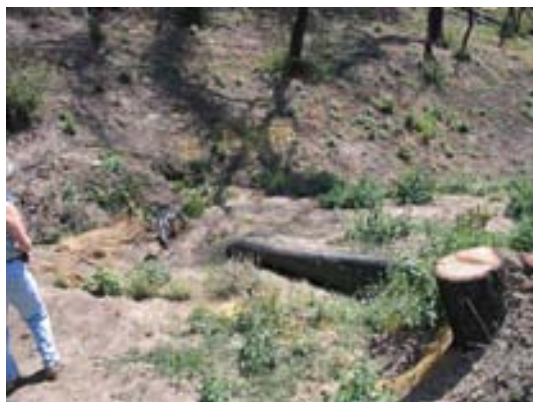
Fig. 4.21. To remediate the check dam installation, notching or removal of middle portion of some check dams was initiated.

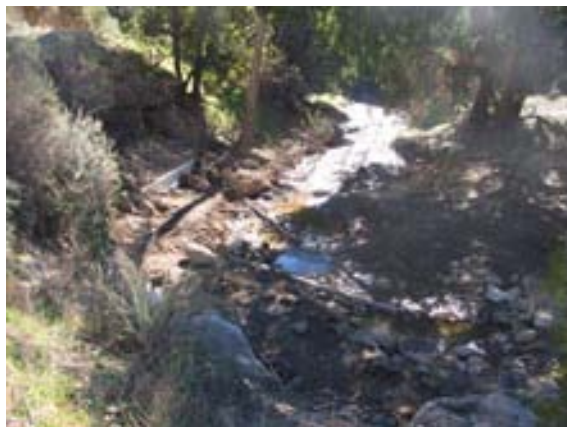
Fig. 4.22. Vein structure of K-rails set in channel at angles to lessen water energy and prevent additional eroding of bank. Mile point 0.78. See road log for narrative.

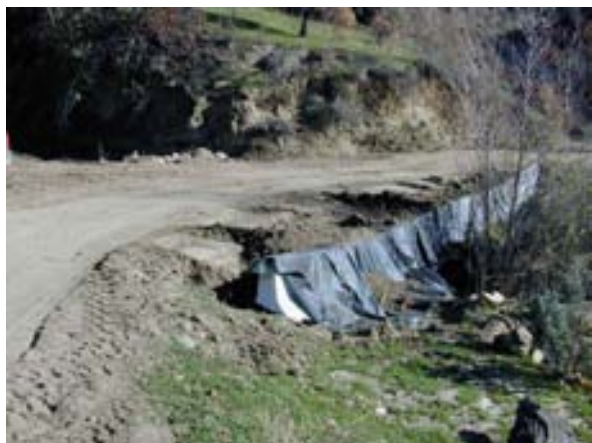
Fig. 4.23. Low water crossing with K-rail covered with filter cloth (mile point 1.2).

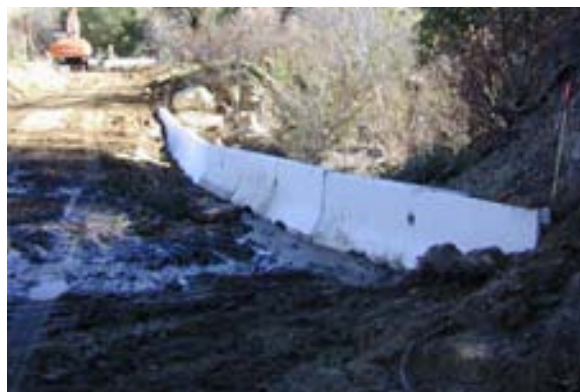
Fig. 4.24. K-rails installed at mile point 1.4.

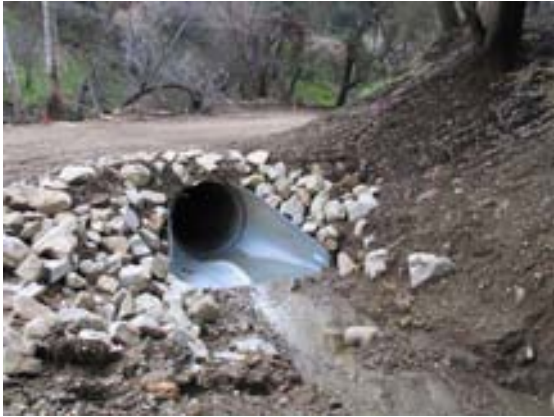
Fig. 4.28. New culvert with rock armoring at inlet (mile point 1.97)

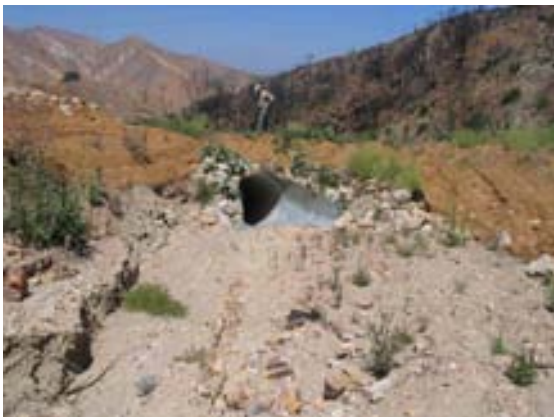
Fig. 4.29. Old culvert replaced with new 60" culvert (mile point 2.1). Culvert was off-center when placed as seen in photo. Additional rock riprap was added to the right of the culvert opening to channel flow into culvert drain.

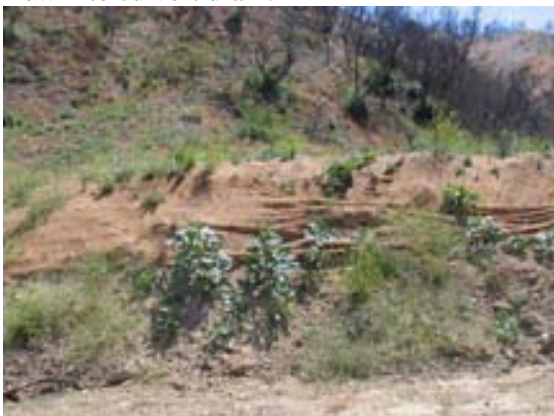
Fig. 4.30. Geo-textile fabric with jute was added on slope bordering road located above the 60 in. culvert (mile point 2.1).

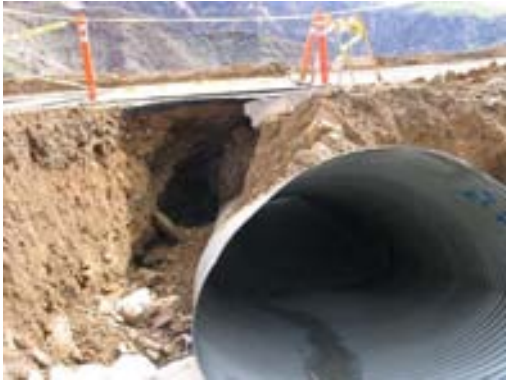
Fig. 4.31. Culvert that has failed located at mile point 0.4 on Squaw Flat Rd.

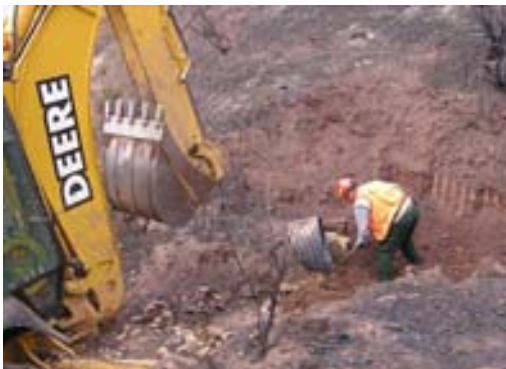
Fig. 4.32. Culvert being replaced.

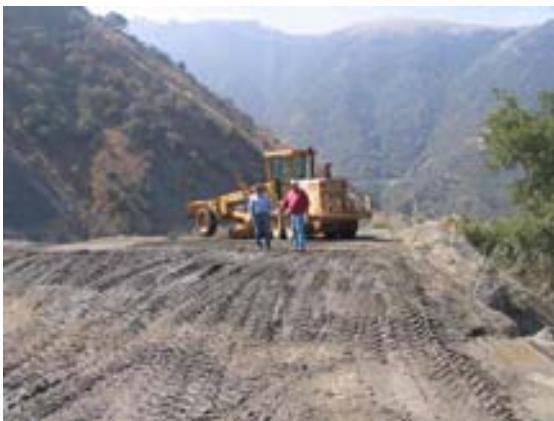
Fig. 4.33. Road grading completed and approximately 280 cu. yds of mud, rock, and debris was removed at mile point 1.9.

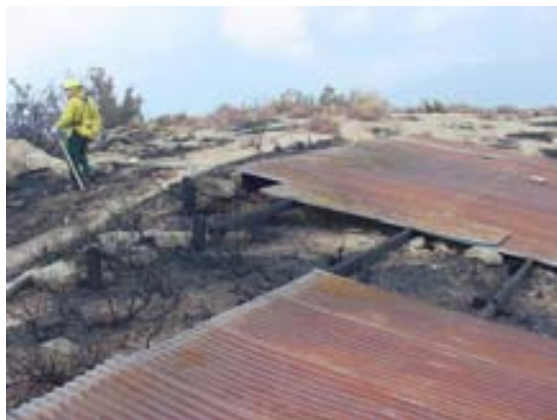
Fig. 5.1. Burned components of the Sunset Peak Lookout site, looking southwest. Site visited in November following fire.

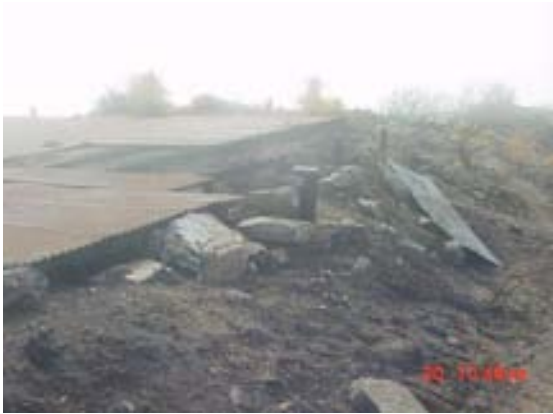
Fig. 5.2. Photo taken of Sunset Peak Lookout site on January 20, 2004.

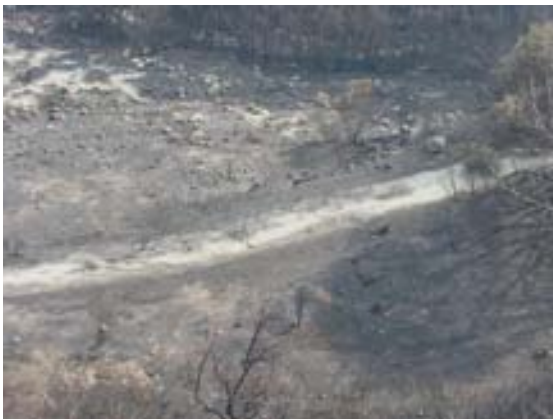
Fig. 5.3. Camp Baldy Road, from the west side of the canyon, looking southeast.

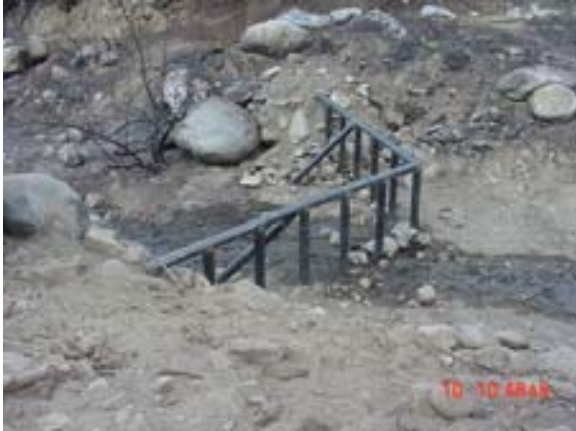
Fig. 5.4. Installation of a trash rack in Stoddard Canyon.
