United States Department of Agriculture
Forest Service

FY 2005
Aviation Safety Summary

Prepared by the
National Aviation Safety Center
Boise, ID

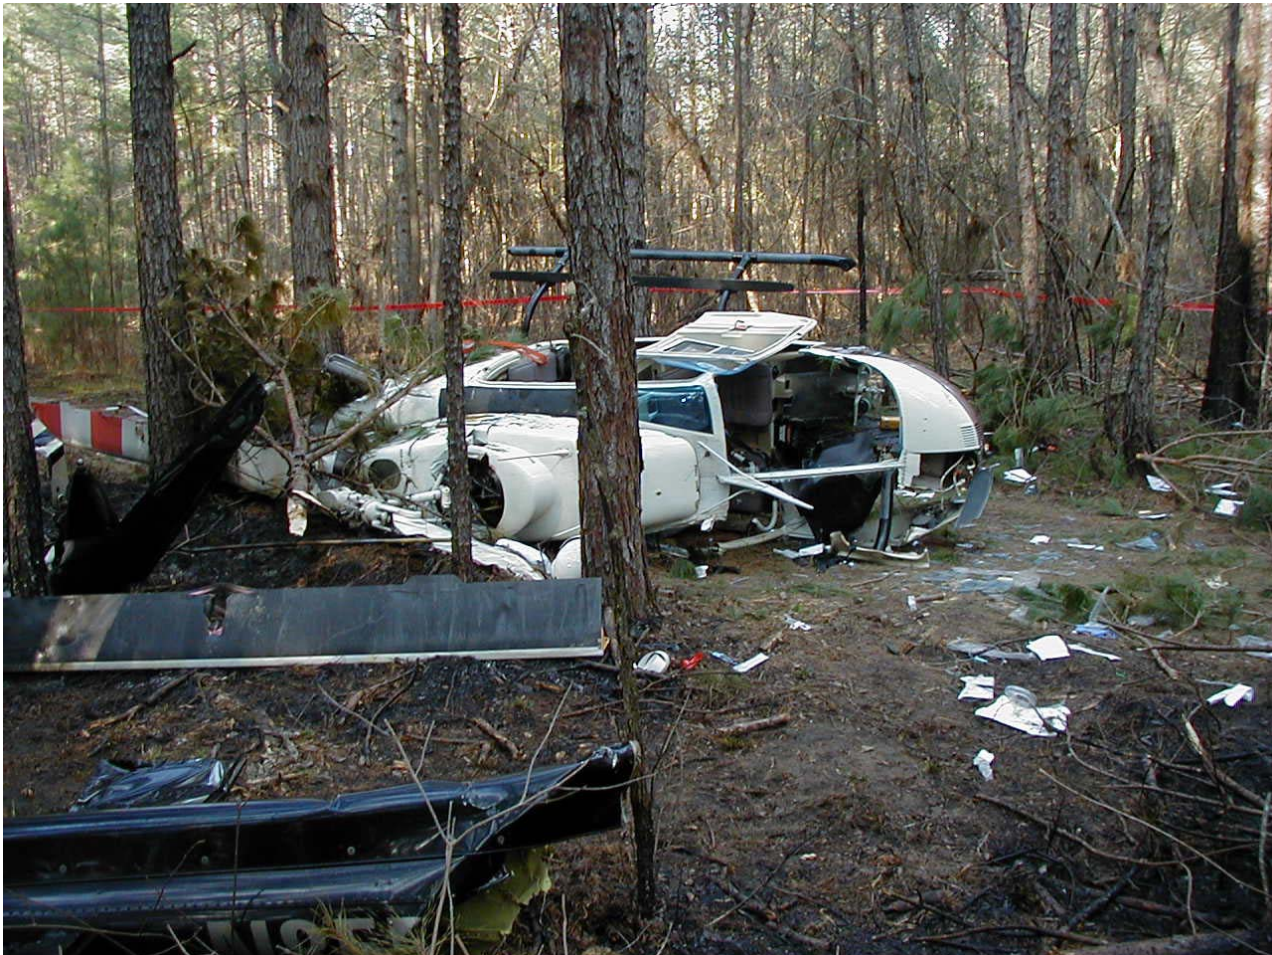
NTSB Identification: DFW05FA086
Accident occurred March 10, 2005 in Shelbyville, TX
Aircraft: Bell 206 BIII
Fatalities: 3
Operational Control Region 8, Sabine NF

On March 10, 2005, approximately 1354 central standard time, a Bell 206B-III helicopter, N85BH, registered to Brainerd Helicopter Service, Inc, sustained substantial damage when it impacted heavily wooded terrain in the Sabine National Forest near Shelbyville, Texas. The airline transport rated pilot and two USDA Forest Service crewmembers sustained fatal injuries. Visual meteorological conditions prevailed, and the flight/mission was being monitored and conducted in accordance with USFS aviation policies for public use aircraft in fire management operations. The flight departed at 1347 from a field helicopter pad (H1), located approximately 7 miles southeast of the accident site.

On the morning of the accident, the helicopter was assigned to support a prescribed fire within heavily wooded terrain with 50-60 foot high trees near Shelbyville, TX. The prescribed fire was supported by the application of aerial ignition spheres utilizing a cabin mounted plastic sphere dispenser (PSD) machine. PSD missions are typically flown at 50-150 feet above the top of vegetation at airspeeds from 20-40 knots. The helicopter was pre-positioned and a mission brief was conducted at Angelina County Airport, Lufkin, Texas. At 0900, after the mission brief, the helicopter and re-fueling truck re-positioned to H1 (coordinates North 31 degrees 42.110 minutes West 93 degrees 52.540 minutes) and were met by support equipment and personnel from the Sabine National Forest to conduct a prescribed fire mission.

At 1417, the helicopter wreckage was found at coordinates North 31 degrees 45.425 minutes West 94 degrees 00.244 minutes. Immediate rescue operations commenced.

The NTSB has not determined probable cause at this time.

Recommendation 1: Include in FS agency policy, relative to pilot approval (carding), a requirement that agency pilot inspectors review/verify pilot time for those pilots that have never been approved by the agency (Initial approvals). Subsequent approvals would not require this review for total time.

- C. Modify FSM 5700 and FSH 5709.16 to require pilot inspectors to verify pilot time for all initial pilot cards, utilizing verification records provided by contractor.
- D. Ensure all pilot inspectors are briefed regarding the changes at annual pilot inspector workshops.
- E. Make recommendation to DOI, Aviation Mgmt Directorate regarding above changes to incorporate into OPM 21.

Recommendation 2: Recommend to Interagency committee to include a requirement in the Interagency Aerial Ignition Guide pre-mission briefing that addresses PSD flight profile “watch out” situations including but not limited to loss of tail rotor effectiveness (LTE), Settling with Power, etc.

Recommendation 3: Require pilots being evaluated for an Initial pilot approval (carding) demonstrate to the Inspector Pilot their skill in low level, low airspeed maneuvering in a PSD flight profile during flight evaluation.

- A. Modify Interagency Helicopter Practical Test Standards document to incorporate requirement.
- B. Ensure all pilot inspectors are briefed regarding the changes at annual pilot inspector workshops.

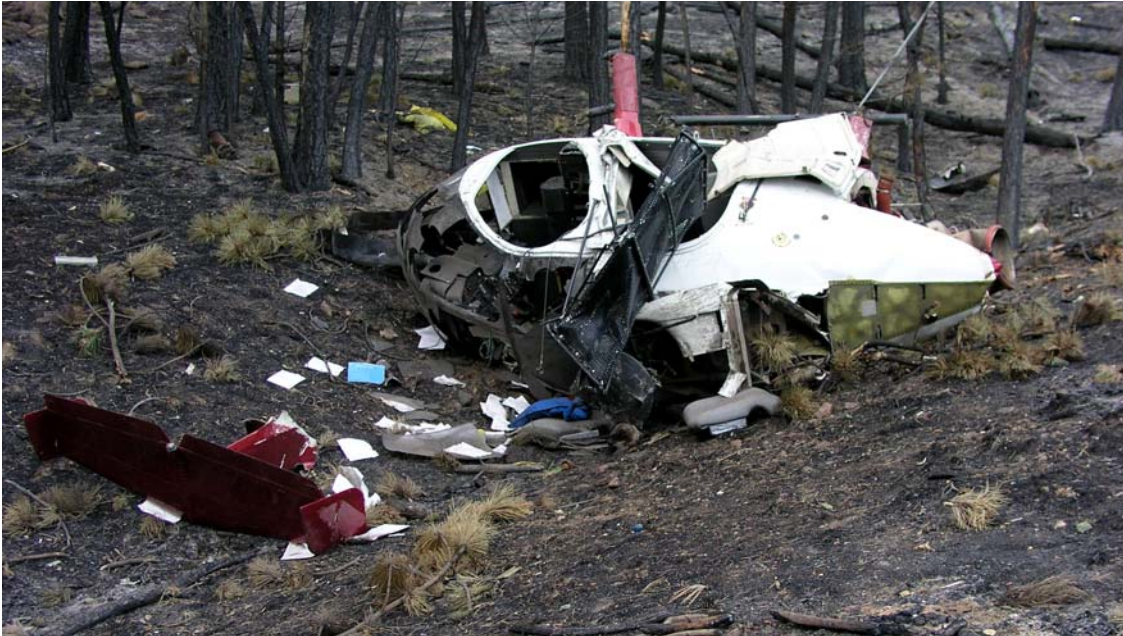
NTSB Identification: **DEN05TA113**
Accident occurred July 19, 2005 in Loveland, CO
Aircraft: Hughes 369FF, registration: N530TJ
Injuries: 1 Minor.
Operational Control: Arapaho-Roosevelt NF

On July 19, 2005, approximately 1515 mountain daylight time, a Hughes 369FF single-engine helicopter, N530TJ, was destroyed when it impacted trees and terrain following a loss of control while hovering approximately 20 miles west of Loveland, Colorado. The commercial pilot, who was the sole occupant, sustained minor injuries. The helicopter was operated by the United States Department of Agriculture (USDA) Forest Service Rocky Mountain Region (Region 2) for public use firefighting missions, and registered to Utility Aviation Inc., Fort Collins, Colorado. Visual meteorological conditions prevailed, and a flight plan was not filed. The flight originated from a staging area west of Loveland at 1504.

The helicopter was being used to support firefighting operations in the area and was attempting to deliver supplies via external load. The helicopter was equipped with a 100-foot long line and a 20-foot choker, the external load weighed 615 pounds, and the helicopter weighed a total of 3,000 pounds.

According to a witness, who was assisting near the LZ, the surface winds were light at the time; however, it had been a "pretty windy day." As the helicopter approached the LZ, "everything was normal when he did a 180-degree turn. The load was fairly stable below him and the ship did a quick 180. Paused briefly, did another (180), completed to the 360, and then kept slowly spinning...The flight pattern started getting a little more erratic, as far as the load of his, the sling was kind of penduluming...swinging." The witness then observed the helicopter release the external load. The witness lost sight of the helicopter behind a tree and heard the impact. The witness responded to the accident site and the engine was still running. Shortly after that, "the engine cut."

On August 16, 2005, the NTSB investigator-in-charge, a representative of Boeing, and a representative of the USFS examined the helicopter. Examination of the airframe revealed the fuselage was crushed and deformed. The tail boom was fractured into several fragments. Damage to the tail boom was consistent with impact forces and main rotor blade strikes. The main rotor hub assembly and components were destroyed and consistent with sudden stoppage. All five main rotor blades were separated from the rotor head and exhibited fractured and bent spars, skin delamination, cuts and gouges.

The main transmission rotated when the main rotor system was turned by hand. Continuity was established to the tail rotor output pinion and the engine input quill when the transmission was rotated. The tail rotor drive shaft was fractured into multiple segments which corresponded to the fractures in the tail boom structure. The tail rotor gearbox was fractured across the case elbow. The tail rotor gearbox output quill rotated when turned by hand. One tail rotor blade was fractured into three sections with one fracture at the pitch change arm, one at the root fitting, and one approximately 10 inches from the blade end. The other tail rotor blade was fractured at a point just past the blade doubler.

The longitudinal and lateral cyclic flight controls and collective flight controls exhibited continuity from the controls to the upper flight controls. The upper flight controls were damaged; however, movement of the controls operated the flight control links. Anti-torque flight control continuity was established from the foot pedals to the separated control rod located at the aft fuselage station 100. The tail rotor control rods and bell cranks were bent and fractured in numerous locations.

Examination of the engine revealed damage consistent with the impact to the exhaust and combustion sections. Continuity was established to N1 and N2 control linkage from the throttle and collective to the fuel control and power governor. No anomalies that would have precluded operation were noted with the airframe systems and engine.

On the day of the accident, the pilot completed another Interagency Load Calculation form based on the following: departure pressure altitude 9,500 feet, departure temperature 35 degrees Celsius; and helicopter operating weight of 2,454 lbs. A review of that form revealed the pilot incorrectly completed the form in several areas; adjusted weight, selected weight, and allowable payload. Based on the conditions listed by the pilot, the pilot's calculated jettisonable OGE allowable payload was 646 lbs. The improperly completed form was signed off by the pilot and the USFS Helicopter Manager. According to the USFS Helicopter Inspector Pilot who reviewed the form after the accident, the allowable payload calculations could not be performed because the pressure altitude and temperature values exceeded the manufacturer's performance limitations for the helicopter.

According to the USFS, at the time of the accident, the gross weight of the helicopter was 3,072 lbs, based on an aircraft weight of 1,860 lbs; pilot 200 lbs; fuel 280 lbs; and an external load of 732 lbs. The reported actual environmental conditions were pressure altitude 8,000 feet, and temperature 32 degrees Celsius. In accordance with the Rotorcraft Flight Manual, CSP-FF-1, dated August 14, 1998, with revision 5, dated October 3, 2003, Page 8-4, Figure 8-3, Hover Ceiling, Out of Ground Effect, Engine Air Particle Separator Inlet with Mist Eliminator, indicated that the maximum gross weight for OGE was 2,940 pounds.

According to the Federal Aviation Administration's Rotorcraft Flying Handbook, FAA-H-8083-21, Chapter 11, LTE at Altitude, "At higher altitudes, where the air is thinner, tail rotor thrust and efficiency is reduced. When operating at high altitudes and high gross weight, especially while hovering, the tail rotor thrust may not be sufficient to maintain directional control and LTE can occur. In this case, the hovering ceiling is limited by tail rotor thrust and not necessarily power available. In these conditions gross weights need to be reduced and/or operations need to be limited to lower density altitudes."

The pilot's failure to maintain aircraft control due to delayed remedial action during the encounter with the loss of tail rotor effectiveness. Contributing factors were the pilot's inadequate preflight performance planning, and the inadequate supervision by the US Forest Service personnel.

Action Item #4: Work with cooperating agencies in developing policy and procedures for Dispatch Centers to ensure that radio communication transmissions generated during incidents and accidents are recorded and retained.

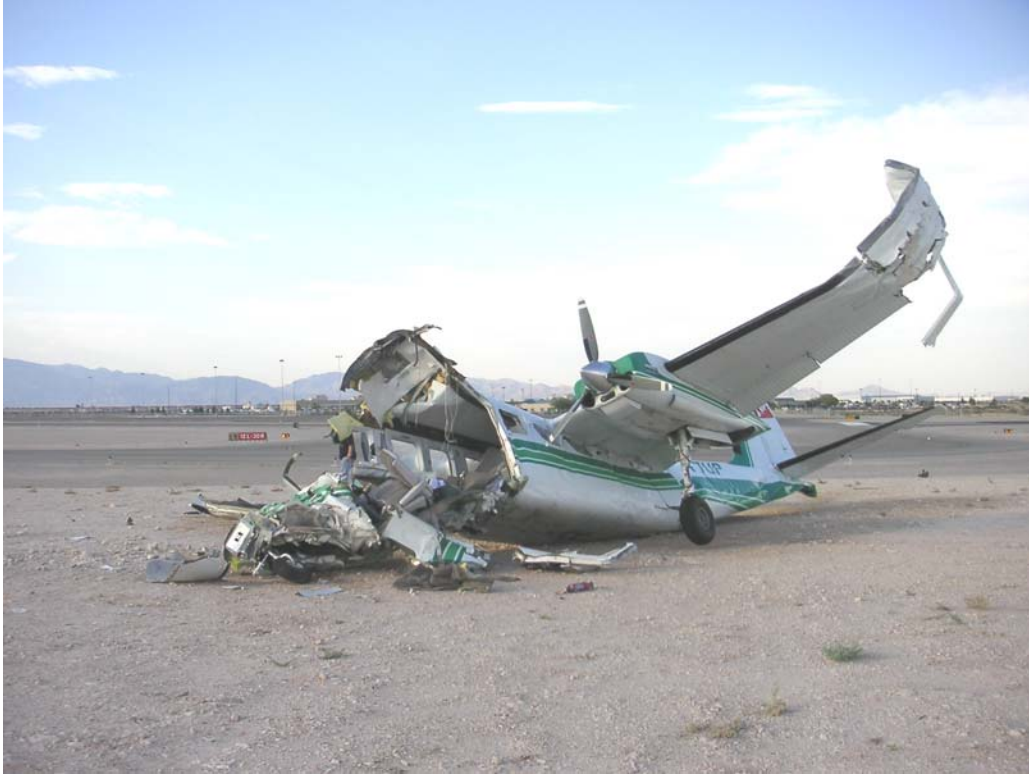
NTSB Identification: LAX05GA243
Accident occurred July 21, 2005 in Las Vegas, NV
Aircraft: Aero Commander 680 FL, registration: N7UP
Injuries: 2 Serious, 1 Minor.
Operational Control: R-4 Humboldt-Toiyabe NF

On July 21, 2005, about 1707 Pacific daylight time, an Aero Commander 680 FL, N7UP, impacted terrain during takeoff at North Las Vegas Airport (VGT), Las Vegas, Nevada. Commander Northwest LTD was operating the airplane under contract for the US Forest Service under the provisions of 14 CFR Part 91 as a public-use aircraft. The airline transport pilot and one passenger sustained serious injuries; the second passenger sustained minor injuries. The airplane was destroyed. The local fire reconnaissance flight departed VGT at 1707. Visual meteorological conditions prevailed, and a company flight plan had been filed. The primary wreckage was at 36 degrees 12.233 minutes north latitude by 115 degrees 11.289 minutes west longitude.

During takeoff from runway 12R witnesses reported seeing the airplane airborne but not climbing. The airplane continued down the runway in a nose up attitude and remained in ground effect until impacting terrain about 600 feet southeast from the departure end of runway 12R. The airplane impacted in a 30-degree nose down attitude. During the accident sequence the airplane rotated about 270 degrees around the vertical axis. The cockpit section of the airplane was destroyed during the accident sequence.

The representative from Aero Commander identified the airplane wreckage at the beginning of the debris field as forward fuselage and cockpit structure components. Pieces of the left wing tip were found in the middle of the debris field.

The flaps were measured in the 30-degree position; the flap actuator was measured at 1 15/16 inches, which the manufacturer stated corresponded to a 30-degree position. The flap indicator was damaged in the impact sequence but indicated the flaps were in the 30-degree position.

The NTSB has not determined probable cause at this time.

1. Follow-up on a study on fixed-wing performance charts that was started by the National Fixed-Wing Specialist.
2. Review the recommendation in the Interagency Standards for Fire and Fire Aviation Operations (Red Book) for Personnel Protective Equipment (PPE) for special mission use.

The Accident Investigation Team recommended that the federal agencies that utilize the North Las Vegas airport meet with airport officials and be actively involved in the development of a new/updated emergency response plan and considerations when staging aircraft at the airport. The agencies were actively pursuing this shortly after the accident.

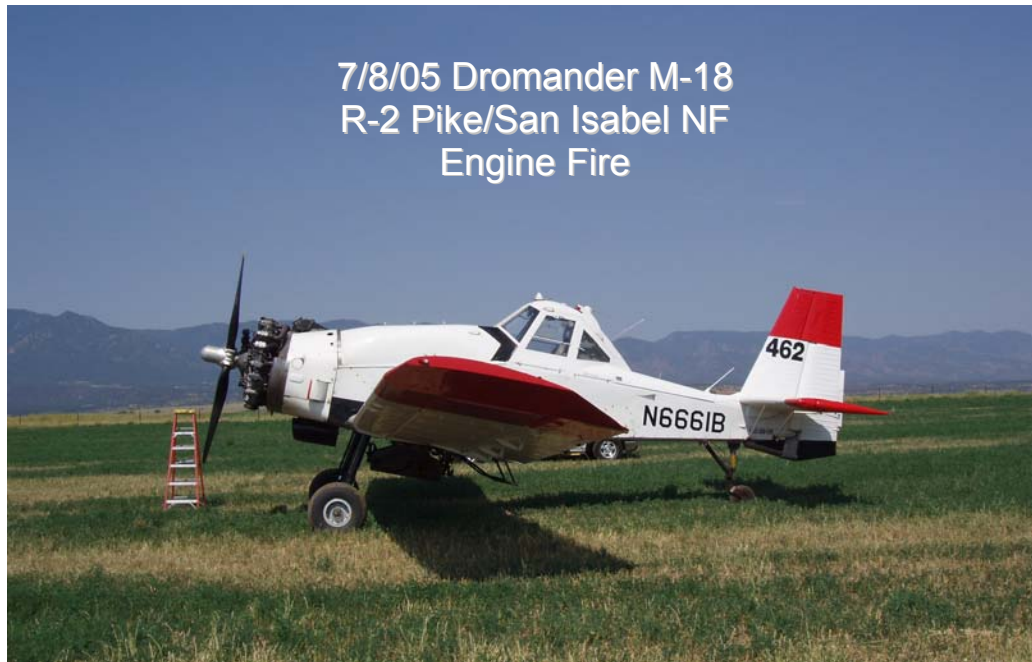
T462 departed Canon City, CO for the Mason Fire with 400 gals of water and foam. While enroute to the fire the pilot noticed the engine running rough, it would loose then gain power. The pilot added carb heat with no change to engine. The pilot contacted the leadplane on the fire and informed him that he was returning to the airport due to engine problems. He punched off the load over farmland and turned towards Canon City. The pilot then noticed flames coming from engine and determined he needed to land the aircraft immediately. He successfully landed the aircraft in a field and extinguished fire. The investigation team found a safety wire that had completely worn through the bolt allowing fuel to leak into the engine, which caught fire.

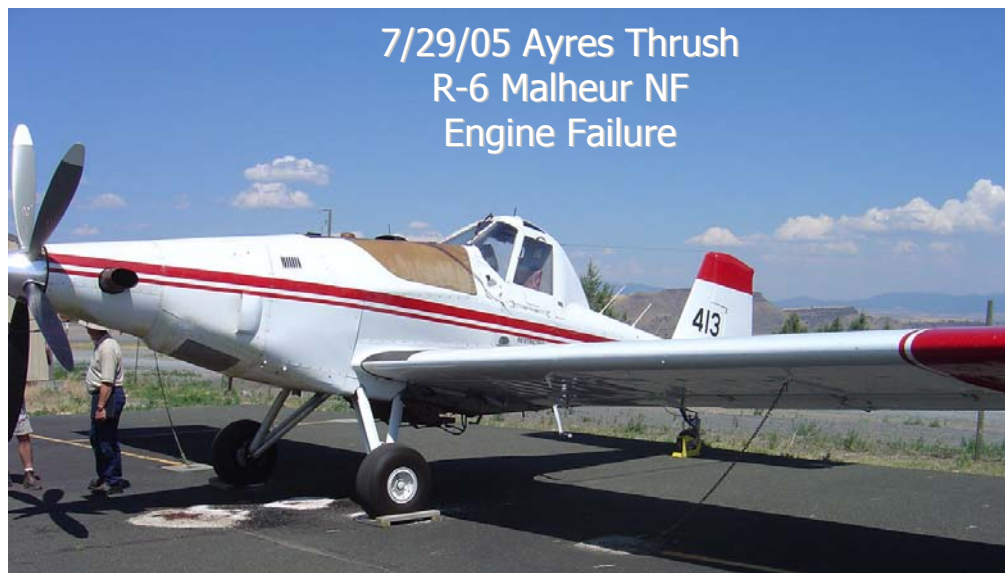
The aircraft was dispatched to fire #060 for retardant drops. On the third drop of the morning, the pilot powers up the aircraft to start his drop run. According to the pilot, the drop run is normal and nothing out of the ordinary. Upon completing his third drop and starting to climb out he scanned his instruments and saw the low oil pressure light come on. He immediately notified the ATGS and keeps climbing towards the middle of the valley and headed for John Day airport. His instruments were showing normal readings at this time except for the low oil pressure and engine torque had dropped to 10%. He noticed a vibration in the engine and felt a slight power drop followed quickly by an engine chip light. He knows he only has a few seconds before the engine would probably quit and reacts immediately to feather the propeller, shut off the fuel and set up for the proper glide profile to get back to the airport. The airtanker is approximately 5 miles from the airport and the pilot has been able to gain enough altitude prior to the engine stopping to complete a successful "dead stick" landing to the airport. The investigation team found that the aircraft had a catastrophic engine failure 38.2 hours after it had been overhauled.

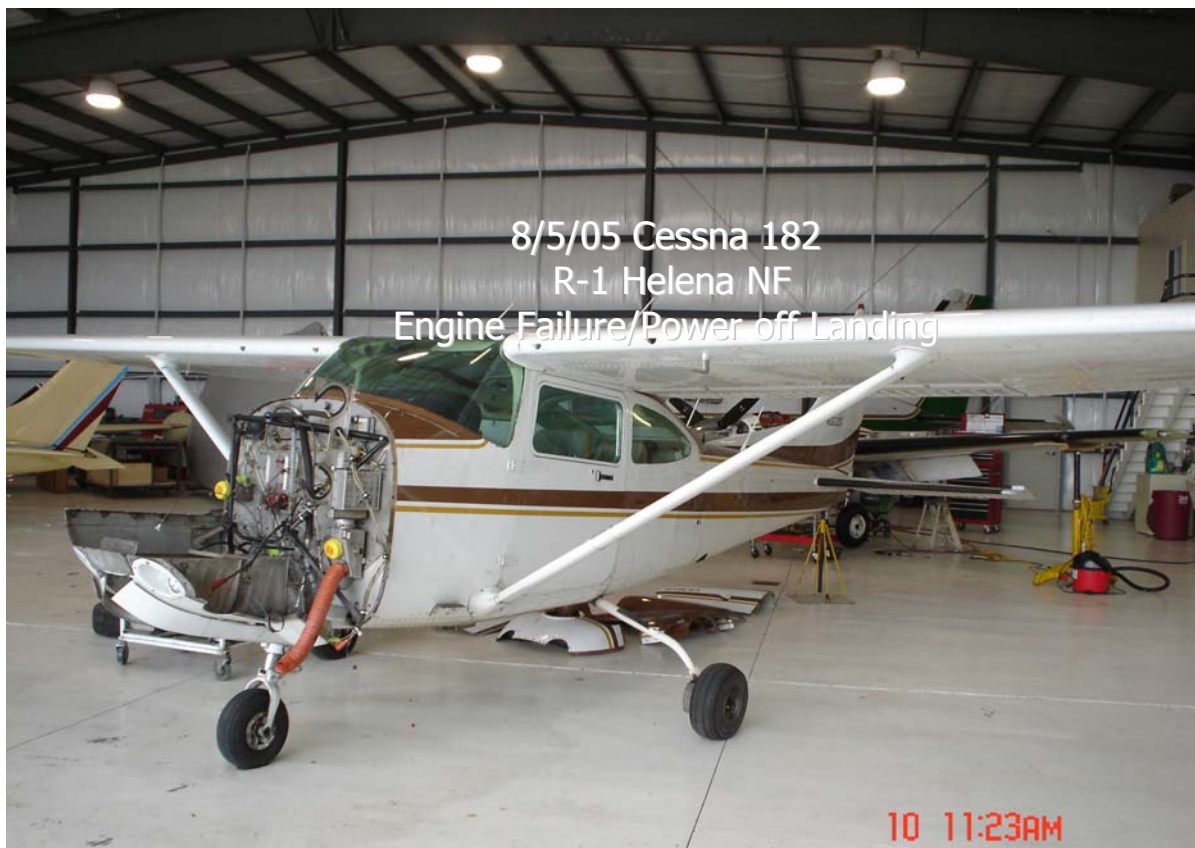
The aircraft was on an insect and disease flight with one USFS aircrew member mapping an area east of the Helena. At approximately 11:45 the pilot noticed a sudden drop of oil pressure and immediately turned the plane toward the airport, they were about 20 mi from the airfield at this point at 10,000 MSL. Within 1 minute the oil pressure dropped below the green and continued to drop toward zero, however, the engine appeared to be running normal. As they continued toward the airport the oil temp gauge began to slightly decrease and the cylinder head temp gauge indicated a slight increase in temperature. At approximately 10 miles the oil pressure indicated zero and the engine rpm began to fluctuate, probably due to a loss of oil pressure in the prop. The pilot kept the altitude high to increase the glide distance, and looked over the emergency checklist cards. At about 5 miles they were losing RPM and the landing gear alarm began to sound since the gear was still retracted. At about 1 mile the pilot lowered the gear, simultaneously the engine began to vibrate violently and the pilot officially declared an emergency with the tower. The tower did an outstanding job of keeping traffic clear and making sure they could make a straight in landing. At about ¼ mile or less, on final, the pilot shut off the fuel and pulled back on the mixture to shut down the engine in case of fire. He landed with the power off and coasted off the active runway onto runway 34 where we met the fire truck. The pilot remained calm and performed all the steps methodically throughout the incident.
