# **United States Department of Agriculture**

## **Forest Service**

### **FY 2007**

## **Aviation Safety Summary**

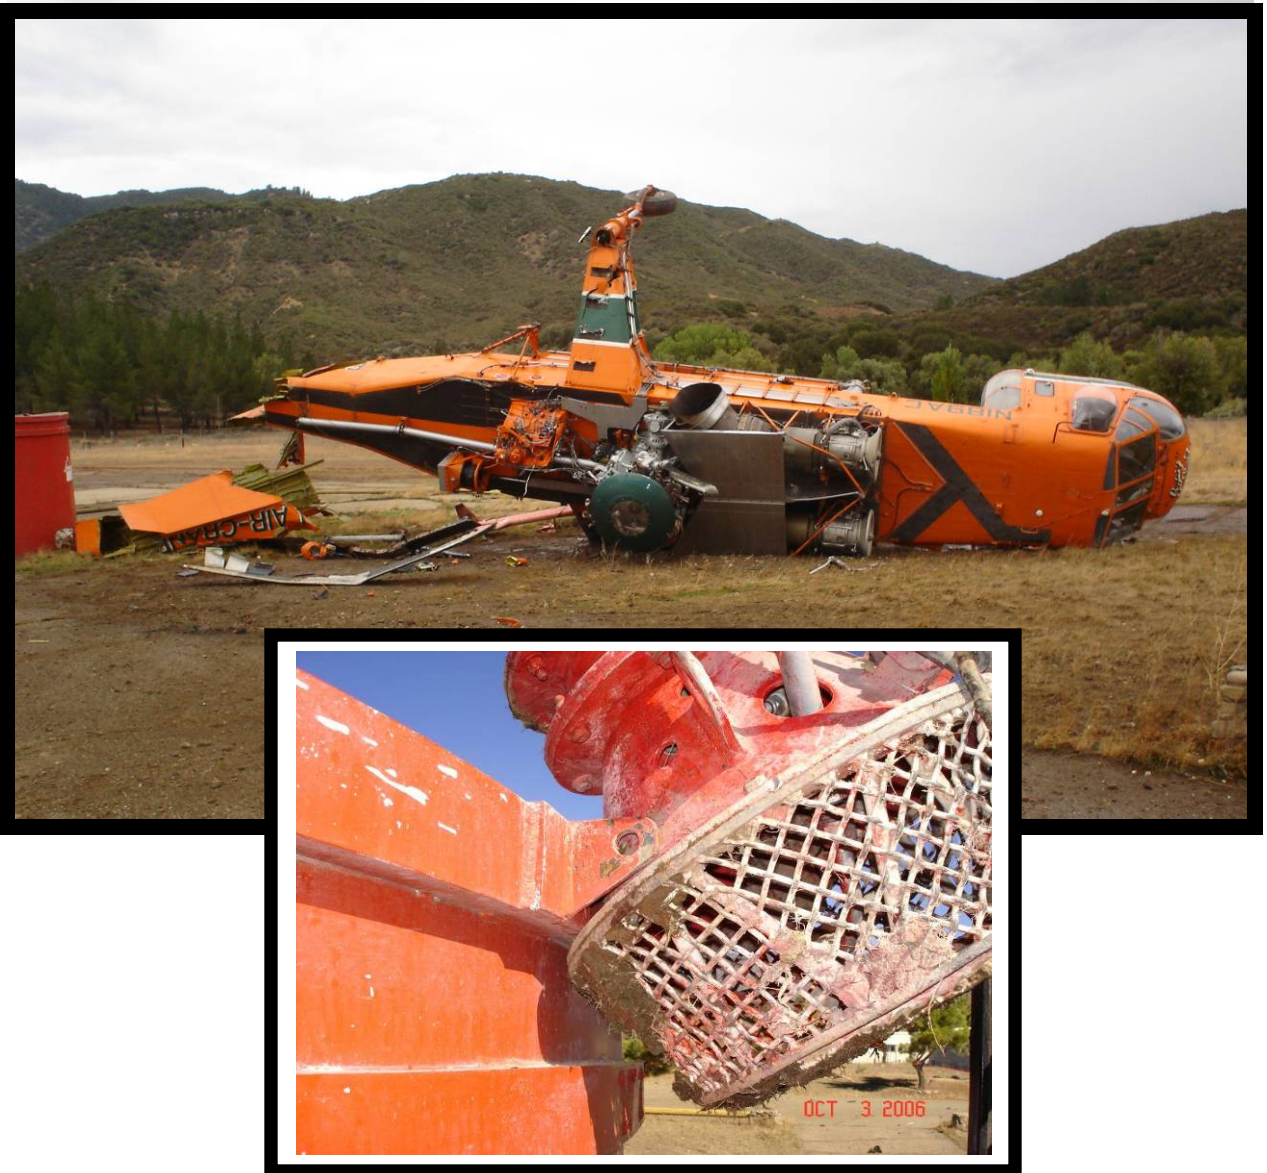
The dip tank exterior was encircled by two support rings, which went around the top perimeter of the tank. The support rings had 90-degree lips. Two lifting eyes, spaced 180 degrees apart, were welded to these support rings. The snorkel installation was through supplemental type certificate. The snorkel tip contained a screen to prevent foreign object ingestion. This screen had a 90-degree upper lip. Scrape marks were evident on the upper ring of the tank moving toward one of the lifting eyes. Investigators also noted damage to the snorkel tip and area of the lifting eye on the tank.

The PIC reported that the approach to the retardant tank was normal and the crew was on their fifth or sixth drop. The mission was to unload the retardant tank. The helicopter drafted 200 gallons of retardant and he elected to pick up out of the retardant tank in order to take on some fresh water. He moved from the retardant tank to the fresh water tank and noted that the helicopter was low. He added power to bring the snorkel up into the water tank and it caught on the side of the tank. The PIC believed that he had felt it come loose. He brought in power and the nose of the helicopter pitched down. At that time, the PIC stated that he, "...lost the tail..." and the helicopter began to spin. He called

According to a USFS regional aviation safety manager, normal procedures following a caught snorkel are to slowly maneuver the helicopter until the snag becomes free. At the time of the accident, there were no widely distributed USFS published procedures on pilot actions following a snagged snorkel condition.

The National Transportation Safety Board determines the probable cause(s) of this accident as follows: The pilot-in-command's improper remedial action, which resulted in a loss of helicopter control. Contributing factors were the retardant tank and snorkel designs.

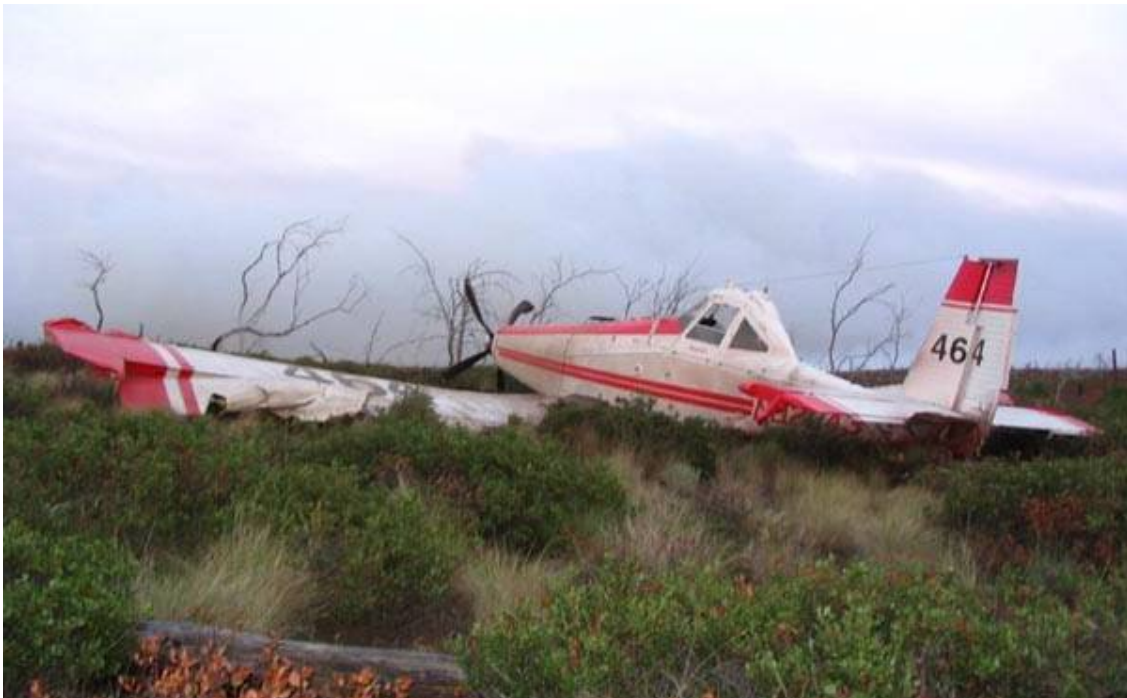
NTSB Identification: **LAX07TA208**  
R-6, Malheur NF  
Aircraft: WSK PZL Mielec M-18A, registration: N92043  
Injuries: 1 Minor.

On July 7, 2007, about 1916 Pacific daylight time, a Msk Pzl Mielec, M 18A (a.k.a. "Dromader"), N92043, experienced a total loss of engine power while maneuvering about 20 miles northwest of Burns, Oregon. The airplane was substantially damaged during the pilot's forced landing in a rough, vegetation-covered, open field. During the accident flight, the single engine air tanker (SEAT) was under the operational control of the U.S. Department of the Interior (DOI). Visual meteorological conditions prevailed at the time of the public-use fire suppression flight, and a company flight plan had been filed. The airline transport pilot sustained minor injuries. The DOI operated the airplane under a "call-when-needed" contract with New Frontier Aviation, Fort Benton, Montana. The purpose of the flight was for the pilot to disperse 500 gallons of fire retardant chemical on the Egley Complex Fire in the Malheur National Forest, near Burns. The airplane was operated with a restricted category Federal Aviation Administration (FAA) airworthiness certificate under the provisions of 14 CFR Part 91. The flight originated from Burns about 1903.

According to the pilot, the engine stopped operating while he was overflying the intended retardant drop zone at 1,500 feet above ground level. The pilot attempted to restart the engine, but he was not successful. Thereafter, he dumped the retardant load, made a distress radio call, and forced landed. The airplane came to rest in an upright attitude.

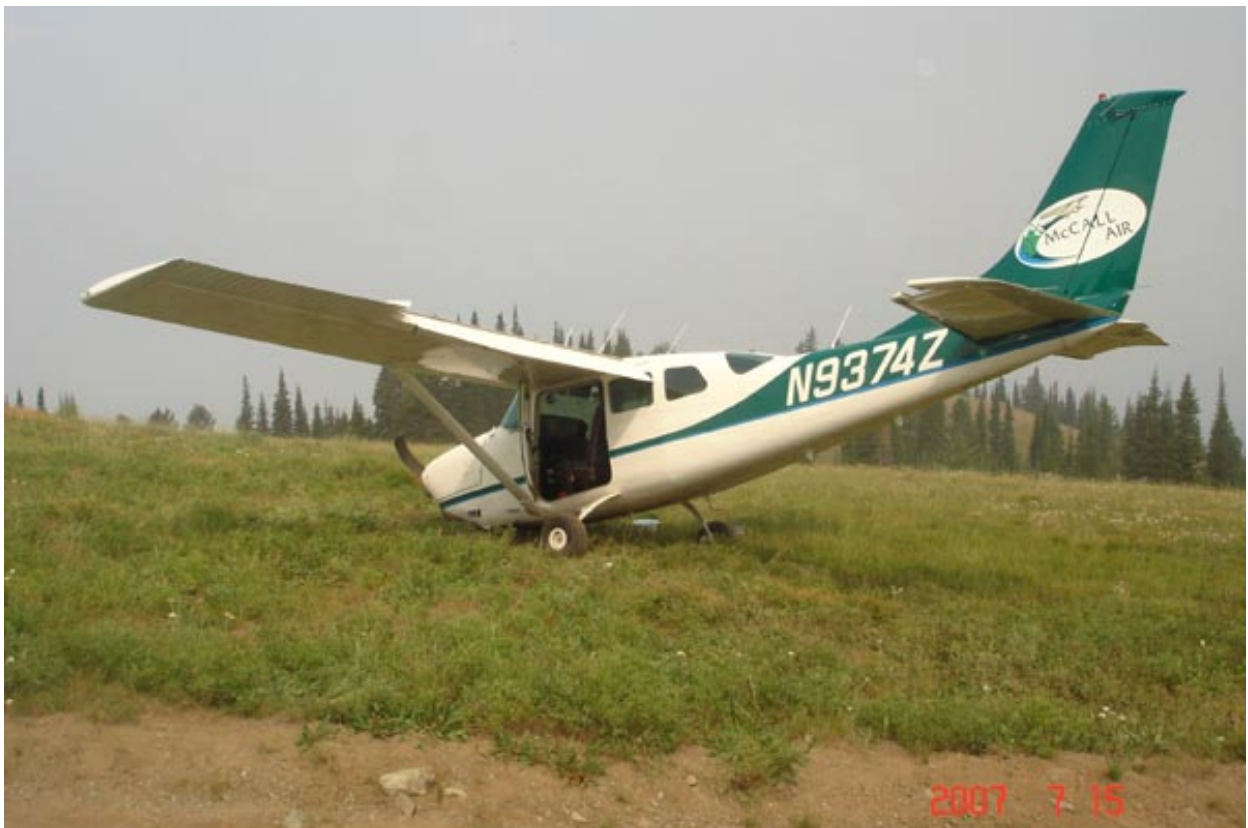
NTSB Identification: **SEA07TA203**  
R-4, Payette NF  
Aircraft: Cessna TU206G, registration: N9374Z  
Injuries: 2 Uninjured.

On July 14, 2007, at approximately 0915 mountain daylight time, a Cessna TU206G, N9374Z, was substantially damaged during a forced landing attempt on Horse Mountain, near New Meadows, Idaho. The commercial pilot and his passenger were not injured. The airplane was being operated under contract to the United States Department of Agriculture, Forest Service (USFS) by Wilderness Aircraft II LLC of McCall, Idaho, as a public use flight. The purpose of the flight was to conduct airborne fire reconnaissance. Visual meteorological conditions prevailed. A company flight plan had been filed; the flight had originated from McCall, Idaho, at 0813.

The pilot said that the airplane's engine began losing oil pressure and RPM. He performed a forced landing, but encountered rough/uneven terrain during the landing roll. The aircraft's nose gear collapsed bending the bulkhead keels, nose wheel bracket, and the right wing tip rib.

The National Transportation Safety Board determines the probable cause(s) of this accident as follows: The loss of engine power due to the loss of engine oil pressure following the oil pump's drive shaft failure for an undetermined reason. Contributing factors were the lack of suitable terrain for a forced landing and the rough/uneven terrain.

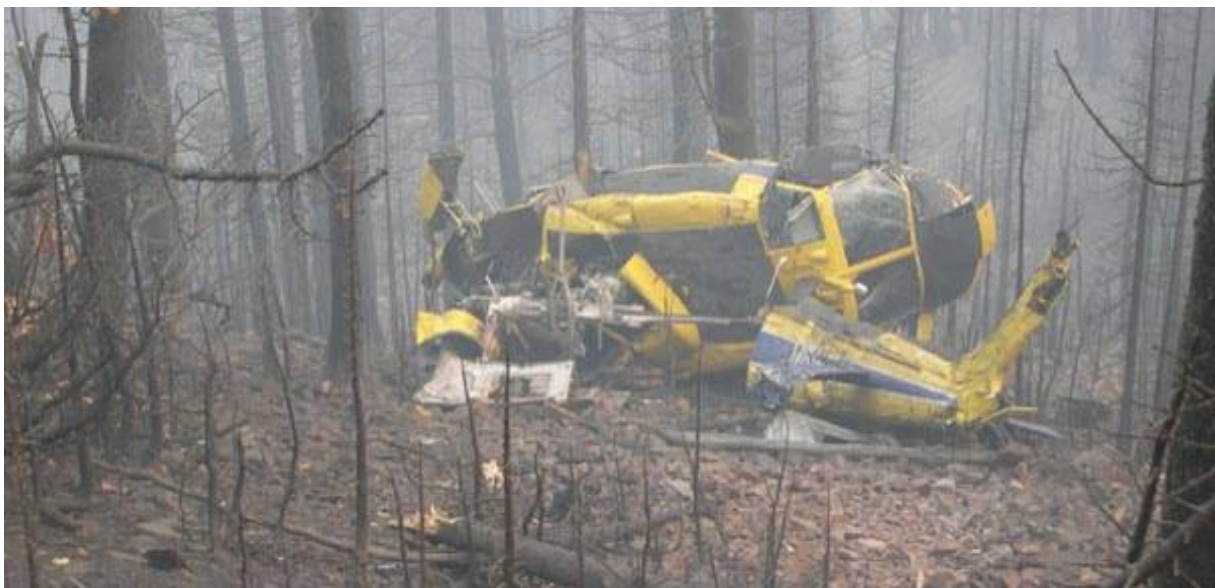
NTSB Identification: **SEA07TA202**  
R-1, Lewis & Clark NF  
Aircraft: Bell UH-1H, registration: N667HP  
Injuries: 1 Minor.

On July 16, 2007, at 0910 mountain daylight time, a Bell UH-1H helicopter, N667HP, sustained substantial damage when it impacted terrain following a loss of control while departing a remote landing zone near Benchmark, Montana. The commercial pilot, the sole occupant, sustained minor injuries. The helicopter was registered to Leading Edge Aviation LLC of Clarkston, Washington, and under the operational control of the United States Forest Service (USFS). Visual meteorological conditions prevailed and a company flight plan was filed for the local public use flight. The purpose of the flight was to carry an external load in support of fighting the Ahorn fire on the Bob Marshal Wilderness Area within the Lewis and Clark National Forest.

According to information provided by USFS personnel, the pilot flew the helicopter from the Benchmark Helibase departing with a visibility of 5 miles under moderate smoky conditions. While en route to the landing zone, the visibility deteriorated and the pilot reported difficulty seeing the landing zone. The pilot successfully landed at the landing zone without incident and set down a load of supplies. The ground crew then attached a load of firefighting equipment that was to be returned to the Helibase. As the pilot transitioned to forward flight to depart from the landing zone, the visibility dropped, and he reportedly lost all visual reference. The helicopter settled into trees and impacted the ground, coming to rest on its right side. In the area of the landing zone at the time of the accident, the visibility was reported to be fluctuating between 1/4 to 1 mile due to smoke.

The National Transportation Safety Board determines the probable cause(s) of this accident as follows: Dense smoke/haze which restricted the pilot's visibility and the pilot's failure to maintain aircraft control during the emergency descent resulting in impact with terrain.

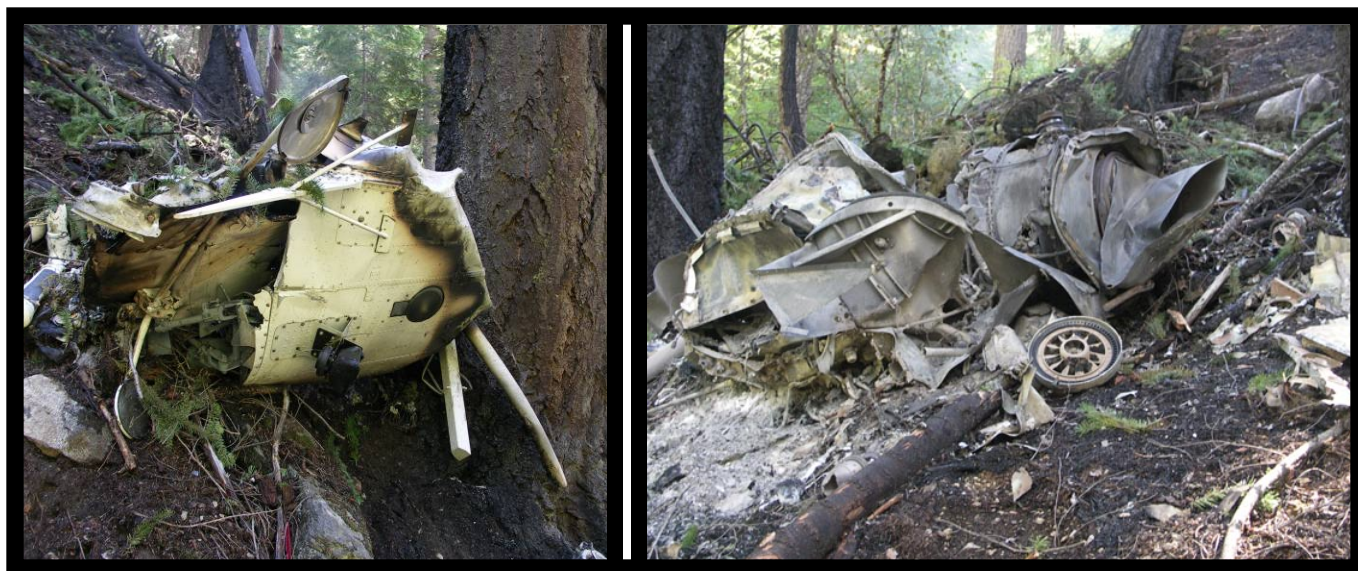
NTSB Identification: **LAX07TA227**  
R-5, Klamath NF  
Aircraft: Bell 205 A1++, registration: N205BR  
Injuries: 1 Fatal.

On July 23, 2007, about 1100 Pacific daylight time, a Bell 205 A1++, N205BR, impacted trees during a long line mission in support of the Norcross Incident about 1/4 mile southeast of the Happy Camp Airport (36S), Happy Camp, California. The United States Forest Service (USFS) operated the helicopter under the provisions of 14 CFR Part 133 as a long line operation to drop off water blivets for ground crews in the area. The helicopter was destroyed after impacting the heavily forested area, and a post-impact fire consumed the cabin area. The certificated airline transport (ATP) helicopter pilot, the sole occupant, was fatally injured. Visual meteorological conditions prevailed for the local public-use firefighting flight, and a USFS flight plan had been activated.

Several firefighters from the Happy Camp Type II hand crew witnessed the arrival of the helicopter and the subsequent accident sequence. They reported that as the blivets were set down on the forest floor, the helicopter drifted to the right and the main rotor blades contacted a tree. The long line along with the blivets remained attached to the helicopter as it made a turn to the left, stopped momentarily, and then flew downhill. The firefighters reported that there were no abnormal engine sounds emanating from the engine during the event.

According to USFS investigators, the helicopter was outfitted with a 150-foot-long long line; the tree that the helicopter struck was about 165 feet tall. The main rotor struck the top 15 feet of the tree. There were no obvious mechanical malfunctions noted with the engine. The investigation is on going, with a planned reconstruction of the airframe and examination of the engine following recovery of the helicopter.

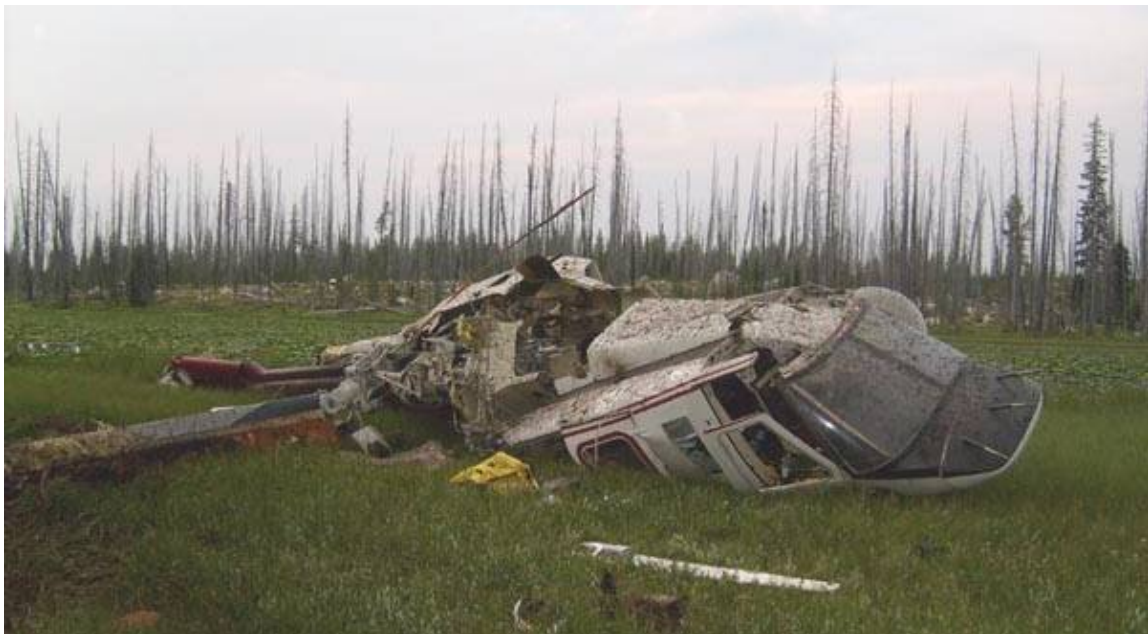
NTSB Identification: **SEA07TA214**  
R-4, Payette NF  
Aircraft: Bell 214ST, registration: N724HT  
Injuries: 1 Serious, 1 Minor.

On July 25, 2007, at 1947 mountain daylight time, a Bell 214ST helicopter, N724HT, sustained substantial damage when it impacted terrain following a loss of control while conducting long-line operations in a remote area 22 miles northeast of McCall, Idaho. The airline transport pilot (ATP) sustained serious injuries and the passenger/crew chief, sustained minor injuries. The helicopter was registered to US Leaseco, Inc of Baltimore, Maryland, and under the operational control of the United States Forest Service (USFS). Visual meteorological conditions prevailed and a flight plan was filed for the local public use flight. The purpose of the flight was to conduct external load operations in support of the Loon fire.

The operator reported the estimated density altitude at the time of the accident was 10,221 feet.

Examination of the helicopter revealed no mechanical anomalies with the engine or airframe.

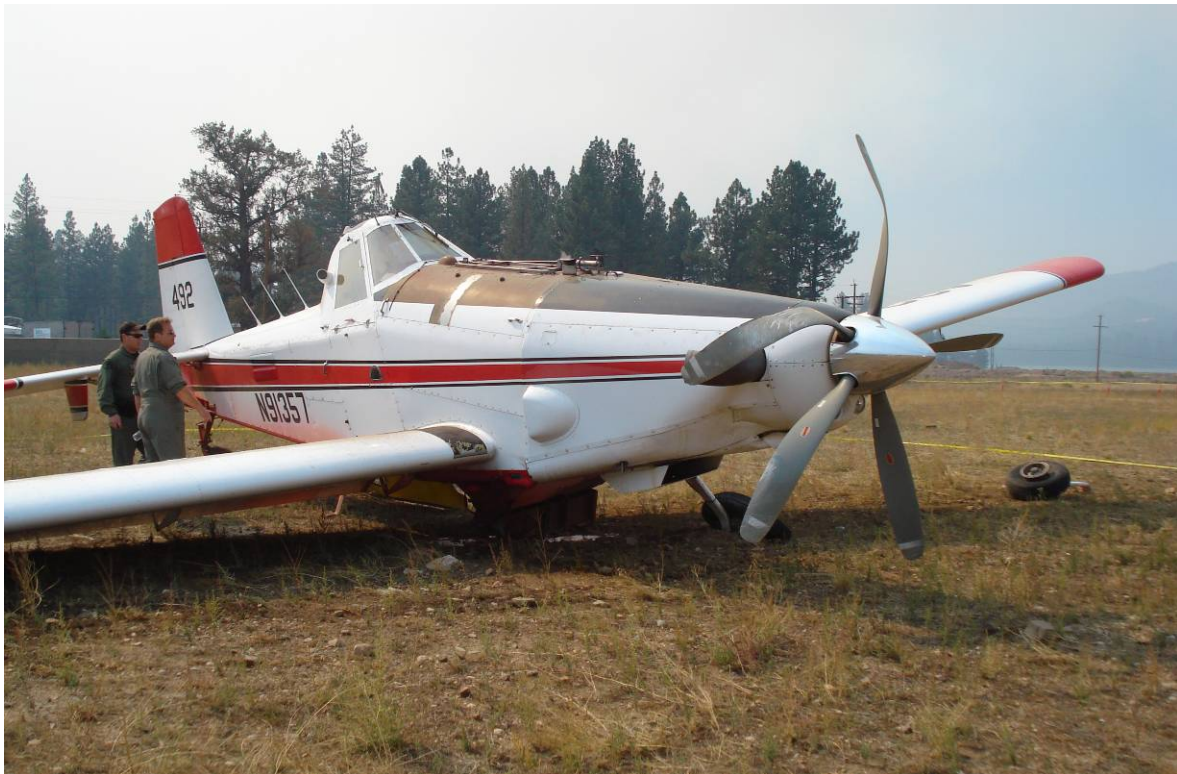
NTSB Identification: **LAX07TA277**  
San Bernardino NF  
Aircraft: Air Tractor AT-802A, registration: N91357  
Injuries: 1 Uninjured.

On September 17, 2007, about 1310 Pacific daylight time, an Air Tractor AT-802A, N91357, collided with terrain during a forced landing following a loss of engine power near Big Bear City, California. The USDA Forest Service operated the airplane under the provisions of 14 CFR Part 91 as a public-use aerial application flight. The airplane sustained substantial damage. The commercial pilot, the sole occupant, was not injured. Visual meteorological conditions prevailed for the firefighting mission, and a company VFR flight plan had been filed.

According to the pilot, he had just reloaded the airplane with fire retardant, taken off, and was on his way to the drop zone when he observed the engine chip indicator light had illuminated. He released the load, and made a forced landing in an open field. During the landing rollout, the airplane impacted a berm. When it came down again, it slid sideways, and the landing gear separated.

Recovery personnel reported metal debris in the exhaust stack.

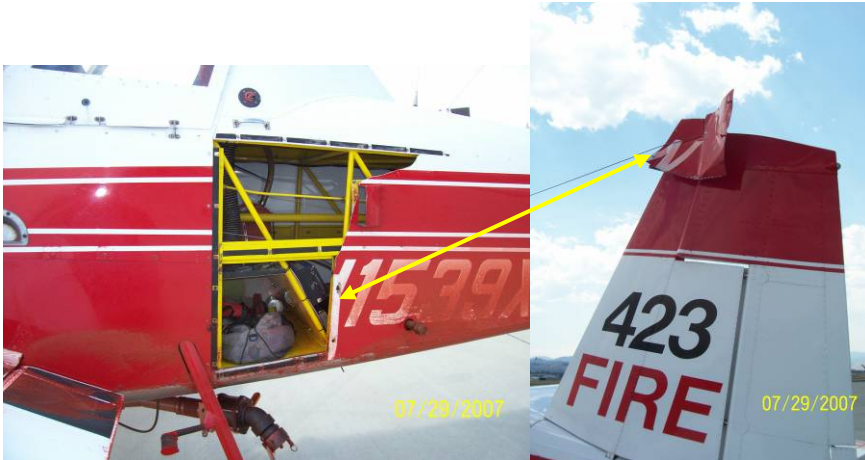
- ❖ 6/3/2007 Air Tractor 802, San Bernardino NF
  - Crossing ridgeline on retardant drop at 5-7 feet AGL
- ❖ 7/29/2007 Air Tractor 502A, Helena NF
  - Cargo door came off in flight and stuck between the rudder and cable.
