Interagency Aviation Accident Prevention Bulletin

No. IAAPB 16-04

Subject: Premo MK III Plastic Sphere Dispenser (PSD) Machine Plexiglass Sphere Chute Cover Cracks

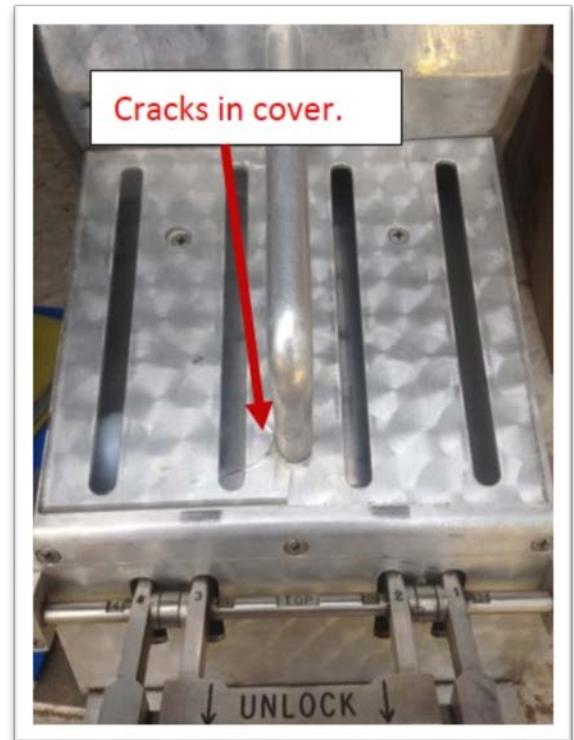
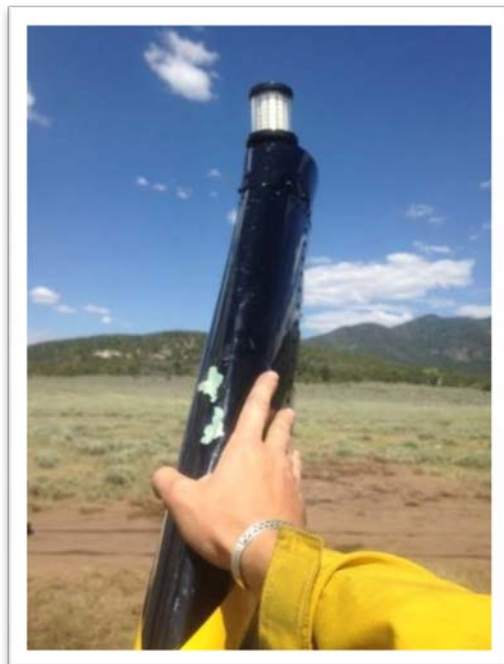
That afternoon while the helicopter was being washed, two dents were discovered on the vertical stabilizer fin six inches below the anti-collision light. They were approximately one inch wide and three inches in length with a depth ranging from 1/8 - 1/4 inch. It is believed that the sprayer used to wash the aircraft removed the paint chips that were covering the dents.

The mechanic conducted a visual and structural inspection and sent pictures to the contractor's Director of Maintenance. The Helicopter Manager informed the home unit Aviation Officer, Regional Helicopter Operations Specialist (HOS), and the DOI Maintenance Inspector of the damage to the aircraft. The mechanic received word from Director of Maintenance that the damage was beyond serviceable limits and the stabilizer fin required replacement.

It cannot be determined for sure that the piece of plexiglass that departed the aircraft on June 26 struck the tail fin and caused the damage that was discovered during the aircraft wash.

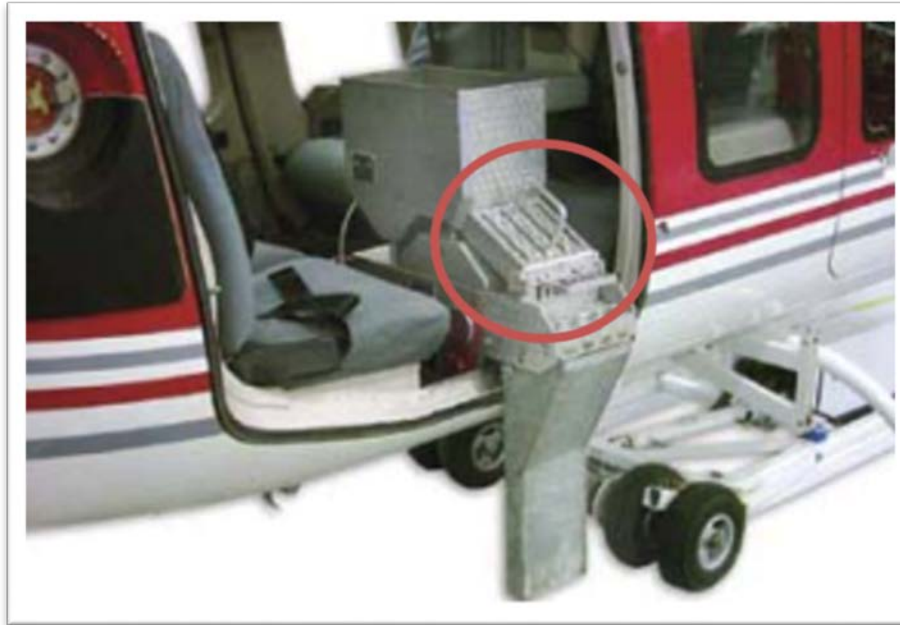
Discussion: On June 26, 2016 an AS350 B3 was returning to the helibase after completing PSD operations when a 3"x 5" piece of plexiglass that covers the sphere chute on the machine broke and flew off. The qualified Plastic Sphere Dispenser Operator (PLDO) was aware that the sphere dust cover was cracked prior to launching on the mission, yet he felt there was no threat since that crack had been present for many years. After landing, the crew performed a post flight inspection but failed to identify any aircraft damage.

The photo shows the Premo Mk III installed in a helicopter. The location of the chute plexiglass cover is indicated by the circle.

Several other sphere covers with cracks were later discovered by regional helicopter operations staff within the region where this occurred. If the sphere chute plexiglass cover has any cracks, take the PSD machine out of service until the cover is replaced. The replacement covers are available to order (approximately \$15) from:
