Interagency Aviation Lessons Learned

No. IALL 15-01

Date: February 17, 2015

Subject: Helicopter Load Management

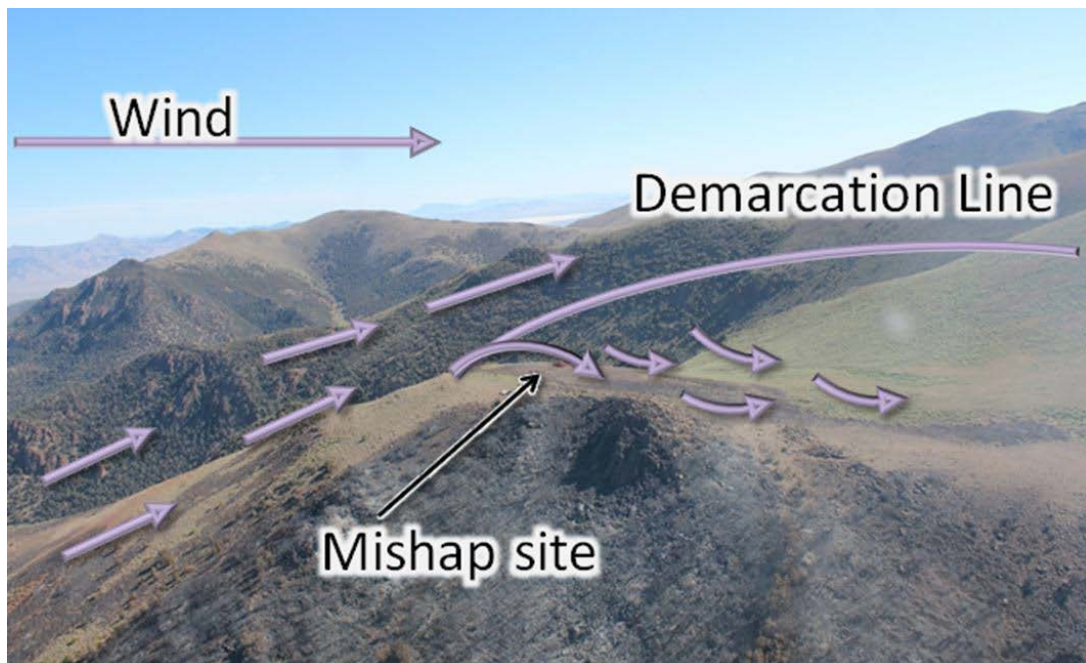
zone was on top of the ridge at an elevation of approximately 9000 feet. The requested landing zone moved the landing area below the ridge where winds were likely to travel downslope. Operating a helicopter with a long line places the helicopter in the environment that is conducive to Loss of Tail Rotor Effectiveness (LTE) due to increased weight and the requirement to HOGE. The pilot was likely experiencing turbulent wind conditions due to the rising terrain in this area. The unstable air mass and surface heating caused moderate winds (10-20 knots) that were measured at the surface. These winds were flowing up over and around the hilltop near the landing area creating updrafts on the windward side of the ridge and downdrafts and turbulence on the leeward side. A demarcation line, or the point that separates the up flow air from the turbulent down flow air, forms at the mountains highest point and extends diagonally upward. The velocity of the wind and slope gradient determines the demarcation line. The higher the wind speed and the steeper the terrain, the steeper the demarcation line angle is and the closer it forms near the crest. This would likely create the turbulent wind conditions near the location that the mishap aircraft would be hovering out of ground effect (HOGE). It's highly conceivable that the down flowing air reduced performance thus increasing the power required which in conjunction with directional winds, contributed to the onset of LTE. As the aircraft slowed to a hover to deliver the sling load, it began to rotate to the left. The pilot attempted to maintain control and to jettison the load, but was unable. The aircraft rotated several times, lost altitude, and impacted the ground.

Figure 1 Wind flow over mountainous terrain contributed to increased performance requirements and the onset of LTE.

The goal in recovery is to gain airspeed without increasing power. Decreasing collective (reducing power) also decreases the power required for antitorque. The problem is that these recovery actions will also result in a substantial loss of altitude which may not be an option when operating in close proximity to the ground. Prudent pilot planning should include a clear escape route in these types of conditions/operations. Although it is not included in the AS350 B3e Rotorcraft Flight Manual, jettisoning the load will reduce weight and subsequently reduce the power required. This action should have been accomplished simultaneously along with the other procedures.
