Interagency Aviation Lessons Learned

No. IALL 15-03

Date: June 30, 2015

Subject: Engine Magnetic Chip Caution Lights
Area of Concern: Helicopter Operations
Distribution: All Aviation Users

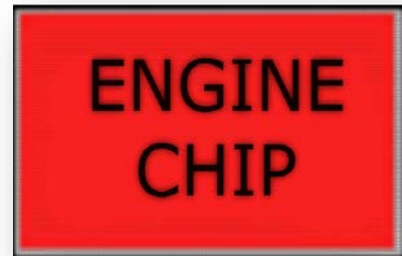
Discussion: On November 11, 2013, a contractor owned Bell 407 helicopter operating under an Exclusive Use Contract, departed an oil platform enroute to the home airport with a pilot and a bureau employee on board ([SAFECOM 14-0030](#)).

Approximately 5 minutes after takeoff, the engine chip Light illuminated and the pilot diverted to a nearby airport and performed a precautionary landing. The pilot called his company mechanic who coordinated for the services of a local Airframe and Powerplant (A&P) mechanic. The chip detector was removed and metallic fuzz and two metal slivers were discovered. The detector was cleaned, replaced, and the pilot performed a 15-minute ground run as instructed by the company mechanic.

During the first ground run, the engine chip light illuminated for a second time. The chip detector was inspected again revealing more metallic fuzz and small metallic debris. The chip detector was cleaned and replaced followed by second 15-minute ground run. During the second ground run, the engine chip light illuminated again for the third time. The mechanic and pilot repeated the same sequence of cleaning the chip detector and conducted a third 15-minute ground run. The mechanics assumed the detector had not been adequately cleaned from the previous events and even suggested using electrical contact cleaner.

Approximately 5 minutes into the flight, the engine chip light illuminated for the fourth time and the pilot immediately returned to the same airport. During the approach, the engine began losing engine oil pressure approximately ½ mile from the intended landing area. The pilot maintained a higher than normal approach airspeed in order to expedite the landing and to ensure adequate airspeed for an autorotation (if necessary). The pilot landed safely, but the engine was significantly damaged (seized).

Follow the maintenance manual. Operations and maintenance procedures were not followed. After the first chip light event, the manufacturer's instructions for this helicopter (engine) requires that the chip detector be cleaned and replaced followed by a **30-minute (not 15-minute)** ground run. If the chip annunciator light illuminates again during the initial 30-minute ground run, it then requires the mechanic to **drain the oil (not done), clean or replace the filters (not done),** and perform a second **30-minute** ground run. **If the chip light illuminates during the second 30-minute run, the maintenance manual then requires the engine to be removed from service.**
