Interagency Aviation Lessons Learned

No. IA LL 18-01

Subject: Aircraft Accident Success Story

Area of Focus: Crew Resource Management

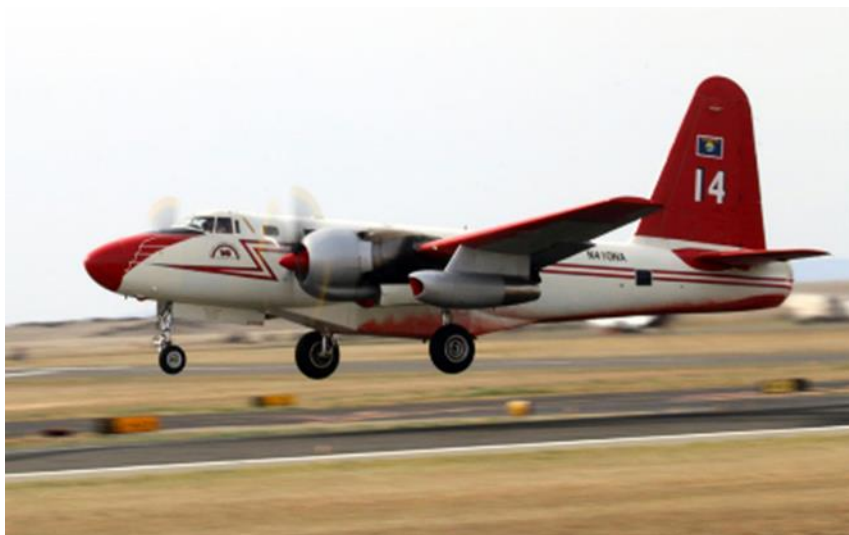
A post-accident examination of the varicam's left hand outboard drive stop and yoke showed that one bolt had been secured to the drive coupling but not safety wired. A bolt hole was found on the opposing side of the drive coupling, but the bolt was missing. The missing drive coupling bolt was found inside the varicam without any safety wire in the bolt head. The remaining bolt and the bolt that came out should have been safety wired to each other.

The absence of the drive coupling bolt hinders the torque capabilities of the drive shaft; thereby allowing one side of the varicam to move and the other side to remain stationary or turn incrementally.

Since the varicam is a secondary control surface that directly connects to the elevators and provides a primary structural load path for all elevator loads, the NTSB classified the damage as substantial (accident).
