Interagency Aviation Lessons Learned

No. IA LL 18-02

February 6, 2018

Subject: Accident Lessons Learned**Area of Concern: Human Factors****Distribution: All Aviation Activities**

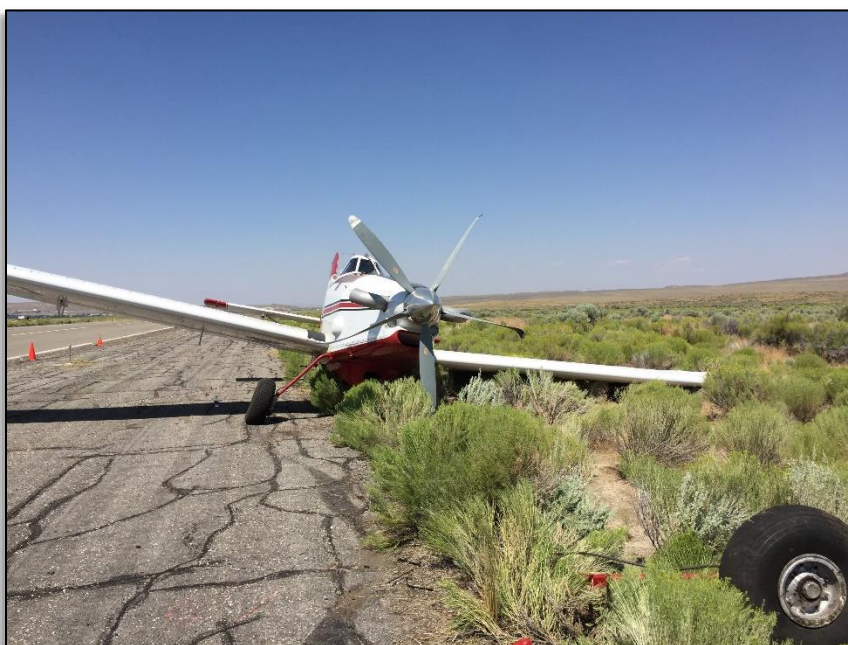
The SEAT finished the first drop of the day and proceeded to the airport to reload with retardant. The PIC entered a standard left-hand traffic pattern for runway 26. He observed the windsocks and estimated the wind to be approximately 5-10 mph from the north, resulting in a right crosswind. The PIC performed a wheel landing, touching the main gear first. As the PIC was slowing during the after landing roll and just before the tailwheel settled, the aircraft turned abruptly to the right. The PIC applied full left rudder, but was unable to arrest the turn. As the aircraft veered to the right side of the runway apron, the left main wheel hit a small pot hole and caused the aircraft to pivot nearly 180°. During this sequence, the left main landing gear separated from the aircraft and contacted the propeller and the underside of the fuselage.

The pilot described the events leading up to the accident as completely normal; that is, right up to the point where the aircraft abruptly turned and he lost control. Let's review the findings and see what might have gone wrong.

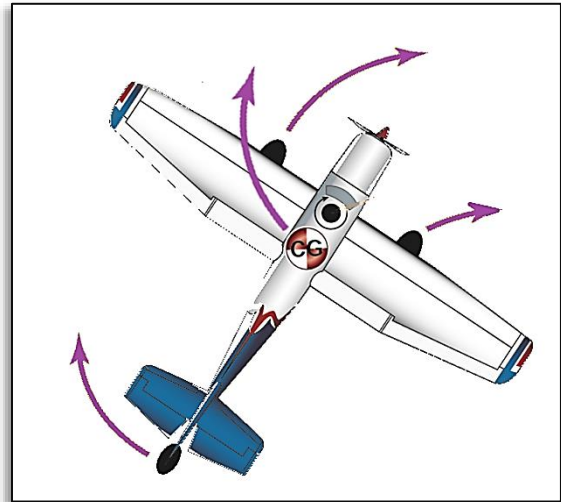
Center of Gravity. For those who are not familiar with the AT-802, it has conventional landing gear. This means that it has two main wheels forward of the wing spar and a tailwheel in the back. The center of gravity (CG) in this aircraft is behind the main wheels which negatively impacts directional stability on rollout. Any difference between the direction the airplane is traveling and the direction it is headed will produce a moment about the pivot point of the wheels, and the airplane will lose directional stability (swerve). The aft CG will aggravate this swerve and if not controlled quickly, may develop in to a complete loss of directional control otherwise known as a “ground loop”.
