**Technology &
Development
Program**

2300 Recreation Mgmt
September 2000
0023 1202—SDTDC

Soil Stabilizers On Universally Accessible Trails

September 2000

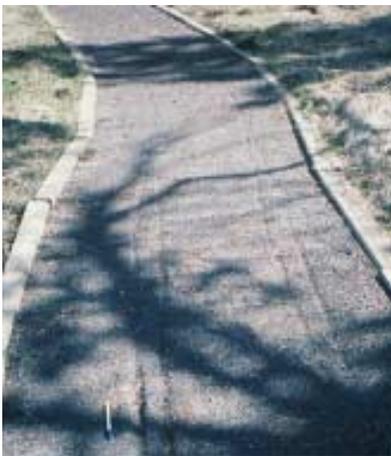
shaded areas, but the trail itself was free of snow. This section of trail was saturated with water, and it was apparent from the visible ruts that a wheelchair user had recently been on the trail. (See figure 3). Even though there were no obvious signs that a wheelchair had traveled from the parking area over the trail constructed with Road Oyl[®] (described later in this report), there were 1-inch (25.4-millimeters) deep ruts created by the chair wheels beginning at the start of the EMC² section and continuing through the entire length of the EMC² section. As the trail dried out through the spring and summer, the surface did not harden. Later in the summer, it was possible to easily scrape 2 inches (50.8 millimeters) through the surface with the edge of a boot. When John Parker did his trail evaluation, he found the trail to have a soft surface and it was not easy to push his wheelchair over. He felt that the surface was all right for a short distance, but he would not want to travel far on that type of surface.

Figure 3. Visible ruts on trail.

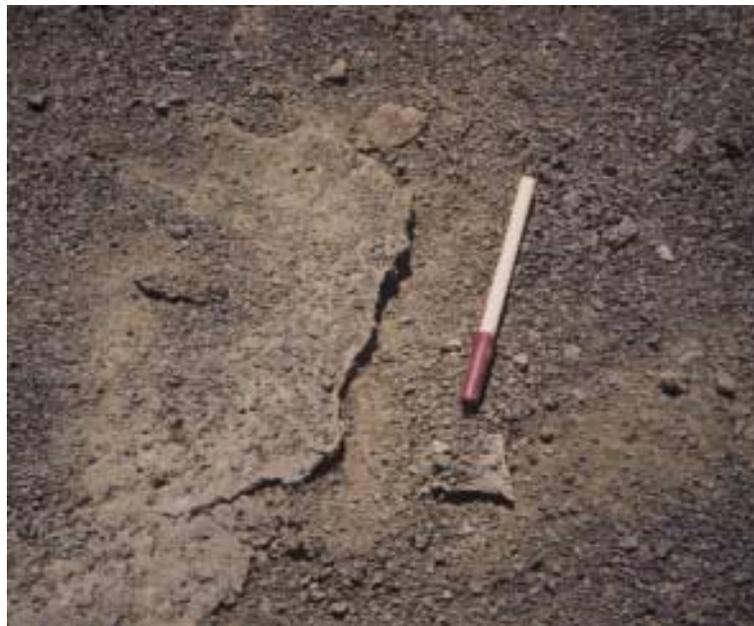
After 5 winters, there has been one small section about 1 square foot (0.1 square meters) in size that has cracked and begun to flake up on one edge. This crack shown in figure 5 developed over the second winter, and no attempt to repair it was done in order to see if the area would get worse over time. It did not develop into a more serious defect, and it is expected that a repair could be done fairly quickly by removing all of the loose surface material, wetting the surface, mixing the proper amount of ROAD OYL into a "fine" aggregate, placing it into the damaged area, and compacting.

Figure 5. Crack that developed in trail after second winter.

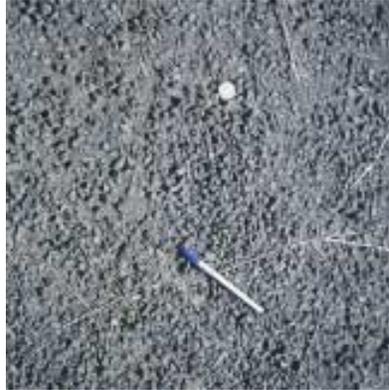
The macadam sections of this project were completed in late September 1994. Over the years, most of the blotter sand had been blown off of the trail surface. (See figure 6). In August 1998, John Parker rated most of this trail very low because the exposed pea gravel created a consistently bumpy ride in the wheelchair. There was also a distracting crunching sound as the wheels traveled over the surface. Structurally the surface was very firm and stable, and with maintenance of the sand surface

the problems of noise and bumpy ride for a wheelchair user would probably be resolved.

Figure 6. Macadam surface with blotter sand blown away.

The macadam construction method did provide a firm surface though there was a considerable amount of surface raveling of the pea gravel. Regular maintenance of the blotter sand top surface may solve the problems of raveling, noise, and bumpy ride.

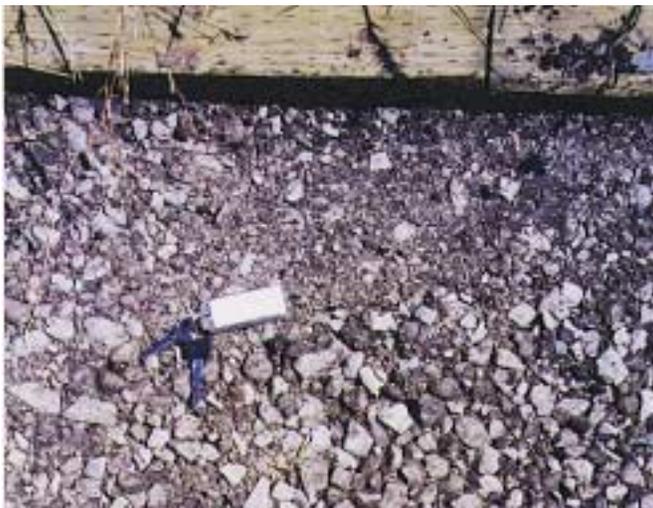
Figure 7. Coarse materials and loose surface rocks make it difficult to turn the wheels on a chair or walker.

To achieve a firm and stable surface it is recommended that one use fine aggregate (3/8-inch minus; 9.53-millimeters minus), rather than coarser aggregate that can cause problems for individuals using mobility aids. If a surface with coarse materials has any raveling, the loose surface rocks can make it very difficult to turn the wheels on a chair or walker. Loose surface rocks can also make placement of canes or crutches very difficult. (See figure 7.) Two types of fine aggregate material that are not suitable for accessible trails are sand and pea-size gravel. Both of these materials create surfaces that are very difficult to move a wheelchair across. Sand does not have any large particles (1/2-inch, 12.7-millimeters) to help keep the wheels from sinking into the soft surface, and pea-size gravel does not have enough interlocking surfaces or any fine material to give the pea-size gravel stability. A well graded mixture from 3/8-inch (9.53-millimeters) down through the very fine material is what is needed.
