Tech Tips

United States Department of Agriculture
Forest Service

May 2009

Vault Toilet Interception Analysis

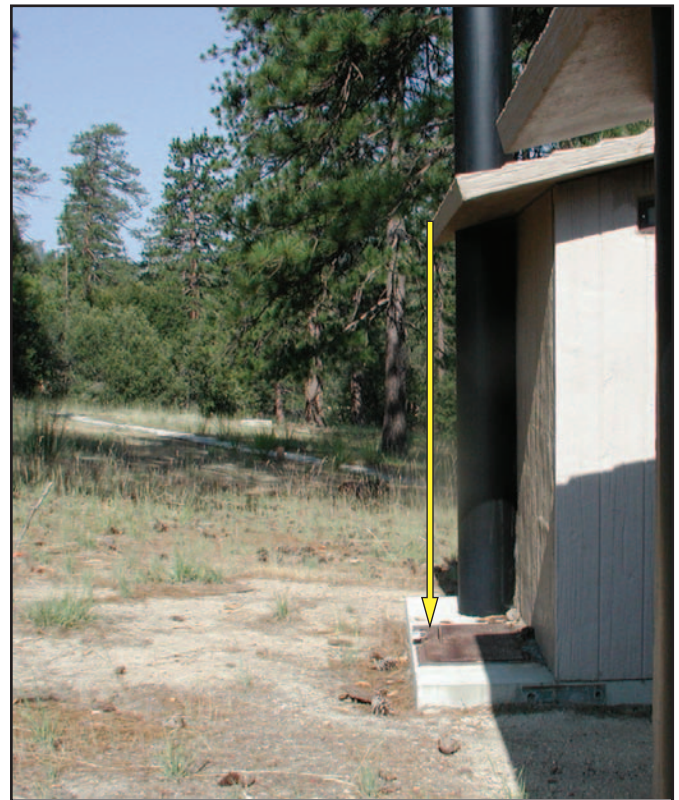
The CXT single-vault toilet has its roof dripline directly over the manhole lid (figure 1). Because the floor slab is set to drain out the front door of the toilet building, water running off the roof flows to the building wall and back under the manhole lid (figure 2). While the manhole lid has a gasket to seal it from intrusion, over time debris can get under the gasket, causing it not to seal properly (figure 3).

Figure 1—The roof dripline is directly over the manhole in the single vault CXT toilet building.

To prevent water from entering the vault through the manhole, retrofit the manhole lid with a raised “shoebox” lid (figures 8 and 9). To fabricate a shoebox lid, weld a piece of angle iron to the frame, weld bar stock to the lid, and attach a new hinge. This overlapping configuration stops runoff from entering the vault through the manhole. Fabrication drawings are included in appendix.

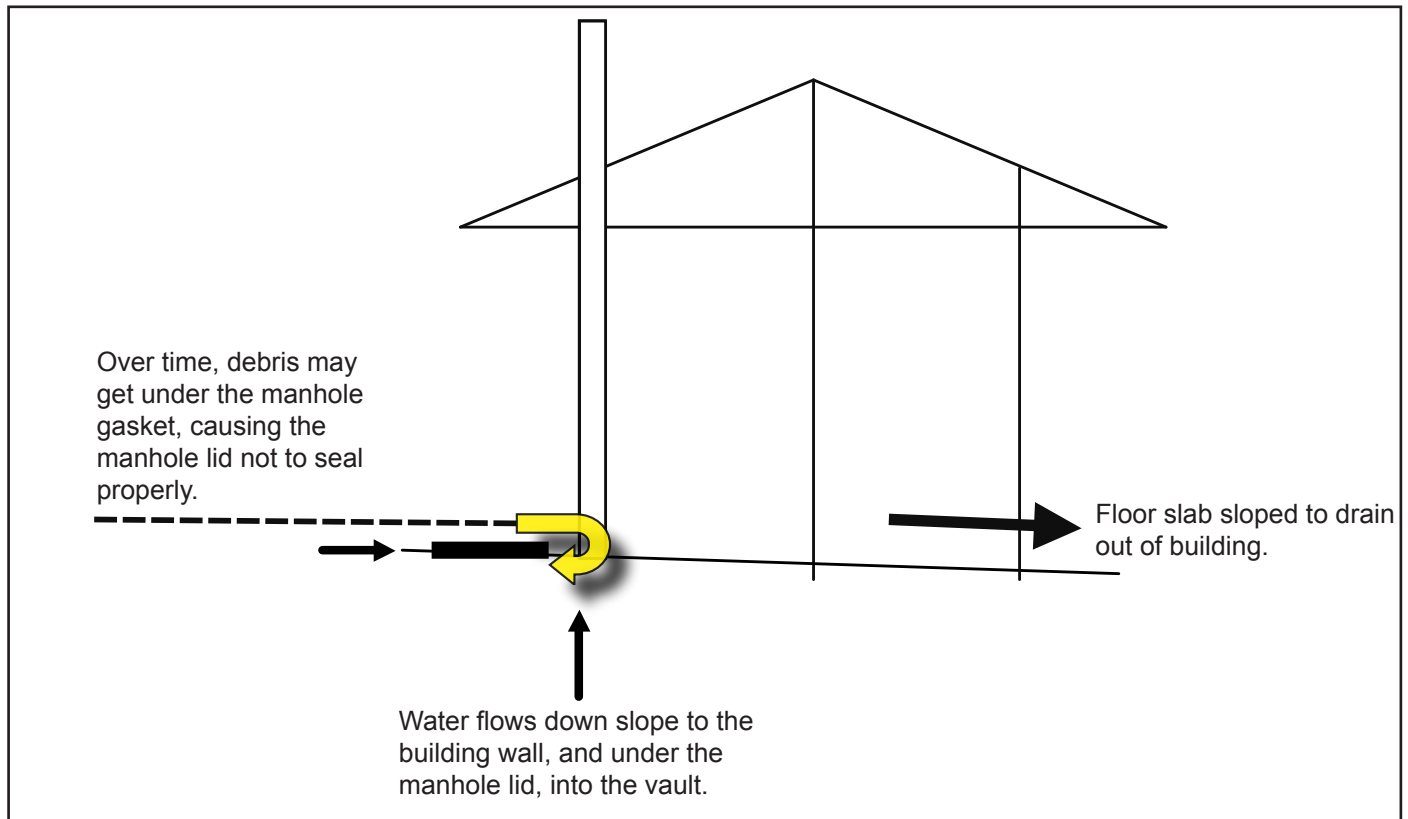
In the CXT two-vault, and other concrete vault toilets, the roof dripline is not over the manhole cover. However, debris can still get under the gasket causing the manhole cover not to seal properly. If the building was installed in a low area, it can still get rainwater intrusion (figure 4).

Figure 4—Building in low area.

For buildings that are set too low, construct a swale or ditch to intercept and divert water away from the building (figure 11). This is the least expensive method. An engineer can design a retaining wall to divert water if the backslope is steep. Use asphalt paving around the building to move the water away from the front of the vault. An engineer or geotechnician can design a French drain to move water away from the vault and percolate it into the ground rapidly (figure 10). Ensure that the pedestrian pathway remains accessible. Install a culvert if necessary to maintain access.

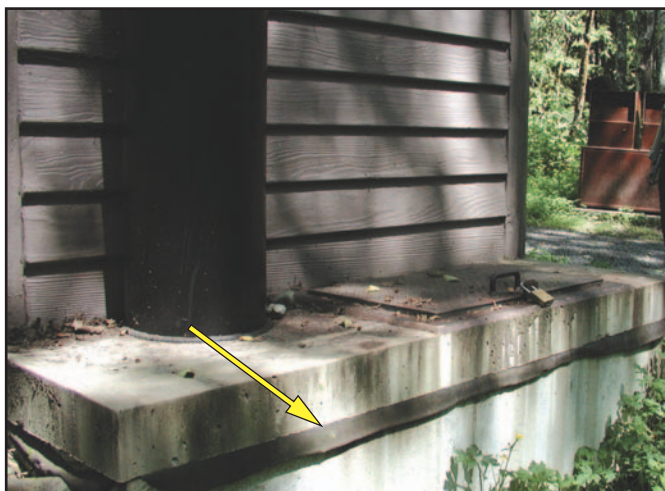
Figure 5—Mastic between the vault and building slab make a watertight seal

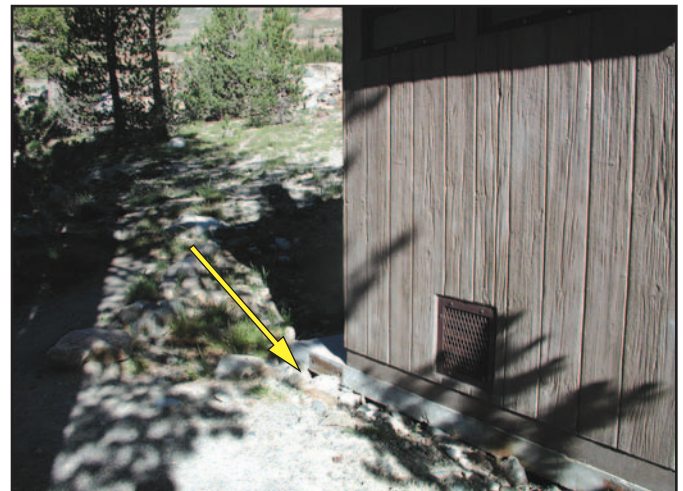
Figure 6—This vault is below finished grade. The mastic between the building slab and vault is damaged. The vault fills with water every spring.

Resetting a building and replacing an older liner is possible, but very expensive. The vault would need to be excavated, and a crane brought in to lift the building and vault. The old liner could then be removed and the vault resealed. Place a layer of aggregate in the excavation to raise the vault's grade 6 inches above the surrounding grade and reset the vault and building.

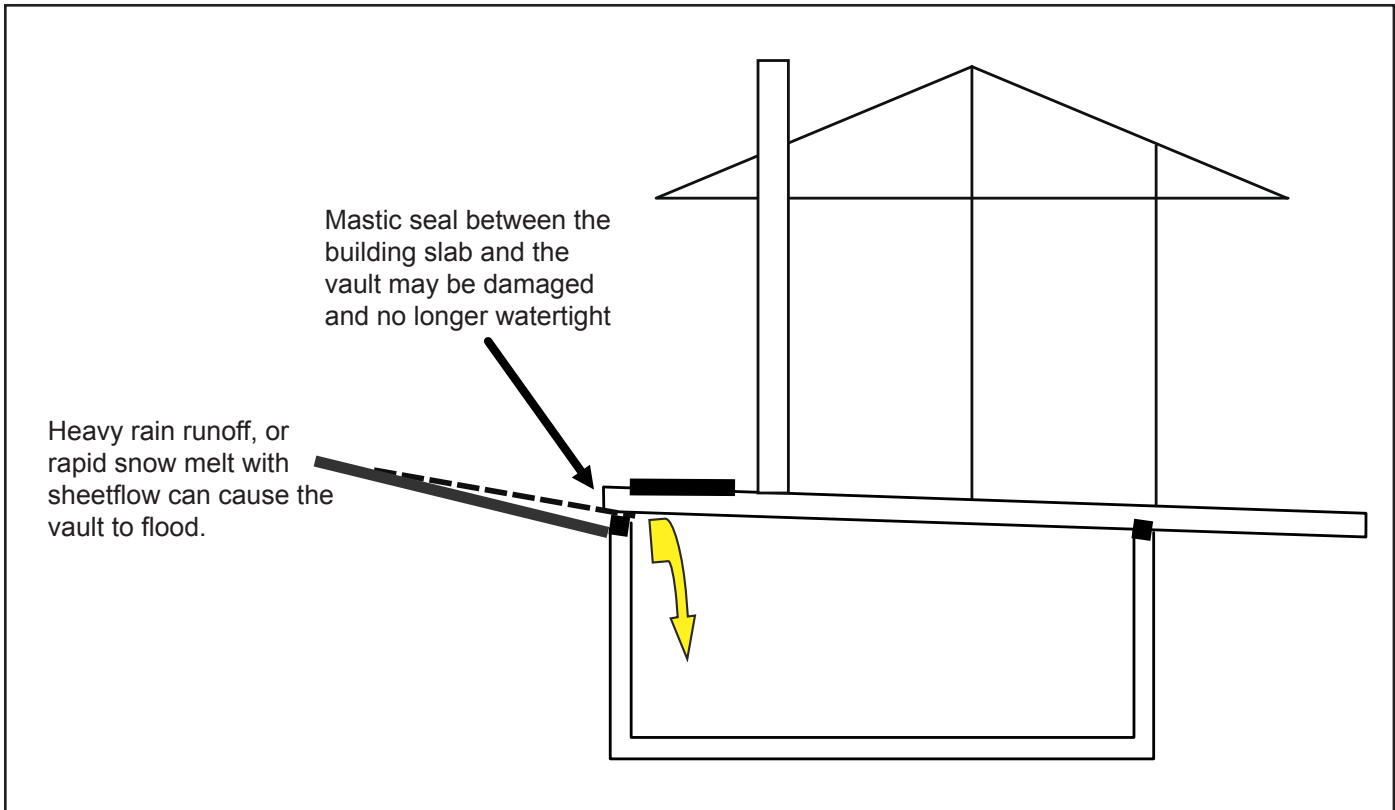
Another potential location for water intrusion is at the joint between the vault and building slab. During installation, mastic or butyl tape is applied to the top of the vault before the building slab is set. This mastic makes a watertight seal (figure 5). Intrusion occurs if the mastic seal between the slab and the vault is damaged, and the vault is set too low (figure 6). Heavy rain, or rapid snowmelt, will get into the vault by going between the slab and the vault (figure 7).

Figure 7—Heavy rain runoff or rapid snow melt can cause the vault to flood.

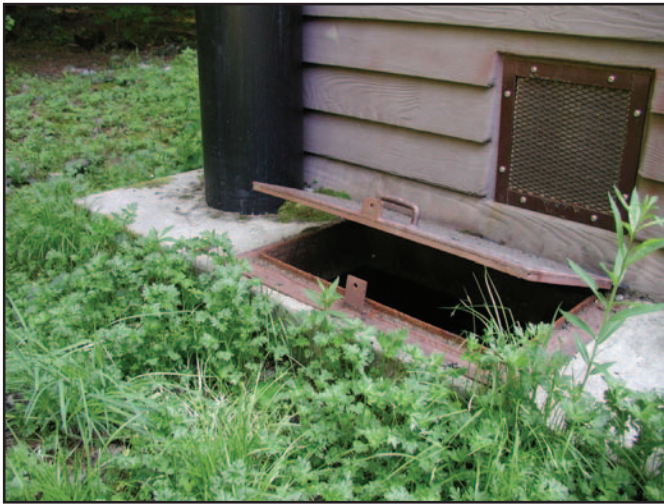
Figure 8—Retrofit “shoebox” lid stops water from entering the vault by going under the lid.

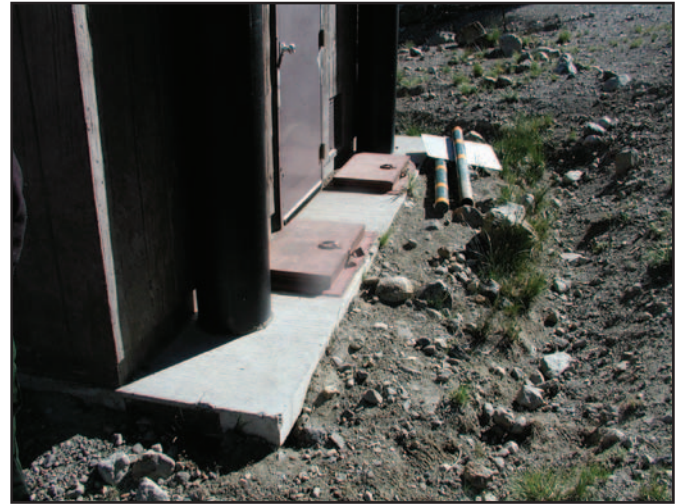
Figure 9—Another style of “shoebox” lid.

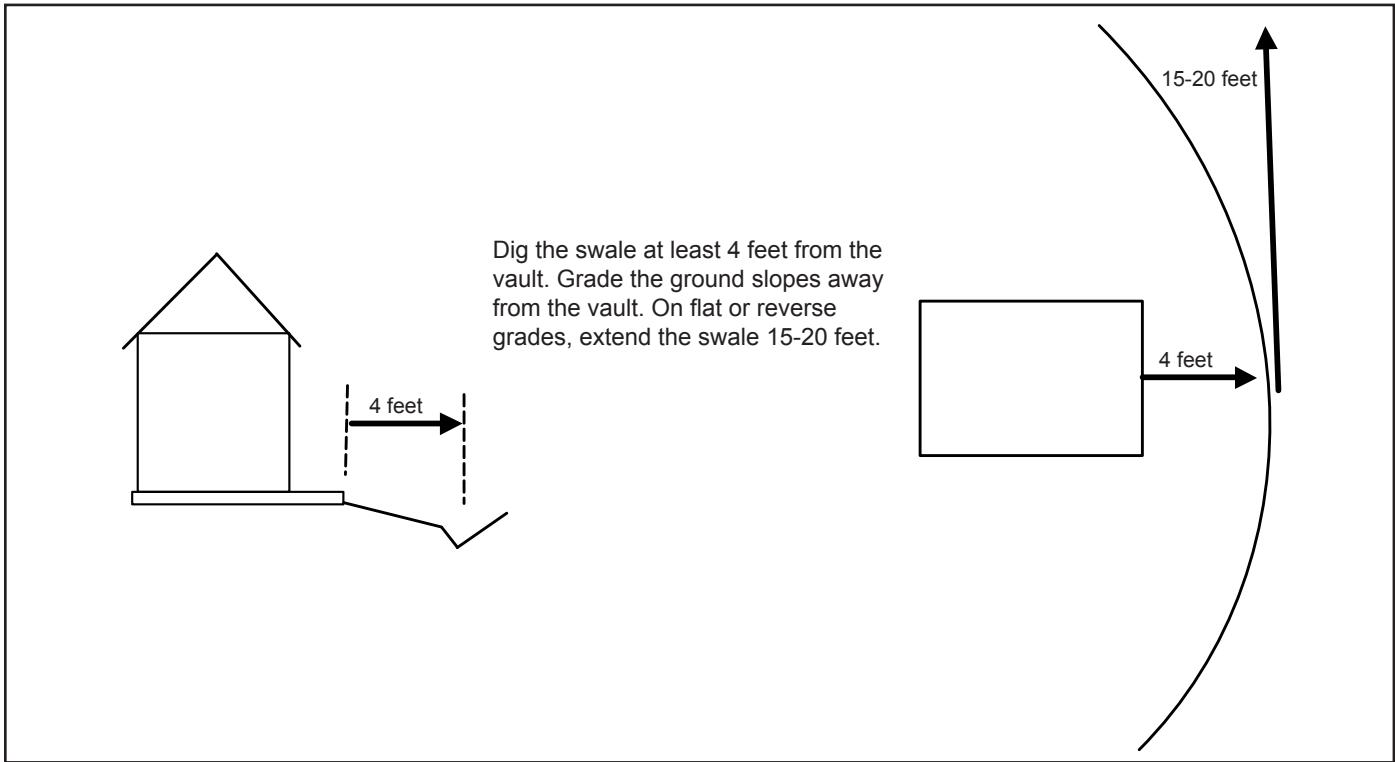
Figure 11—How to construct a swale.
