## Case Study 17. Stony River Treated Timber Box Culverts

Northern Minnesota. Superior National Forest, Isabella Ranger District. Stony River, south of Boundary Waters Wilderness Area. 8 miles west of Isabella, adjacent to State Highway 1, approximately ½ mile from McDougal Lakes. Forest Road 933.

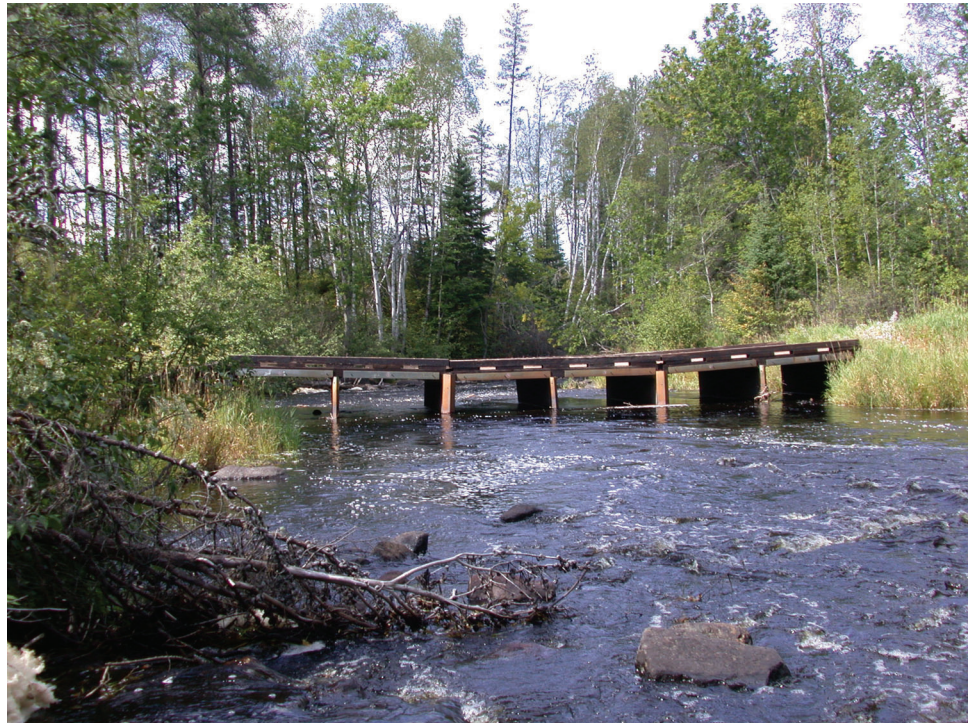
This structure was constructed in 1984 on a perennial fish-bearing stream (figure A112). It is a series of treated timber box culverts embedded into a cobble-boulder streambed. The opening is about 85 to 90 percent of bankfull width on a relatively straight pool-riffle channel. Low flows pass through the structure at similar velocities and depths as in the channel itself, and the structure appears to be passable to fish most or all of the year. The ford was designed to pass the 25-year flow under the bridge deck, and to resist common ice jams. Water has barely overtopped the deck twice, and the structure has required only occasional debris removal and some reinforcement of the joints and connectors.

Figure A112. Stony River box culvert ford.

The flood history of this site is unknown, but there have been very heavy storms in the general vicinity within the structure's lifetime. Since construction, flow has twice been observed to just overtop the structure. Some shifting has occurred and the box connectors have required reinforcement. Debris removal from the upstream face of the structure has been the only other maintenance need.

This high-VAR ford continues to function well after 20+ years. Boulder streambed material covers 100 percent of the structure bottom, so that streambed continuity and flow velocities similar to the natural channel are maintained through structure. The designer would opt for using concrete if he were building a similar box structure today, because of structural strength and durability. Other recommendations from forest personnel are to pave approaches to protect water quality, and to provide an upstream take-out and portage for kayaks.

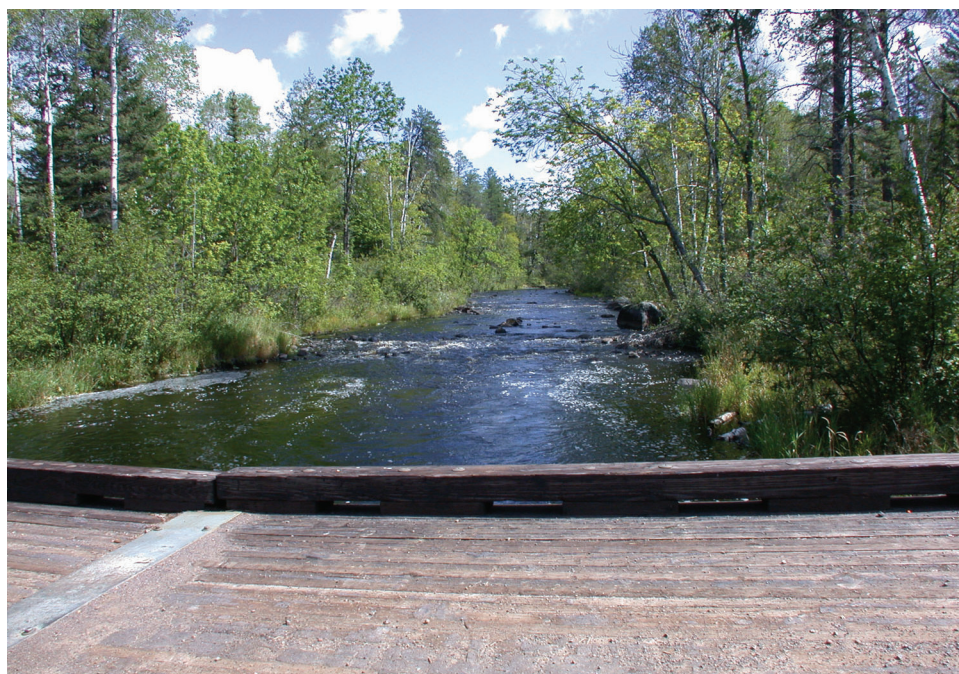
**Channel Description:** Stony River is a low sinuosity pool-riffle channel (a B2c or C2 stream type) about 50 feet wide. Boulder riffles provide streambed structure, and pools are quite shallow. Slope near the site is approximately 1.25 percent. Boulders vary from large to small, with a predominance of small to medium sizes. The adjacent riparian area has some tree cover, with dense shrub and sedge vegetation, and the potential for large woody debris recruitment to the channel is low to moderate. Boulders, wood, and vegetation provide good bank stability. The channel is moderately entrenched to unentrenched at the site, with a 5-foot terrace on one bank, and a narrow flood plain on the other (figure A113).

Figure A113. Stony River looking upstream from the ford.
