## Case Study 10. Black Canyon Concrete Plank Ford

North central Idaho. Clearwater National Forest. North Fork Clearwater River. Road 250, about 45 miles from Superior, Montana, and 55 miles from Pierce, Idaho.

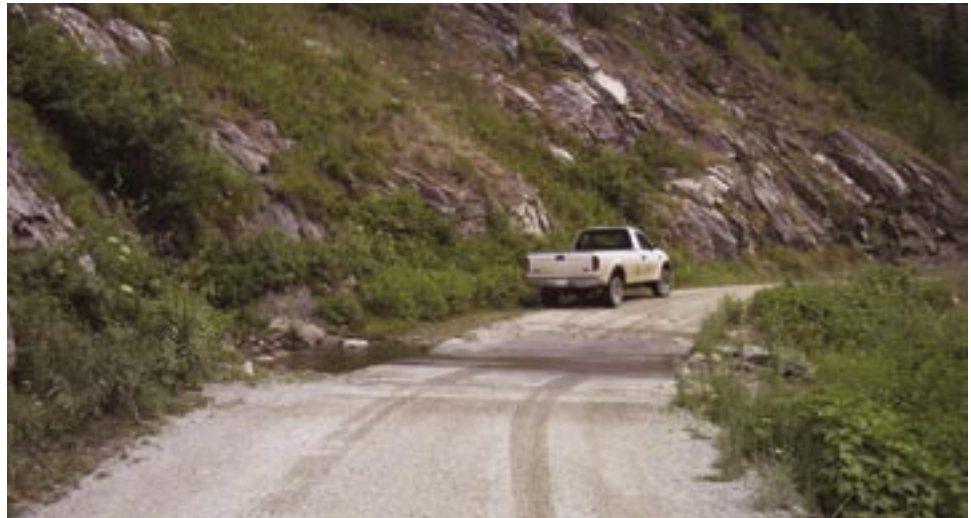
Figure A60. Ford is located on a valley bottom road at the base of an avalanche chute.

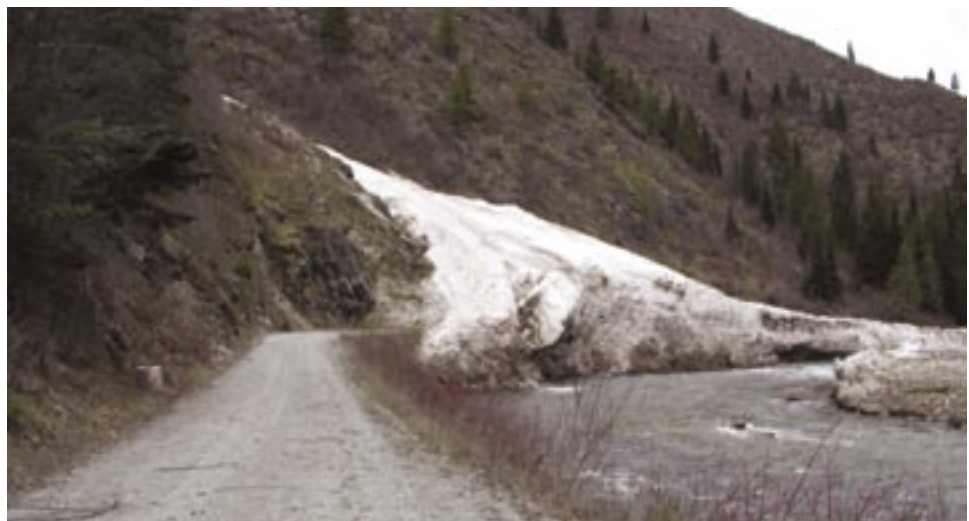
**Hydrology:** The North Fork Clearwater River is a steep perennial river. The side drainages experience massive snow slides most years (figure A61). Summer low flows on the side drainages are generally about 1 to 2 feet wide and a few inches deep.

Figure A61. Spring snow slide on top of ford, April 2003.

As expected, snow, sediment, logs, and rocks are deposited on the structure annually. The structures are inspected and cleaned each year before the road opens. Expectations are that the structures will be cheaper to repair than slab fords, since individual planks can be replaced if they are broken by rock or debris during a slide.

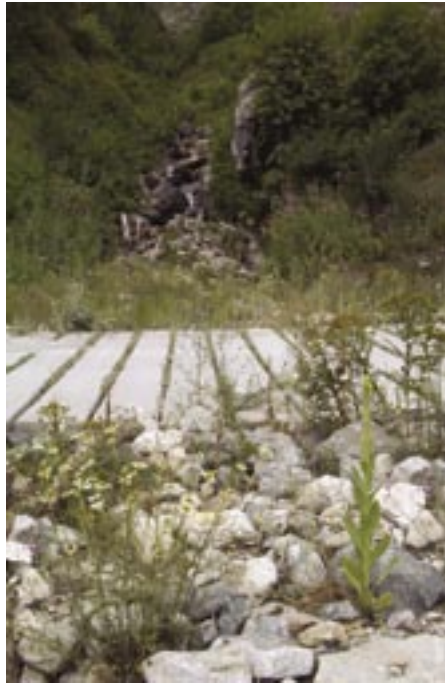
**Channel Description:** The ford is located on a steep tributary channel, a Rosgen A1a+ in a bedrock avalanche chute (figure A62). Drainage area is approximately 320 acres, and near the bottom of the slope the channel is approximately 6 feet wide. Banks are not well vegetated or particularly stable.

Figure A62. Looking upstream across the ford to the channel. The culvert is to the right out of the frame.

This structure has been in place for 5 years and, like the other plank fords in avalanche chute areas, it has performed well handling annual slides. The ‘channels’ between the planks, and the culvert under the planks, allow for continued water passage even when the structure is covered with debris. In hindsight, the forest would recommend using a larger culvert (36 or 48 inches), in anticipation of a 100-year runoff event.

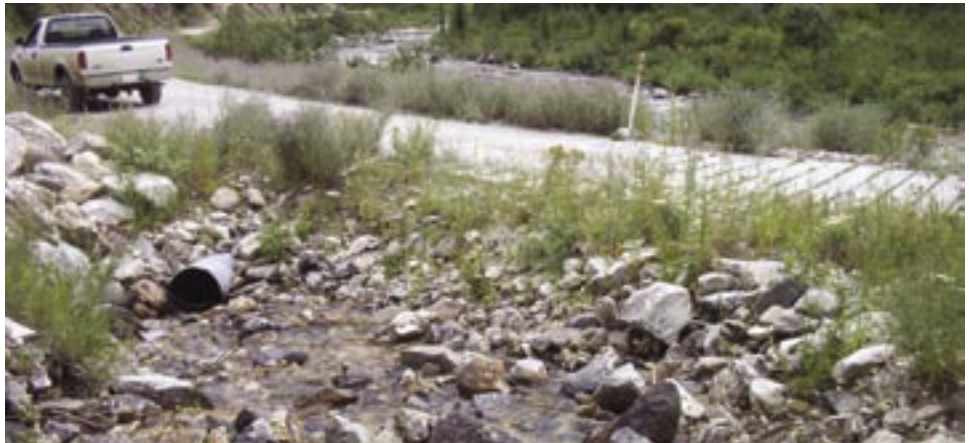
Figure A63. Looking downstream toward the North Fork Clearwater River. Note the sediment catch basin in foreground.
