Case Study 13. North Fork Consumnes River Tributaries Box Culvert Vented Fords

Central California. Eldorado National Forest, Placerville Ranger District. About 18 miles ESE of Placerville. North Fork Consumnes River basin. Meiss Cabin Road, Forest Road 52 upstream of Capps Crossing.

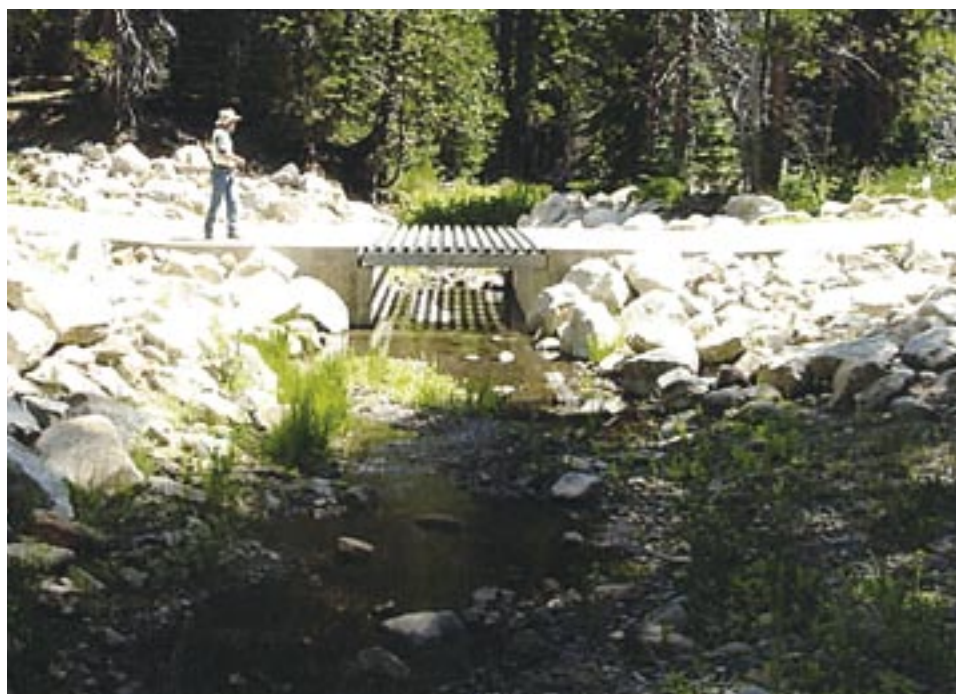
Figure A80. One of several grating-top box culvert fords on tributaries of the North Fork Consumnes River.

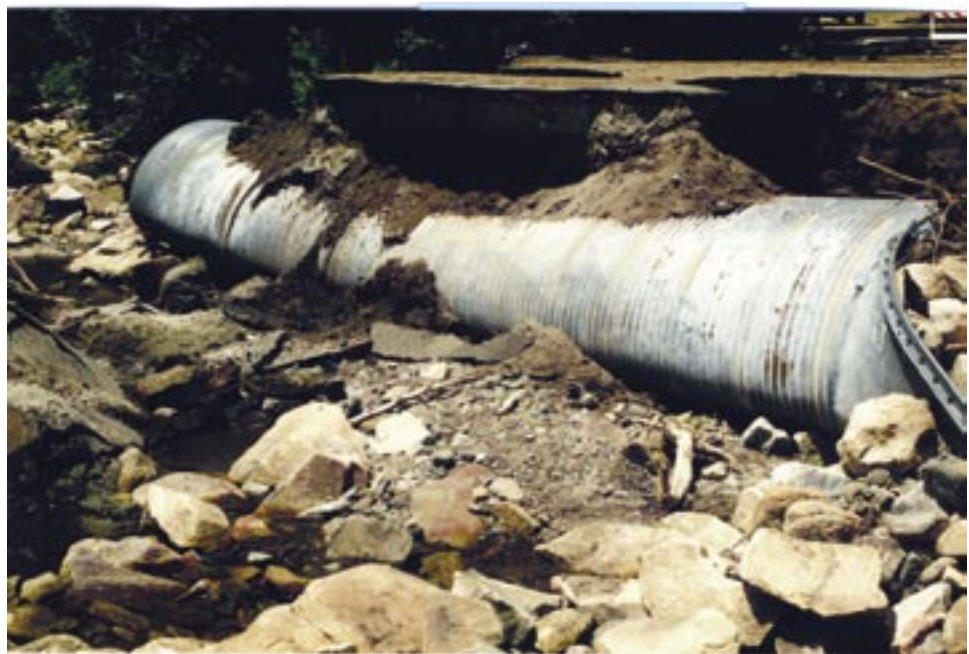
Previous structures at these sites were culverts, which had plugged and been replaced by progressively larger culverts over a period of years. All of the tributary crossings failed in the January 1997 storm event (figure A81). At one crossing, a Hilfiker welded wire headwall was so battered by boulders that it had to be removed. Refer to case study 21 for a review of watershed history and condition that explains why these tributaries are transporting so much rock and sediment.

Figure A81. Typical flood damage at edge of North Fork Consumnes River valley after 1997 rain-on-snow flood.

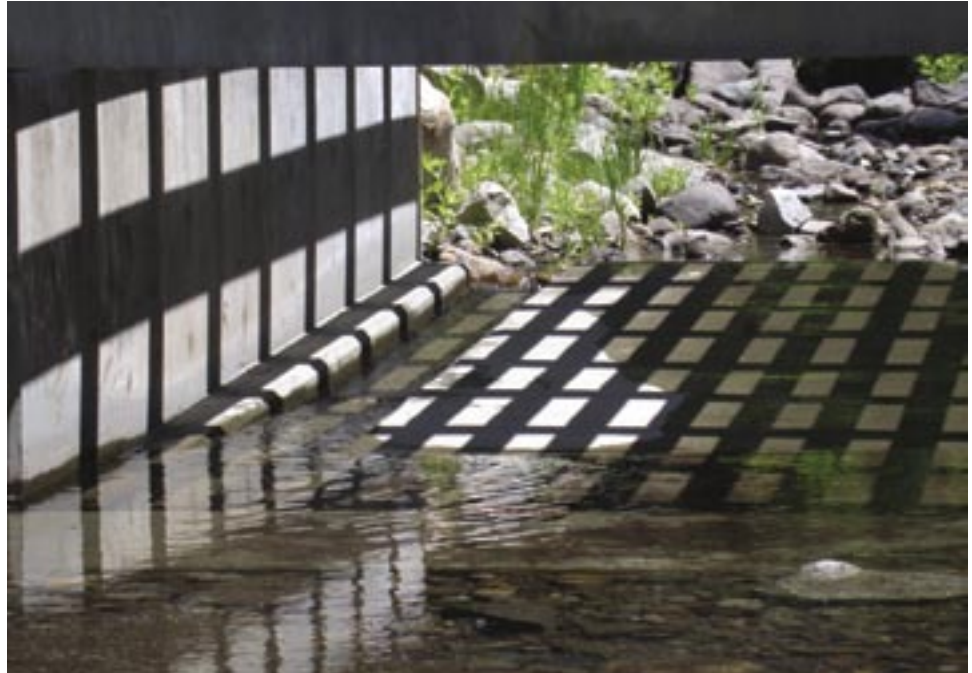
flow. Three-inch fish downstream of one culvert in July 2002 were unable to swim past the backwatered section (figure A83). There may be flows where some fish can move upstream. The structures are no more than 12 feet long, so larger fish may be able to negotiate them at higher flows.

Fish were attempting to move upstream in July 2002, but flow in the trench was too shallow and too fast.

Where fish passage is required, a similar grate-top box with an open bottom and natural streambed would better fit the need.

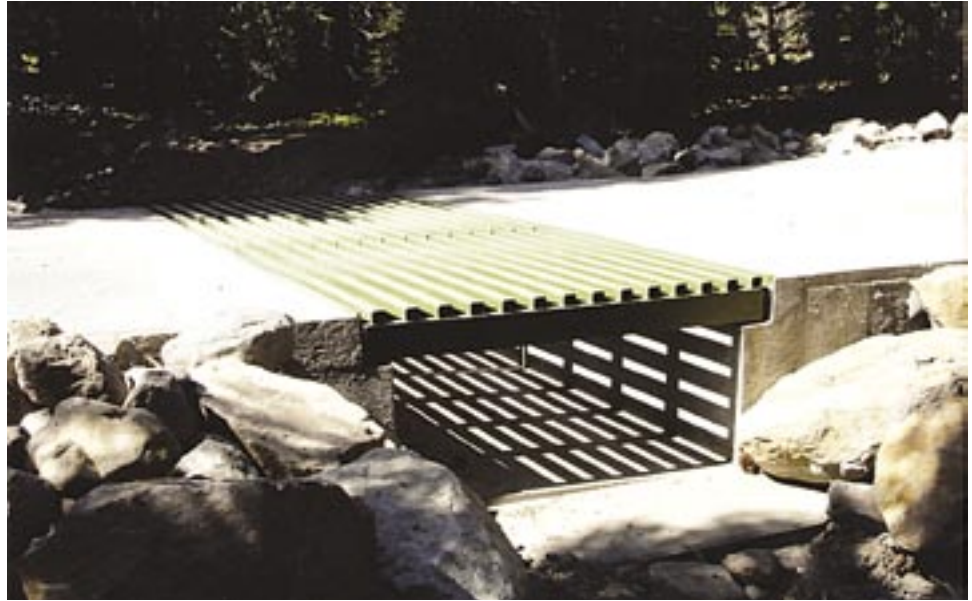
Structure: The structure is a small box culvert with an open top and cattleguard driving surface that can be removed for cleaning (figure A84). Concrete approaches dip into the ford, which has a total length of 75 feet (figure A85). The concrete box is 8 feet wide and 4 feet deep. The box floor slopes slightly perpendicular to the direction of flow to force low flow to concentrate in the trench at one side of the box. An upstream cutoff wall 9 inches deep runs the full length of the ford and is heavily riprapped.

Figure A84. Close up of grate-top vented ford.
