# Tech Tips

May 2009

0823 1307—SDTDC

## Vault Toilet Interception Analysis

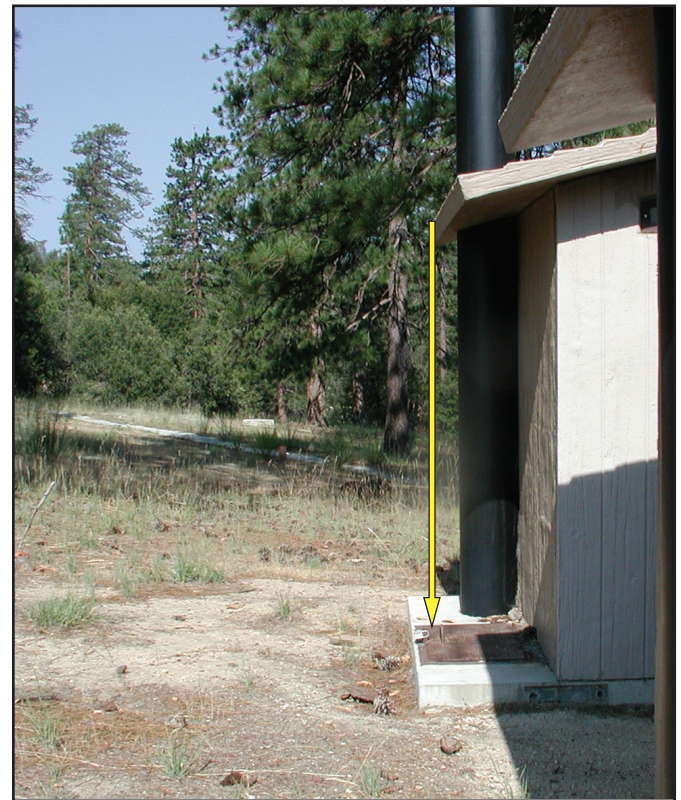
The CXT single-vault toilet has its roof dripline directly over the manhole lid (figure 1). Because the floor slab is set to drain out the front door of the toilet building, water running off the roof flows to the building wall and back under the manhole lid (figure 2). While the manhole lid has a gasket to seal it from intrusion, over time debris can get under the gasket, causing it not to seal properly (figure 3).

*Figure 1—The roof dripline is directly over the manhole lid in the single vault CXT toilet building.*

To prevent water from entering the vault through the manhole, retrofit the manhole lid with a raised “shoebox” lid (figures 8 and 9). To fabricate a shoebox lid, weld a piece of angle iron to the frame, weld bar stock to the lid, and attach a new hinge. This overlapping configuration stops runoff from entering the vault through the manhole. Fabrication drawings are included in appendix.

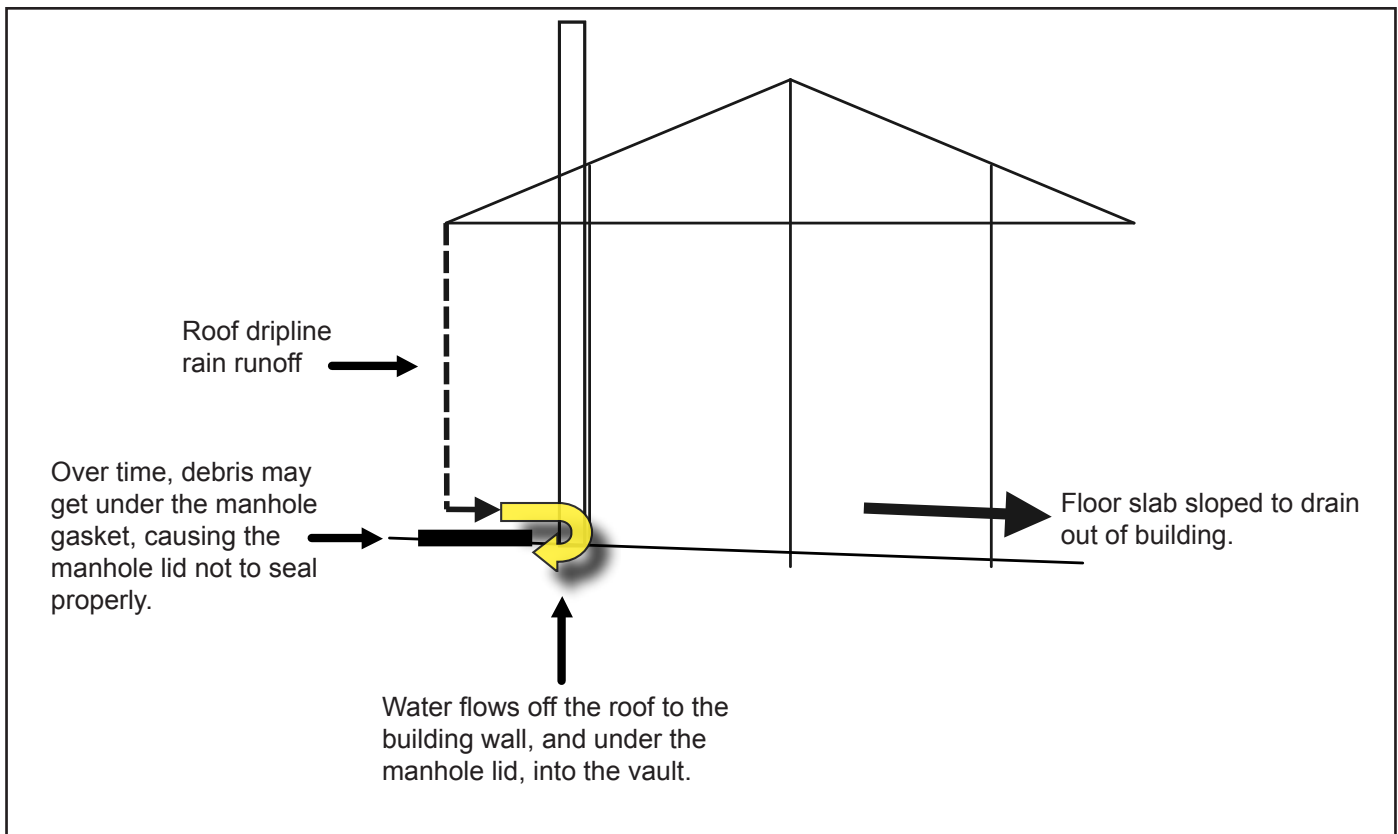
Figure 2—Roof dripline directly over manhole.

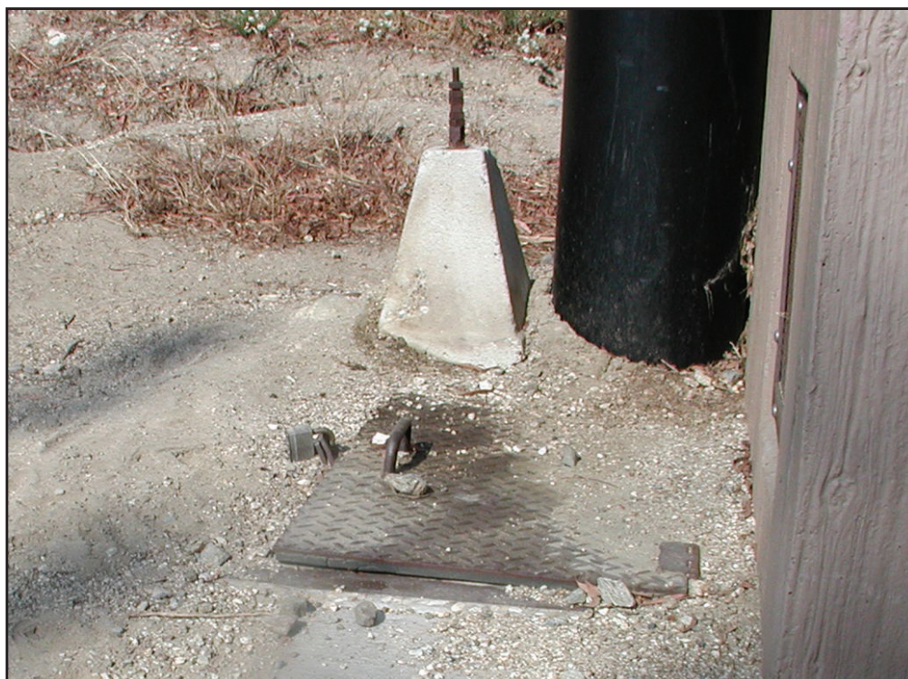
Figure 3—Debris under gasket.

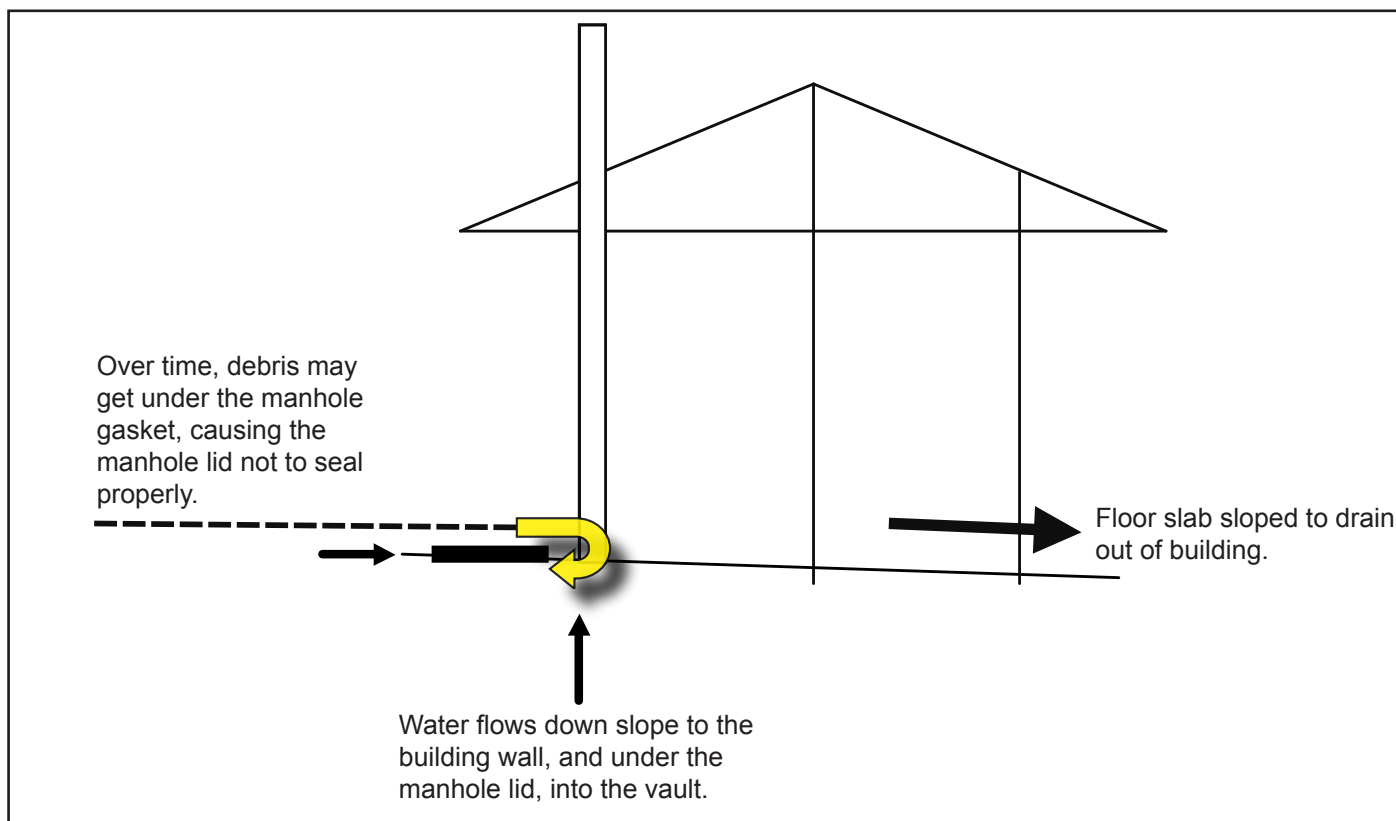
In the CXT two-vault, and other concrete vault toilets, the roof dripline is not over the manhole cover. However, debris can still get under the gasket causing the manhole cover not to seal properly. If the building was installed in a low area, it can still get rainwater intrusion (figure 4).

*Figure 4—Building in low area.*

For buildings that are set too low, construct a swale or ditch to intercept and divert water away from the building (figure 11). This is the least expensive method. An engineer can design a retaining wall to divert water if the backslope is steep. Use asphalt paving around the building to move the water away from the front of the vault. An engineer or geotechnician can design a French drain to move water away from the vault and percolate it into the ground rapidly (figure 10). Ensure that the pedestrian pathway remains accessible. Install a culvert if necessary to maintain access.

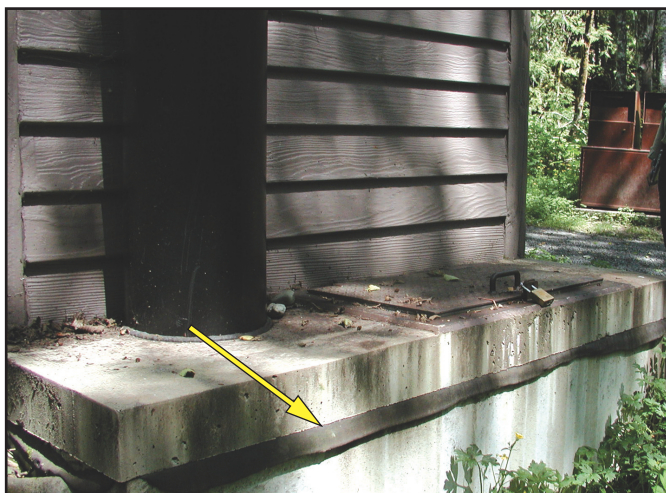
Another potential location for water intrusion is at the joint between the vault and building slab. During installation, mastic or butyl tape is applied to the top of the vault before the building slab is set. This mastic makes a watertight seal (figure 5). Intrusion occurs if the mastic seal between the slab and the vault is damaged, and the vault is set too low (figure 6). Heavy rain, or rapid snowmelt, will get into the vault by going between the slab and the vault (figure 7).

*Figure 5—Mastic between the vault and building slab make a watertight seal*

For new vault toilet purchases, request a raised manhole with a shoebox lid in locations that get a substantial amount of rain or snow, especially on the single-vault CXT. The mastic can become compromised over time due to age and weathering, so do not rely on it to keep floodwater out of the vault. Always set the top of the vault at least 6 inches higher than surrounding grade, per manufacturers' recommendation.

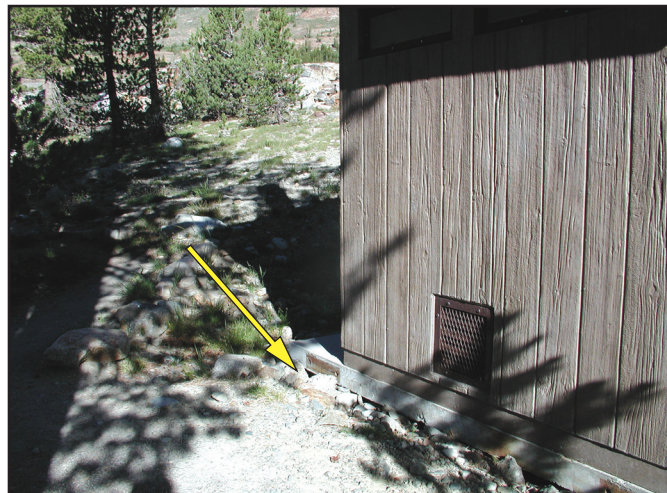
*Figure 6—This vault is below finished grade. The mastic between the building slab and vault is damaged. The vault fills with water every spring.*

Resetting a building and replacing an older liner is possible, but very expensive. The vault would need to be excavated, and a crane brought in to lift the building and vault. The old liner could then be removed and the vault resealed. Place a layer of aggregate in the excavation to raise the vault's grade 6 inches above the surrounding grade and reset the vault and building.

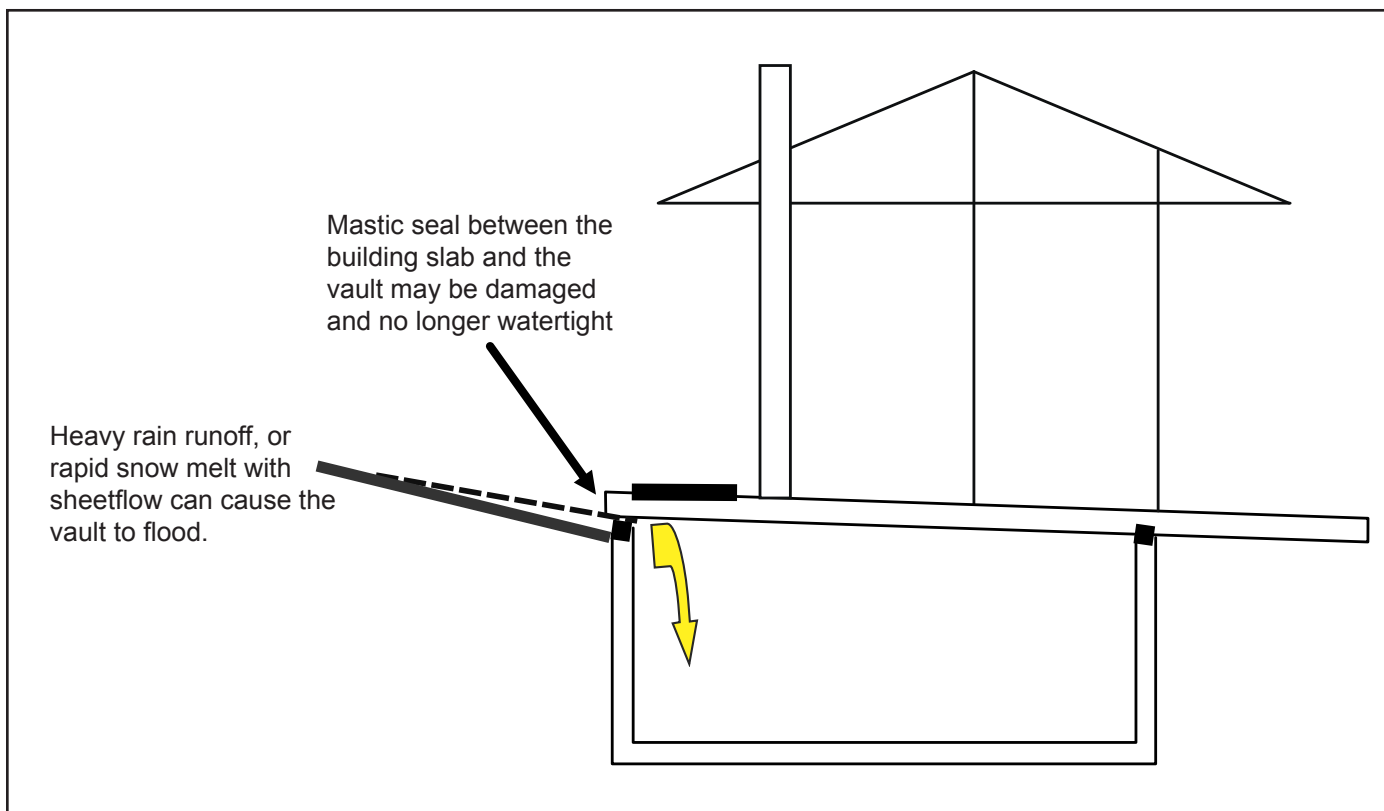
*Figure 7—Heavy rain runoff or rapid snow melt can cause the vault to flood.*

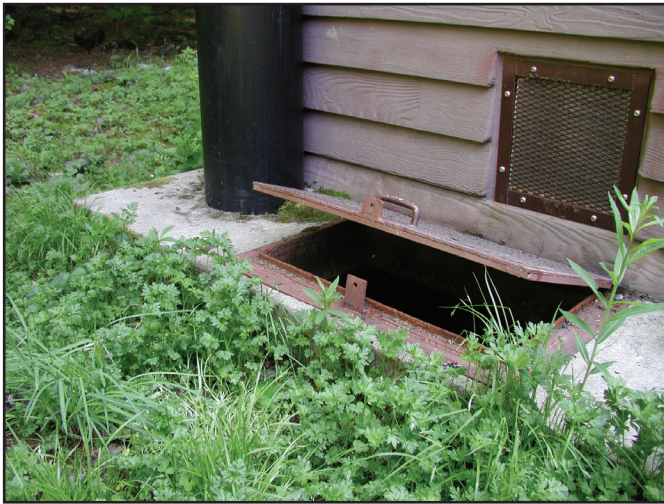
Figure 8—Retrofit “shoebox” lid stops water from entering the vault by going under the lid.

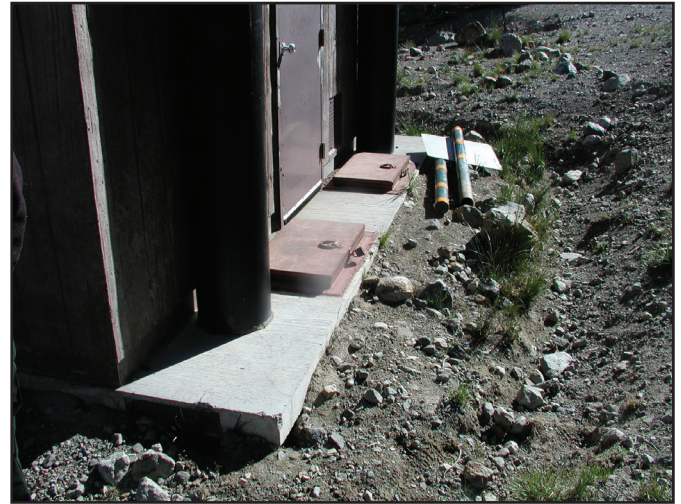
Figure 9—Another style of “shoebox” lid.

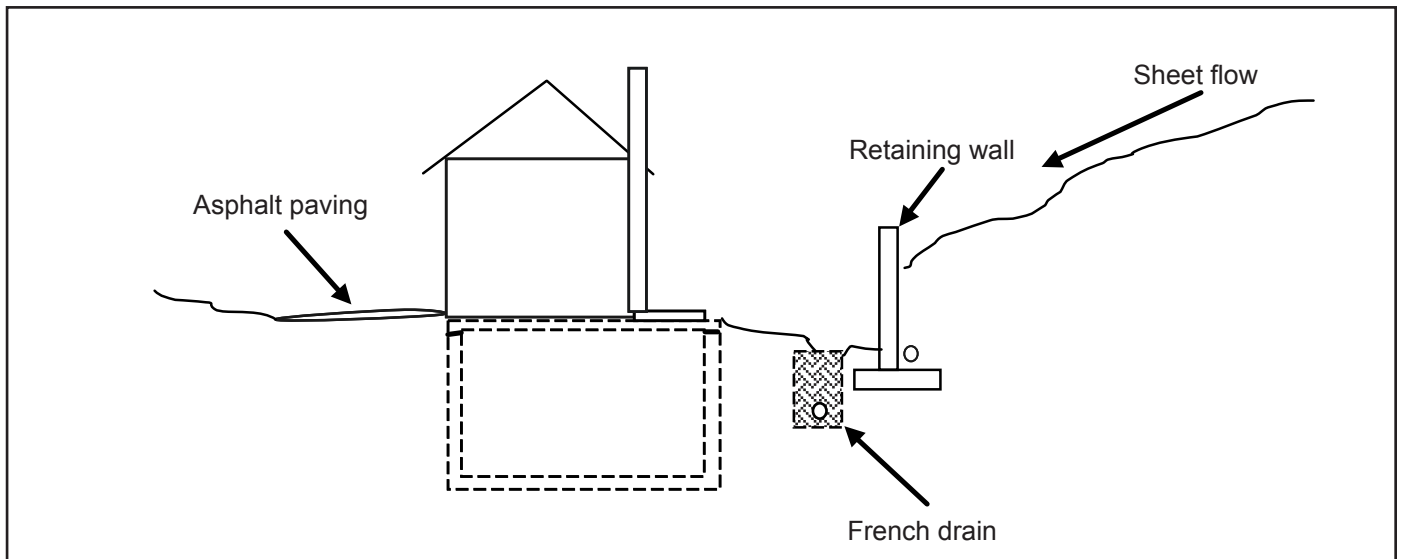
Figure 10—Alternatives to move water away from the building and vault.

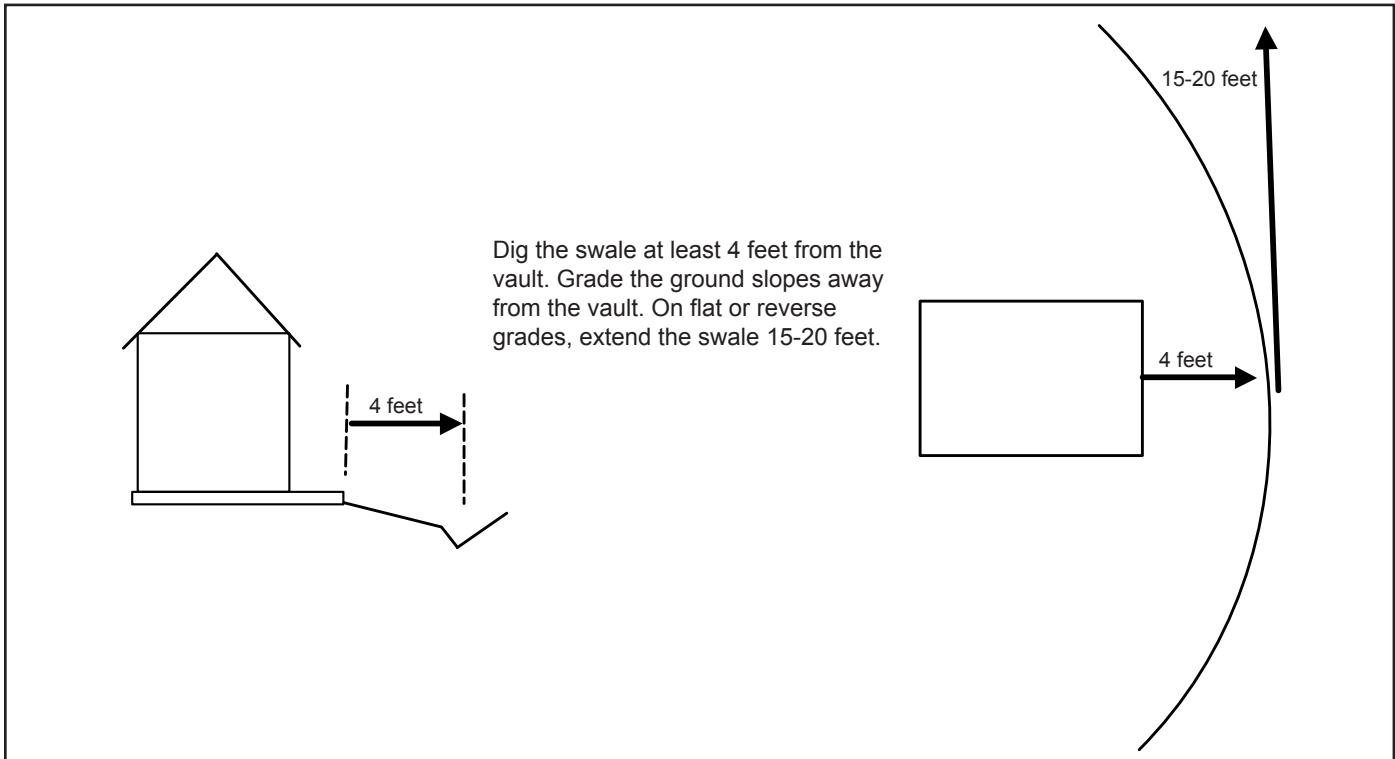
Figure 11—How to construct a swale.
