Technical Report GL-93-20  
August 1993

# **Effects of Variable Tire Pressure on Road Surfacing**

Volume I: Design, Construction, Behavior  
Under Traffic, and Test Results

Geotechnical Laboratory

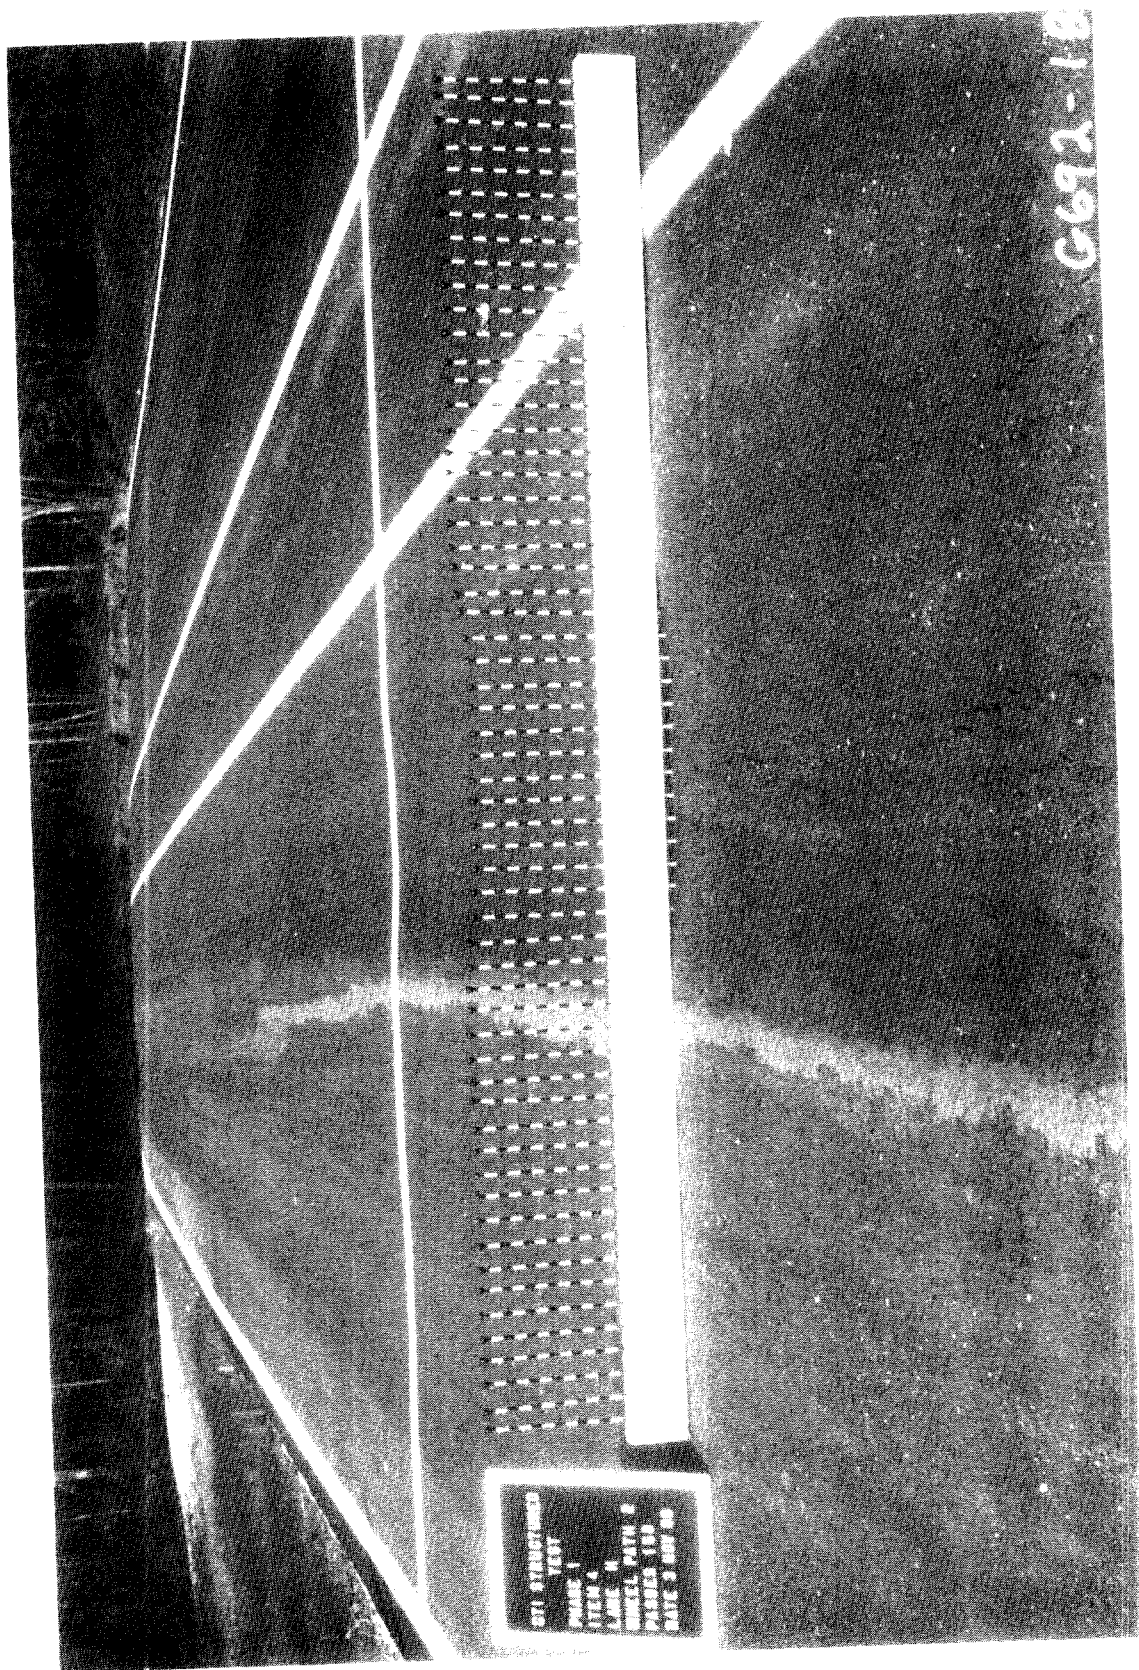
| Test Section | Lane | Wheel Path | Number of Passes | Maximum <sup>1</sup> Rut Depth, in. | Remarks |
|---|---|---|---|---|---|
| 4 | H | 2 | 158 | 2.3 | Severe cracking. |

Photo 13. Item 4, wheel path 2, general view of initial failure, 158 passes

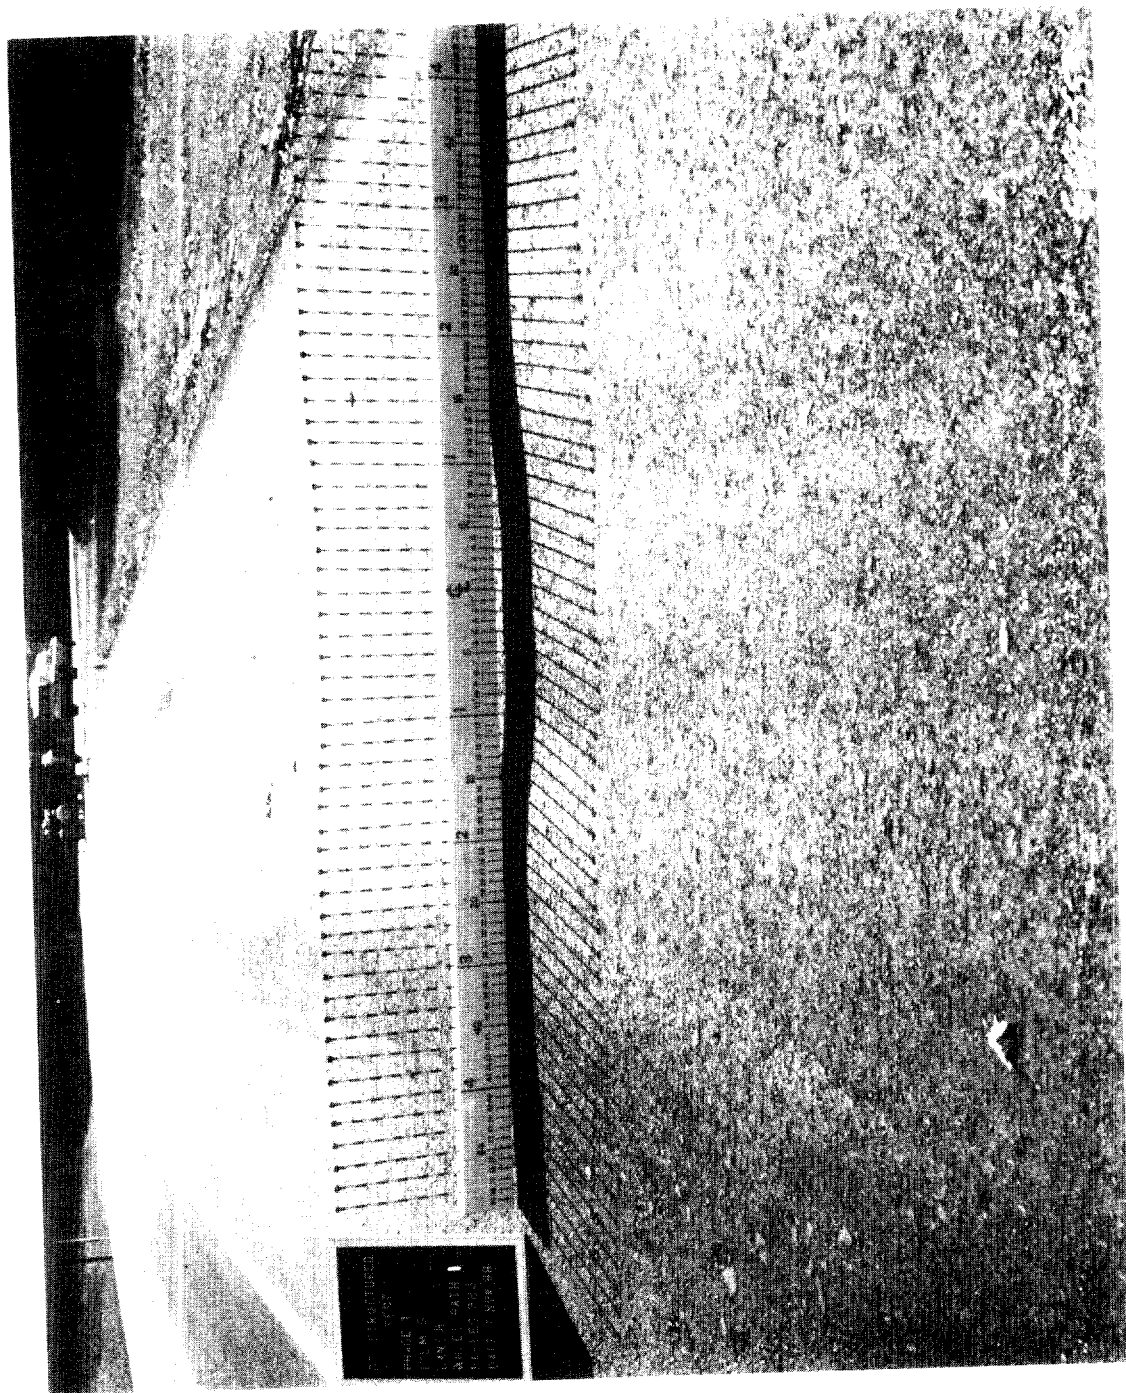
Photo 16. Item 5, high-tire pressure lane, maximum 1-in. rutting after 323 passes

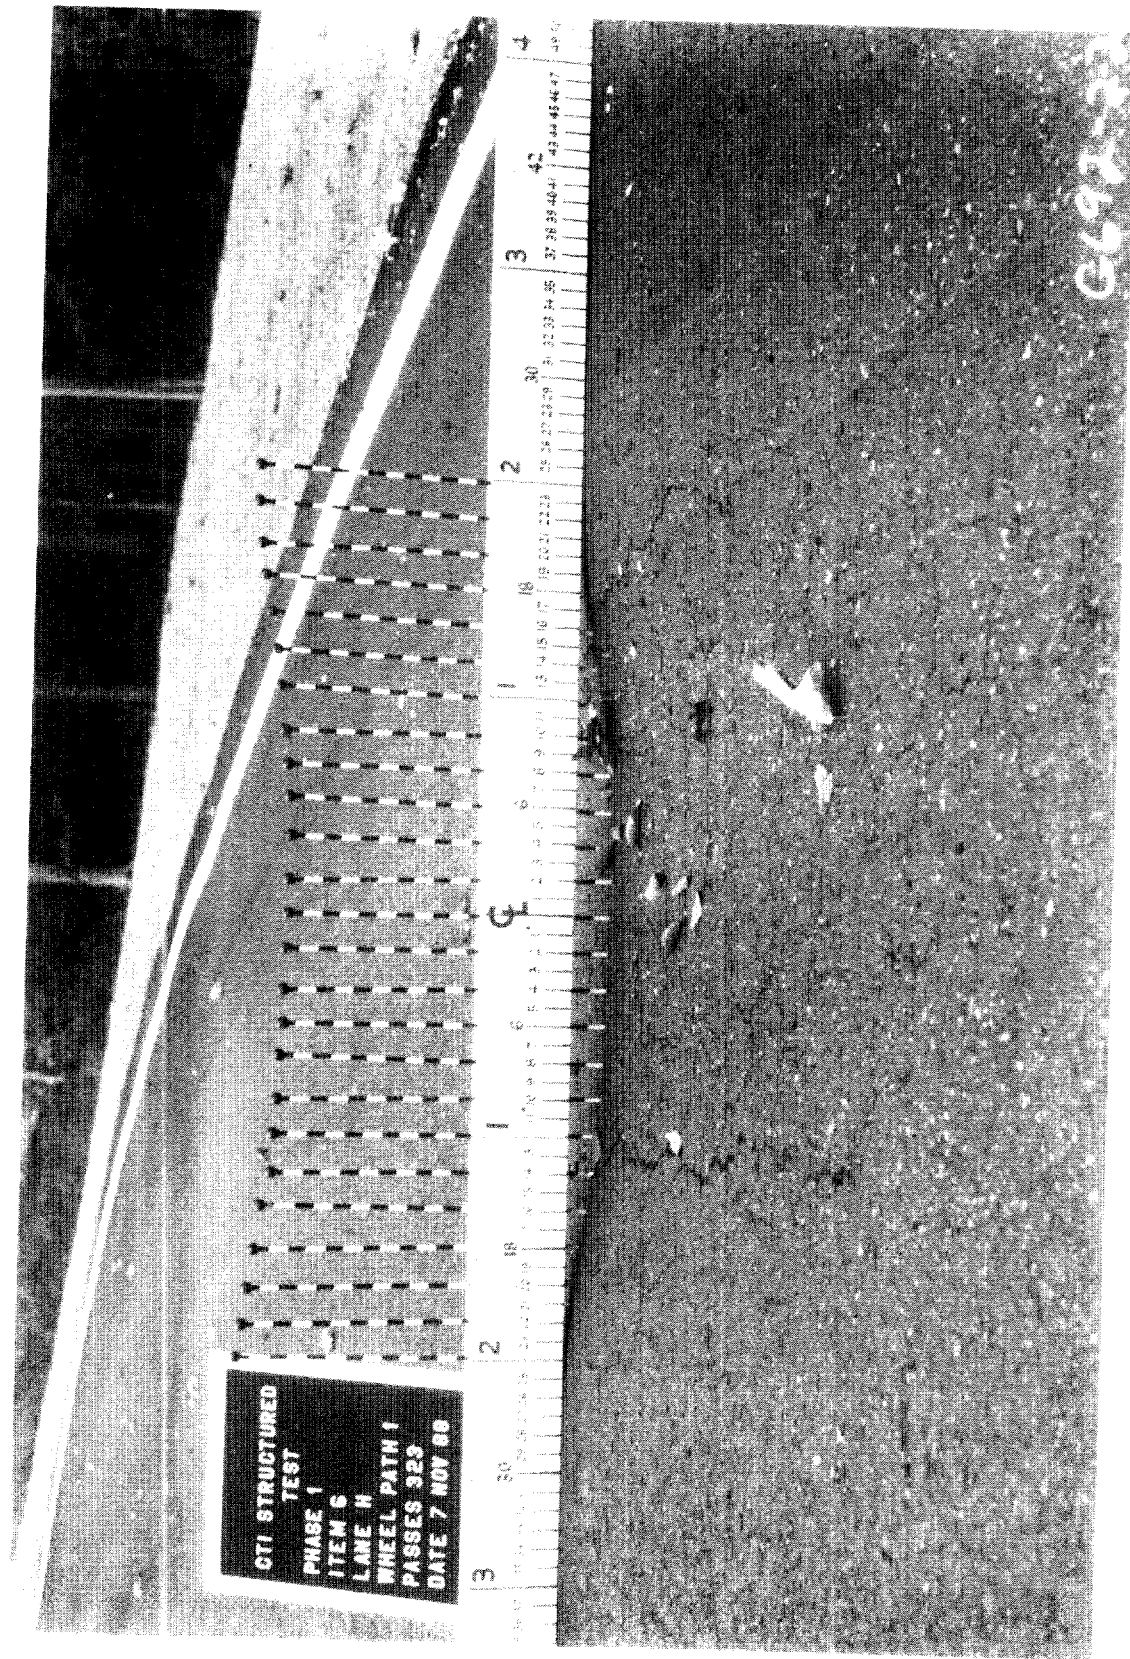
Photo 17. Item 6, high-tire pressure lane, 2.25-in. rutting in localized area after 323 passes

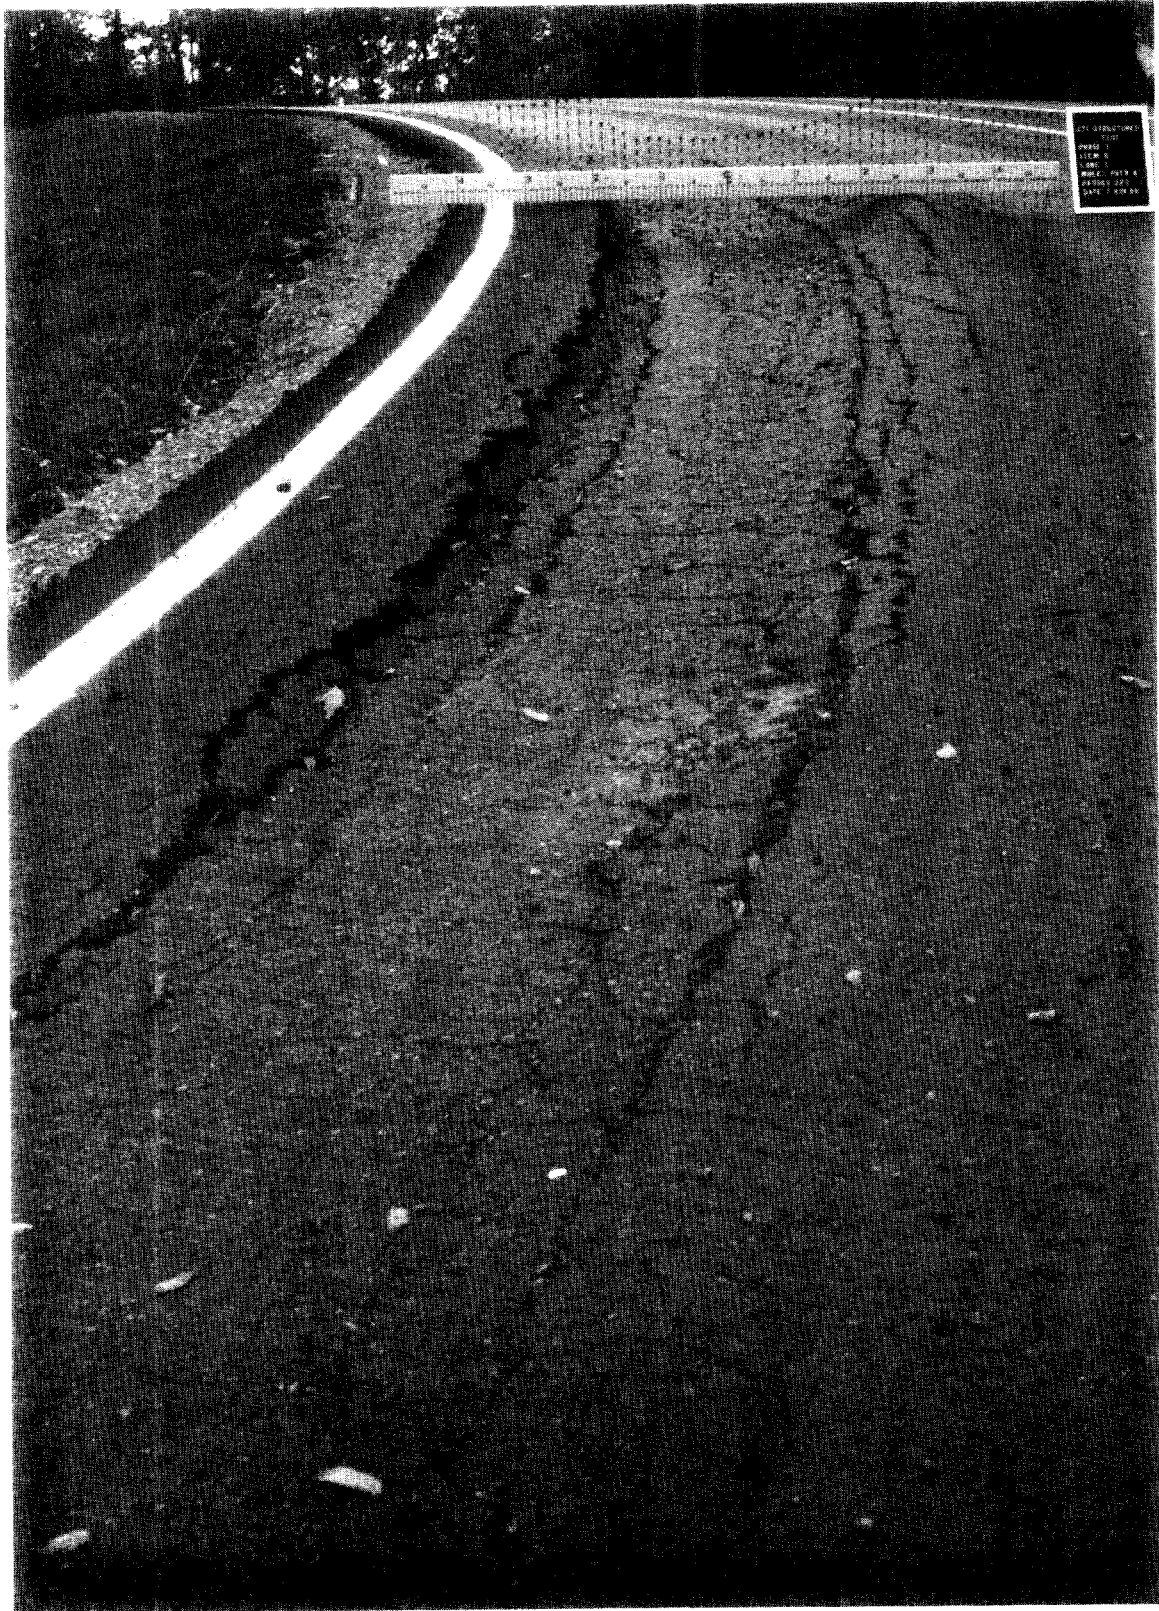
Photo 18. Item 5, wheel path, high-severity rutting and cracking in a localized area

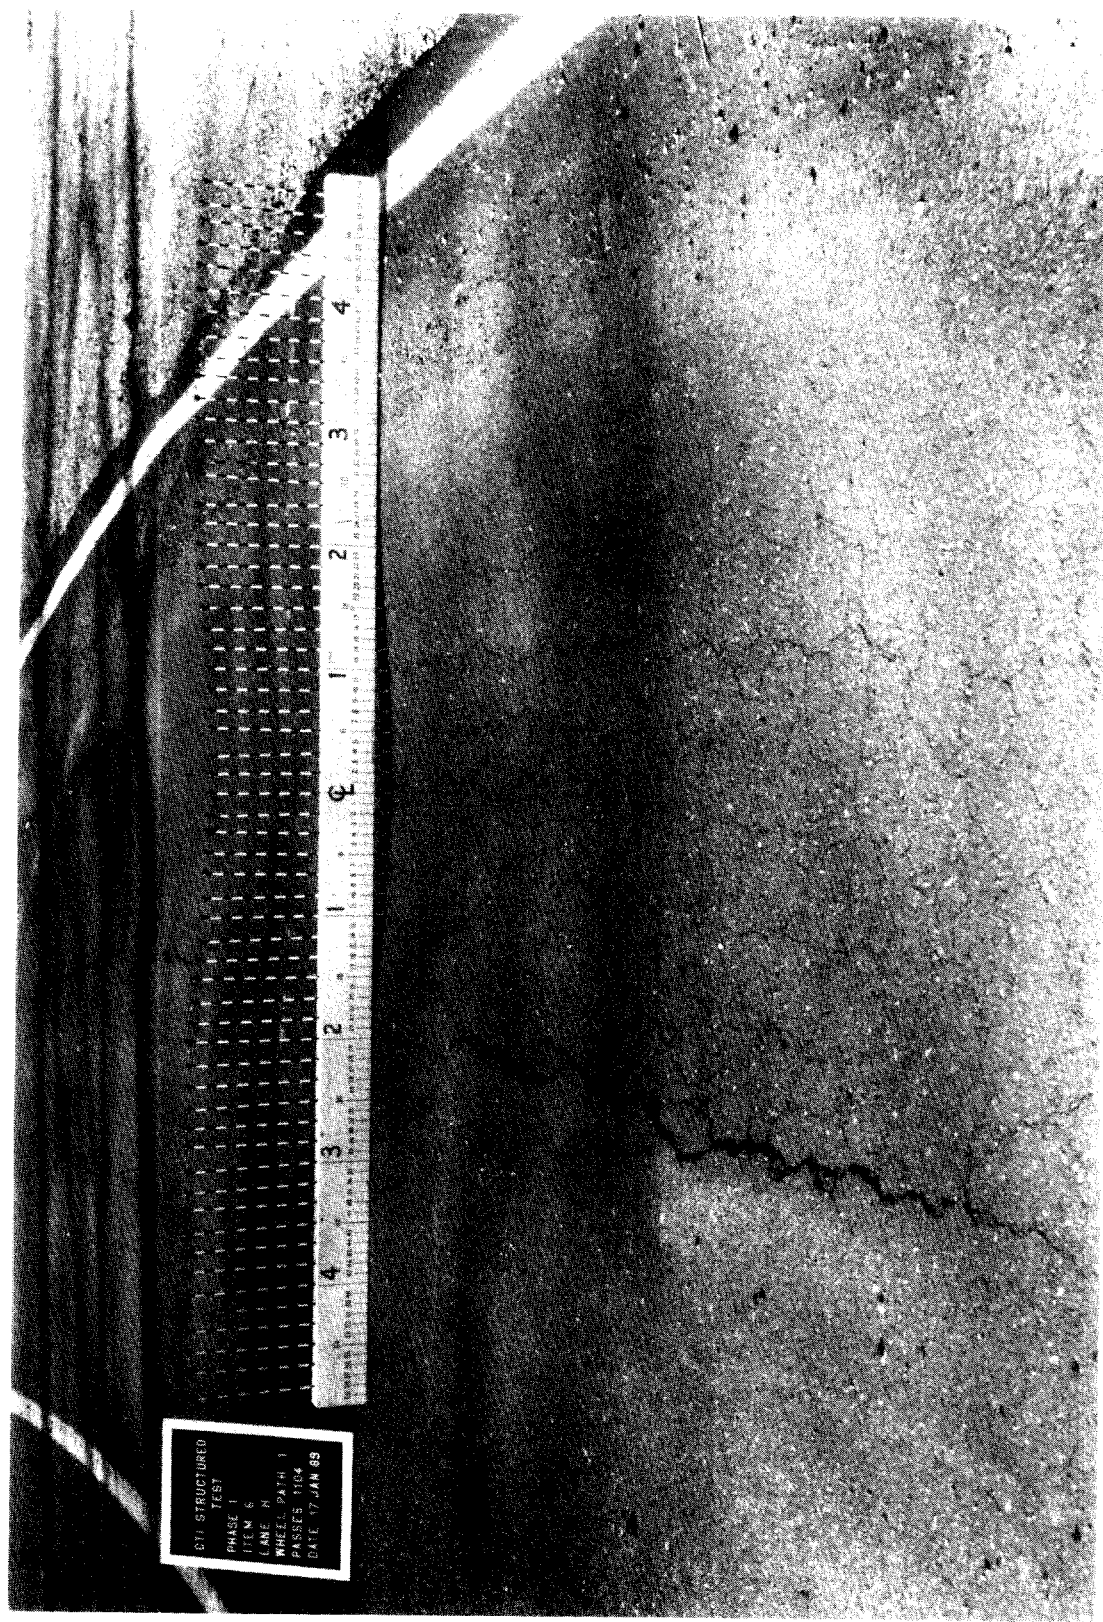
Photo 19. Item 6, high-tire pressure lane general view of failed area after 1,104 passes

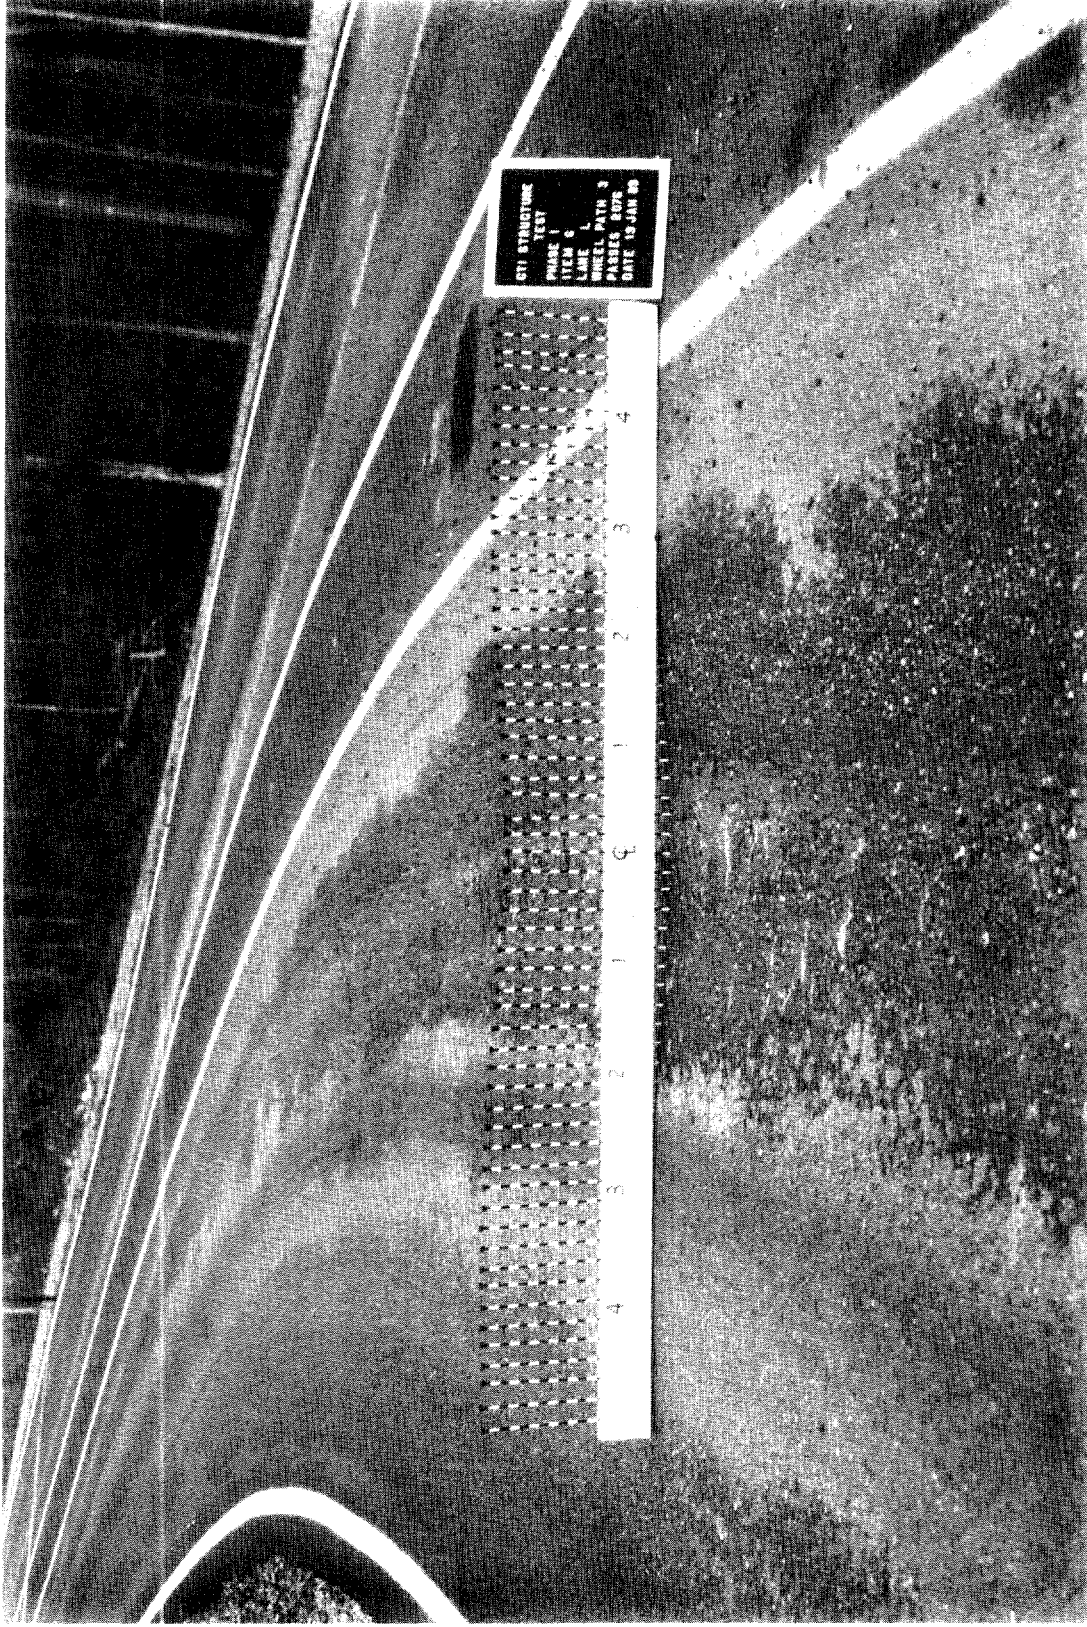
Photo 22. Item 6, wheel path 3, general failure after 2,076 passes

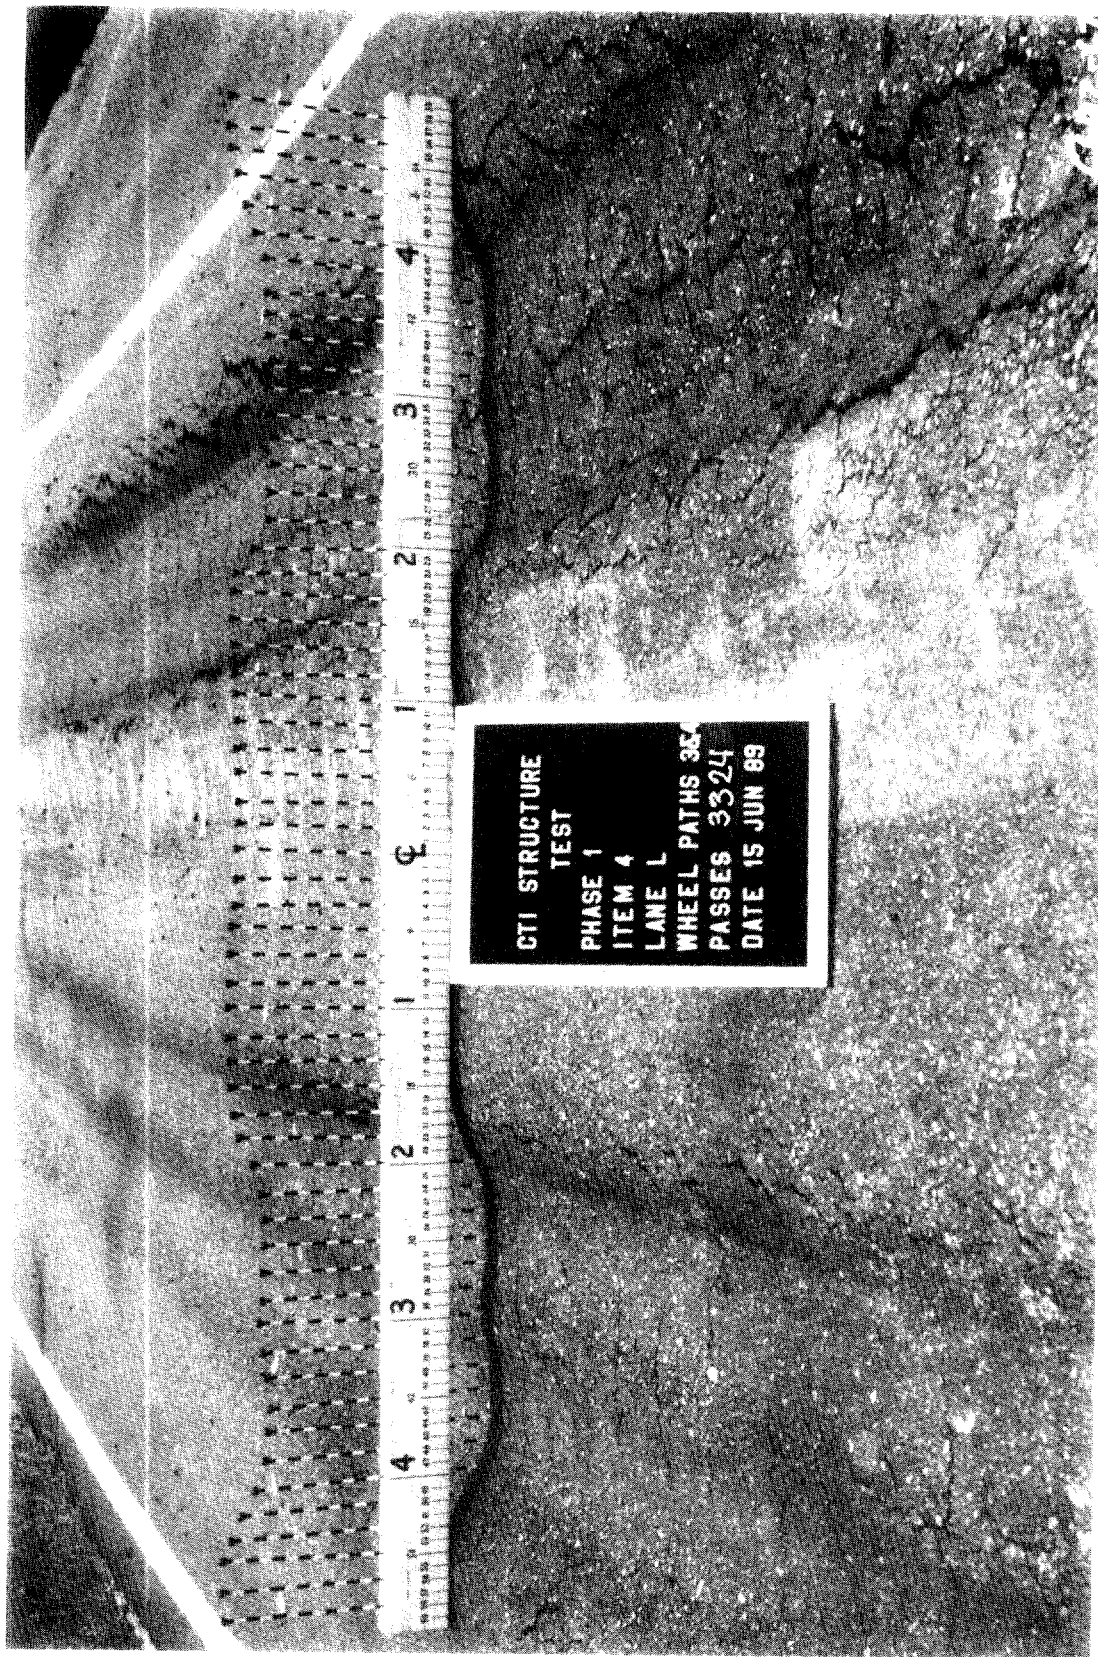
Photo 23. Item 4, low-tire pressure lane, general view of failure after 3,324 passes

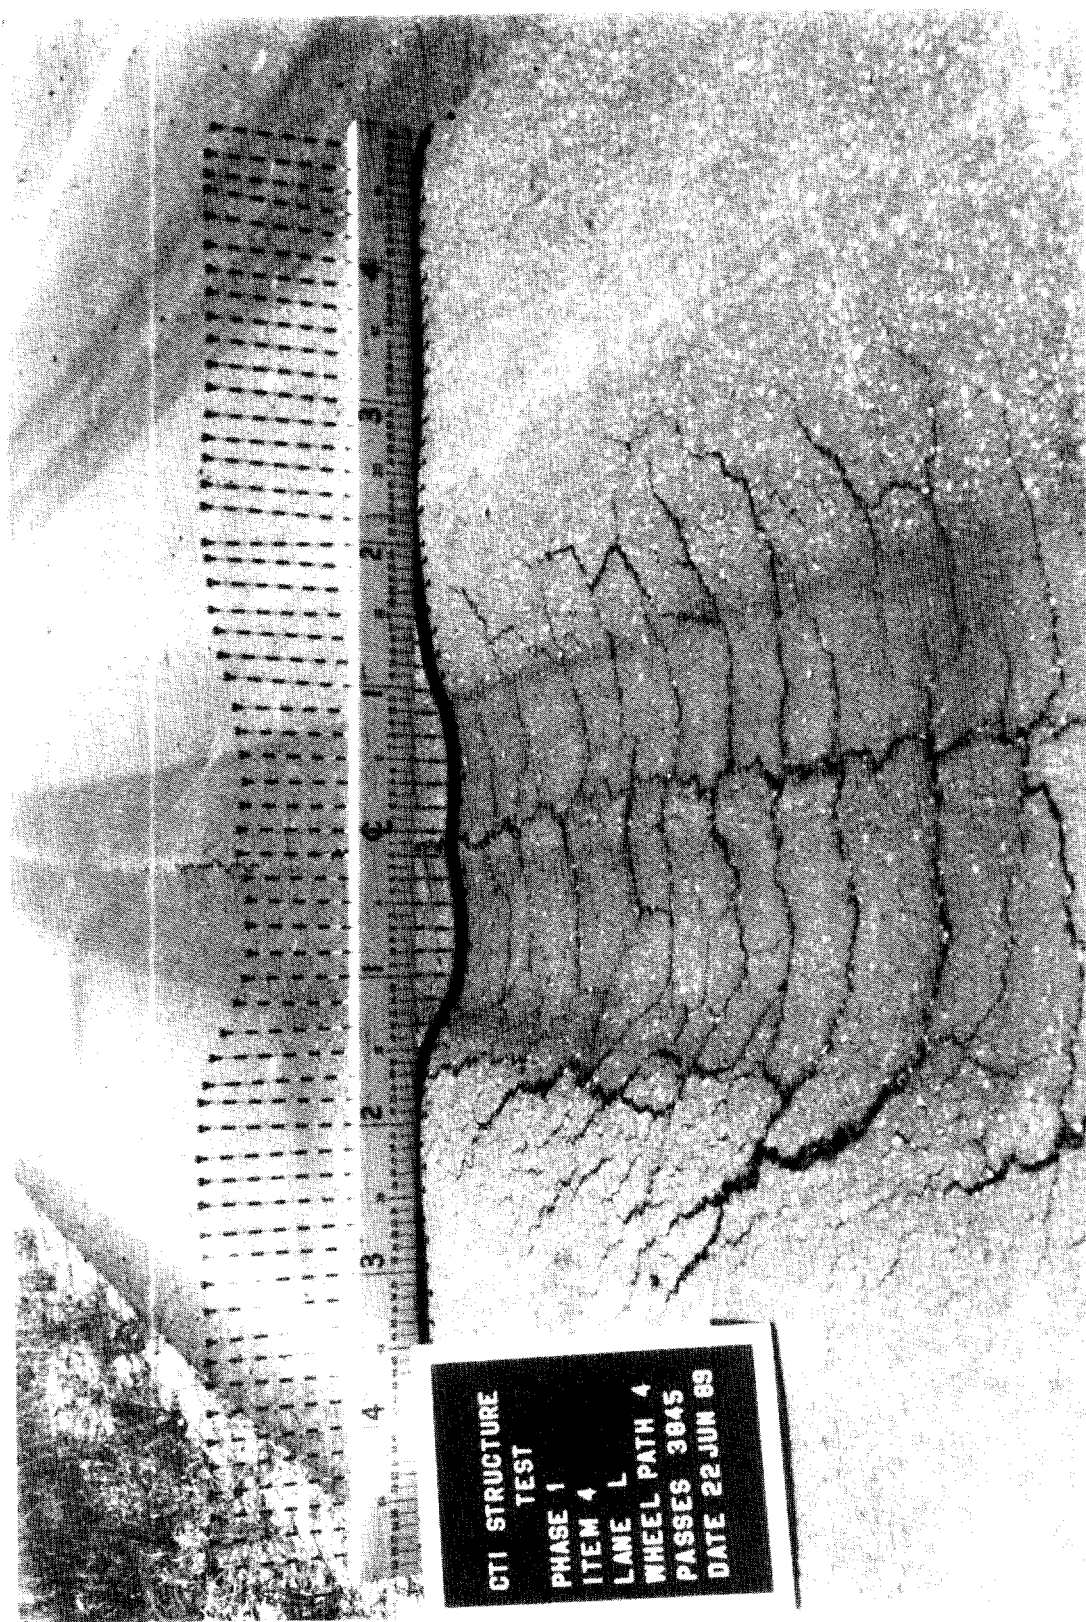
Photo 24. Item 4, wheel path 4, failure after 3,845 passes

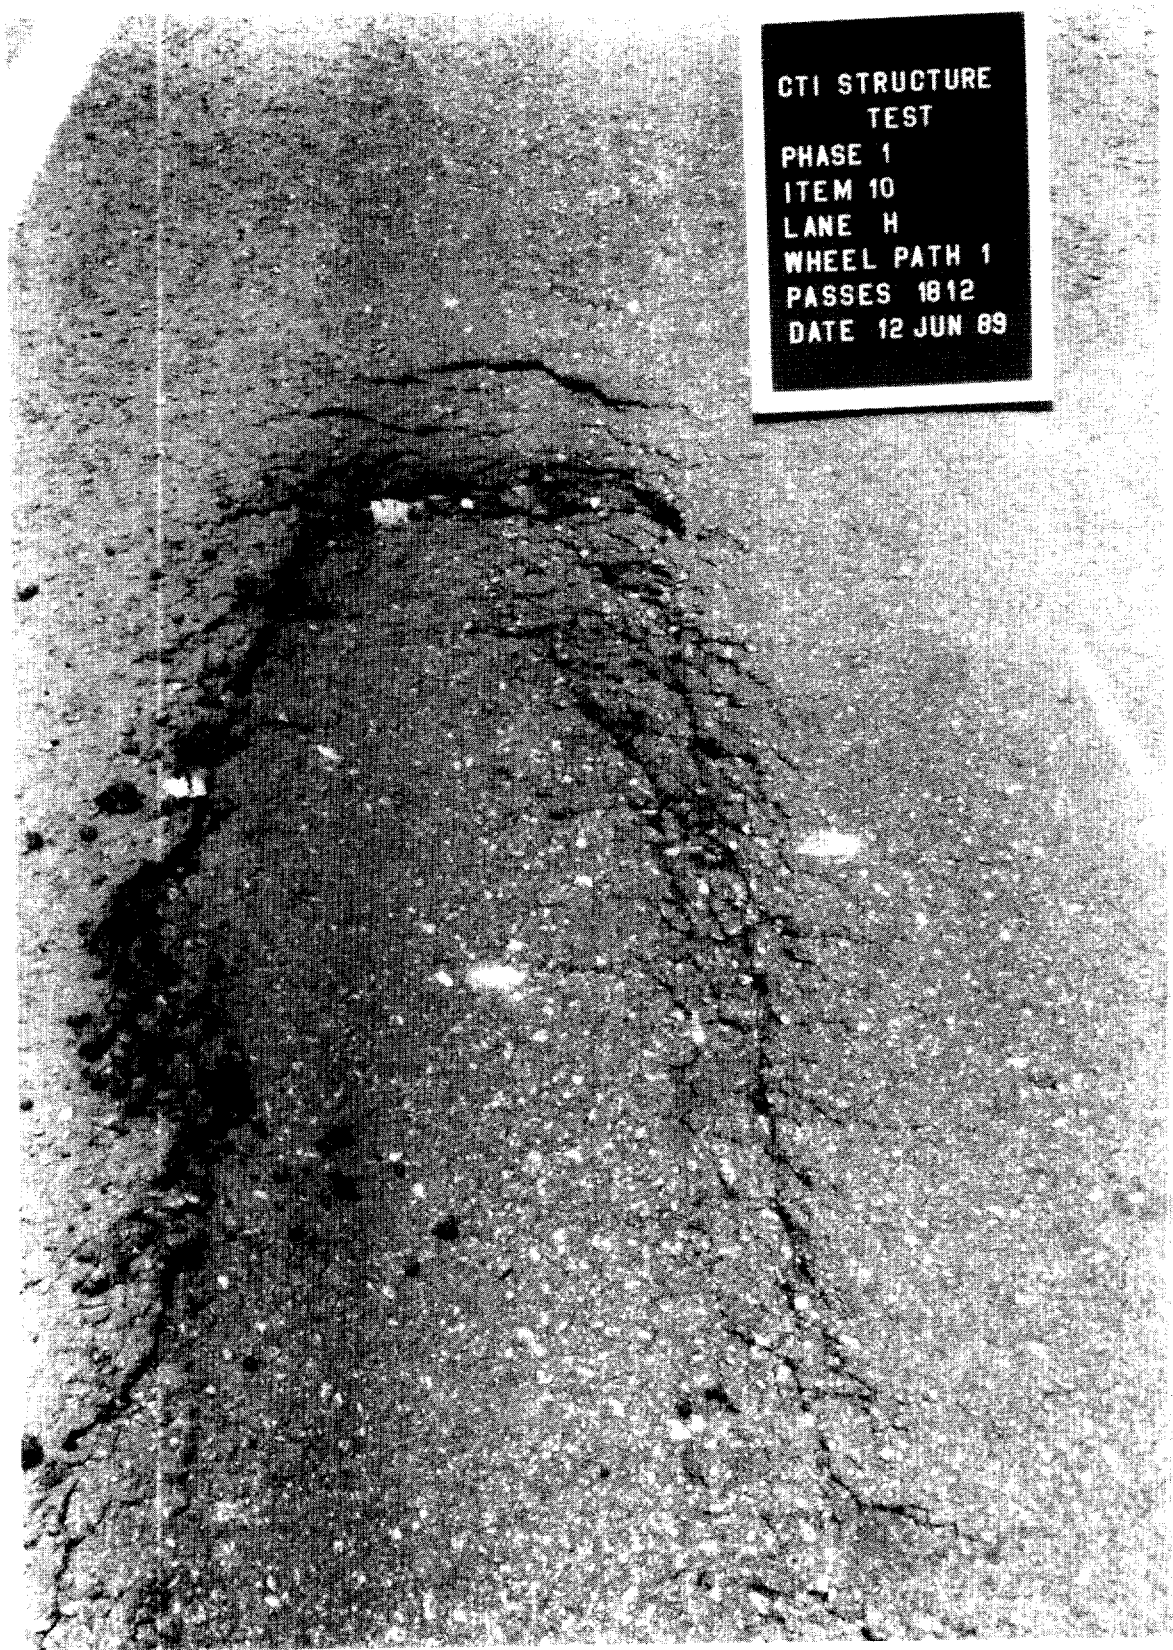
Photo 31 Item 10. wheel path 1. high-severity shoving after 1,812 passes

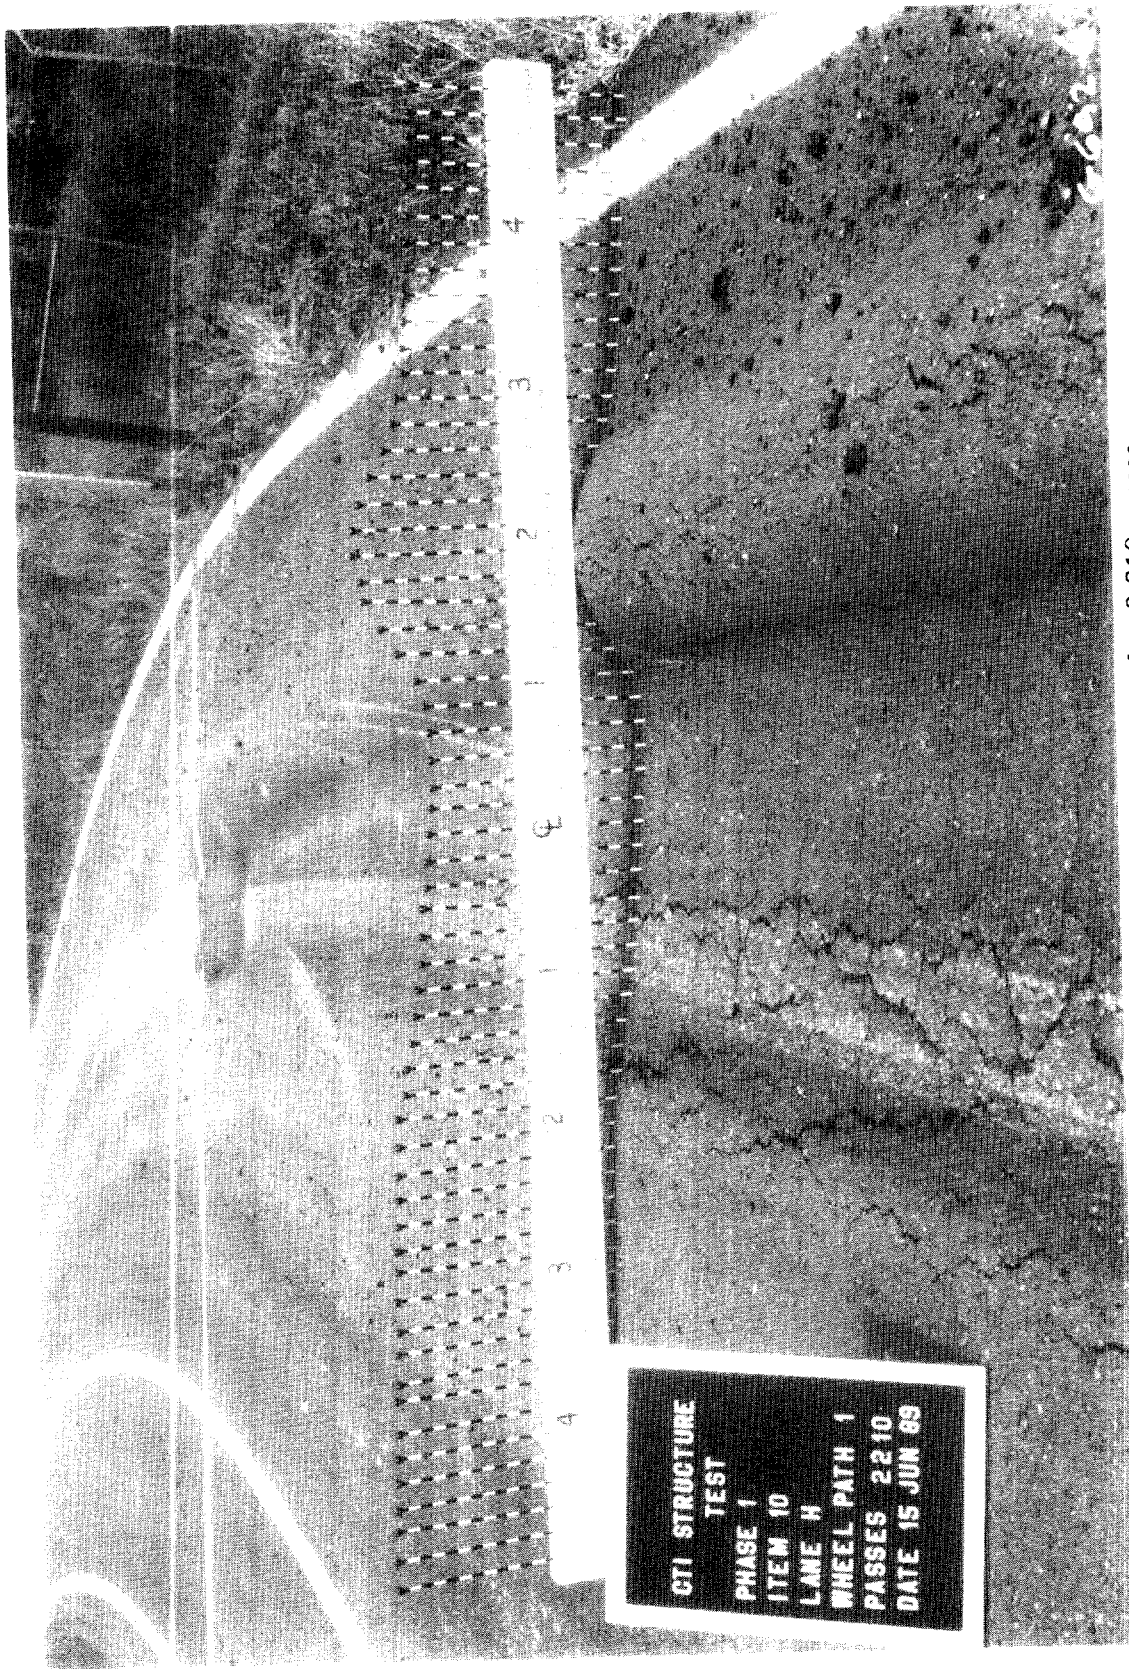
Photo 32. Item 10, wheel path 1, high-severity rutting and cracking, failure after 2,210 passes

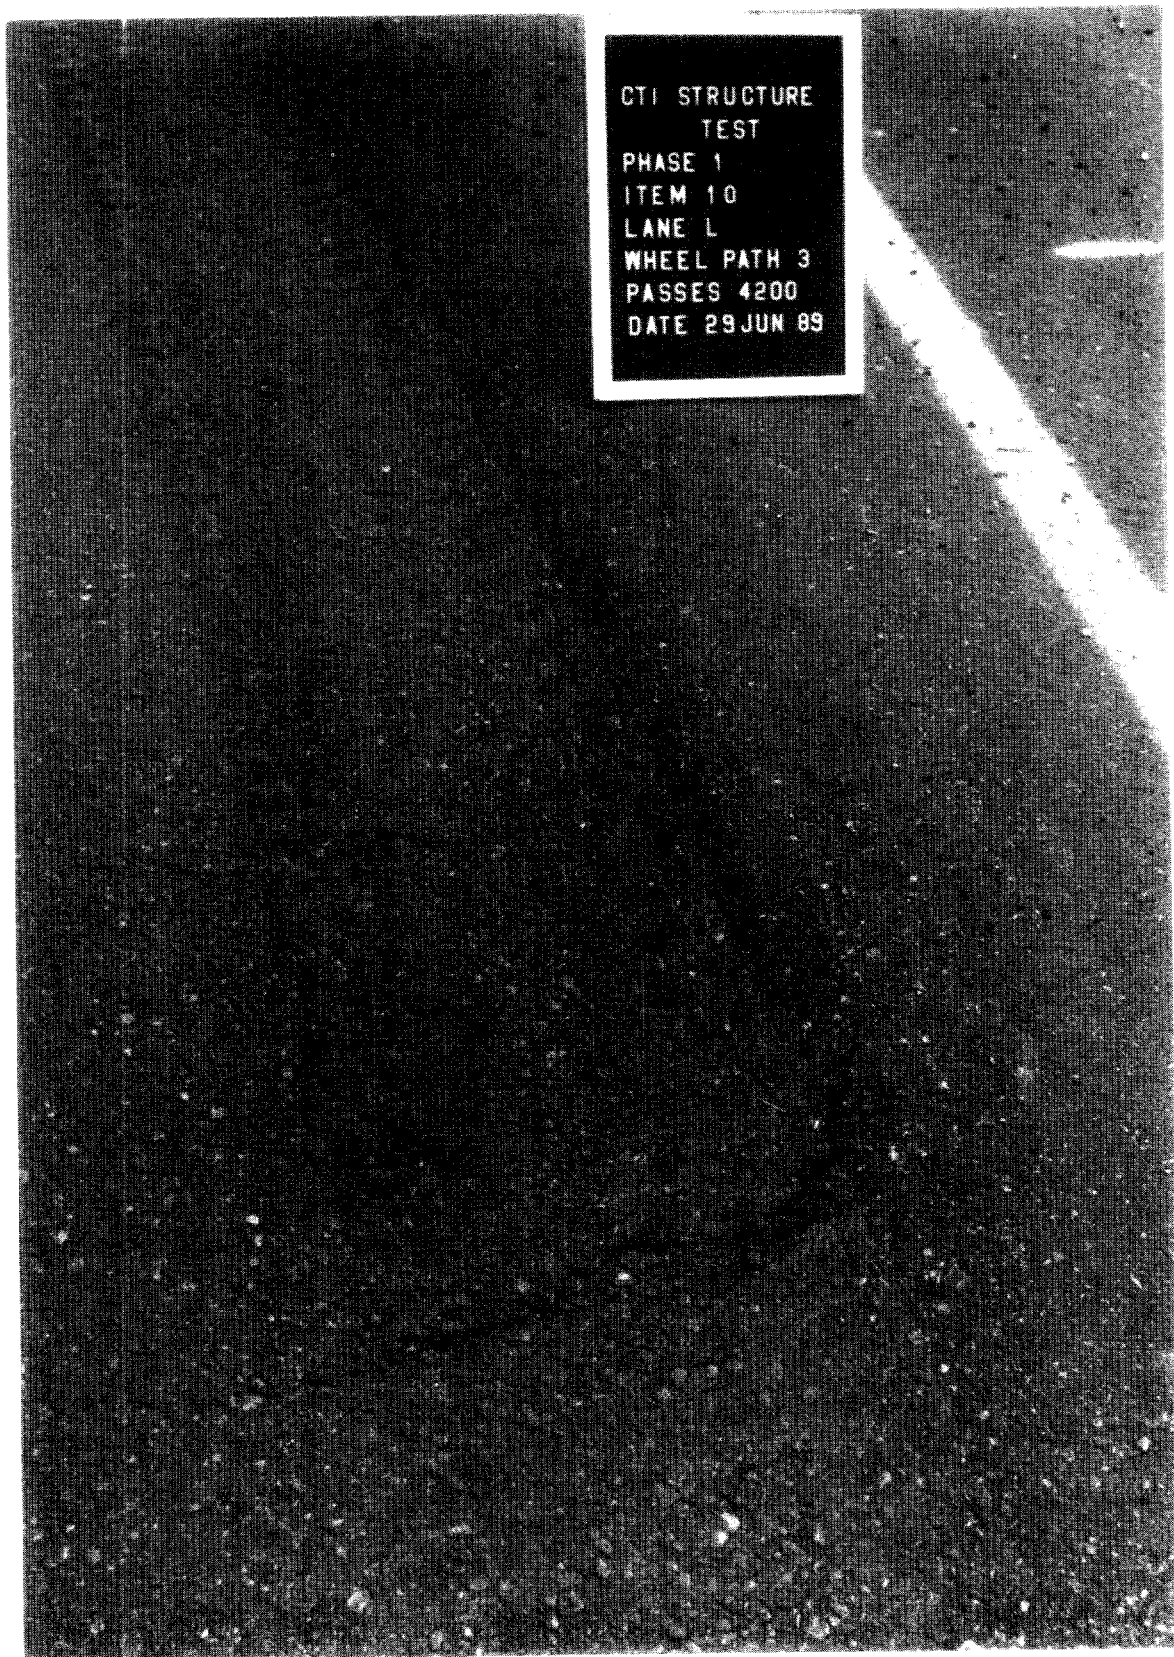
Photo 33. Item 10 wheel path 3, low-severity shoving after 4,200 passes

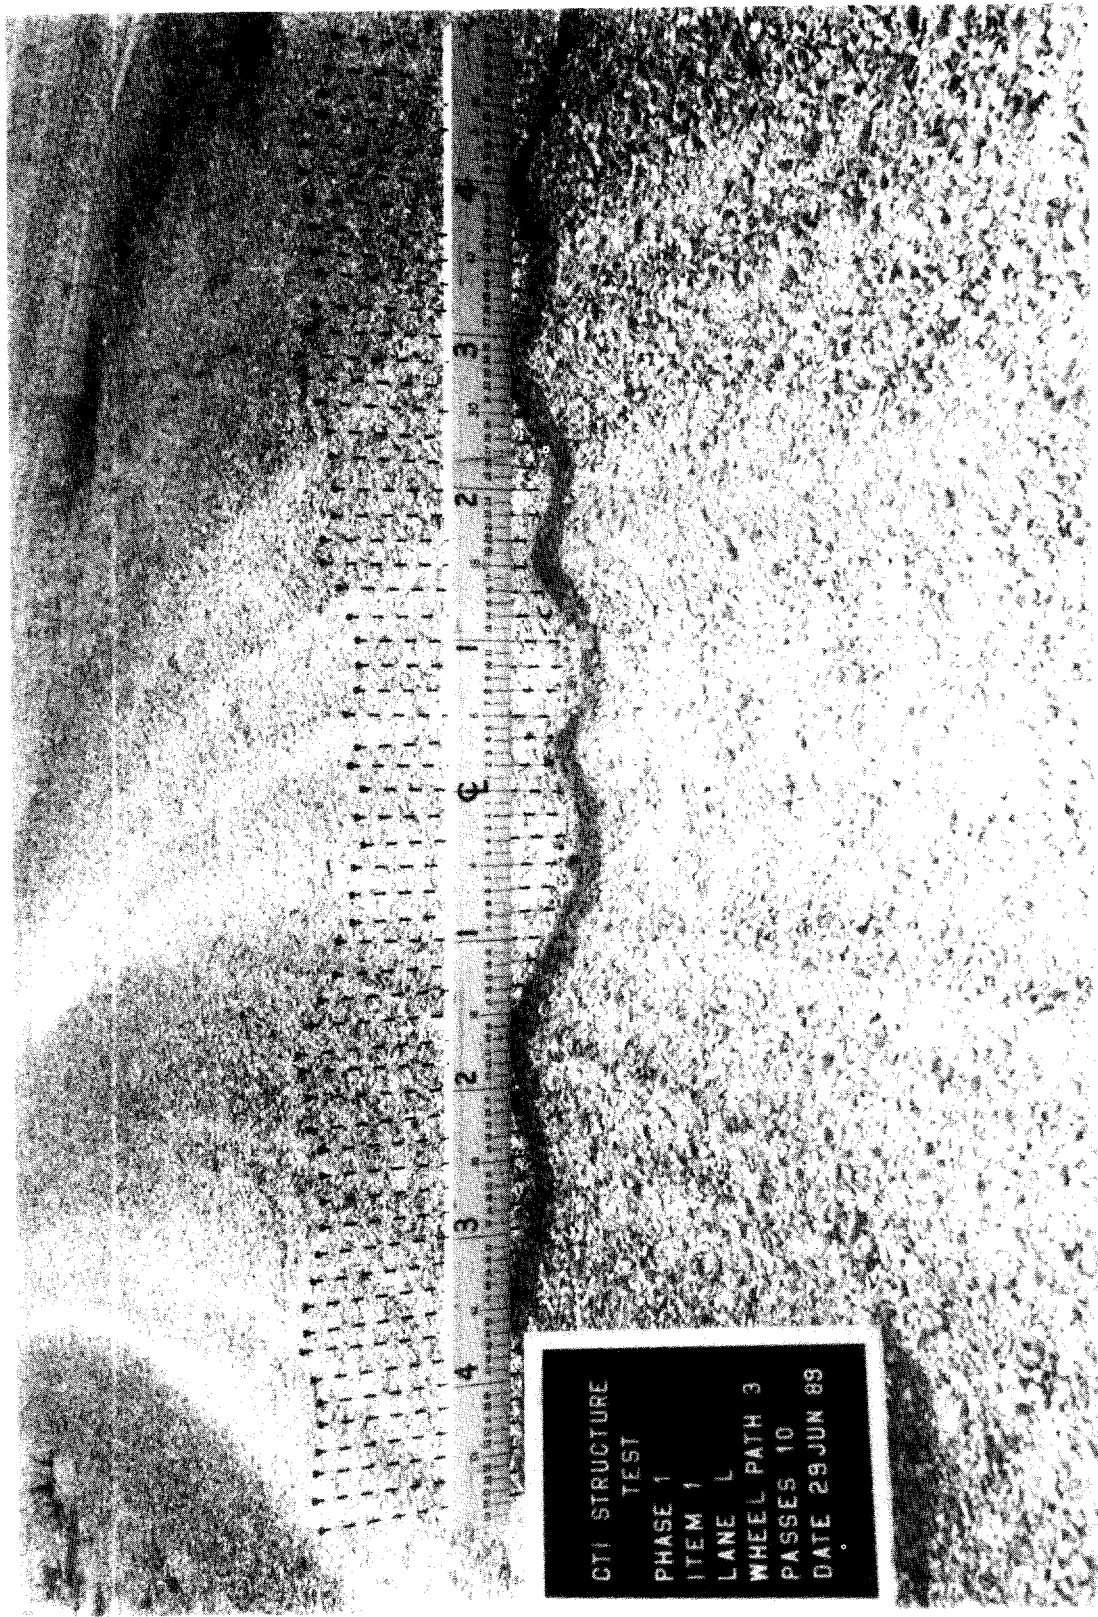
Photo 41. Item 1. low-pressure tire lane 5.5 in. rutting after 10 passes
