Technical Report GL-93-20  
August 1993

# **Effects of Variable Tire Pressure on Road Surfacing**

Volume I: Design, Construction, Behavior  
Under Traffic, and Test Results

Geotechnical Laboratory

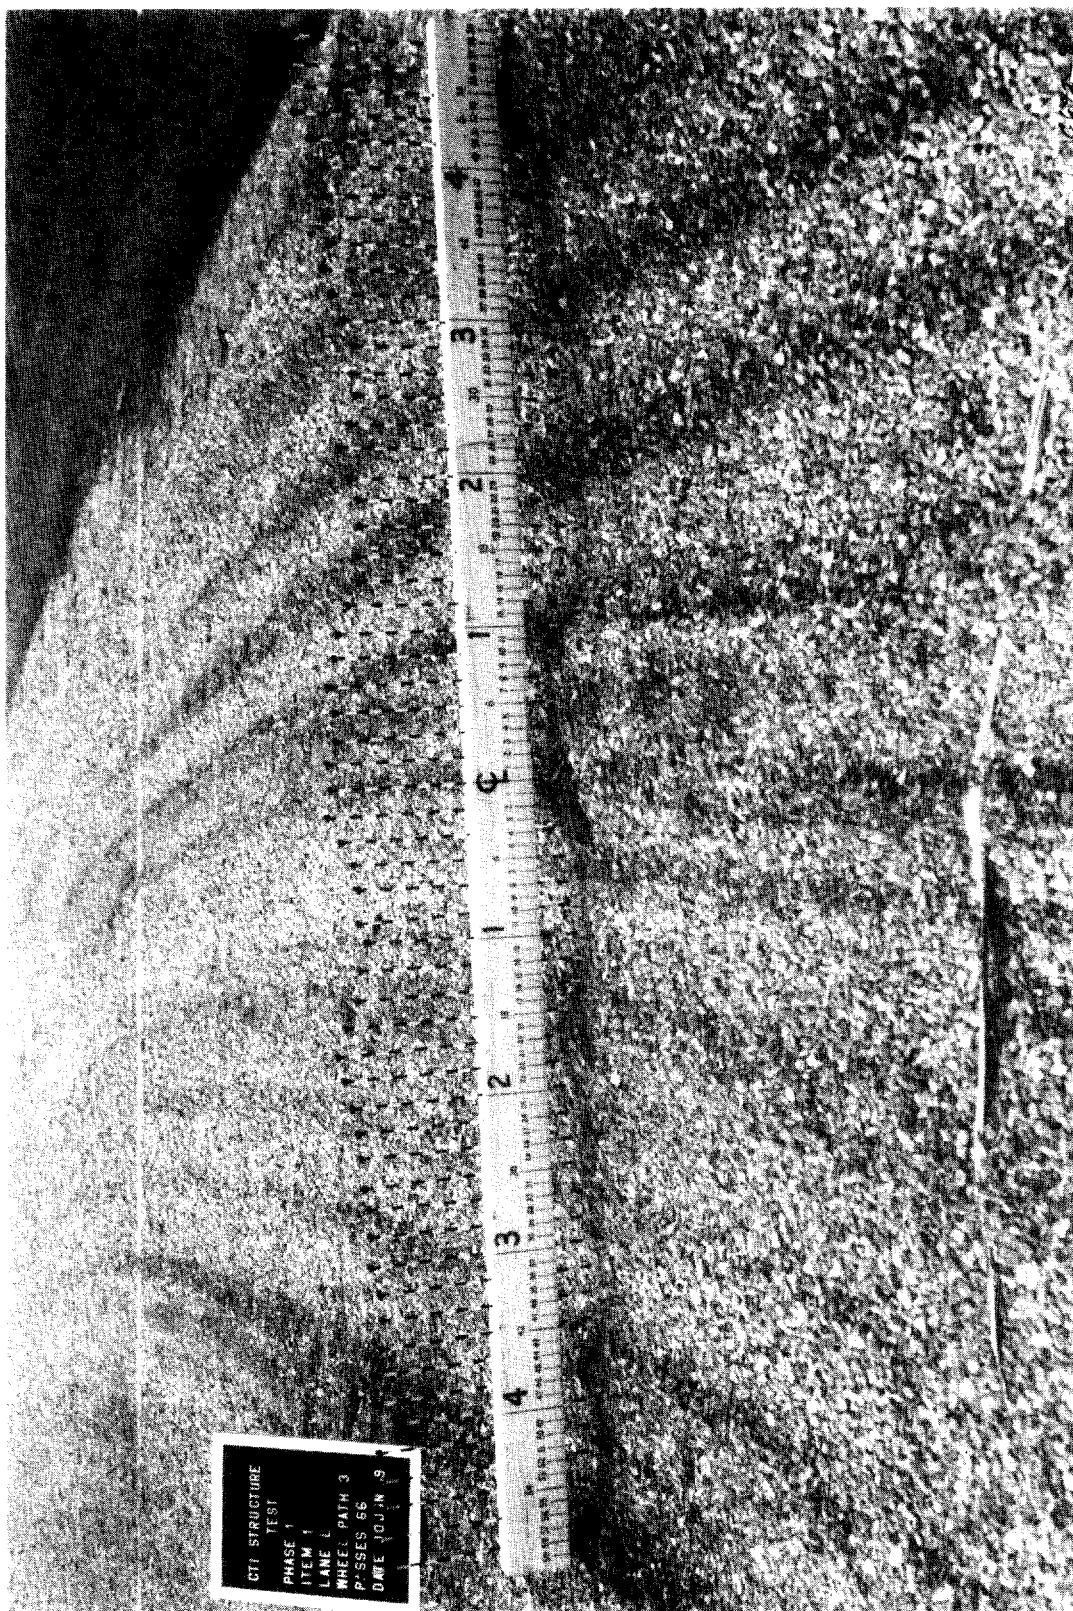
Photo 42. Item 1, low-pressure tire lane, failure after 66 passes

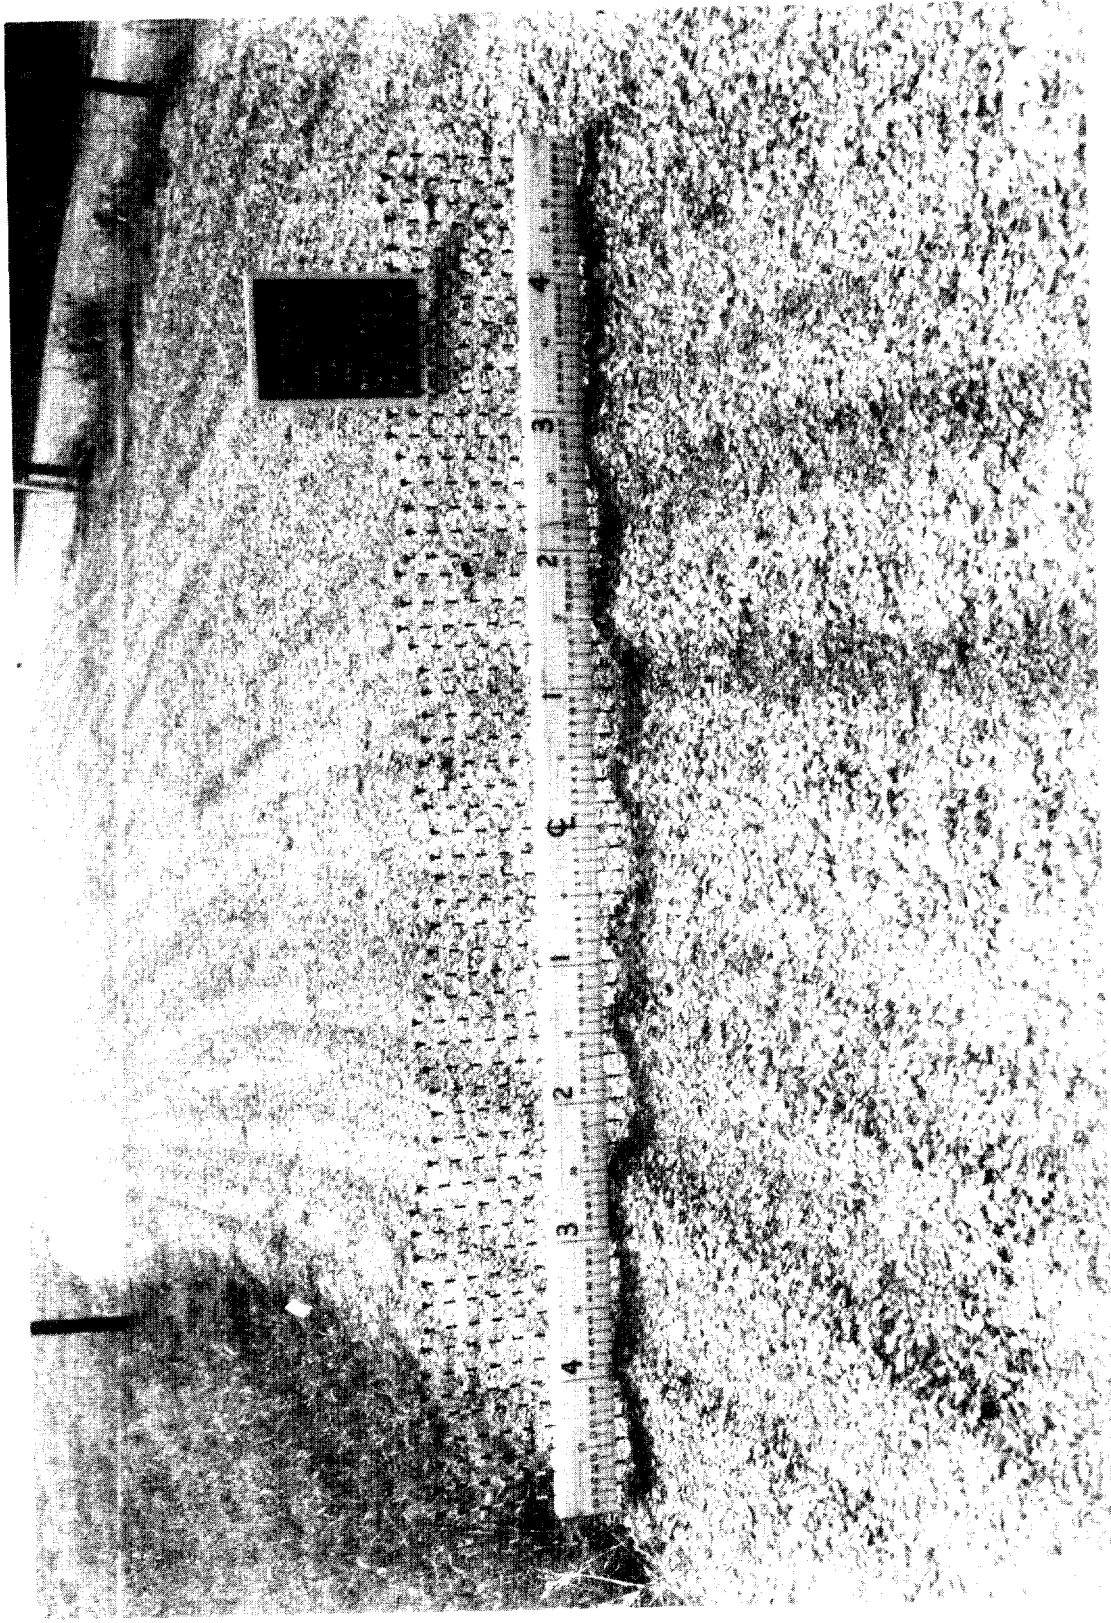
Photo 43. Item 1, high-pressure tire lane, failure after 58 passes

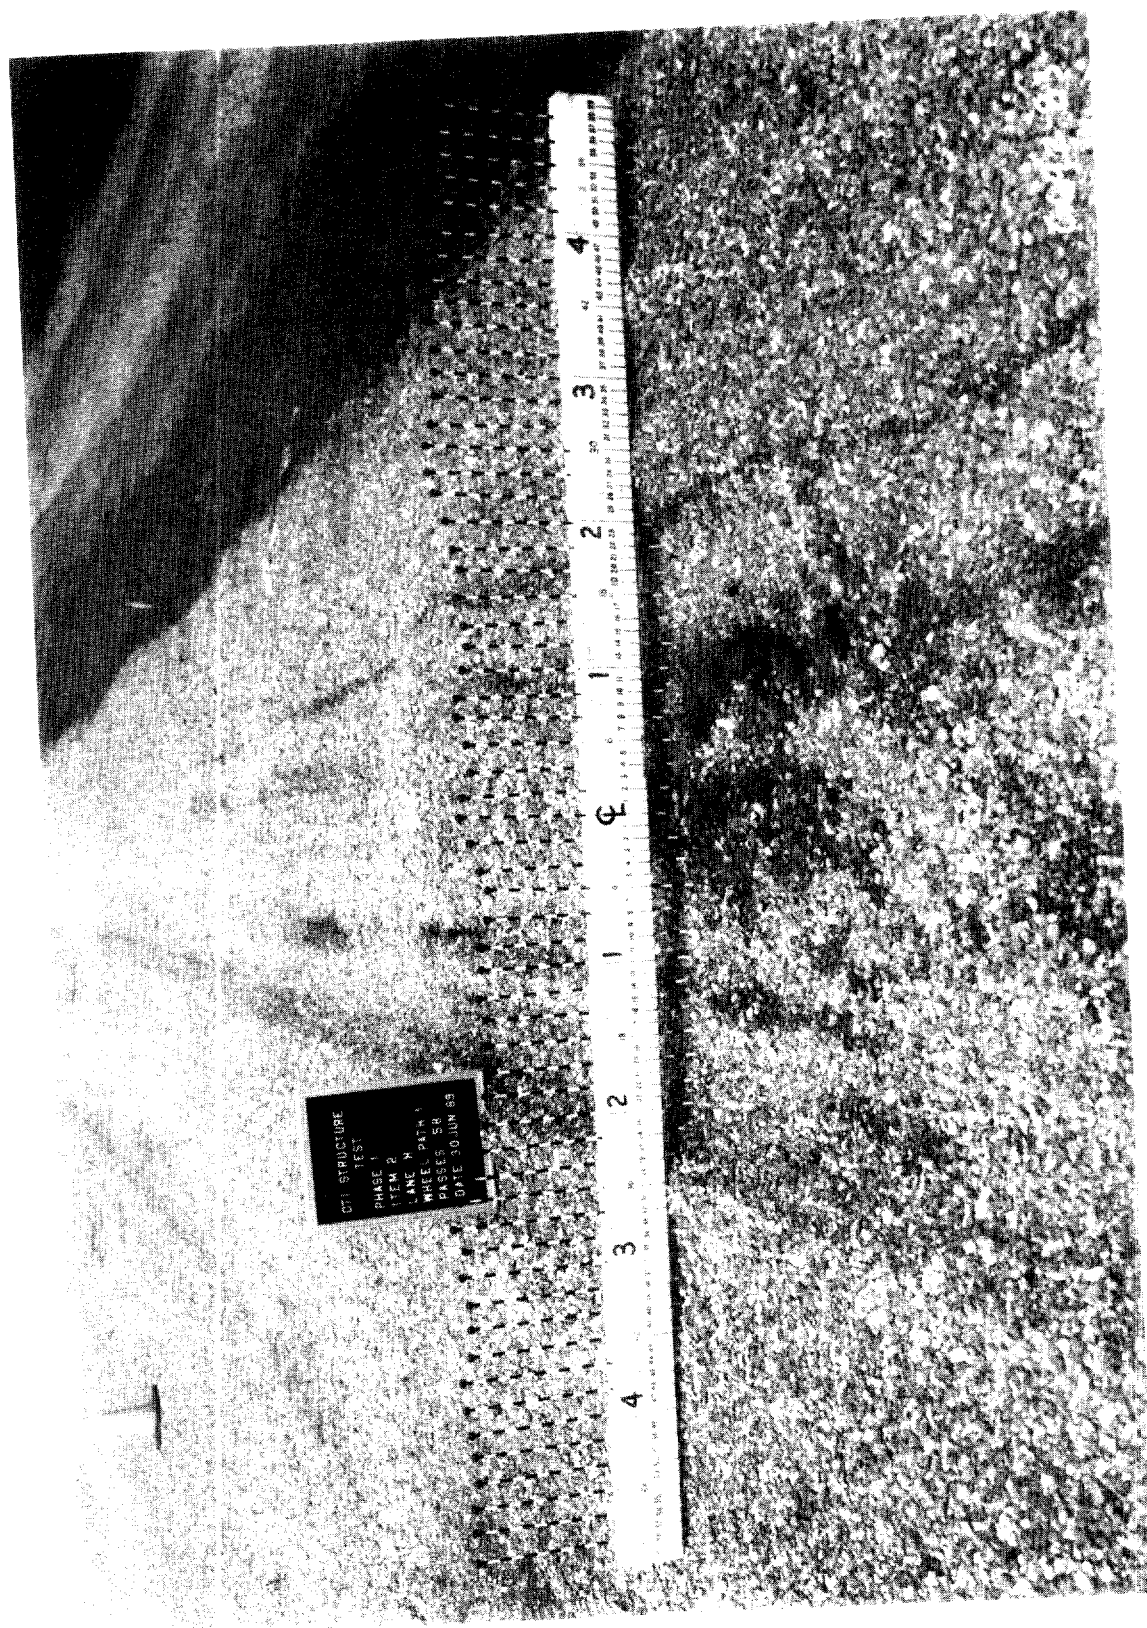
Photo 44. Item 2, high-pressure tire lane, failure after 58 passes

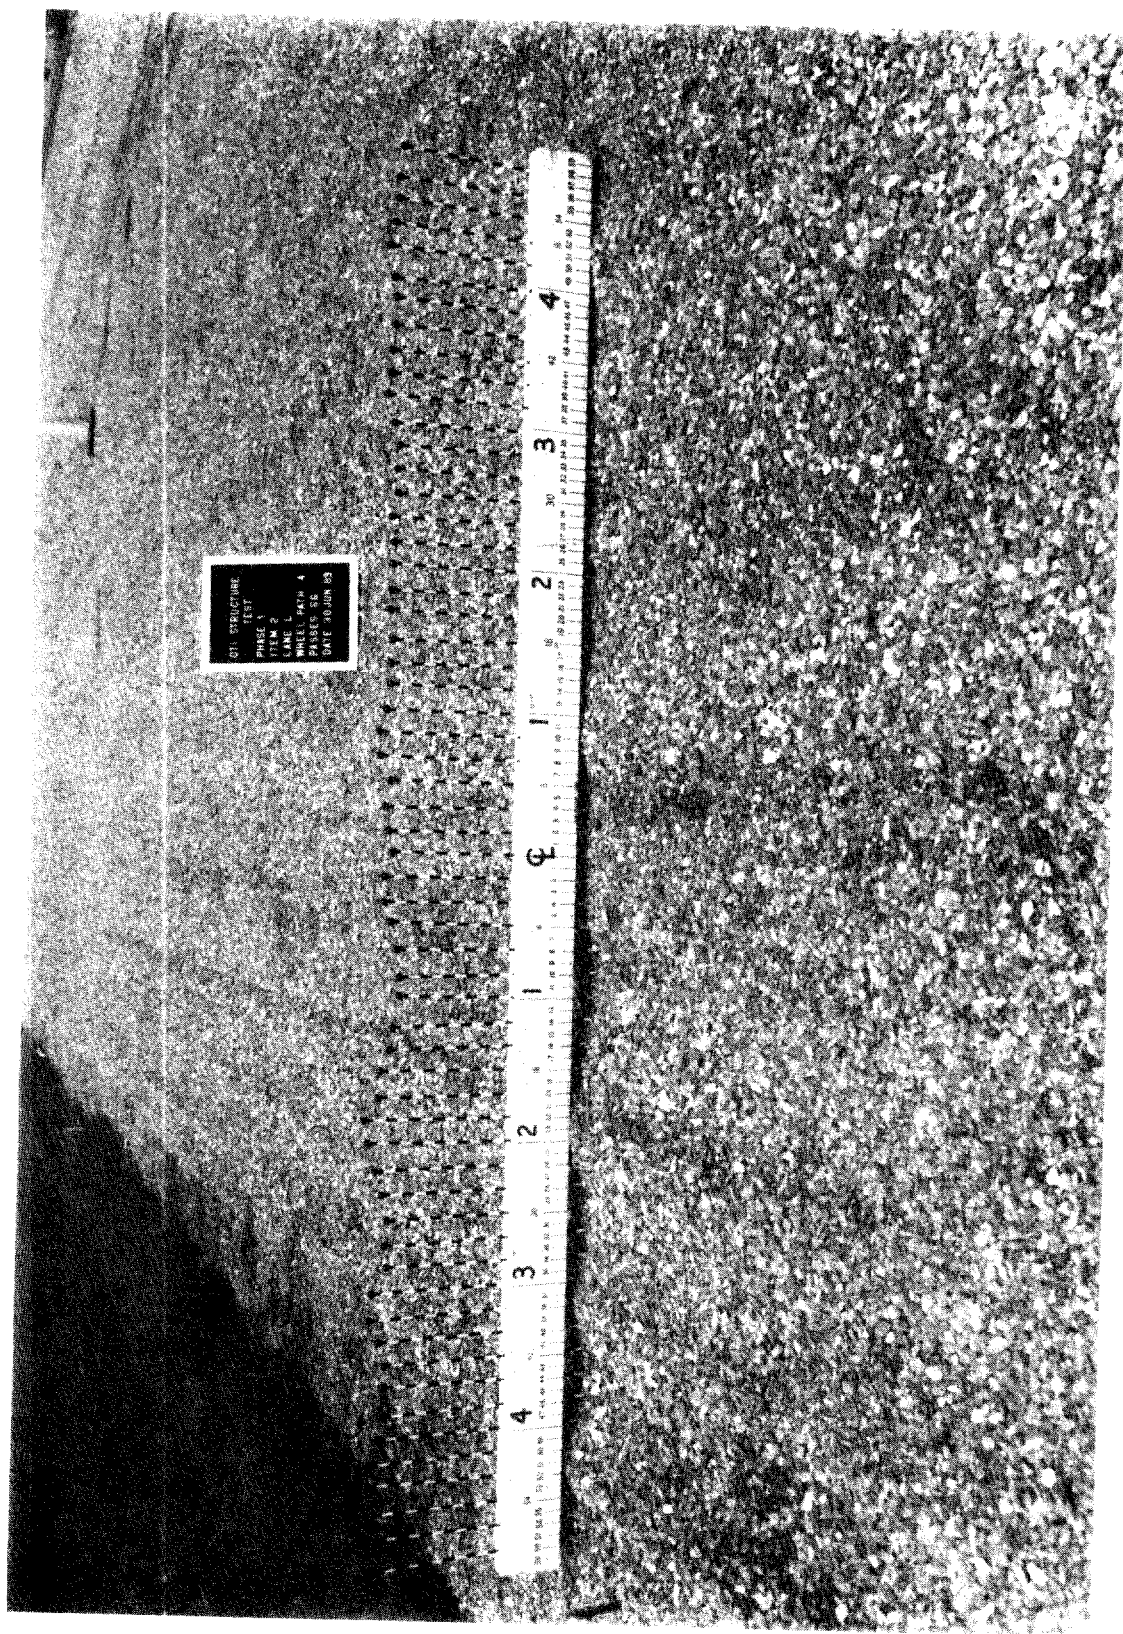
Photo 45. Item 2, low-pressure tire lane, failure after 66 passes

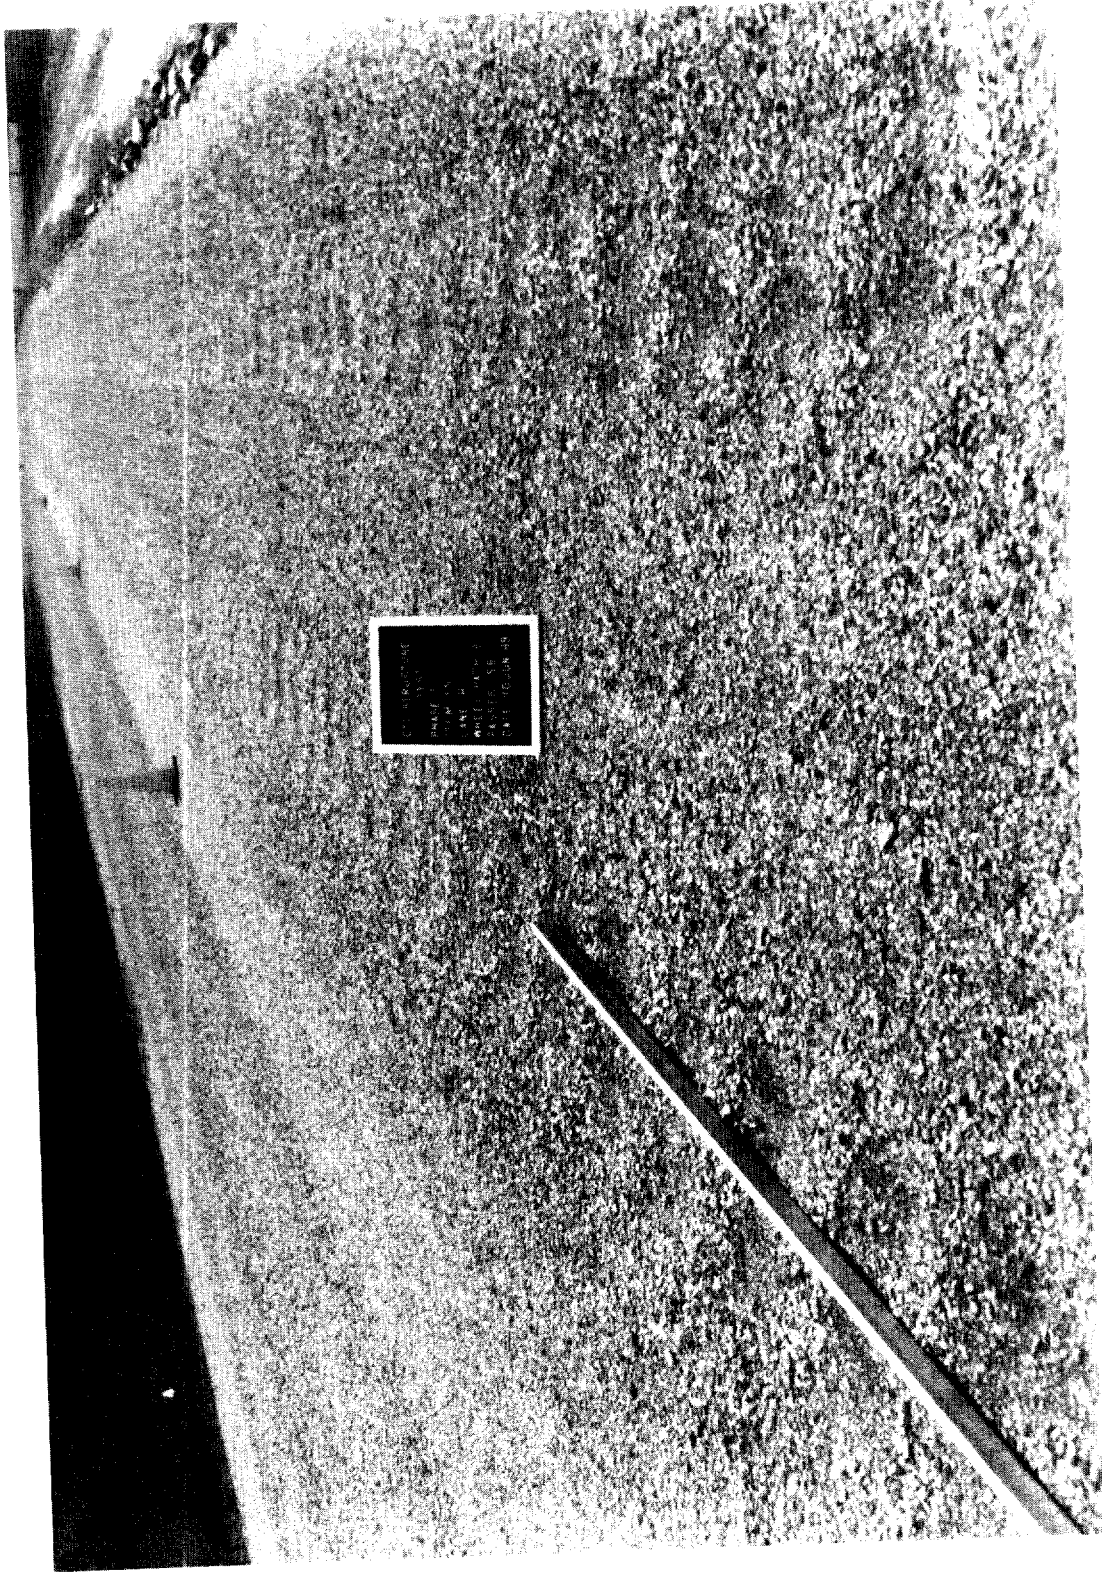
Photo 46. Item 15, high-pressure tire lane, low-severity washboarding after 58 passes

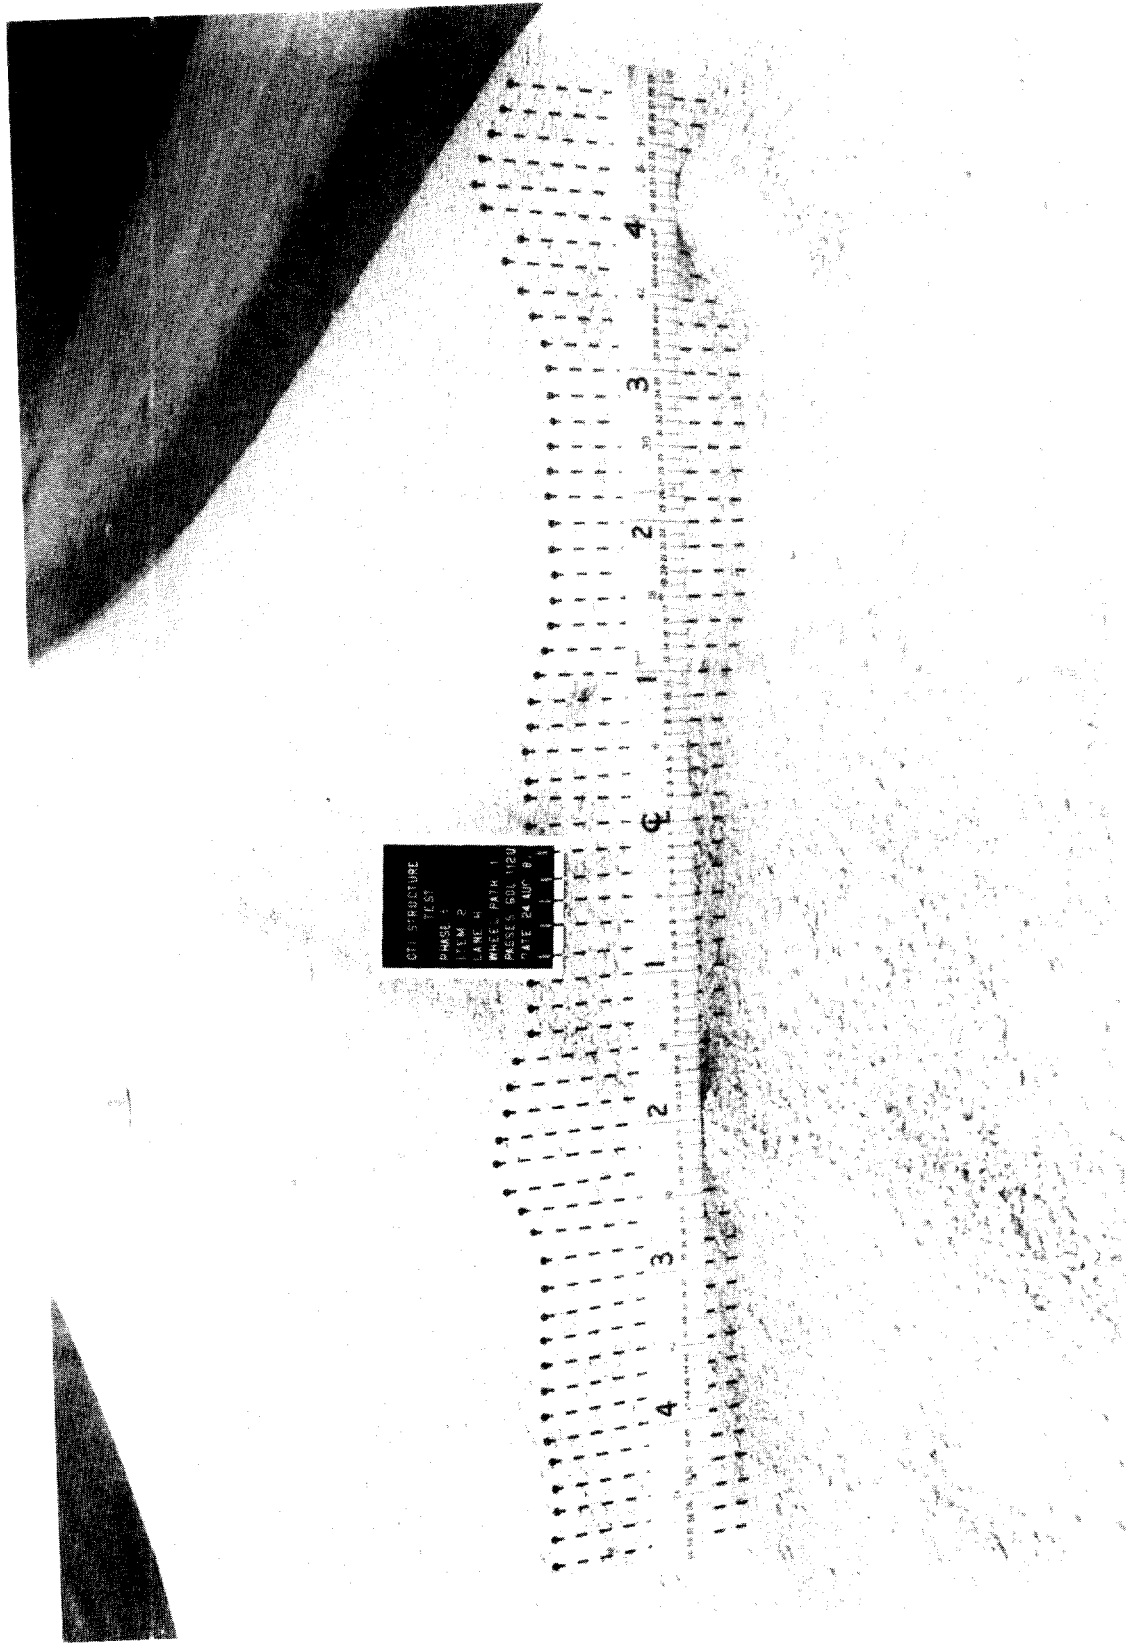
Photo 47. Item 2, high-pressure tire lane, failure after 112 unloaded passes

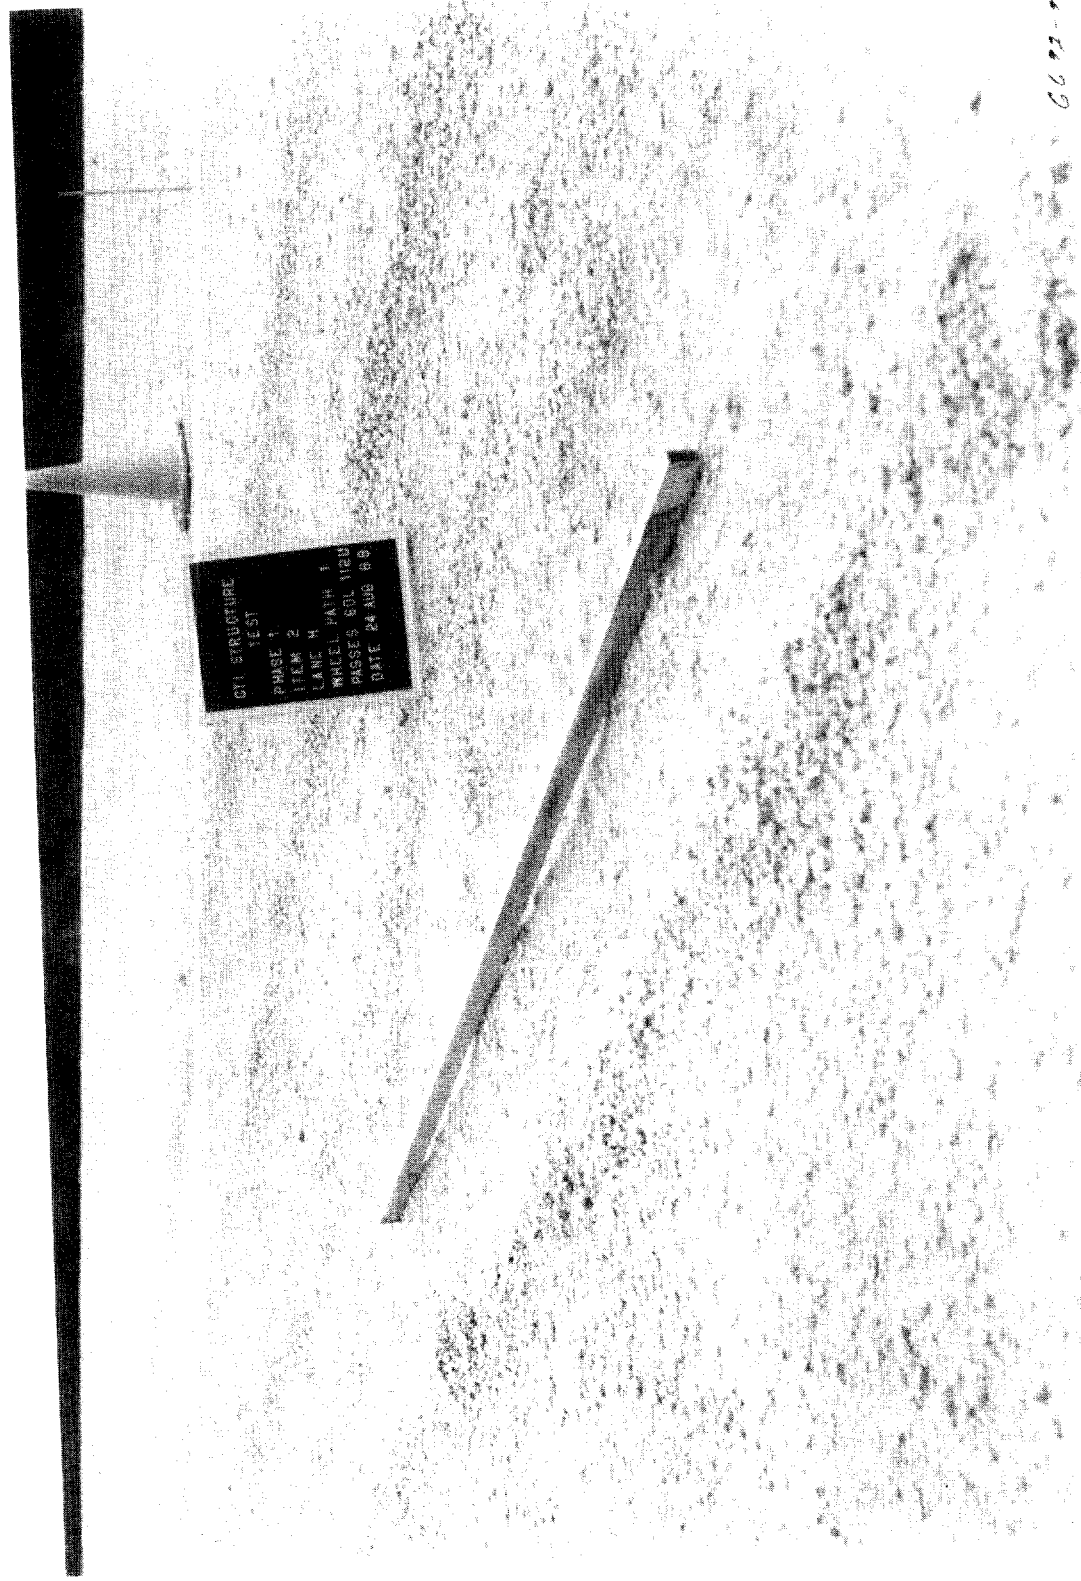
Photo 48. Item 2, high-pressure tire lane, close-up of high-severity washboarding after 112 unloaded passes

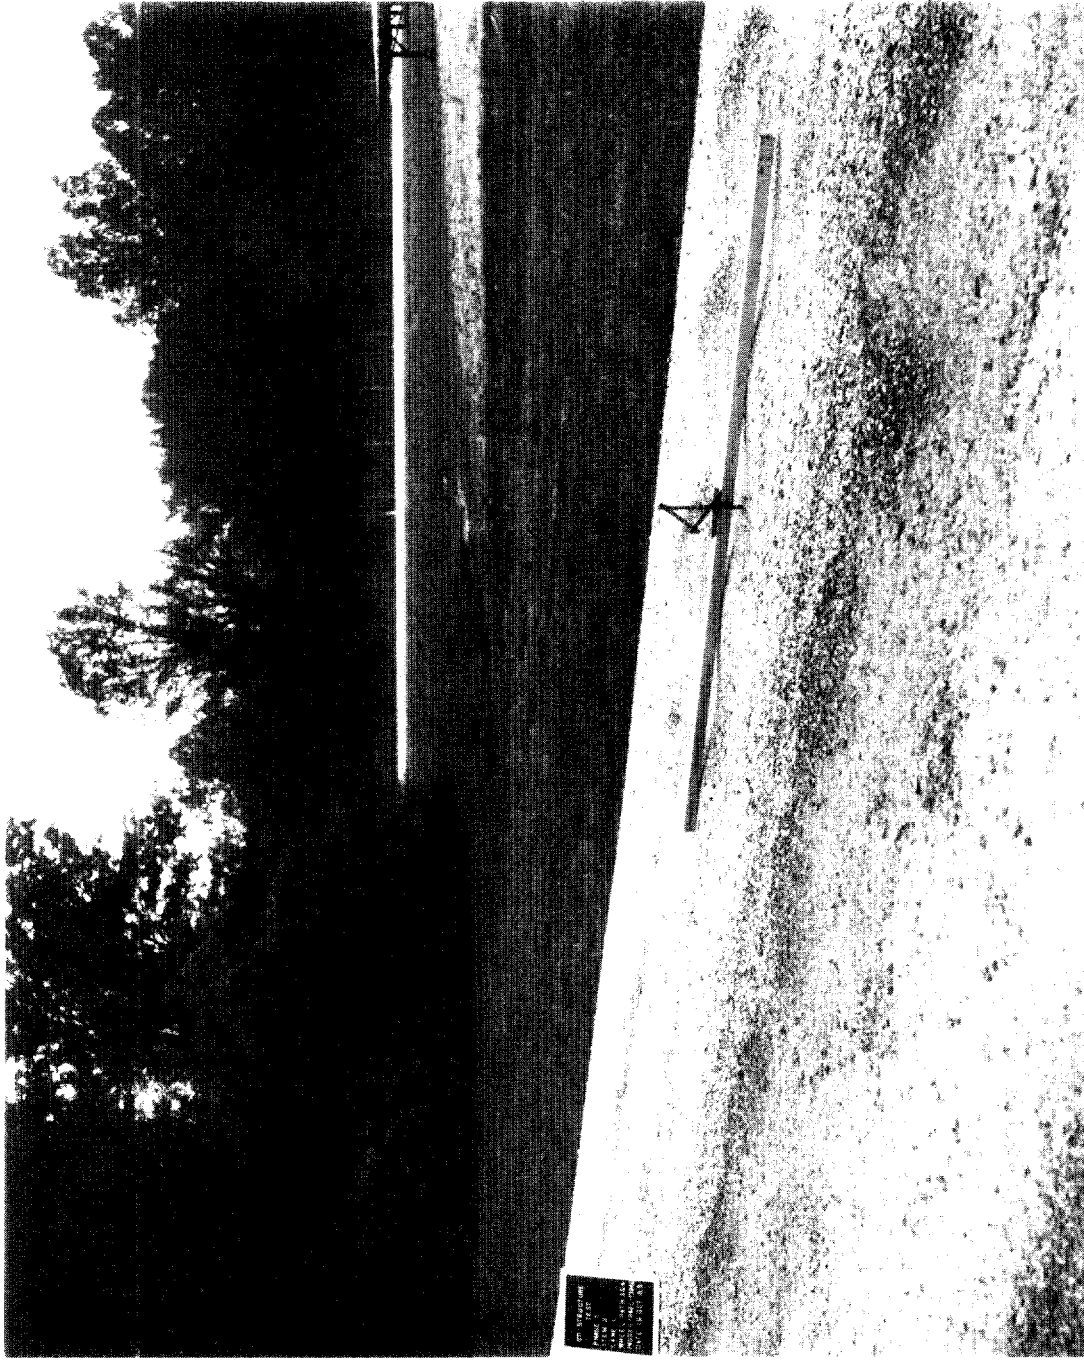
Photo 49. Item 2, low-pressure tire lane, long intervals between corrugation

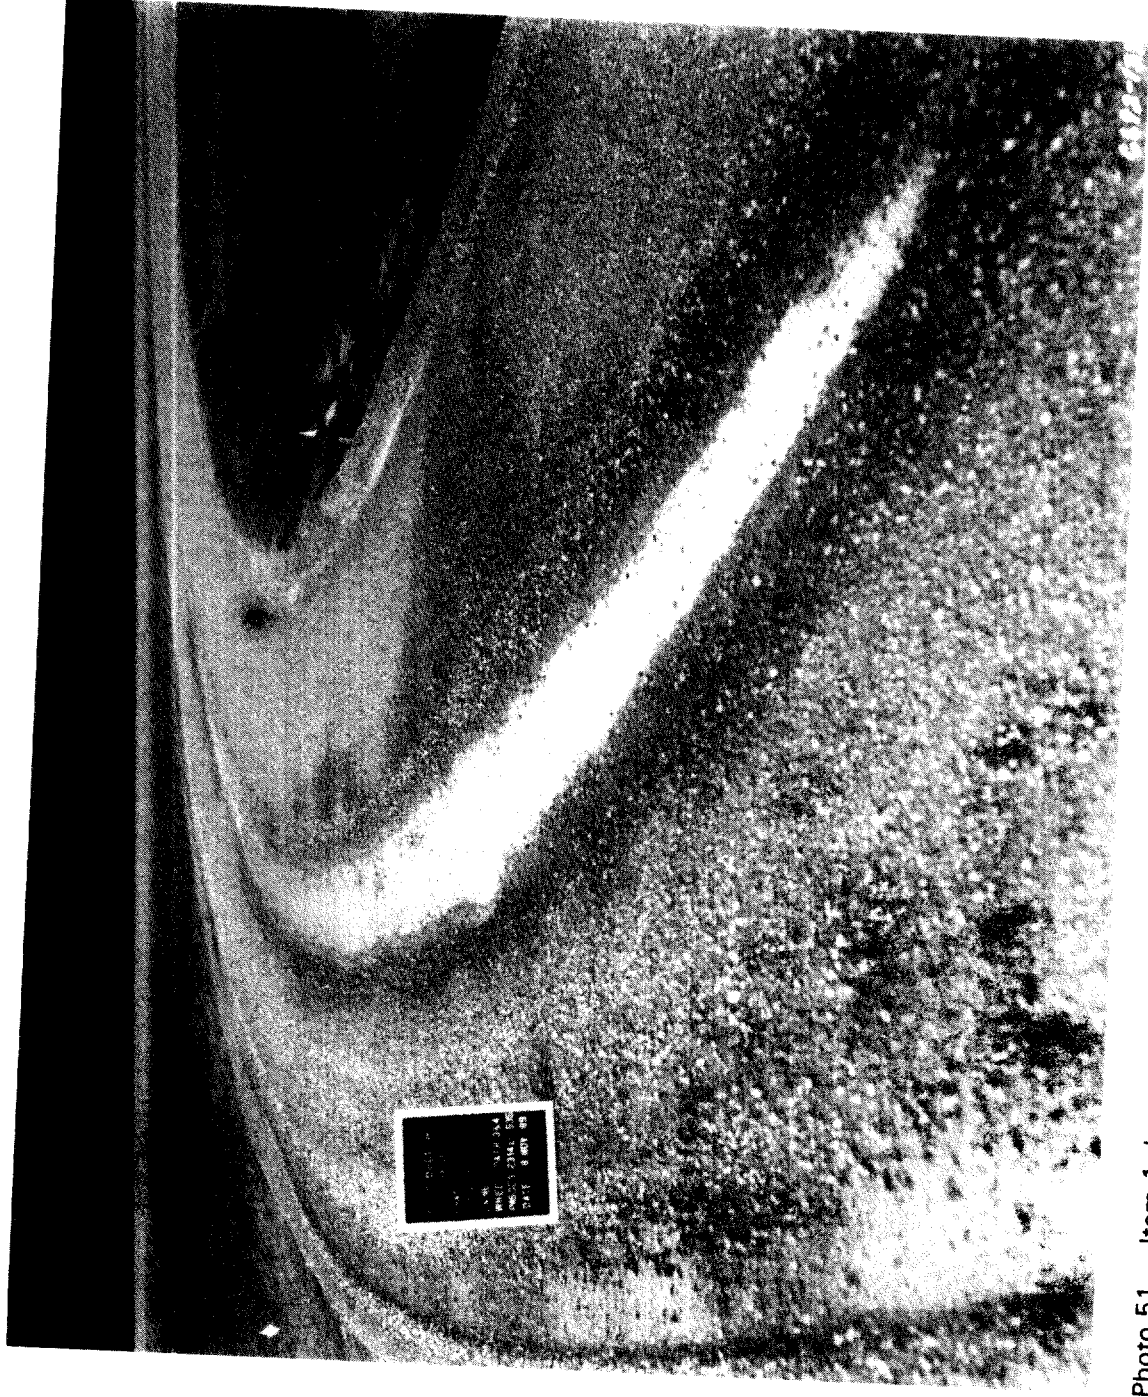
Photo 51. Item 1, low-pressure tire lane, low-severity rutting at the end of traffic

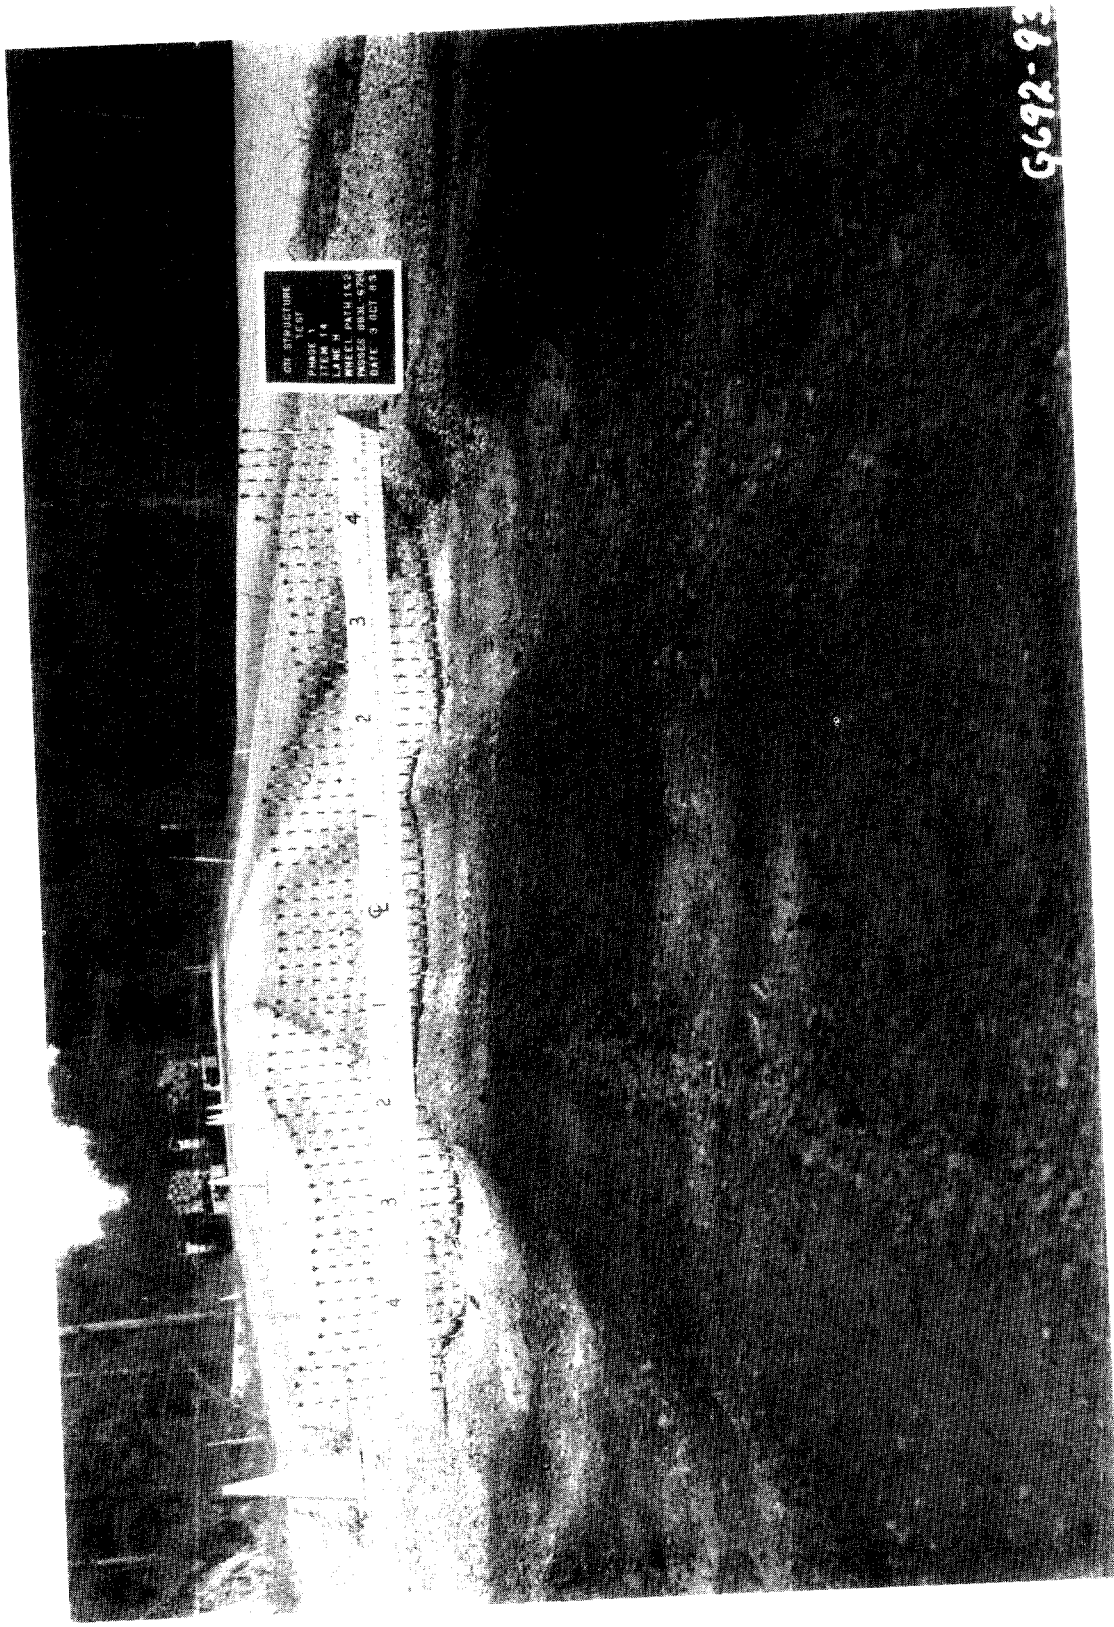
Photo 52. Item 4 high-pressure tire lane, high-severity rutting after 90 passes over a wet subgrade

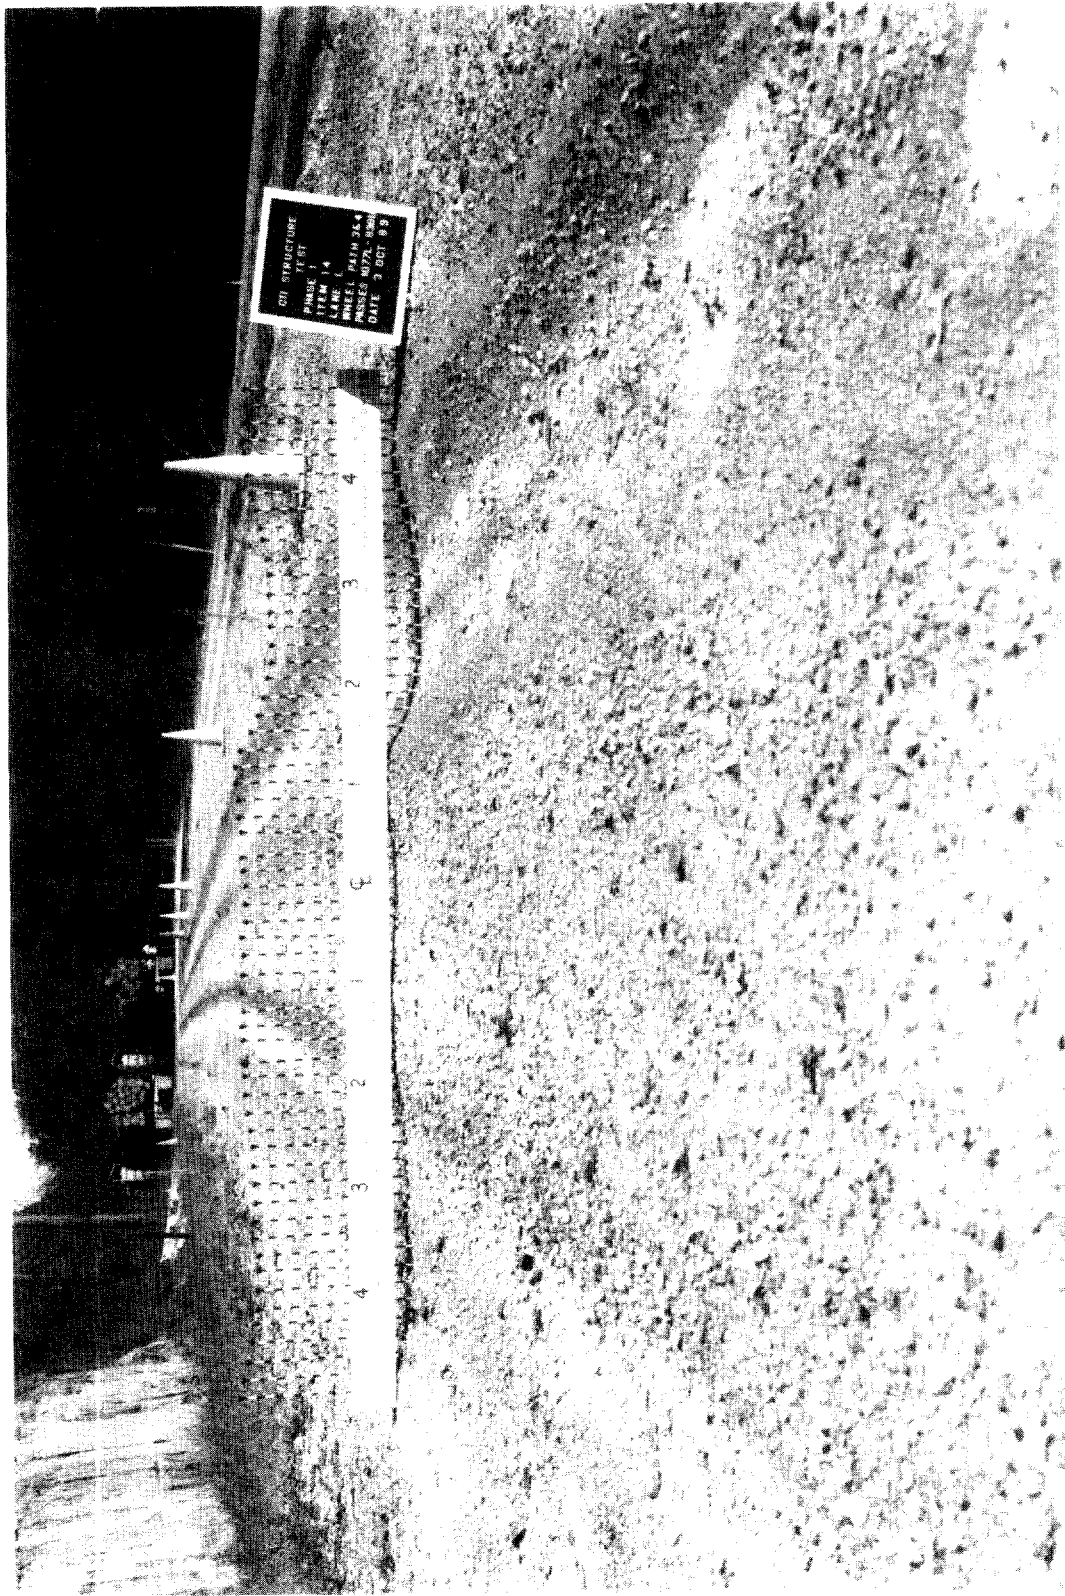
Photo 53. Item 14, low-pressure tire lane, high-severity rutting after 90 passes over a wet subgrade

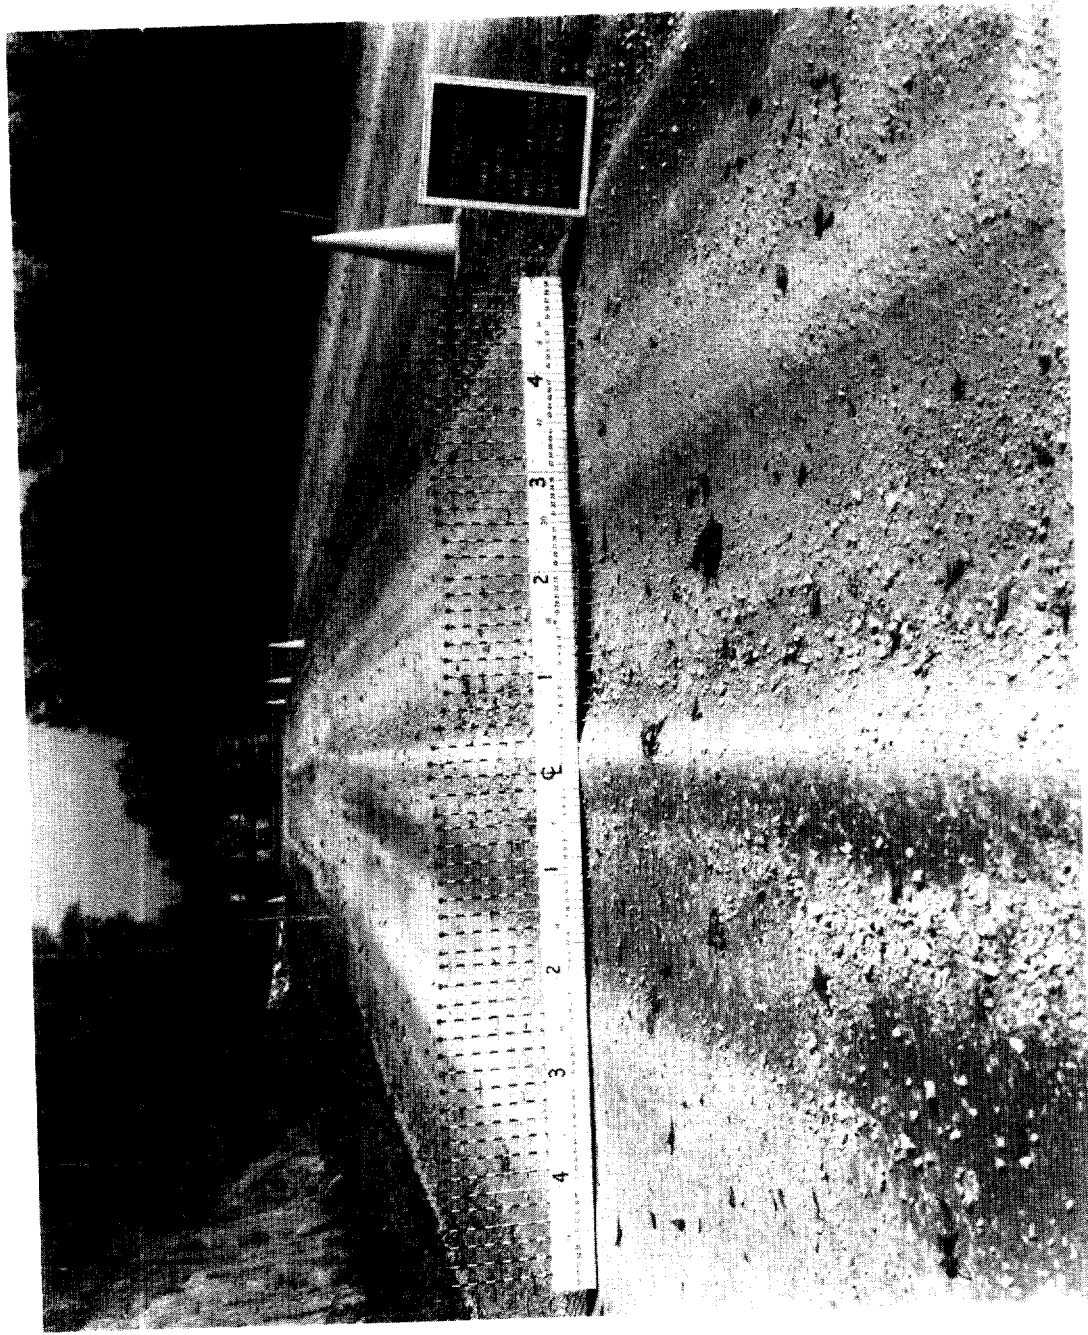
Photo 55. Item 14, low-pressure tire lane, high-severity rutting after 130 passes during induced failure plan

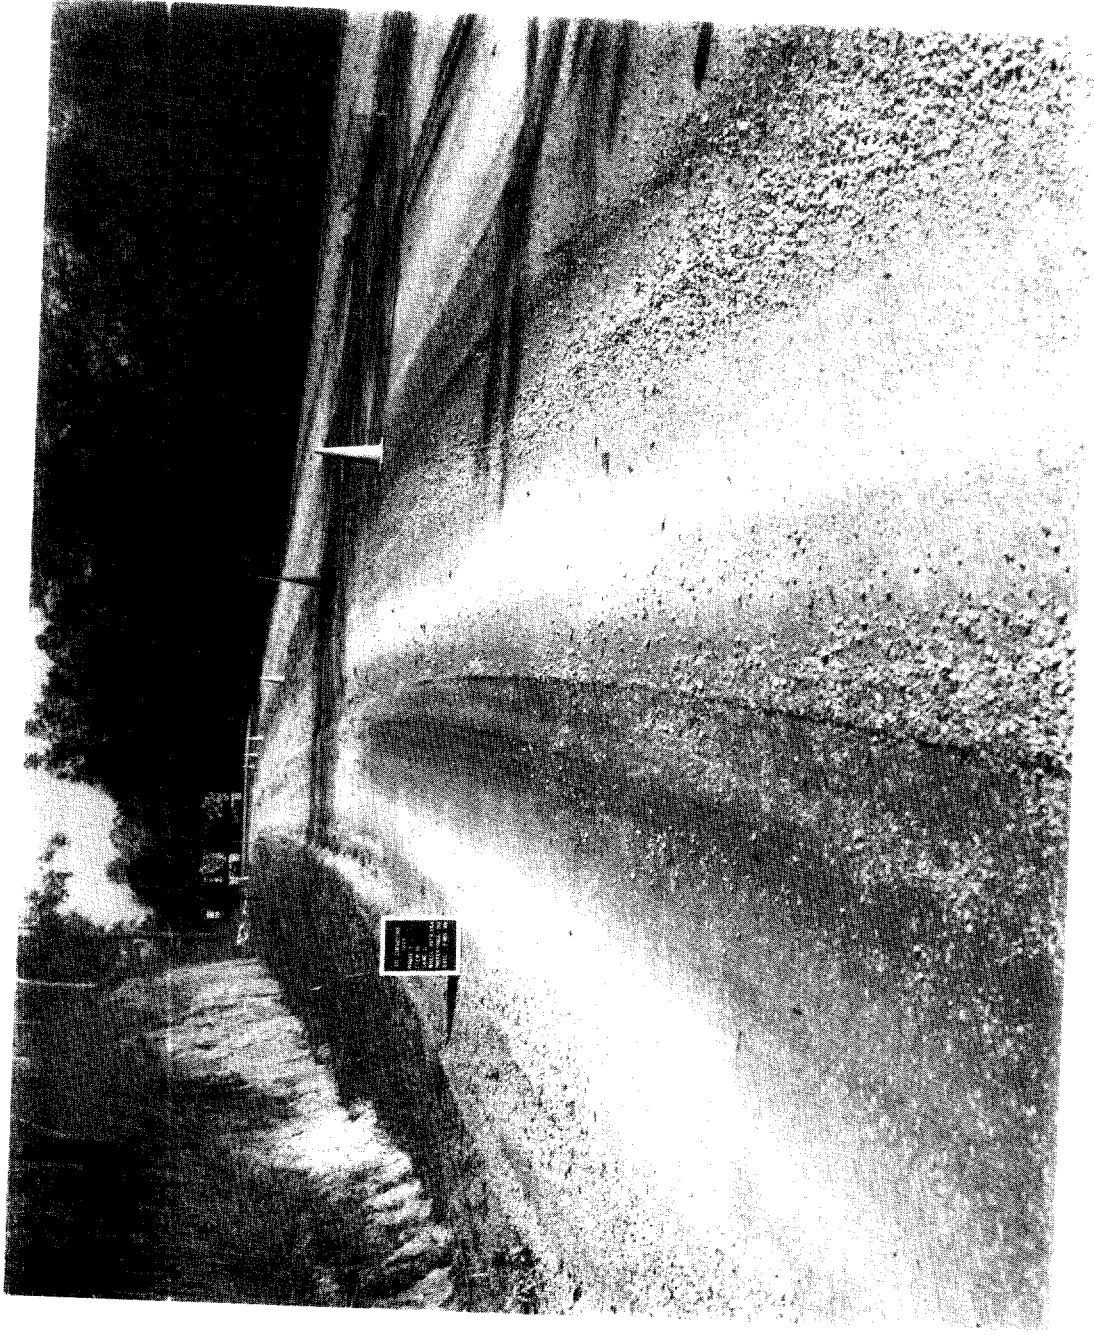
Photo 57. Item 14, low-pressure tire lane, general view after 130 passes during the induced failure plan
