Technical Report GL-93-20  
August 1993

# **Effects of Variable Tire Pressure on Road Surfacing**

Volume I: Design, Construction, Behavior  
Under Traffic, and Test Results

Geotechnical Laboratory

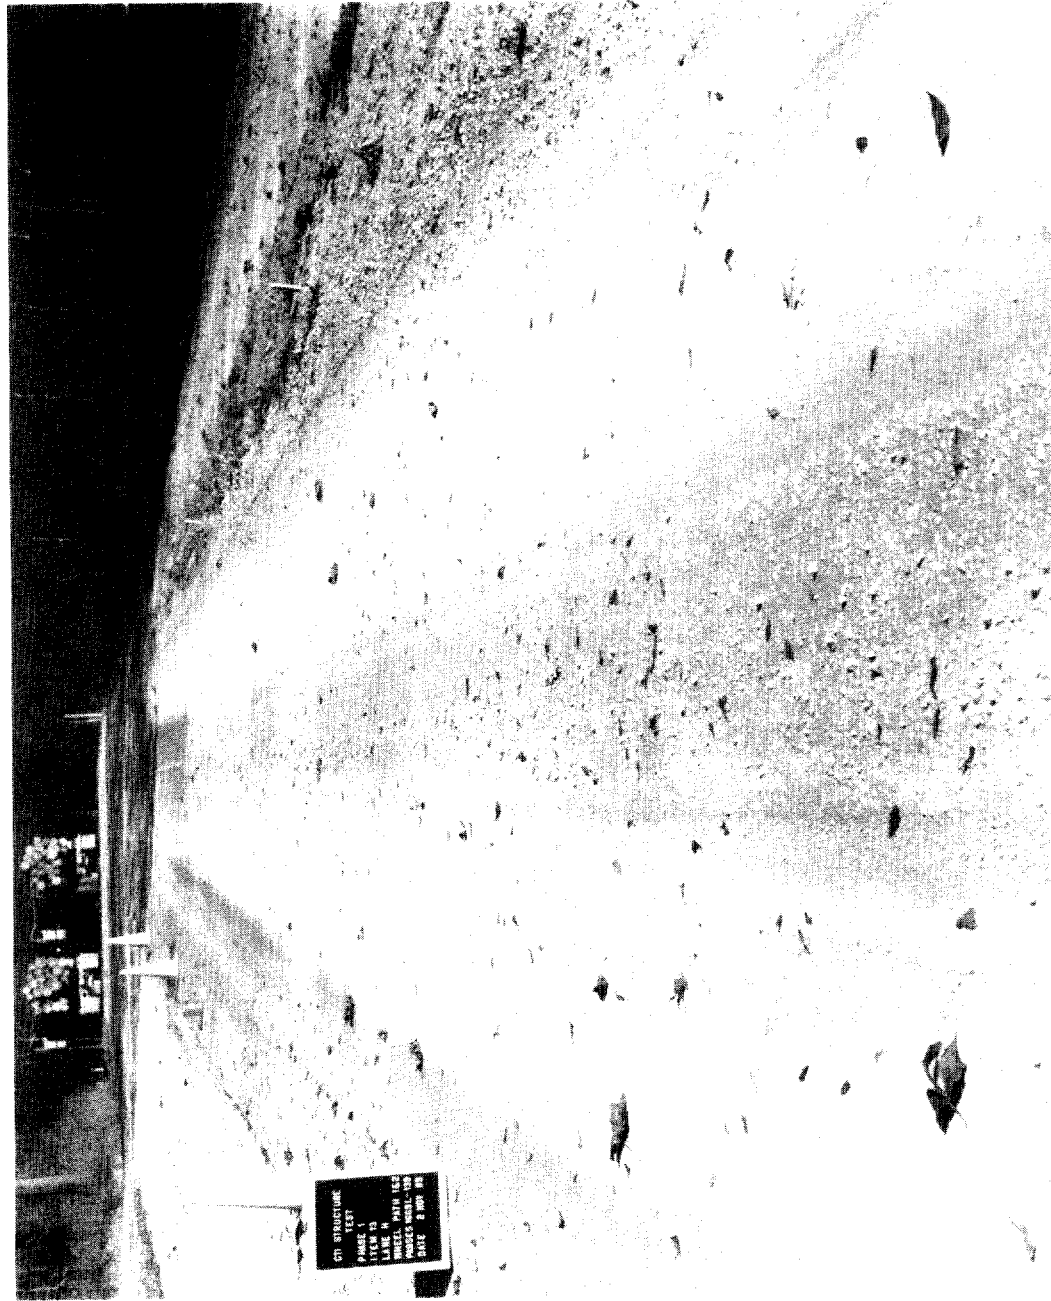
Photo 59. Item 13, high-pressure tire lane, general view after 139 passes during the induced failure plan

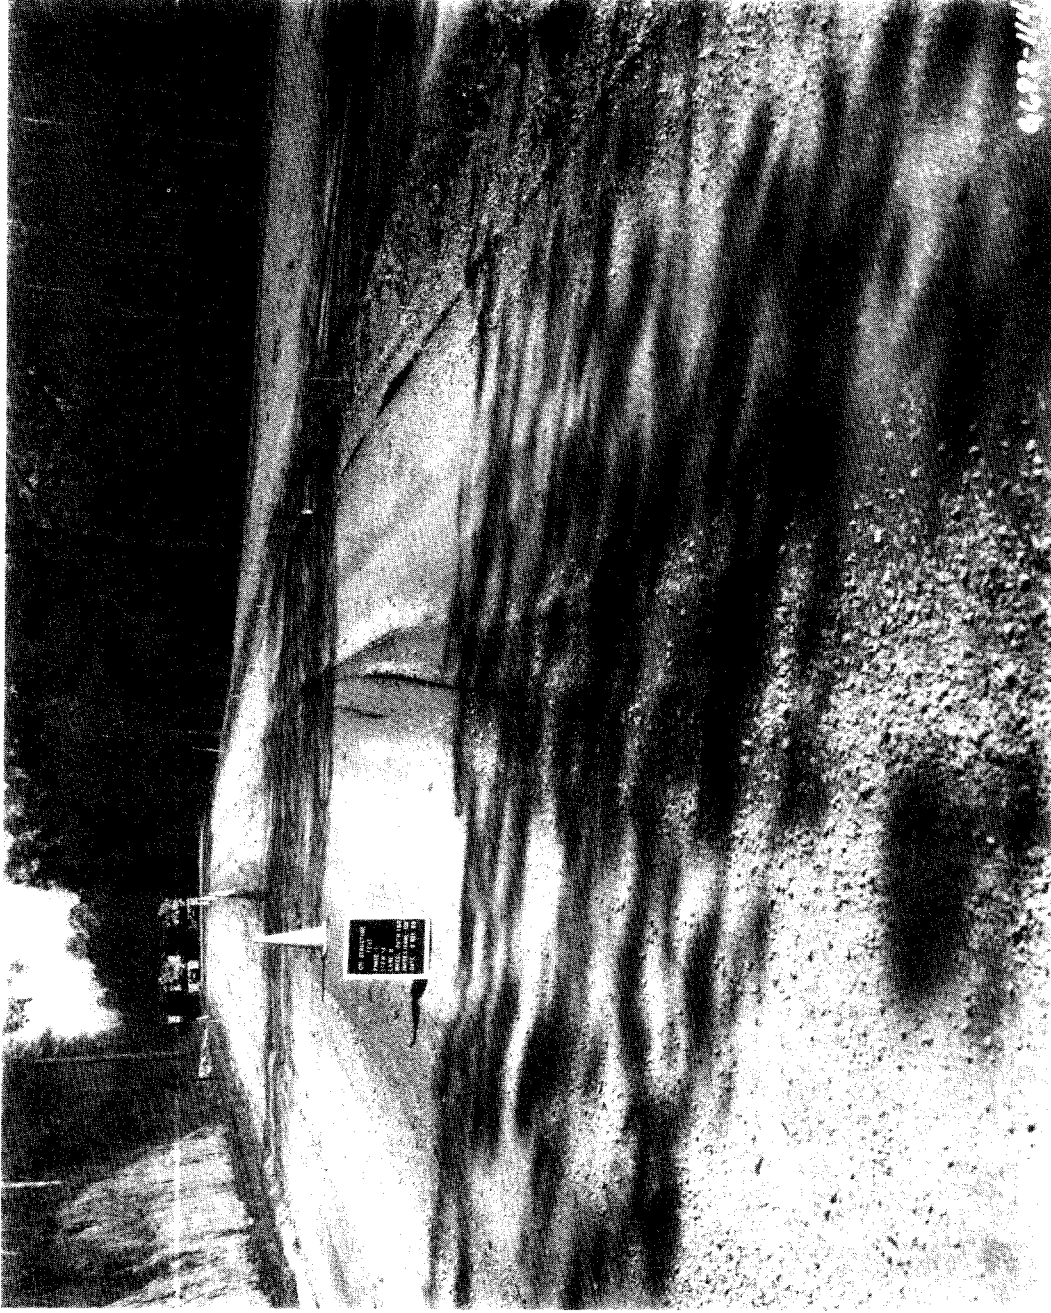
Photo 60 Item 14. high-pressure tire lane, general view after 139 passes during the induced failure plan

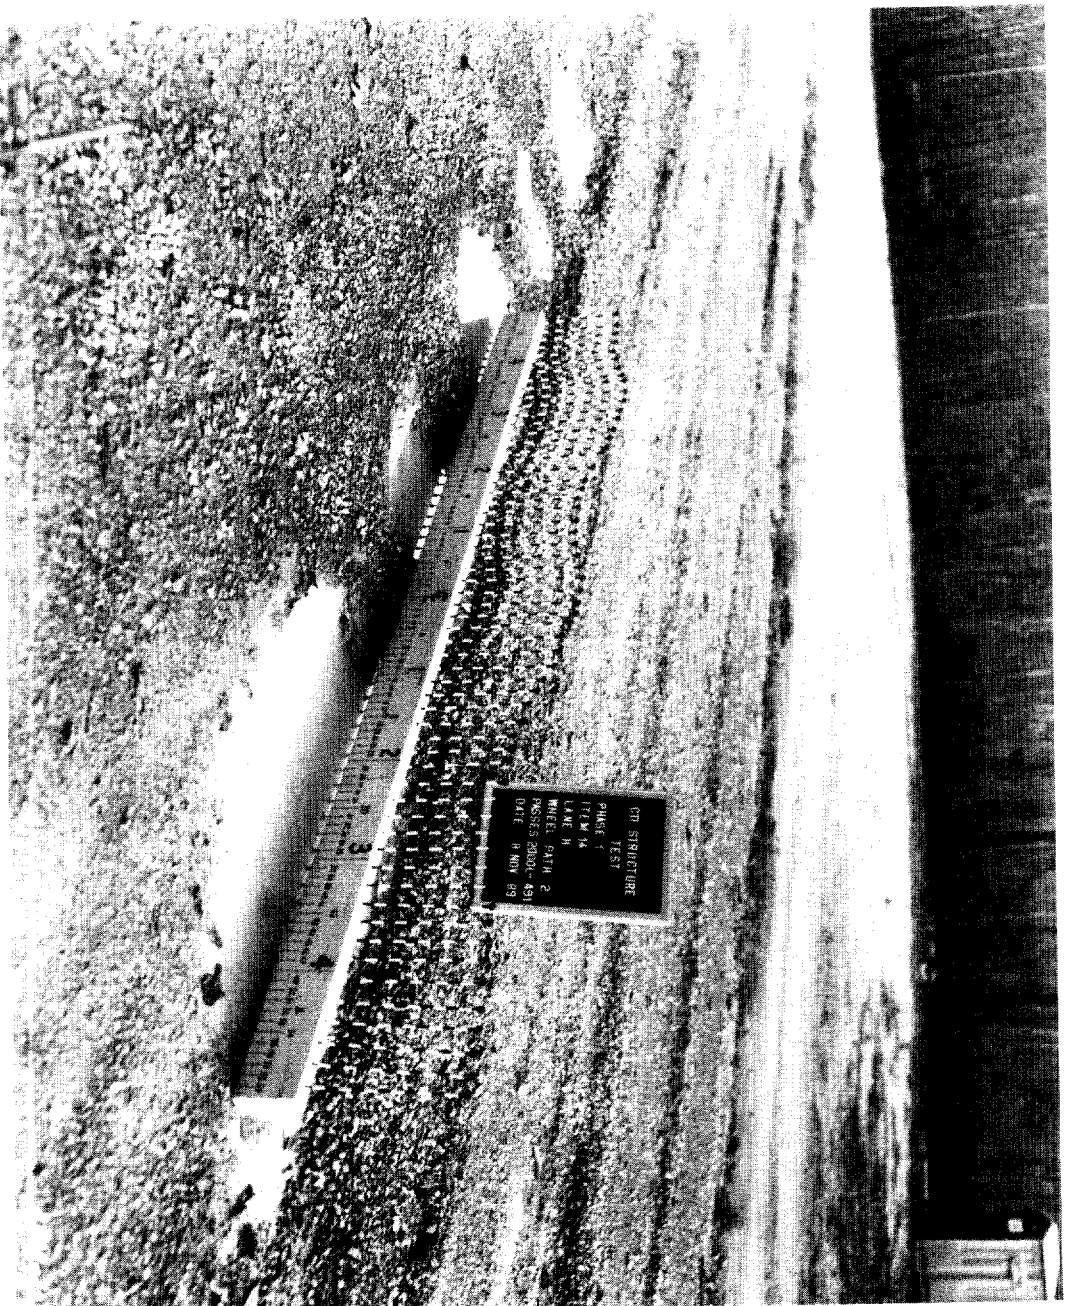
Photo 62. Item 14, high-pressure tire lane, high-severity washboarding after 491 passes during the induced failure plan

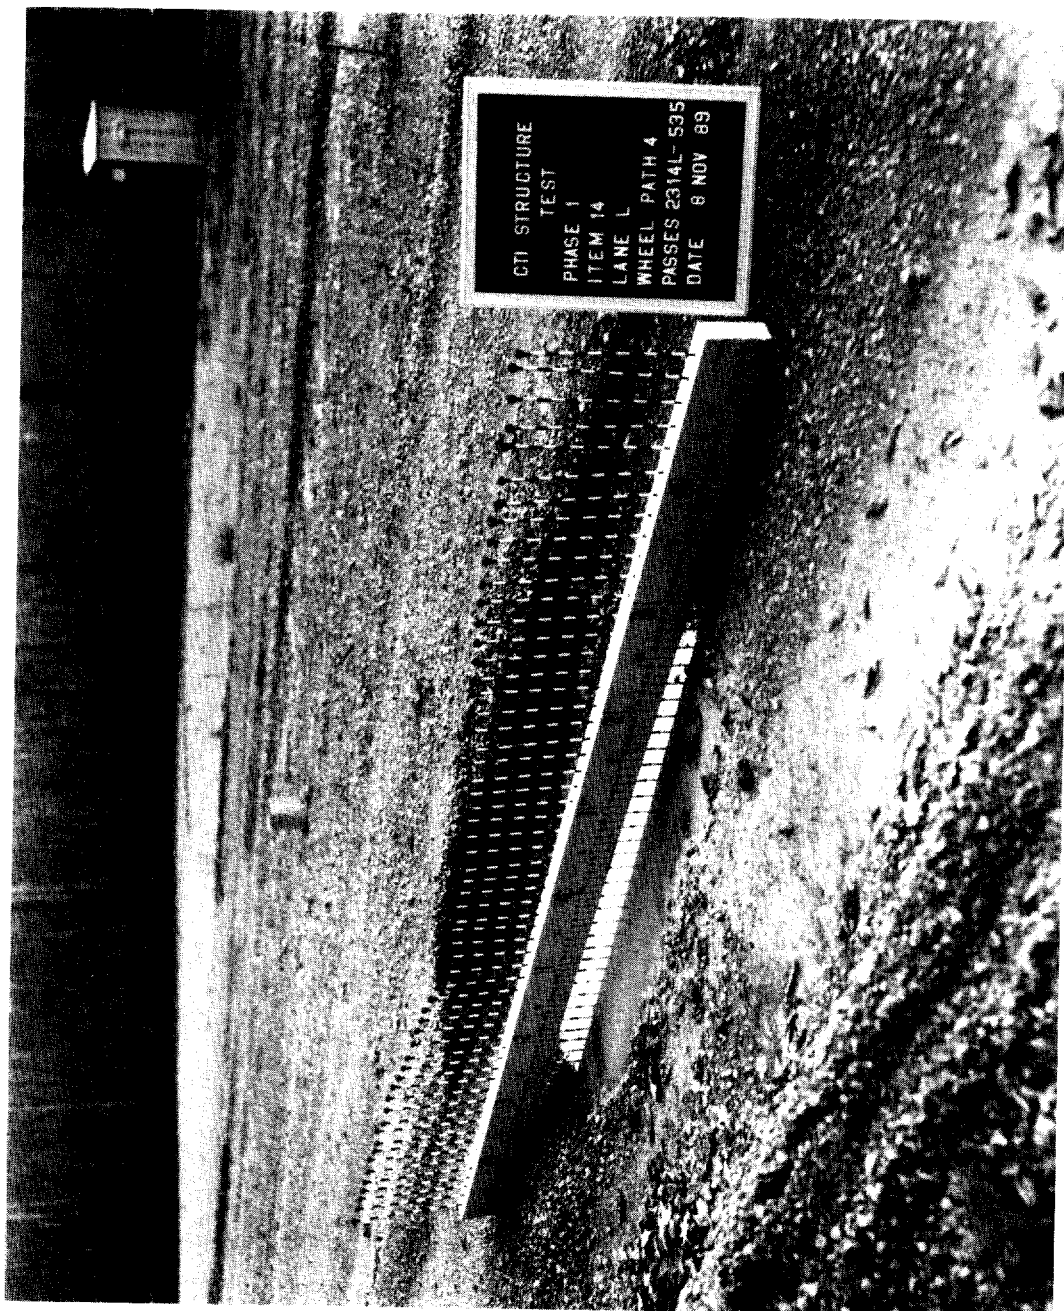
Photo 63. Item 14, low-pressure tire lane, high-severity pothole after 535 passes during the induced failure plan

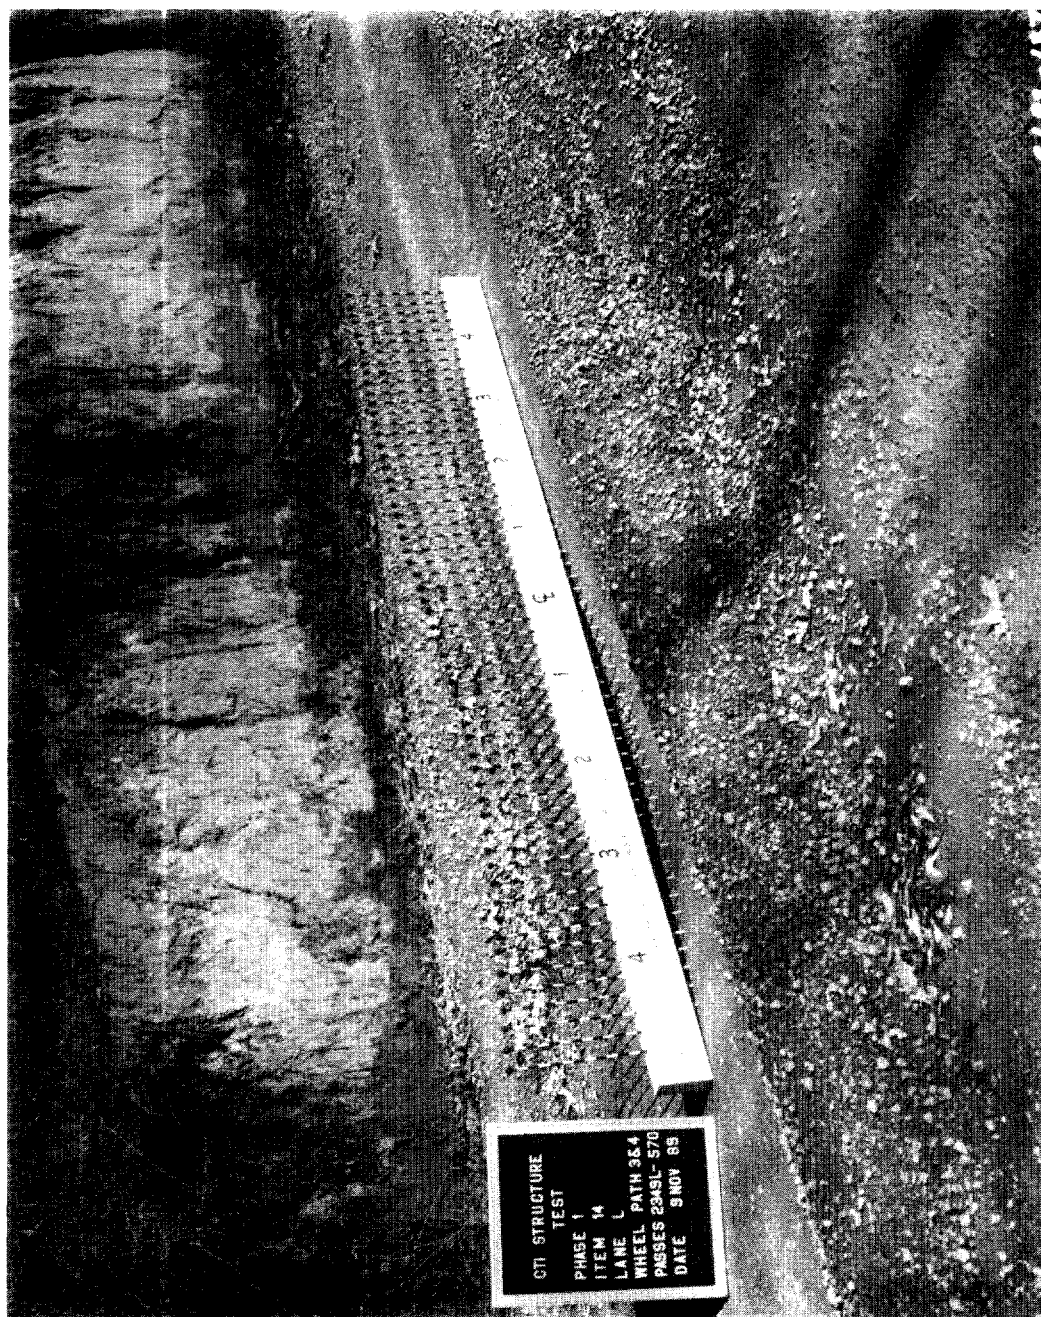
longer, and as shown in Photo 64 after 570 passes, it had developed into a low-severity depression instead of a high-severity pothole. The failures in item 15 were attributed to high-severity rutting with medium-to high-severity washboarding. A typical view of washboarding after item 15 was rated as failed and is shown in Photo 65. At this same time the washboarding in the low-tire-pressure lane was measured as low-severity (see Photo 66). As traffic continued, the majority of additional distress occurred in the high-tire-pressure lane of item 15. The aggregate became very loose and deep ruts developed. A general view of item 15 depicting this condition is shown in Photo 67. Although rutting up to 6.5 in. was measured in item 13 the maximum length never measured 20 ft; therefore, the failure criteria were not met. On 22 November 1989 the decision was made to stop all test traffic. At this time a total of 3,698 and 4,407 passes had been applied to the high- and low-tire-pressure lanes, respectively. The total traffic applied to the high- and low-tire-pressure lanes under the induced failure plan was 1,135 and 1,309 passes, respectively.

Photo 64. Item 14, low-pressure tire lane, low-severity depression after 570 passes during the induced failure plan

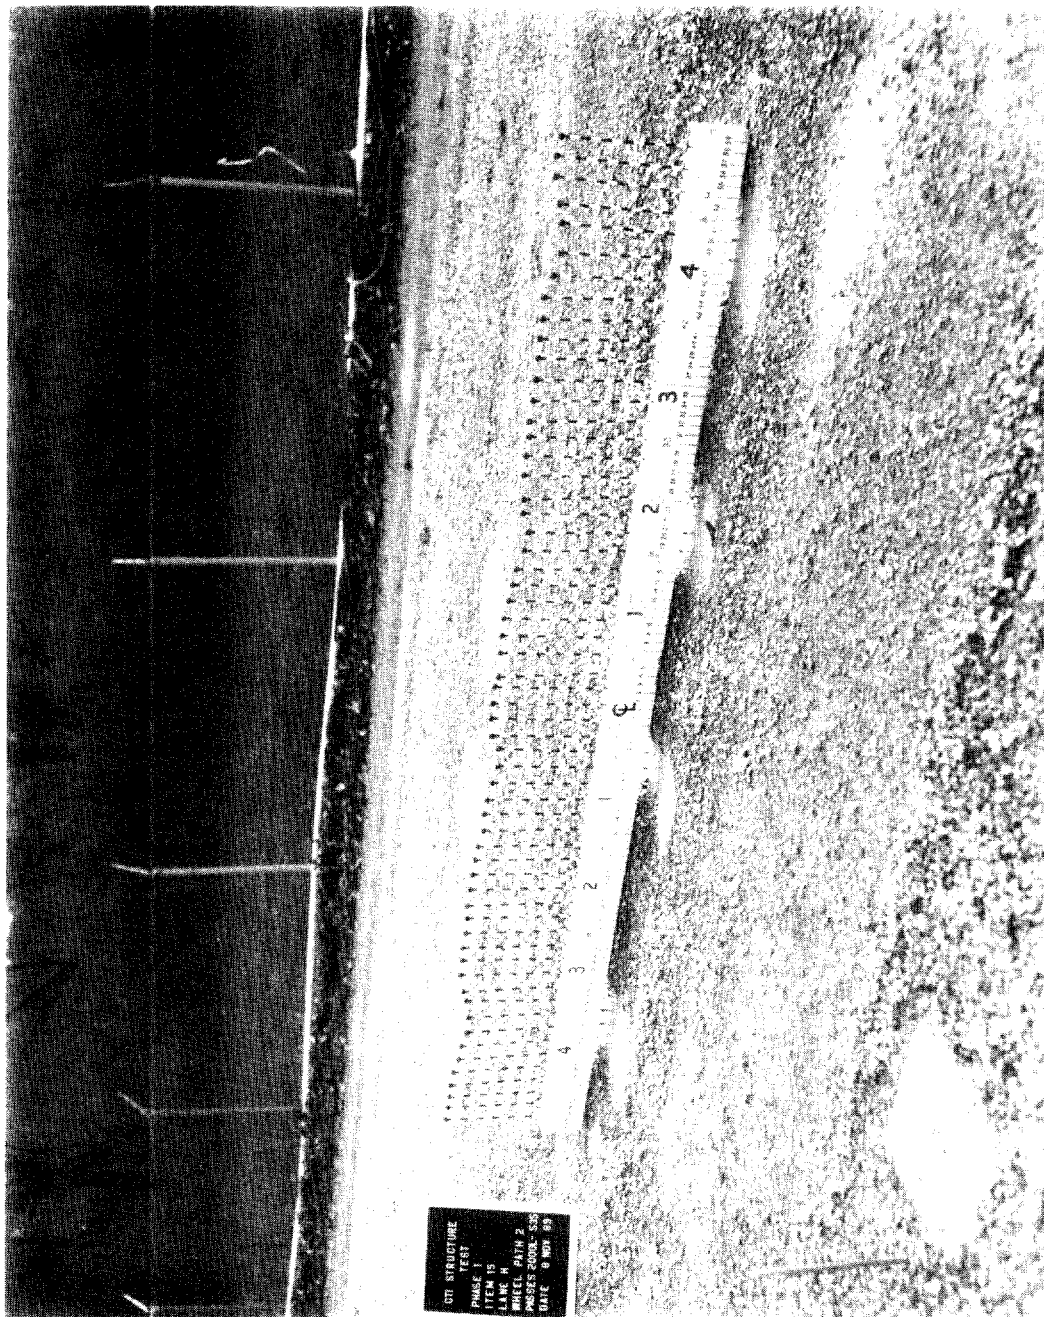
Photo 65. Item 15, high-pressure tire lane, typical high-severity washboarding after 535 passes during the induced failure plan

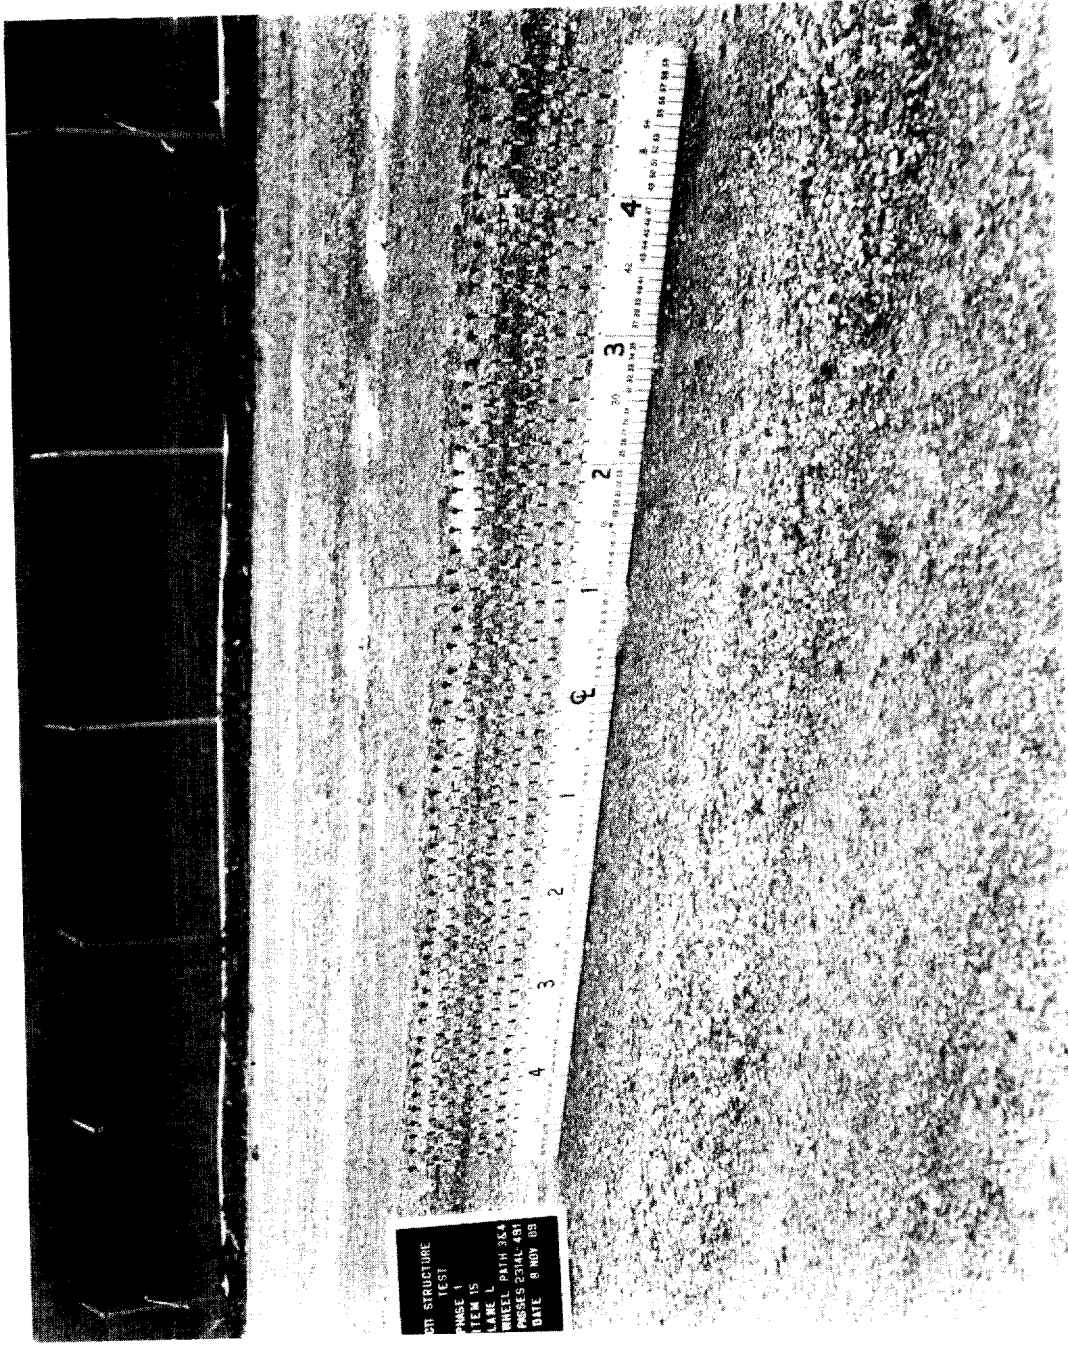
Photo 66. Item 14, low-pressure tire lane, typical low-severity washboarding after 491 passes during the induced failure plan

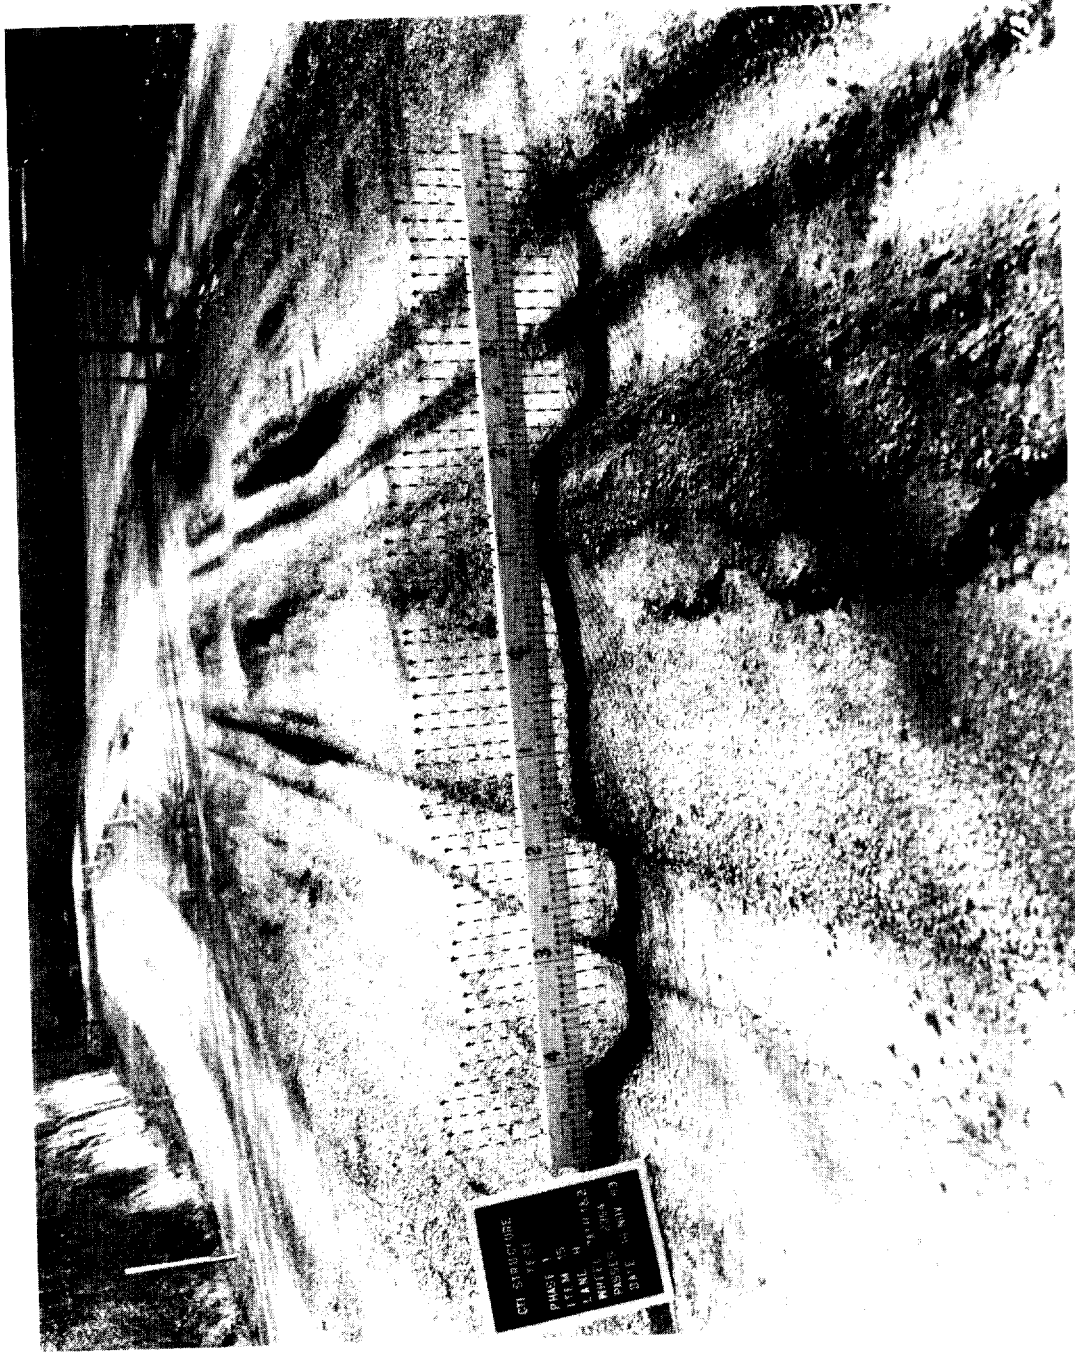
Photo 67. Item 15, high-pressure tire lane, severe rutting and loose aggregate after 913 passes of induced traffic for a total of 2364 loaded passes
