Moving Small Mountains—Vesuvius Dam Rehab

—Susan L. Peterson, P.E., regional dams engineer, Eastern Region, Bedford, IN

Major developments below Vesuvius Lake dam in Ohio, US, led to the reclassification of the 70-year old dam to high hazard status. Sue Peterson oversaw the rehabilitation work undertaken to bring the dam up to current standards

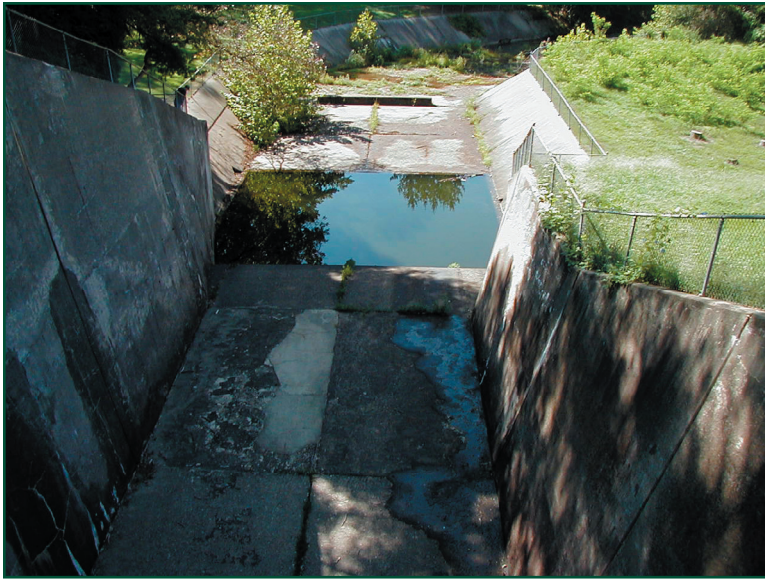
Much has changed in this part of Ohio since 1935. The dam is located about 16km from the Ohio river and two other states; Kentucky and West Virginia. It is within an hour's drive of about half a million people. Major development has occurred downstream of the dam, including the construction of houses, a major highway and a public school. These developments led to the reclassification of the dam to a high hazard status, and it was identified in a 1990 State of Ohio Department of Natural Resources report as being severely undersized. It would pass or store approximately 37% of the design storm volume. The concrete spillway has been patched and grouted a few times over the years (figure 1).

Figure 1 — Stilling basin of spillway before new concrete is installed.

The concrete spillway is 125m long by 7.6–13.7m wide by 8.5m deep and the lake elevation is controlled by an ogee weir. As the concrete was 65 years old, and had been patched and grouted several times, the decision was made to overlay the vertical walls with 30cm of new concrete. The work included the removal and replacement of the floor and the sloped walls downstream of the stilling basin.

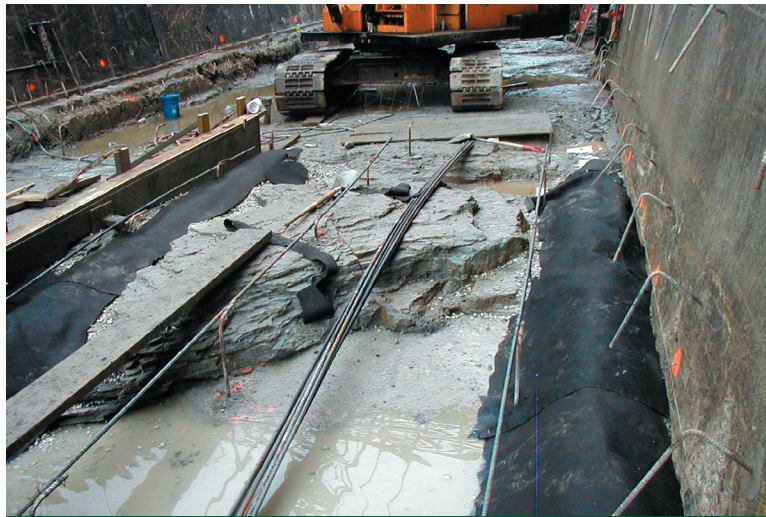
plane and is 3m thick, while the siltstone has soft to moderately hard bedding planes and appears in thin layers. When the soil adjacent to the dam side of the cellular wall was removed, there was very little fracturing of the sandstone and it was suitable for the foundation of the new cellular wall face (figure 2).

Figure 2—Exposed bedrock under the spillway floor with grouted anchor bars installed.

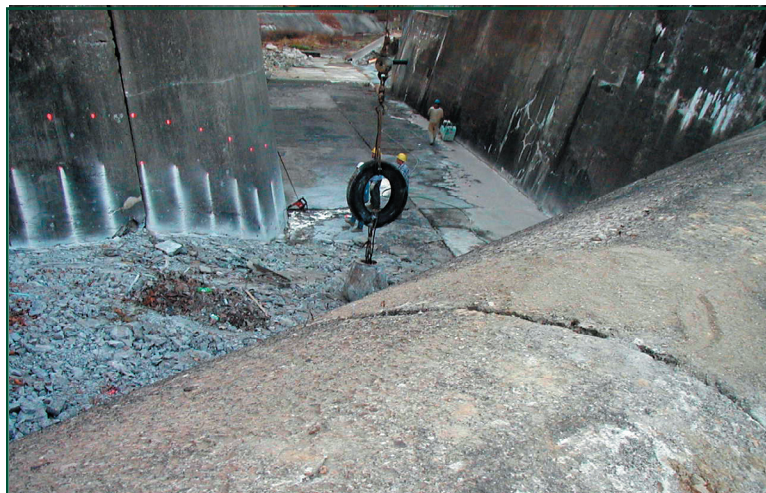
Figure 3—Wrecking ball on crane used to break up the spillway floor.

Floor sections were removed and replaced before the walls' overlays. The existing concrete in the floor of the spillway was removed along its entire length, with the exception of the stilling basin, which was left in place and overlaid with new concrete like the spillway walls. At the junction of the wall with the floor a 7.6cm saw cut was made. The original plans showed the removal of the chute floor required very little extra excavation. Once excavation of the floor began, the depth to bedrock to anchor the new floor was 0.3–2.1m. The void created by removing the old concrete and the loose material underneath was filled by the new concrete, which resulted in substantial overruns in concrete quantities. All foundation surfaces were pressure washed before the placement of new concrete (figure 3).

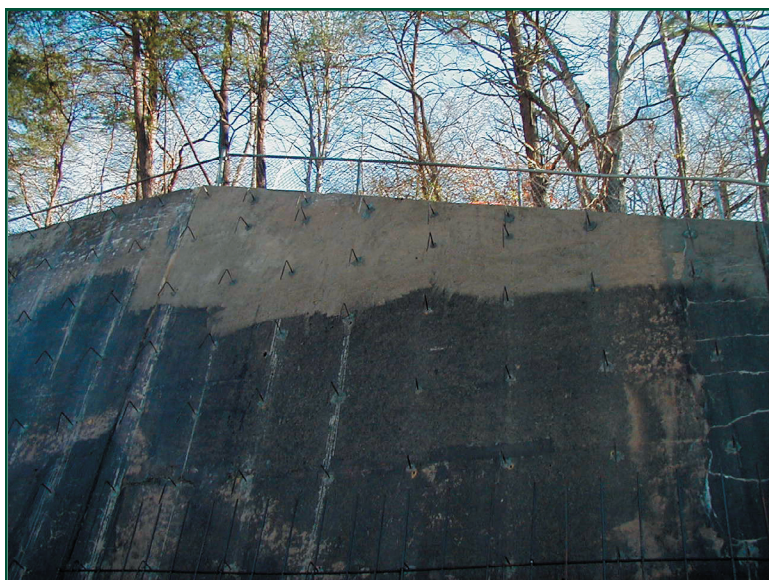
Figure 4—Grouted anchor bars installed in old spillway walls.

The reinforcement of the new concrete wall overlays and chute floor replacement incorporated grouted anchor bars (#4, #6 and #11), reinforcing bars and plain dowel bars. The new 0.3m wall overlays were anchored to the existing walls by drilling holes in the old concrete and #4 or #6 grouted anchor bars (depending on location in spillway) were installed every 0.9m on centre. The anchor bars were embedded at least 17cm on the right spillway wall and 0.3m into existing concrete and rock on the left wall. Attached to the grouted anchor bars was a combination of bars that formed a grid to reinforce the walls and floor of the spillway. The #6 anchor bars, reinforcing bars and plain dowel bars were installed in this grid pattern, with the opening between bars 0.3m each way. The bars were required to be embedded in a minimum of 5cm of concrete (figure 4).

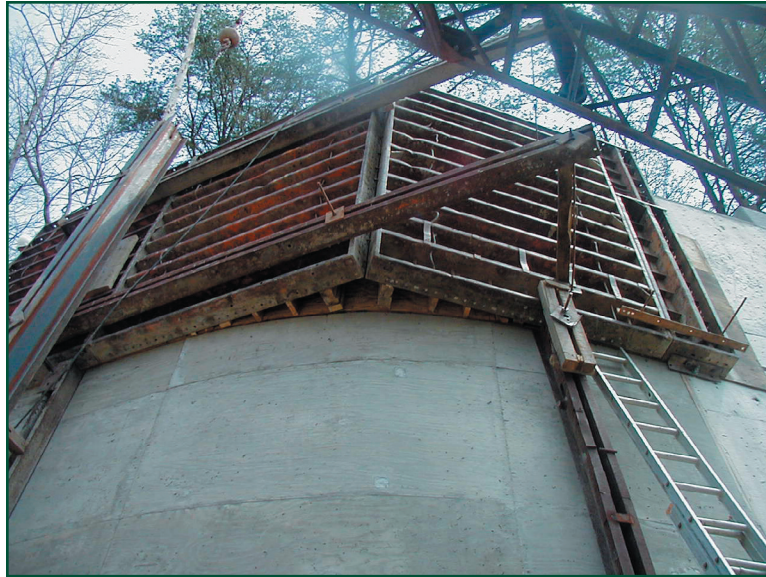
Figure 5—Forming a curved section of spillway wall.

Construction joints were made every 6.1m in the floor slabs. Contraction joints on the concrete overlay on the walls matched the joints on the existing walls and 23cm PVC water stops were installed at all joints in the walls and floor slabs (figures 5, 6, and 7).

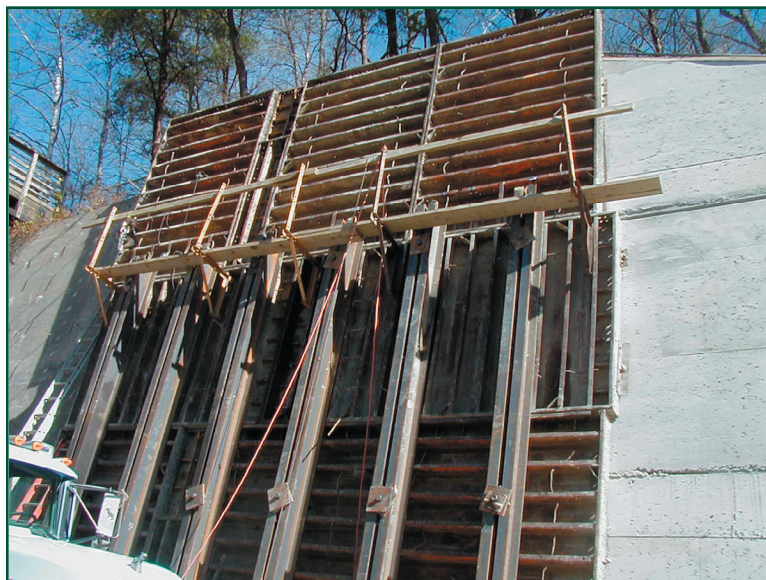
Figure 6—Steel forms used to form spillway walls.

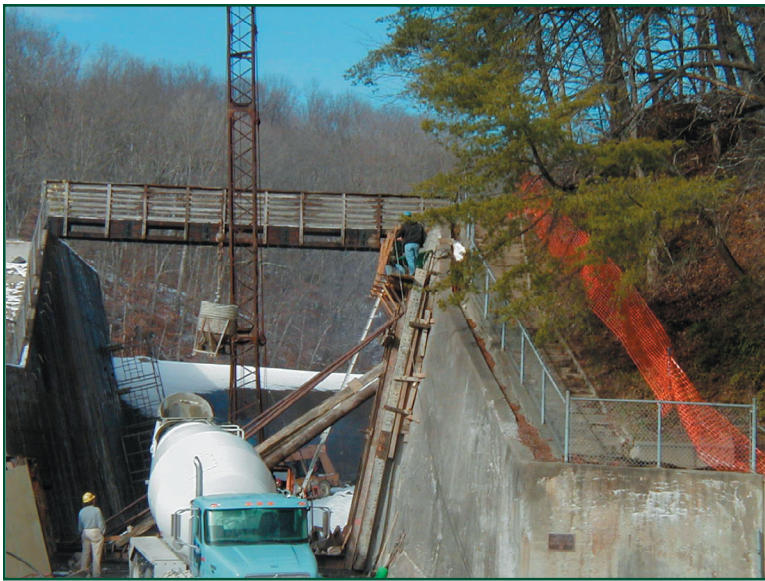
Figure 7—Placement of new concrete overlays of spillway walls using a drop bucket and crane.

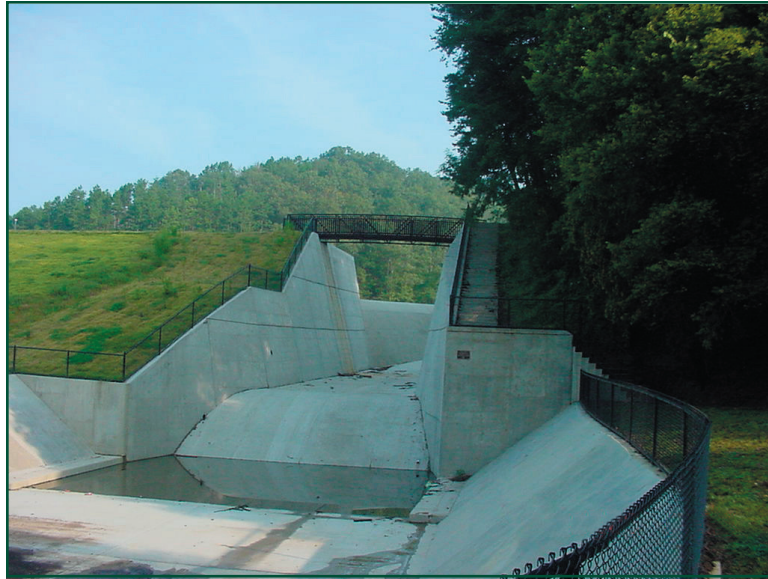
Figure 8—Finished spillway with new trail bridge and fencing installed.

Their costs were estimated at the 76m³ per day and had a significant overrun by the small daily production. All the concrete pours were adequately formed, vibrated and finished, but the contractor was using old steel forms that had to be moved for each section of wall overlay which took extra time and manpower and cut down production rates. The project, although it took longer than anticipated, was very successful and completed professionally by the contractor (figures 8 and 9).

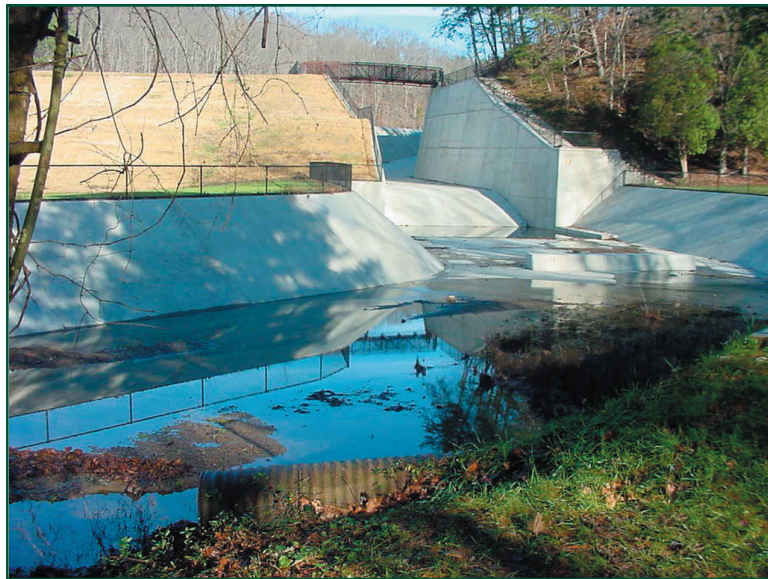
Figure 9—Finished spillway including new stilling basin and partial wier in outlet of spillway.
