Modifying Water Hydrant Handles To Make Them Safer

Mary Ann Davies, Project Leader, and Tyler Kuhn, Mechanical Engineer

Davies, Mary Ann; Kuhn, Tyler. 2005. Modifying water hydrant handles to make them safer. Tech Tip 0523-2348-MTDC. Missoula, MT: U.S. Department of Agriculture Forest Service, Missoula Technology and Development Center. 6 p.

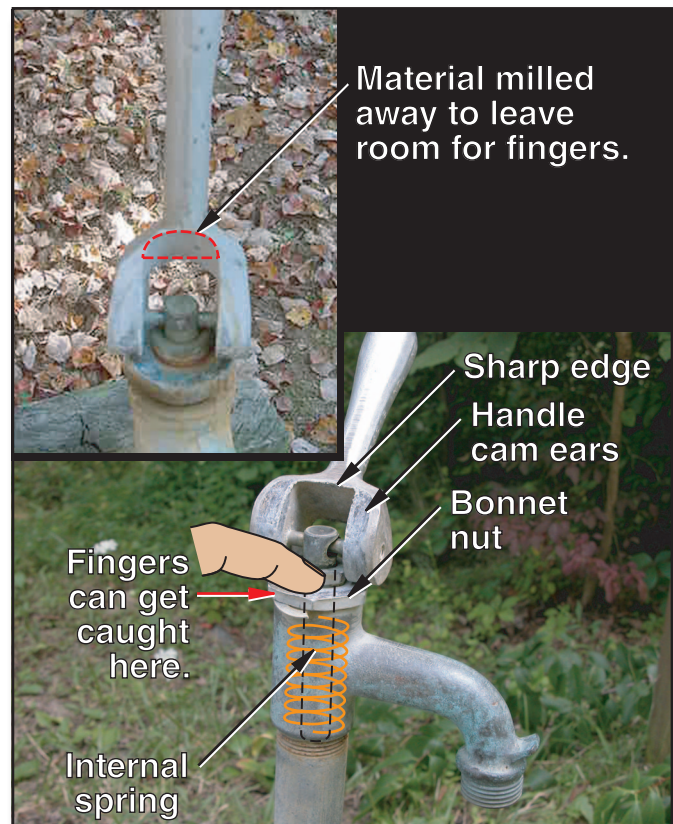
Users must pull the handle of the MK-6 hydrant down with a considerable amount of force, more than the 5-pound maximum specified in accessibility guidelines. The cam ears of the hydrant's handle sit on a large bonnet nut. The handle assembly is pinned through a stem that is attached to a compressed internal spring (figure 1). As the handle is pulled down, the cam ears pivot on the bonnet nut, compressing the spring.

Figure 1—The unmodified Woodford Manufacturing Co. MK-6 water hydrant and the handle after safety modifications.

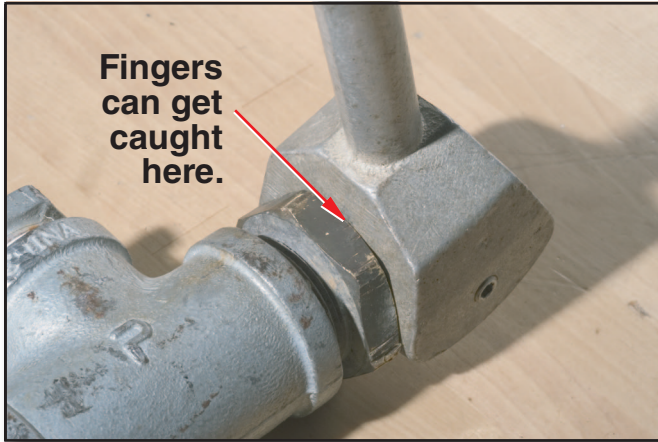
Persons who aren't strong enough to pull the handle all the way down may place their fingers inside the handle opening to gain leverage. When the handle is nearly down, the opening's sharp edge snaps into place against the bonnet nut (figure 2) with enough force to amputate the end of a finger.

Figure 2—The MK-6 hydrant handle showing where fingers can get caught.

A better short-term solution is to modify the handle by milling away material, creating an opening between the handle and nut. The machine shop at MTDC used a milling machine to do so (figure 4). If users place their fingers on the nut when they pull the modified handle down, the opening leaves space for their fingers (figure 5). Figure 6a shows the difference between the original handle and the modified handle (figure 6b).

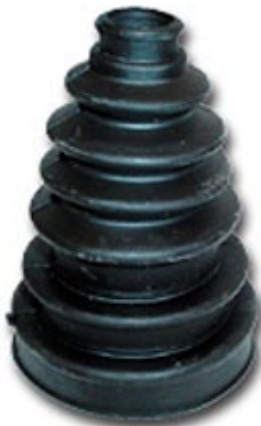
The first attempt to solve the problem enclosed the bottom portion of the handle and the bonnet nut with the universal boot from an automobile's constant-velocity joint (figure 3). The idea was to prevent users from placing their fingers in the handle opening. The boot was placed over the bonnet nut and pivoting handle ears and secured on the top and bottom with nylon tie clamps. Many sizes and shapes of boots were

Figure 3—A universal boot for an automotive constant-velocity (CV) joint.

tried, but the camming action of the handle ears pulled the boots out of place every time.

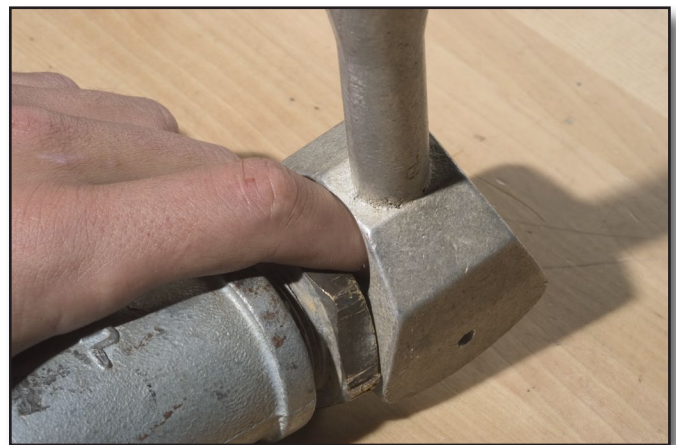
Figure 5—The handle of the modified MK-6 hydrant has room for a finger.

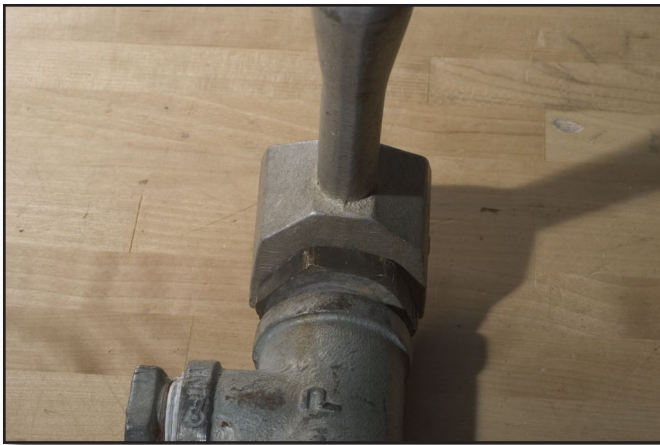
Figure 6a—The original MK-6 hydrant.

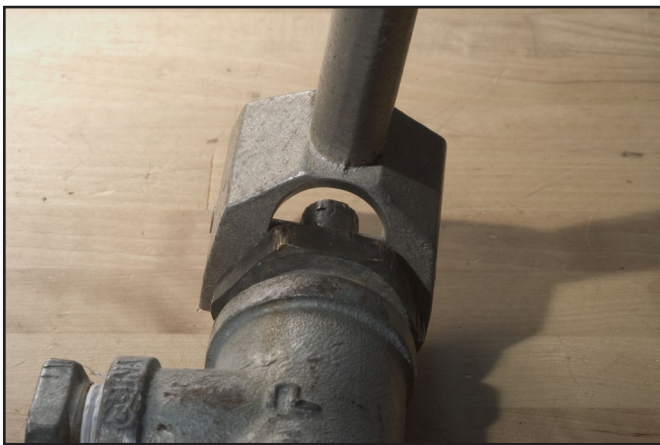
Figure 6b—The MK-6 hydrant with the modified handle.

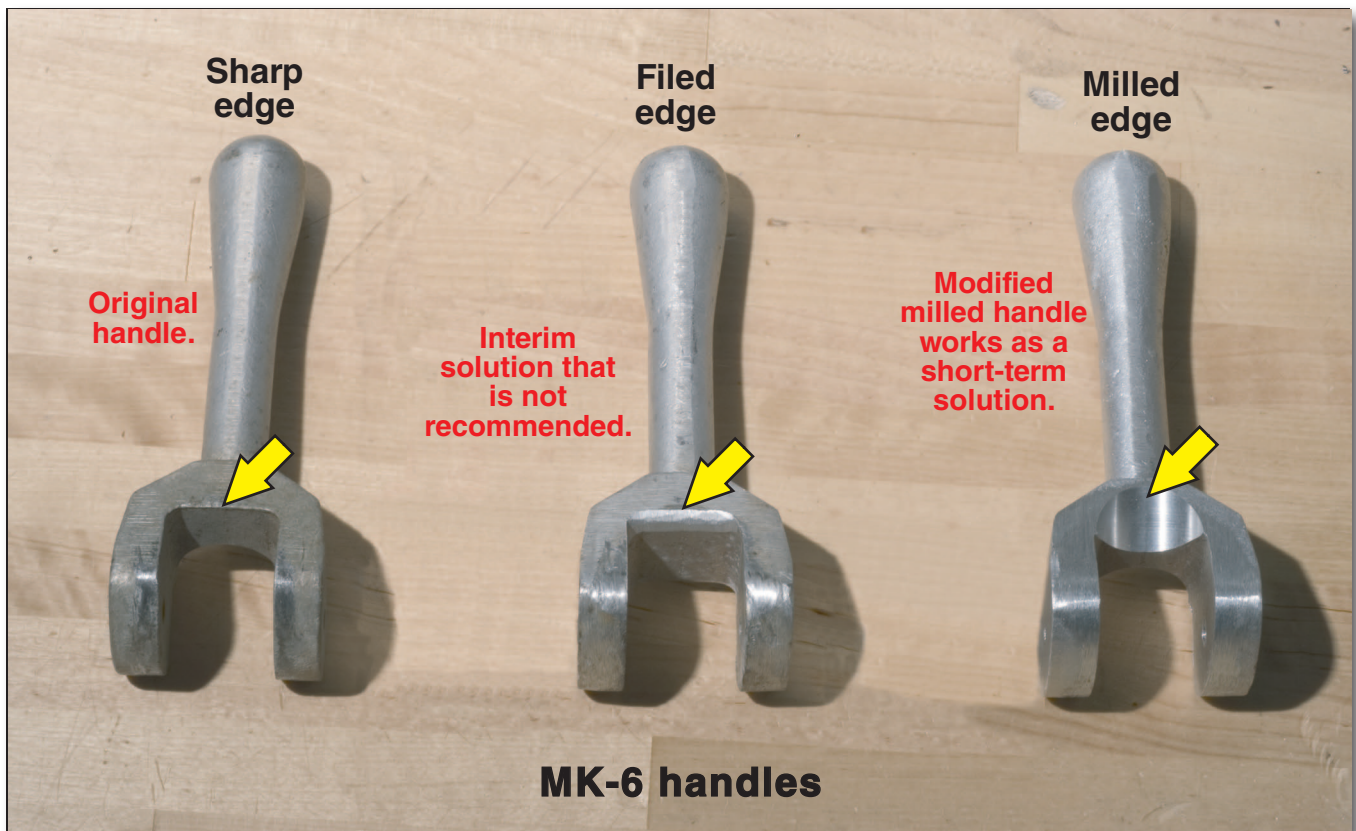
Another solution tried in the field was to dull the handle's sharp edge where it contacts the bonnet nut. This method does not eliminate the risk of injury and is not recommended.

Milling out the handle core at a 55-degree angle leaves enough metal to maintain the structural integrity of the handle (figure 9). Several milled handles that were used in Forest Service campgrounds during the summer of 2005 did not show signs of fatigue.

Figure 9—The original MK-6 handle with a sharp edge (left), a filed edge (middle), and the edge after milling (right), the recommended solution.
