Project Name: Dale Administrative Site – Excess Buildings

Administrative Unit: Umatilla National Forest / North Fork John Day Ranger District

Description of the Buildings to be excessed in “as is” condition:

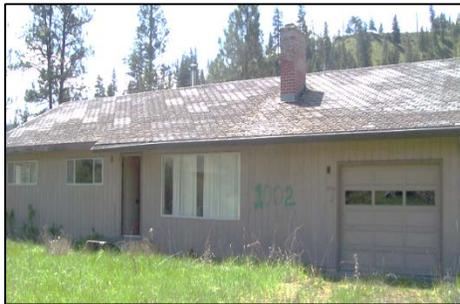
#1002, DALE DISTRICT RANGER RESIDENCE

Single story, single residence, 1,830 sq. ft., 3-bedroom wood framed house built in 1960. This house has a built-in fireplace as well as a Blaze King wood stove and an underground heating oil tank. It is intact with attached garage. The roof material is asphalt based 3-tab.

Asbestos testing was done and found in the linoleum located in the kitchen, laundry room, and restroom. Radon testing was completed with no detection. This building tested negative for Lead Based Paint.

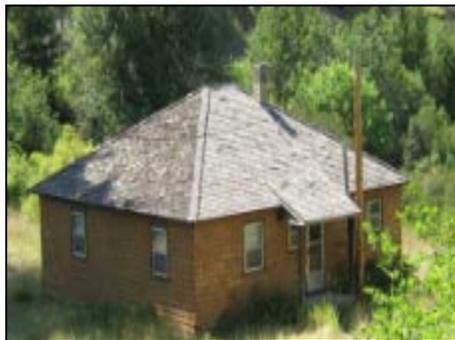
#1052, DALE RESIDENCE

Single story, single residence, 896 sq. ft., 2-bedroom wood framed house built in 1950. This house is intact with cedar shingle roof and siding.

Asbestos testing was done and found in the green linoleum located in the kitchen and laundry room and also in the taping compound. Radon testing was done and detected at 0.4 pci/L. This building tested positive for Lead Based Paint.

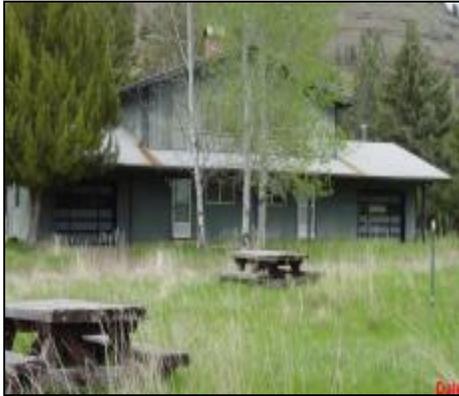
#1057, DALE DUPLEX

Two story, wood framed duplex totaling 2,552 sq. ft. Each unit has 2 bedrooms and attached garage built in 1966. This building has T-1-11 siding, asphalt based 3-tab roof material, aluminum frame windows, and underground heating oil tanks. One Blaze King wood stove located in garage of one unit.

Asbestos testing was done and found in the brown and white linoleum located in the kitchen and restroom. It was also located in the vibration joint cloth in the basement but was removed. Radon testing was done and detected at 1.0 pci/L. This building tested positive for Lead Based Paint on both garage doors (overhead and walk-through), and the ceiling of the front porch.

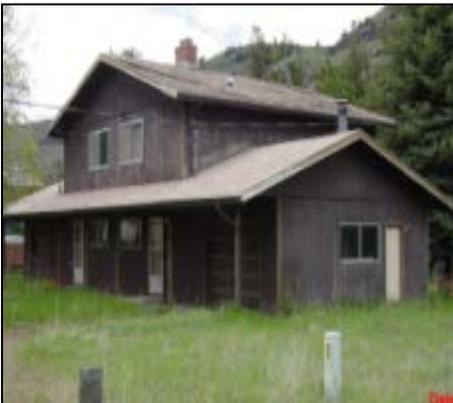
#1060, DALE DUPLEX

Two story, wood framed duplex totaling 2,752 sq. ft. Each unit has 2 bedrooms and attached garage built in 1965. This building has T-1-11 siding, asphalt based 3-tab roof material, aluminum frame windows, and underground heating oil tanks. One Blaze King wood stove located in garage of one unit.

Asbestos testing was done and found in the taping compound. Radon testing was done and detected at 1.2 pci/L. This building tested positive for Lead Based Paint on the exterior walk-through door to the garage.

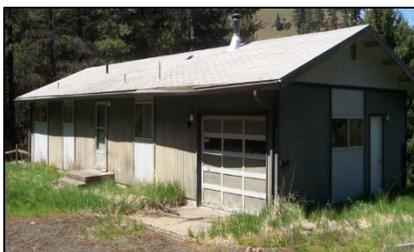
#1074, DALE RESIDENCE (similar to #1075 and #1076)

Single story with day light basement, single residence with attached garage, 1,008 sq. ft., 2-bedroom, wood framed house built in 1969. This building has T-1-11 siding, asphalt based 3-tab roof material, aluminum frame windows, and a Blaze King wood stove.

Asbestos testing was done and found in the 12x12 white floor tiles located in the living room. Radon testing was done and detected at 1.1 pci/L. This building tested negative for Lead Based Paint.

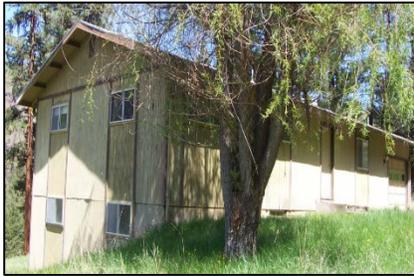
#1075, DALE RESIDENCE (similar to #1074 and #1076)

Single story with day light basement, single residence with attached garage, 1,008 sq. ft., 2-bedroom, wood framed house built in 1969. This building has T-1-11 siding, asphalt based 3-tab roof material, aluminum frame windows, and a Blaze King wood stove.

Asbestos testing was done and found in the 12x12 white floor tiles located upstairs and also in the linoleum in the kitchen and foyer. Radon testing was done and detected at 0.7 pci/L. This building tested negative for Lead Based Paint.

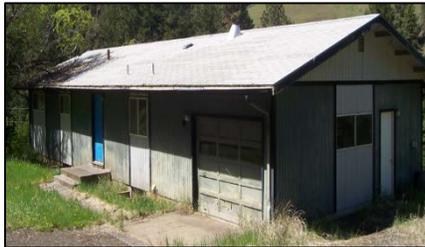
#1076, DALE RESIDENCE (similar to #1074 and #1075)

Single story with day light basement, single residence with attached garage, 1,008 sq. ft., 2-bedroom, wood framed house built in 1969. This building has T-1-11 siding, asphalt based 3-tab roof material, aluminum frame windows, and a Blaze King wood stove.

Asbestos testing was done and found in the 12x12 white floor tiles located upstairs and also in the linoleum located in the upstairs rest room. Radon testing was done and detected at 0.7 pci/L. This building tested negative for Lead Based Paint.

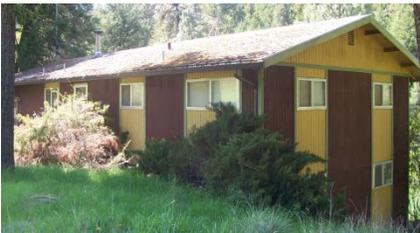
#1082, DALE RESIDENCE

Single story with day light basement, single residence with attached garage, 1,008 sq. ft., 2-bedroom, wood framed house built in 1969. This building has T-1-11 siding, asphalt based 3-tab roof material, and aluminum frame windows.

This building tested negative for Lead Based Paint.

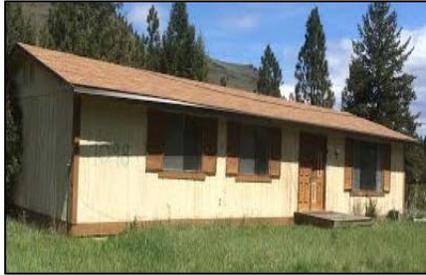
#1098, DALE MODULAR

Single story, single residence, 1,344 sq. ft., 3-bedroom modular home placed on site in 1974. This building has T-1-11 siding, asphalt based 3-tab roof material, and aluminum frame windows.

Asbestos testing was done and found in the linoleum located in the foyer, hall, and restroom as well as in the acoustical plaster located in the living room, bedroom, and office. Radon testing was done and detected at 0.5 pci/L. This building tested negative for Lead Based Paint.

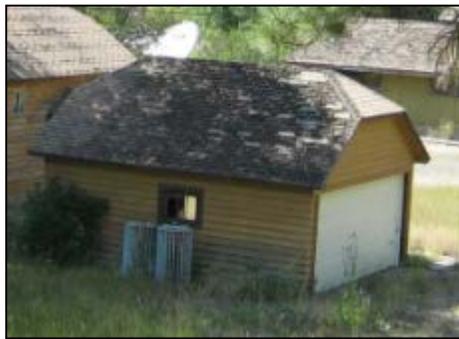
#1500, DALE GARAGE

360 sq. ft. wood framed garage built in 1933 sits on a slab and stem wall. Unfinished interior with bare 2x4 stud walls. Newer overhead door, asphalt based 3-tab roof material, and lap siding.

Asbestos testing was done and found in the tan and beige floor tiles throughout the building. Radon testing was completed with no detection. This building tested positive for Lead Based Paint on the trim and windows.

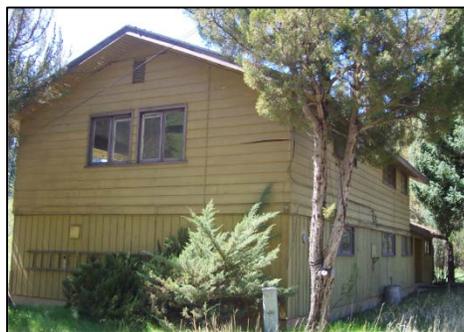
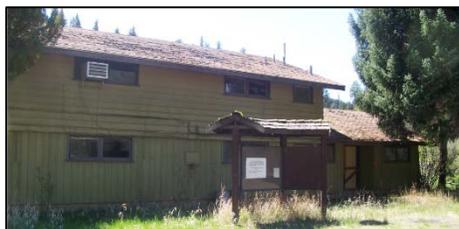
#2002, DALE RANGER STATION OFFICE

Two story, wood framed office building totaling 3,536 sq. ft. built in 1960. It sits on a slab and turned down edge. Main office area finished in V groove knotty pine. Asphalt based 3-tab roof material and wood frame windows and wood siding. This building has an underground heating oil tank.

Asbestos testing was done and found in the tan and beige floor tile located in all of the building. Radon testing was done and detected at 0.4 pci/L. This building tested positive for Lead Based Paint.
