CTWS/BPA Final Project Reporting Outline

2. **Camp Creek Headwaters Project 2016**

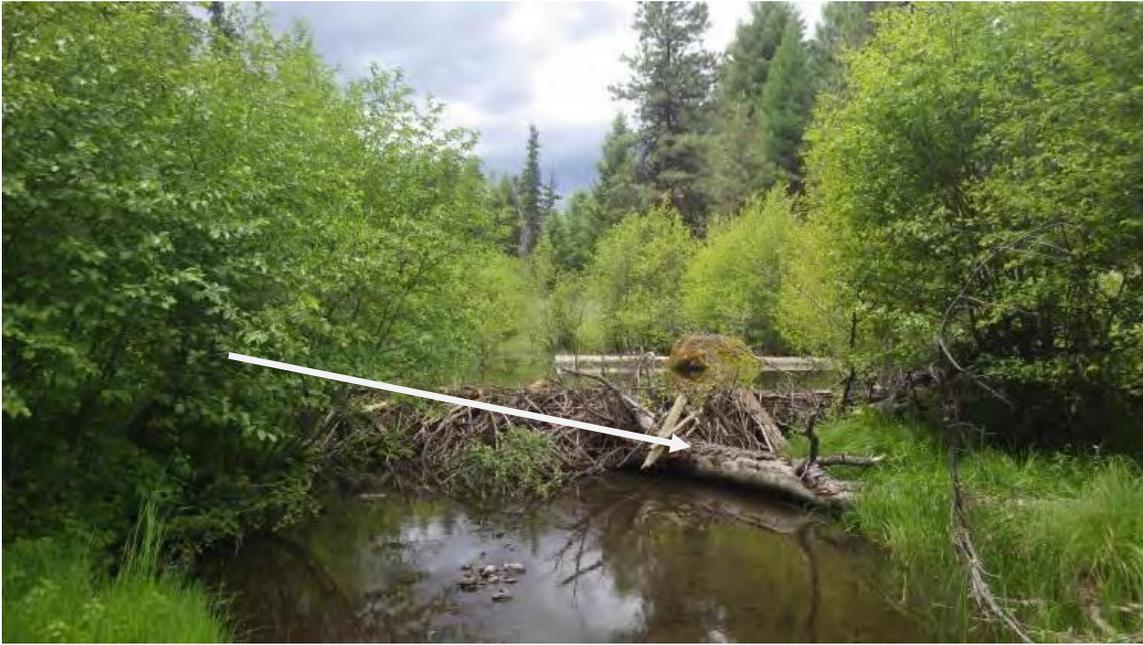
Figure 1: Medium size (< 12 inch) diameter ponderosa pine placed in mid-channel in 2011 following log weir removal. Beaver dam has incorporated rootwad into center of dam (6/15/2014).

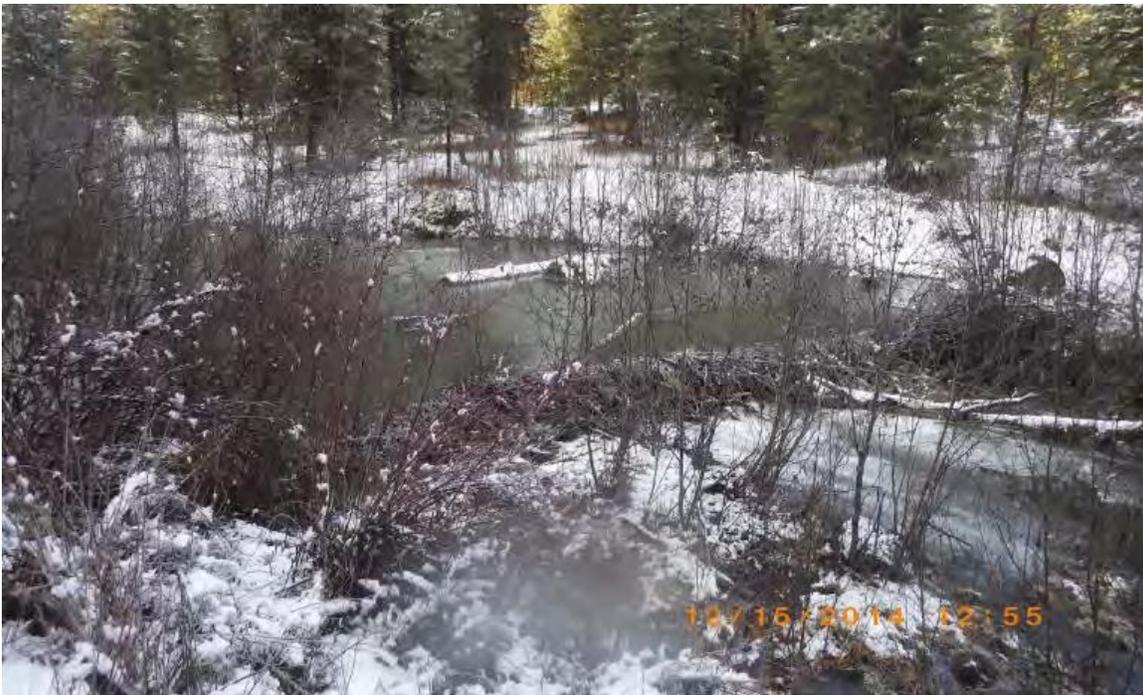
Figure 2: Beaver dam with rootwad incorporated (12/15/14)

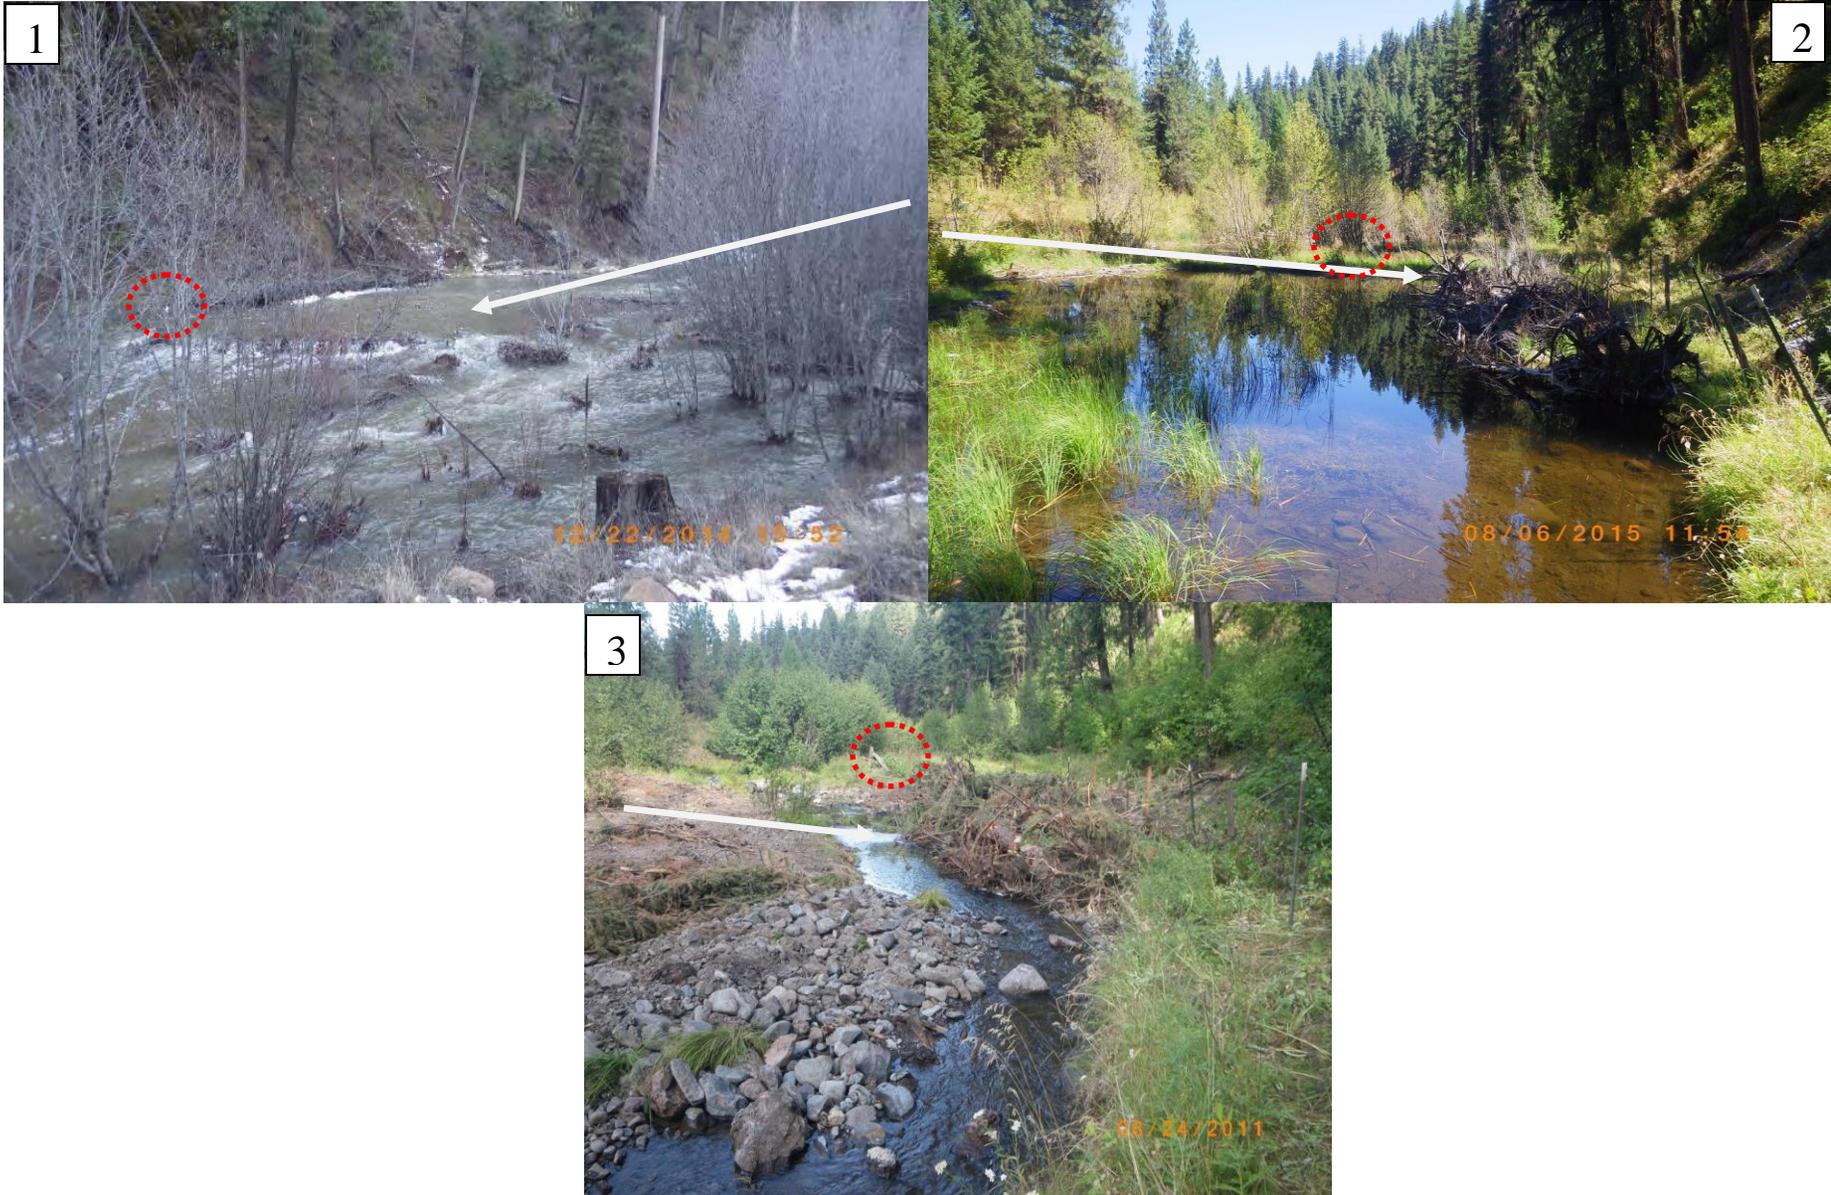
Figure 3: Valley bottom being inundated with moderate flood because of beaver dam influence (12/22/14) (1). Arrow indicates log structure where pool was excavated in 2011. Wood structure and pool immediately following construction 2011 (same as 1) (3). Same area and jam 2015 (2)

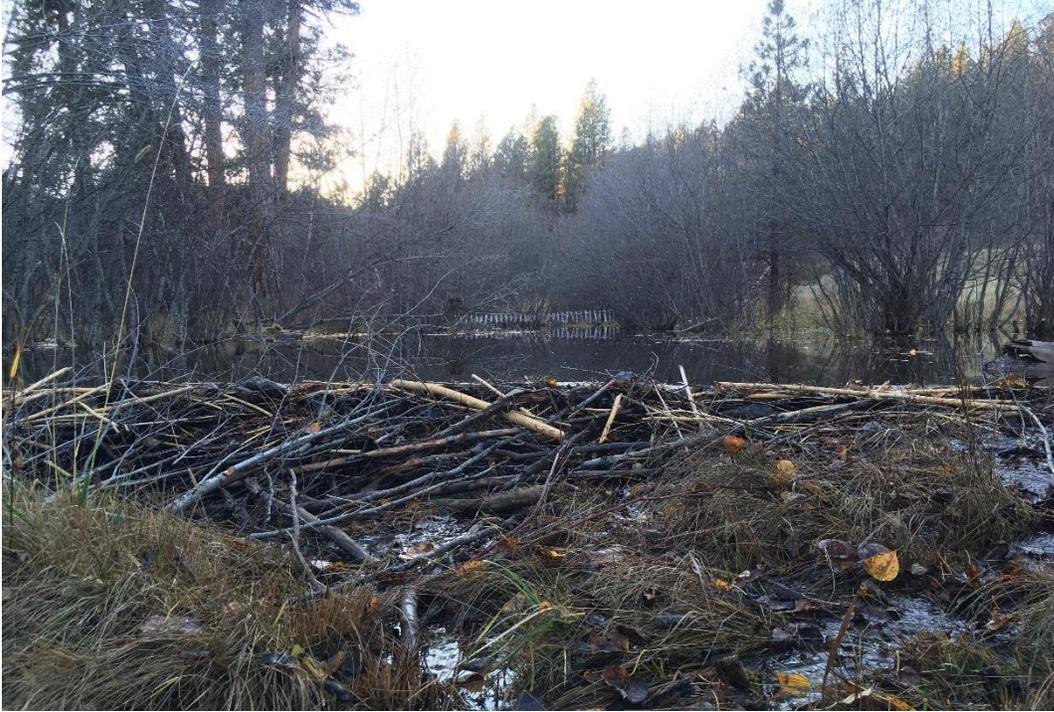
Figure 4 Example of new beaver dam on Camp Creek approximately 3 miles below Camp Creek Headwaters Project Area that was constructed in 2016 and is assumed to be related to offspring from previous colony that originated in 2014 within 2011 restoration work.

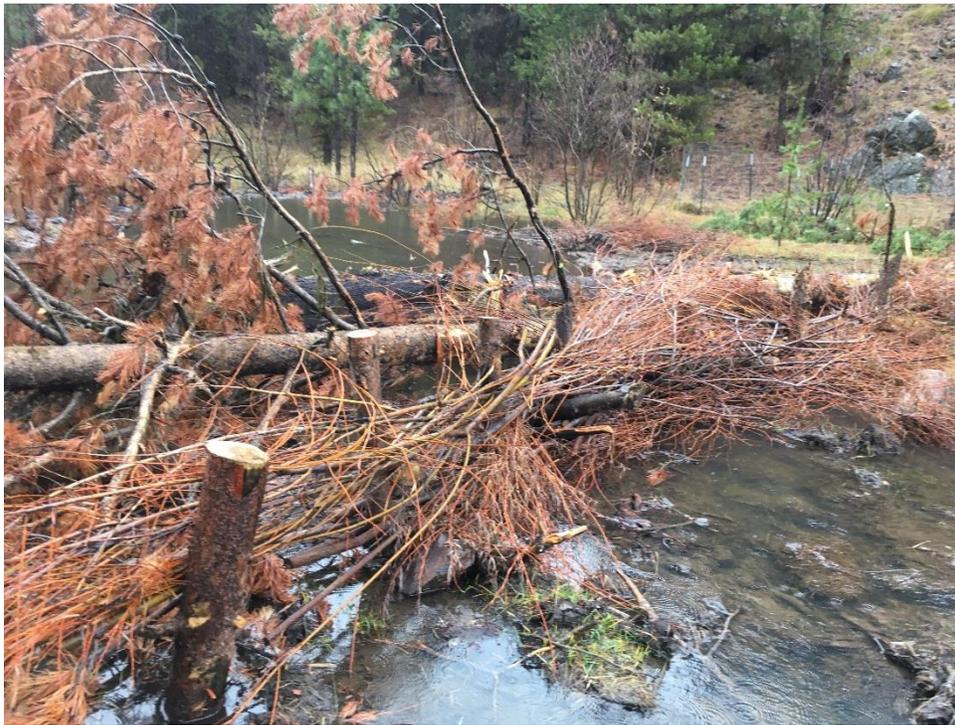
Figure 5: Beaver dam analog with posts and willow weaves installed prior to sealing. Whole lodgepole trees with rootwad were placed in front of and behind BDA's to dissipate stream energy (flanking of BDA) and provide additional cover for beaver and fish.

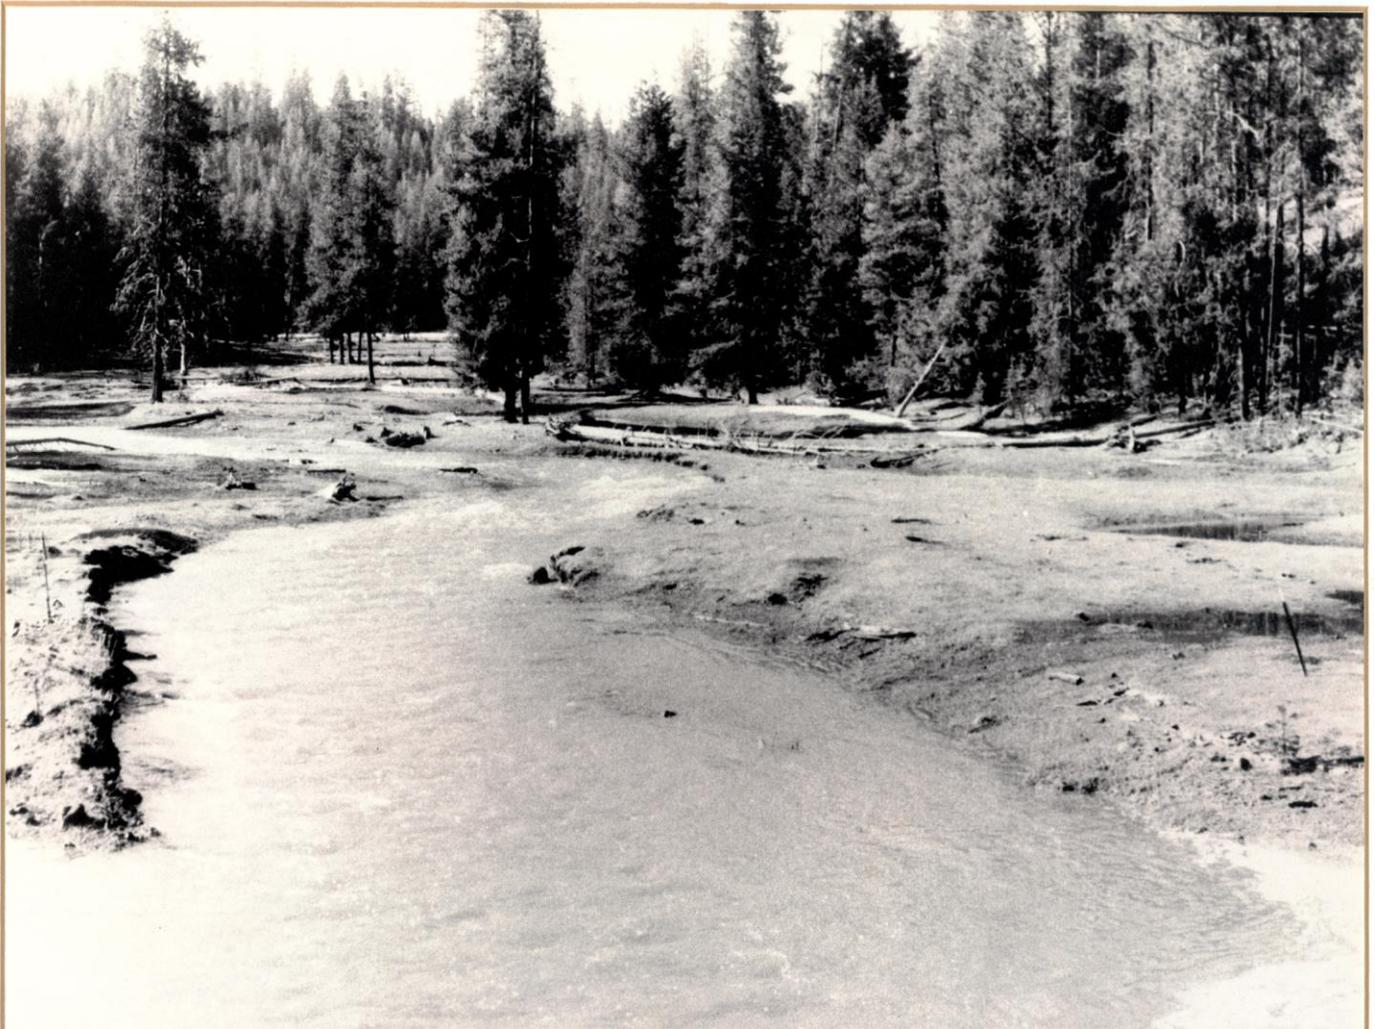
Figure 6 : Camp Creek within project area in 1970s.

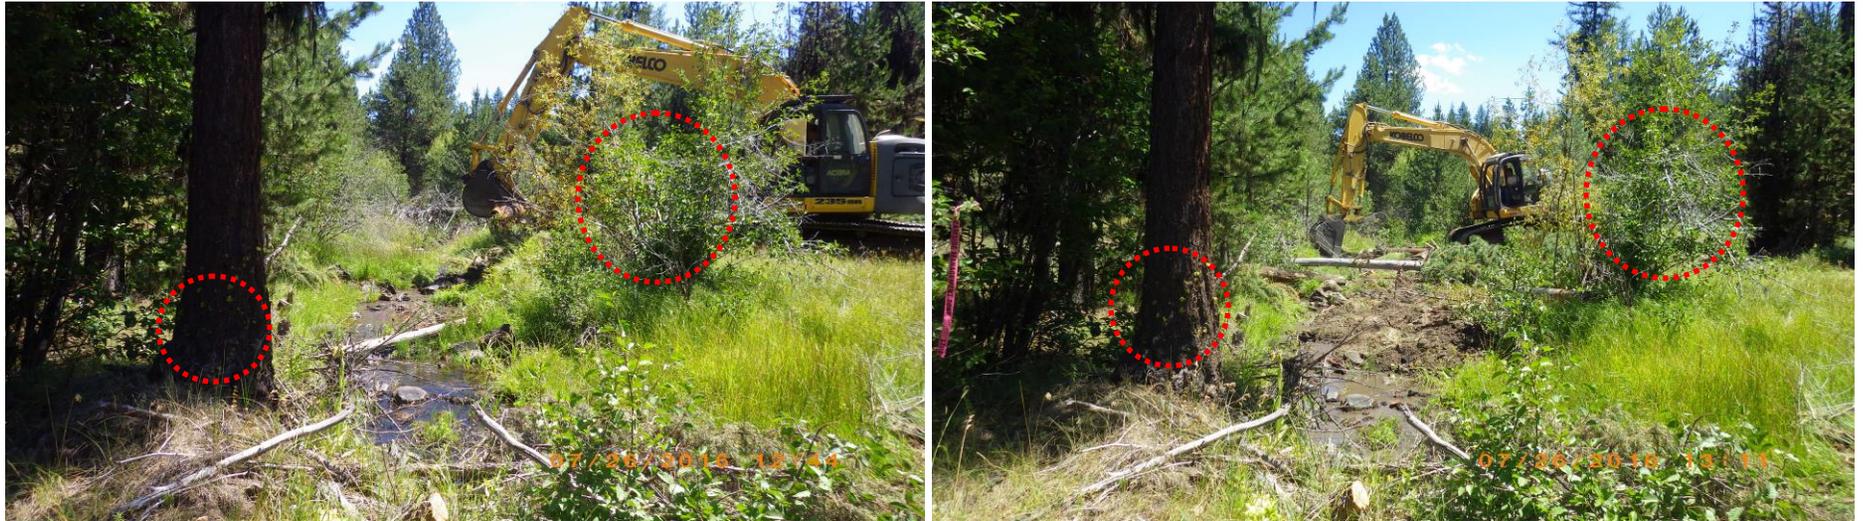
Figure 8: Removing log weirs and re-contouring legacy berms on right river bank (notice how high excavator is sitting in photos)

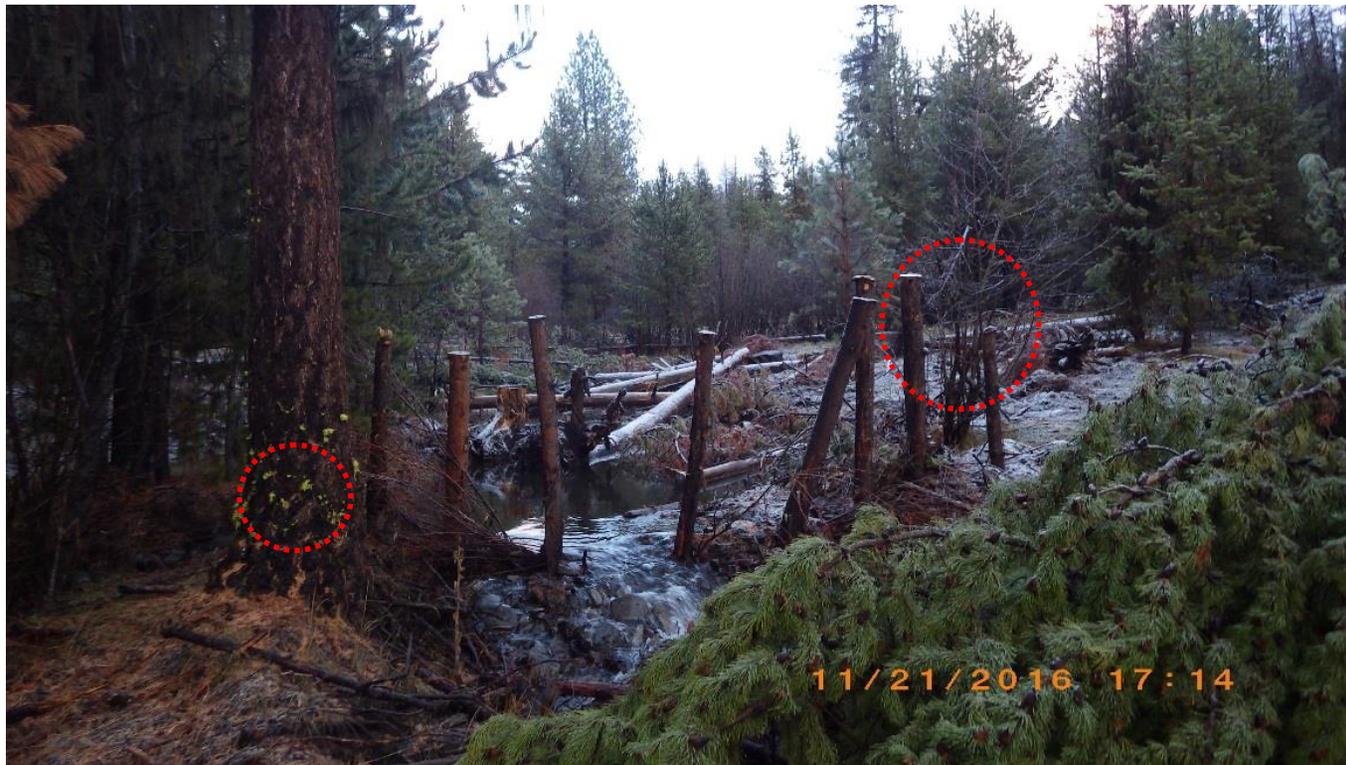
Figure 9: finished product from figure 6 with log weirs removed/modified, legacy berm recontoured and beaver dam analog constructed with wood placement

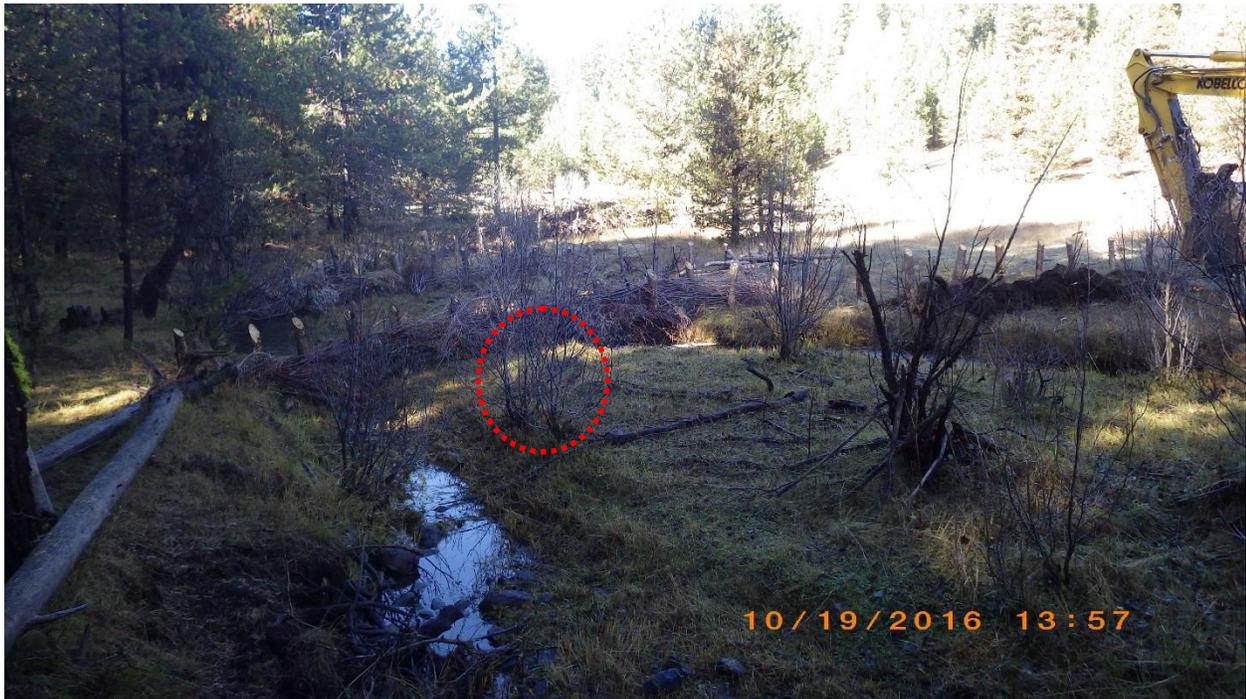
Figure 10: A beaver dam analog after posts have been driven into the streambed and willows woven through posts. Existing sedge clumps were also used to cover willow bundles and seal BDA

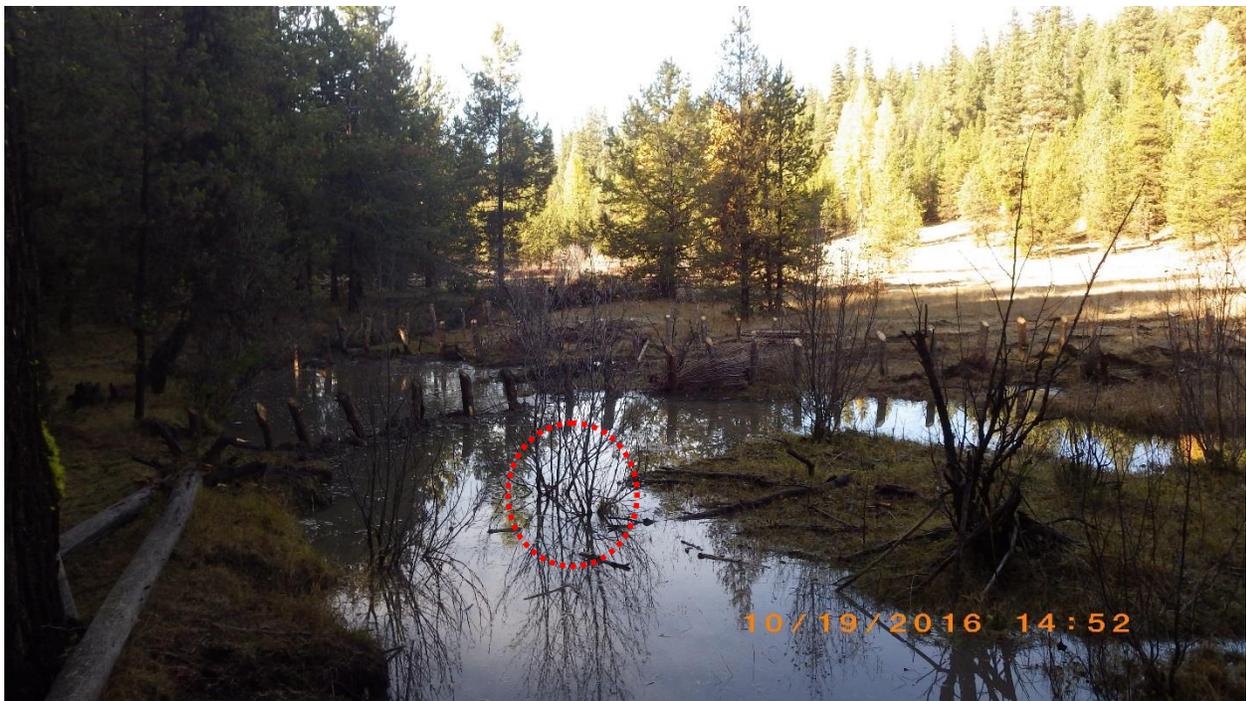
Figure 11: The same BDA complex impounding water after it was sealed with stream substrate material.

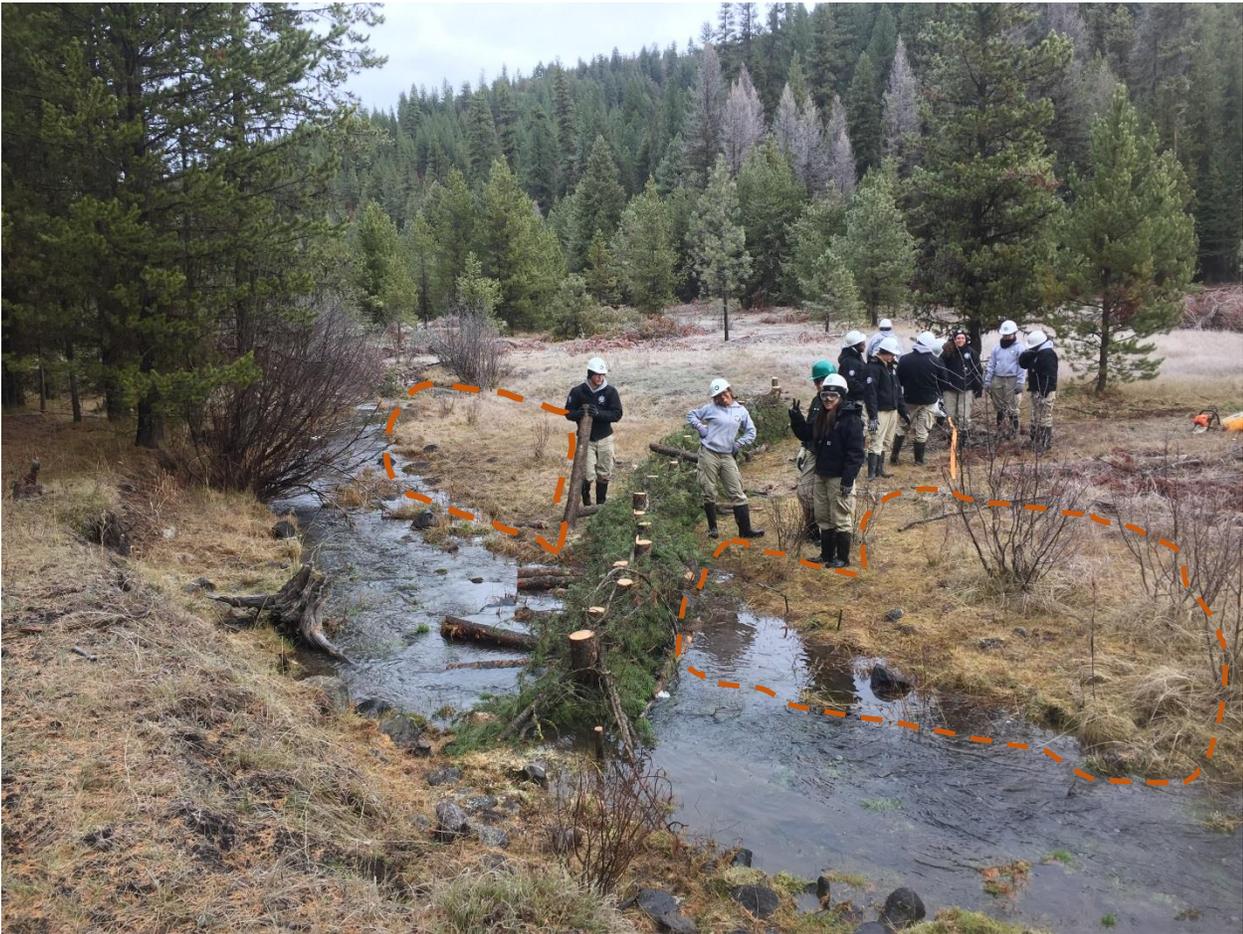
Figure 12: Example of Post Vane with AmeriCorps crew- direct flow towards cut bank and activate over flow channel by pooling water during high flows (Where group is standing), brown dashed line represents deposition area-point bar

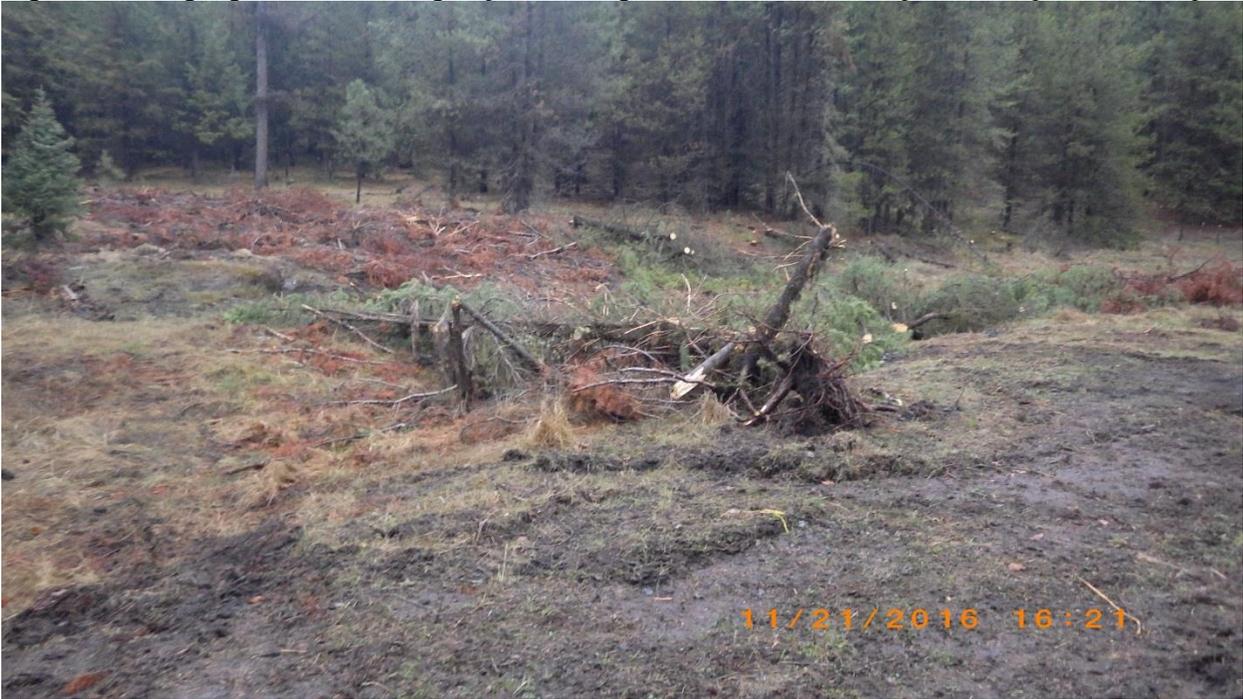
Figure 13: Example of historic flow path with small wood jam. Lodgepole were also felled and staged in overflow channel above structures

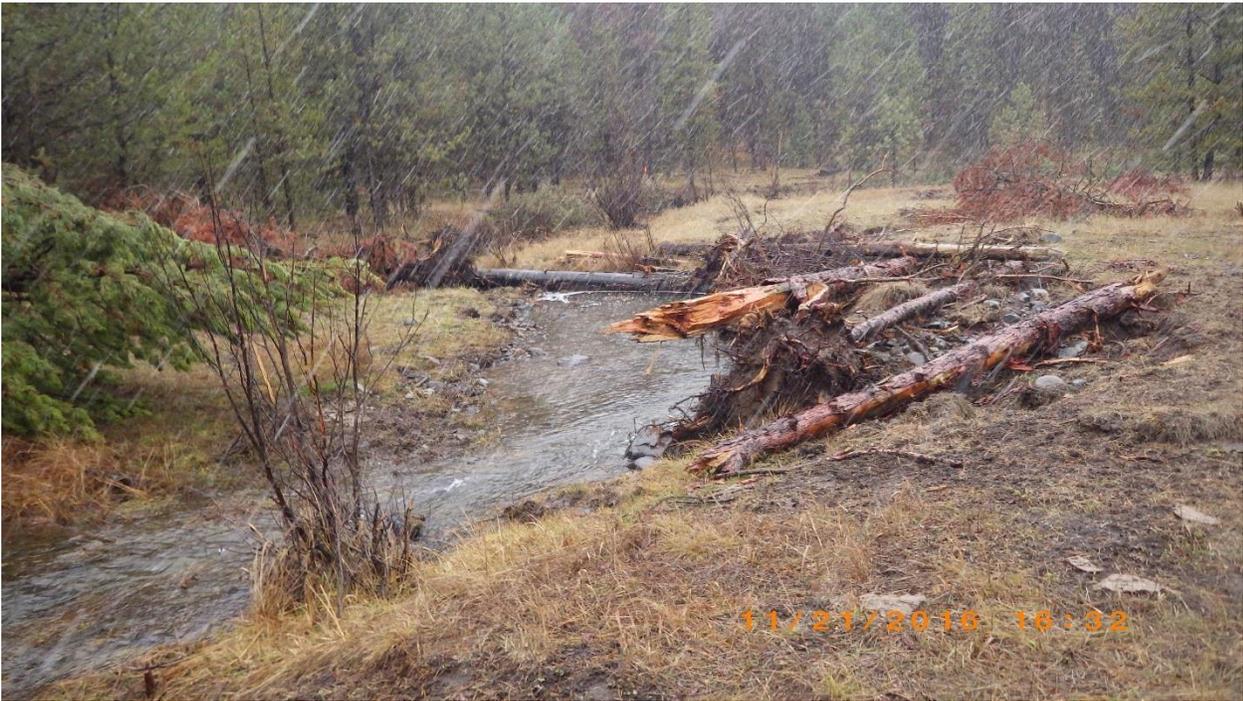
Figure 14: Example of Large Wood Structure with spawning gravel tailout (primary fish habitat)

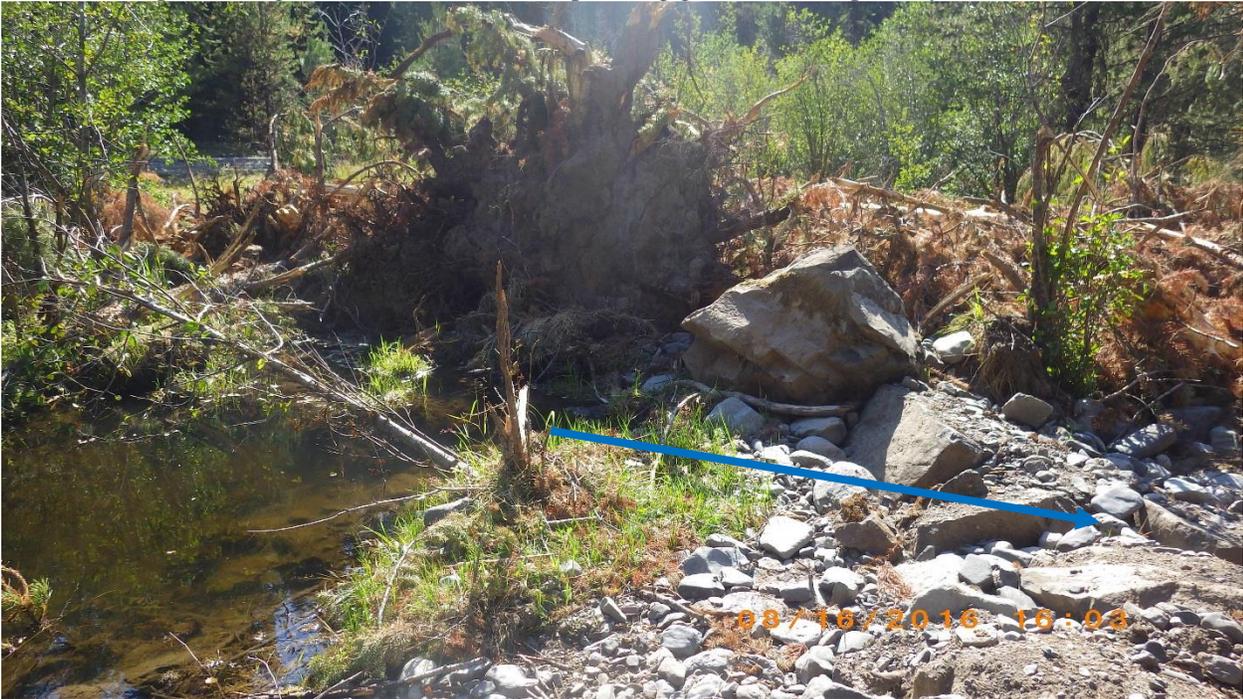
Figure 15: Example of channel spanning wood jam and historical flow path activation (rock was removed from log weir). When built log weir effectively cut off over flow path

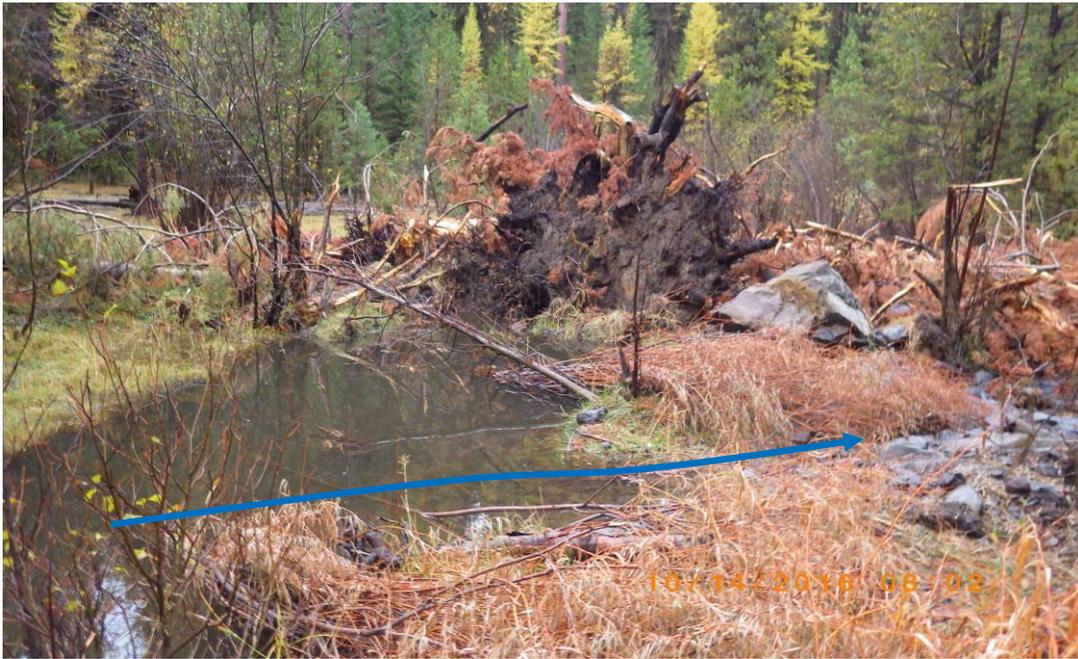
Figure 16: Same structure as figure 15 following fall rains, notice water already percolating thru substrate on right side into 1/4 mile of abandoned over flow channel

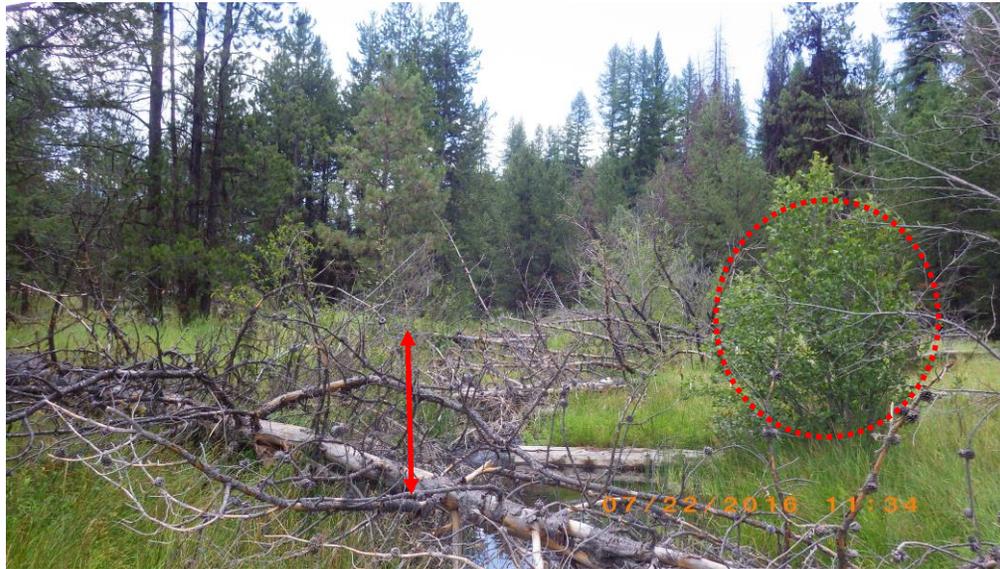
Figure 18: Log weirs with portions cut with chainsaw 2012, red arrow indicates 2-4 foot elevation change (berm)

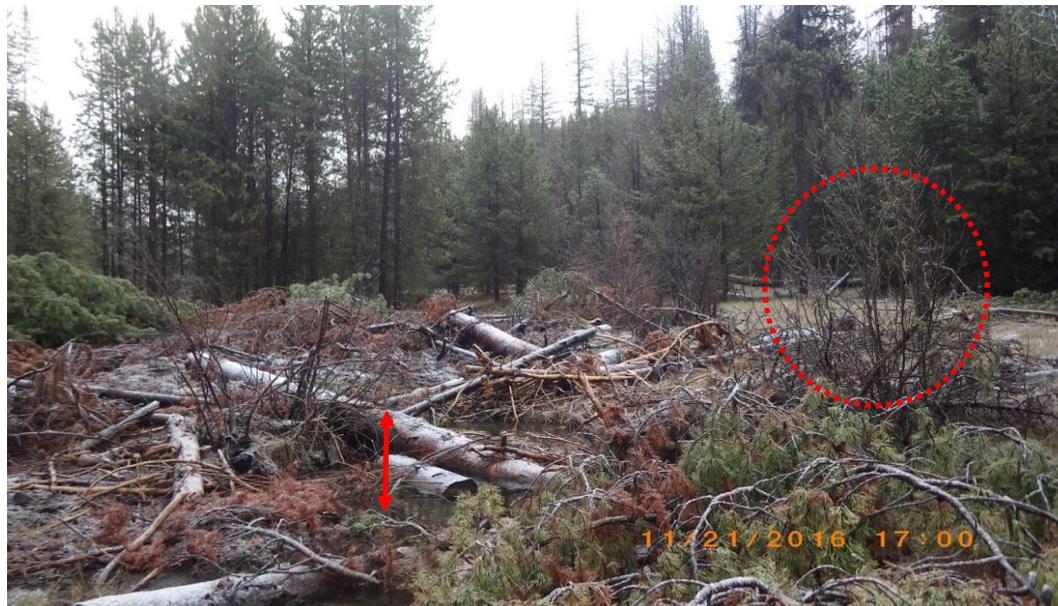
Figure 19: Log weir modified and legacy berm removed 2016

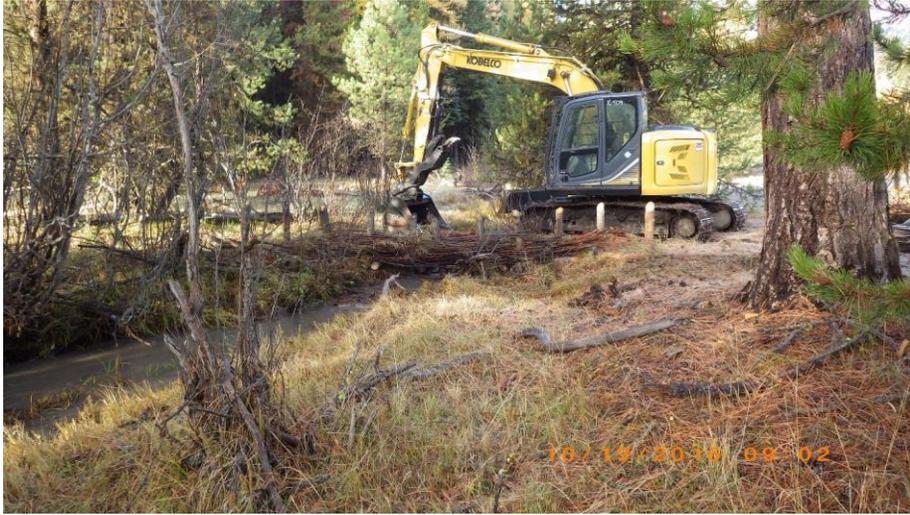
Figure 20: BDA with willows woven through posts.

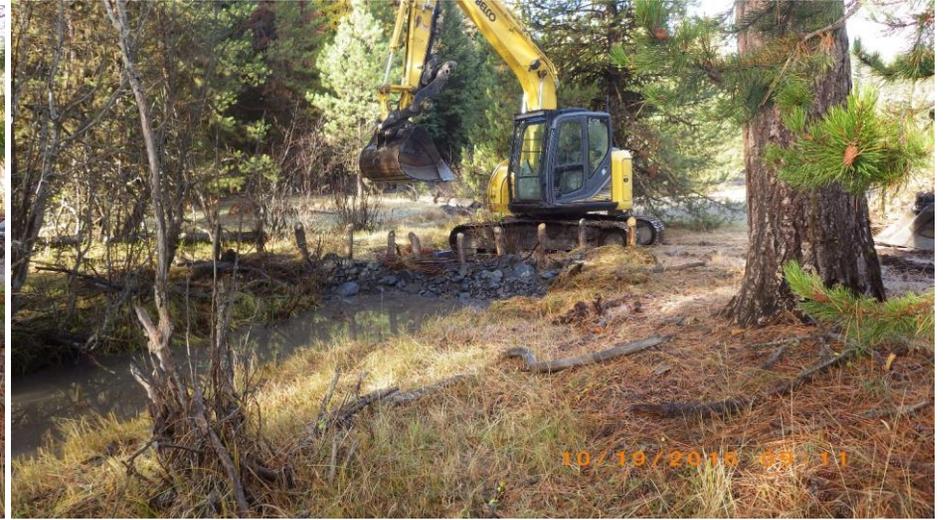
Figure 21: BDA with willows and substrate material sealing it.

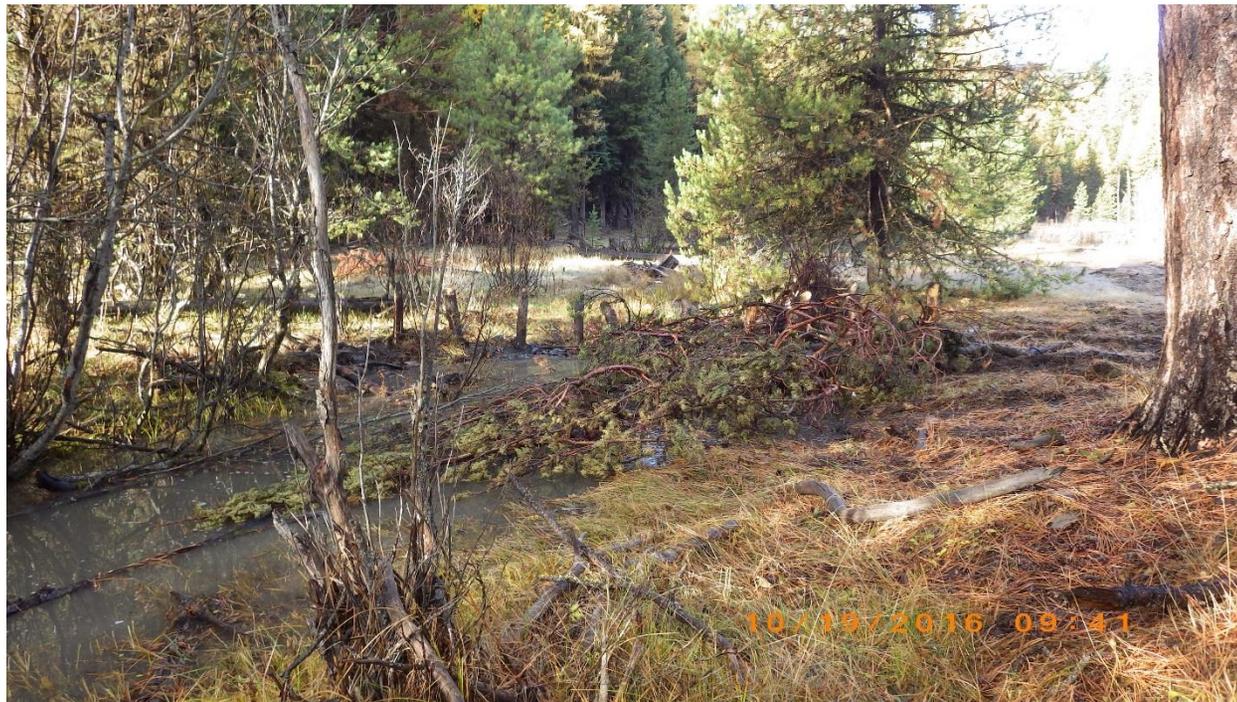
Figure 22: BDA fully sealed and impounding water. Large wood was added near bank to deter livestock and wildlife access to sprouting willows as well as to provide fish habitat complexity and beaver habitat.

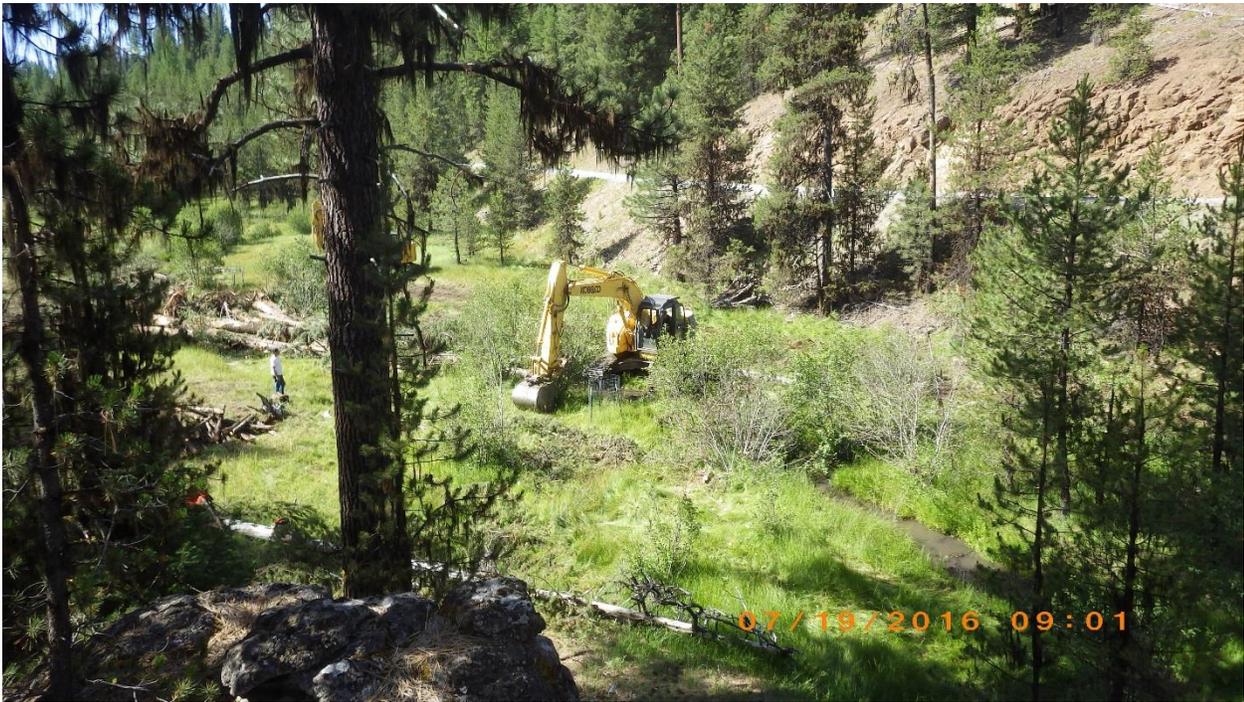
Figure 23: BDA complex and large wood jam during construction.

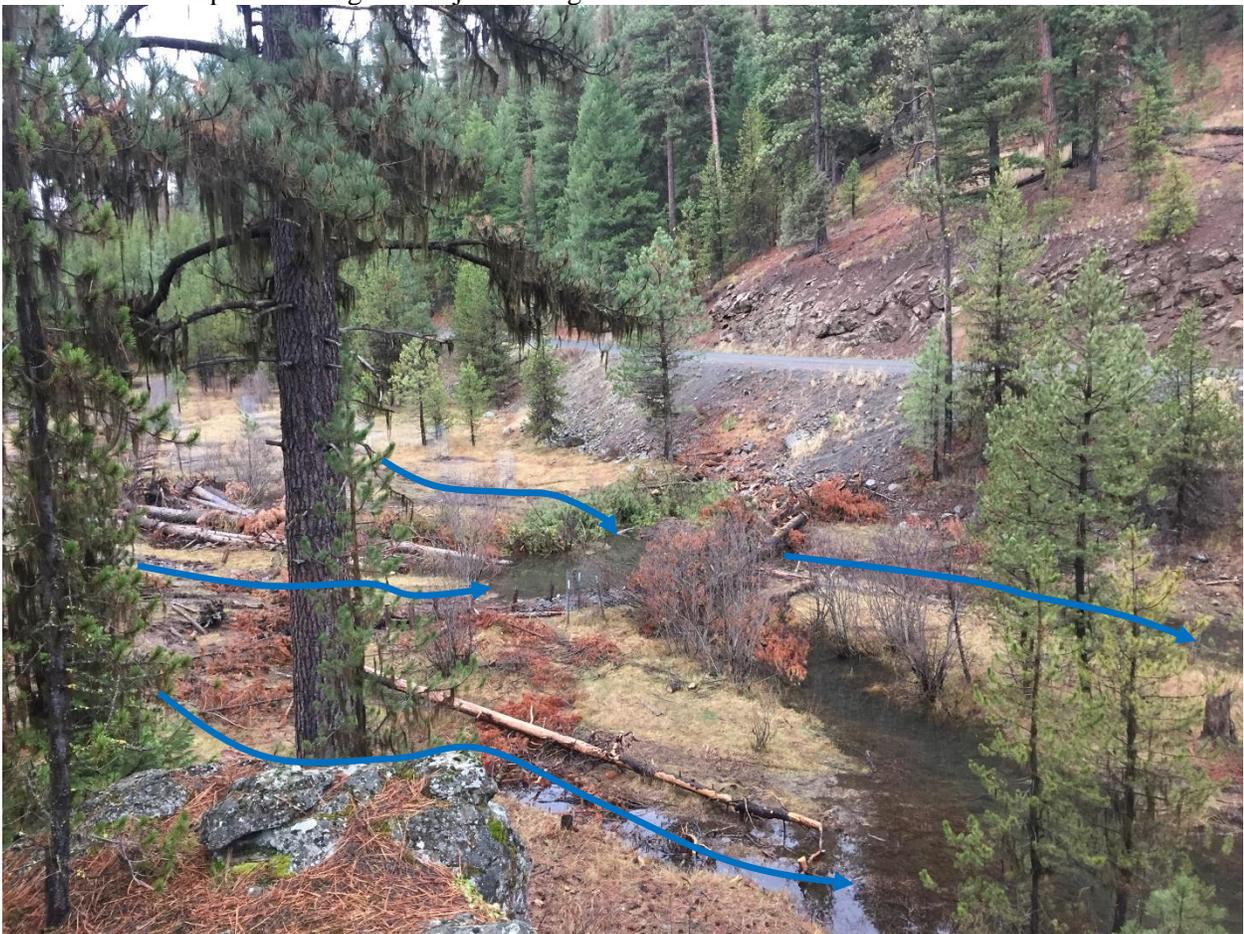
Figure 24: BDA complex with large wood jam just upstream after BDA sealing was completed. Combination of channel spanning wood jam (activate three overflow channels/dissipate stream energy/fish habitat/elevate water table) with BDA series (elevate water table/sediment deposition/pool habitat/ riparian shrub expansion). Wood jam is inundated as well as over flow channels reentry by BDA complex. Blue lines indicate over flow channels

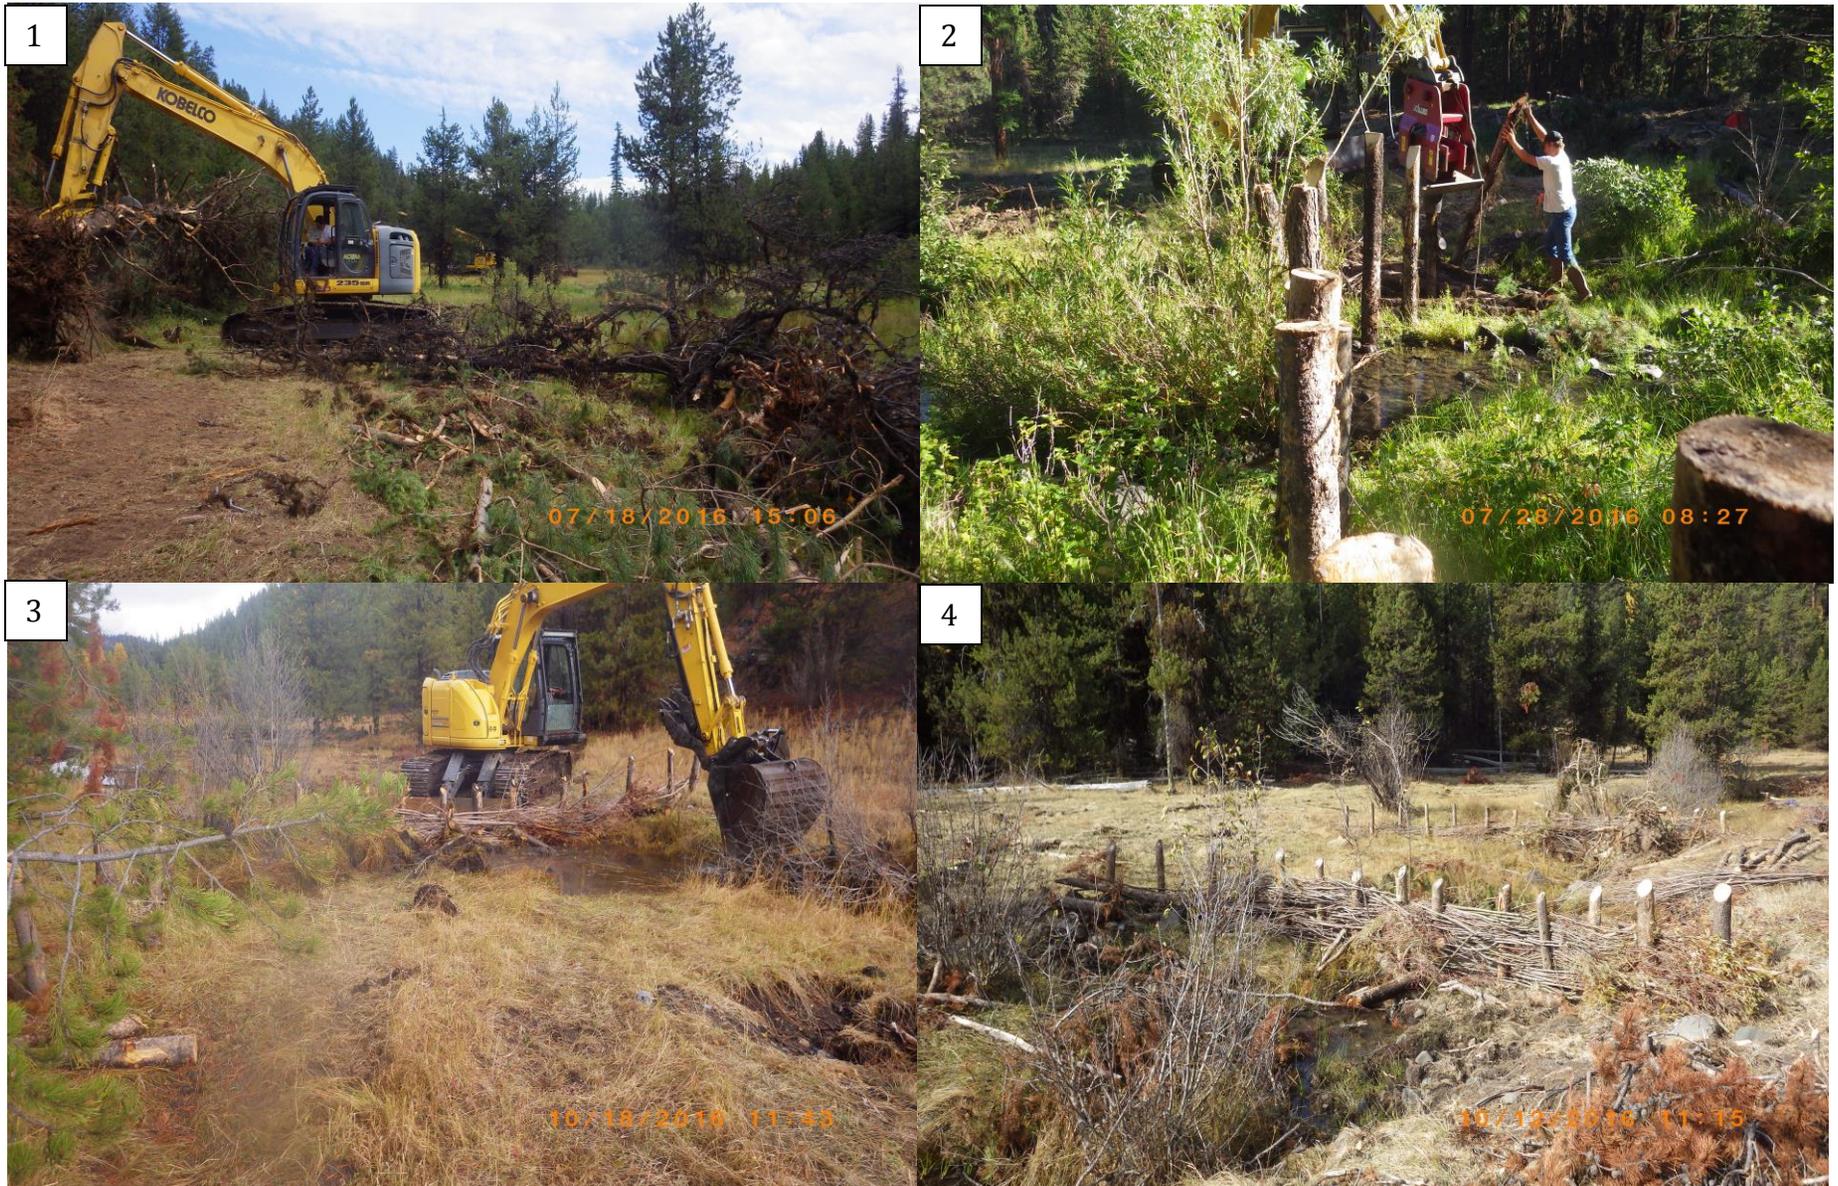
Figure 25: Excavator placing small wood (lodgepole) within over flow channel (1), Excavator with compactor head driving posts for BDA structure (2), Excavator with wide bucket for scraping sedge mats, substrate and soil related to BDA sealing over willow weaves (3), BDA with willow weaves prior to sealing (4).
