CTWS/BPA Final Project Reporting Outline

2. **Camp Creek Headwaters Project 2016**

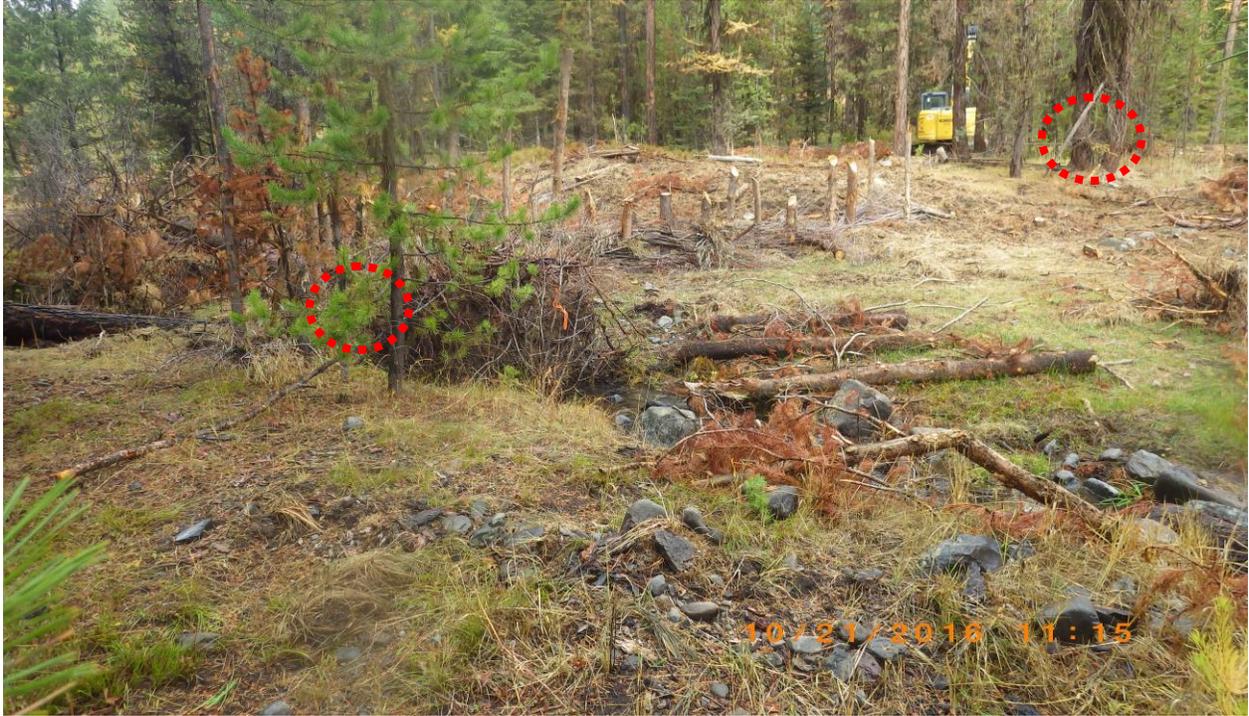
Figure 26: BDA with associated wood jam prior to sealing (Figure 27 below)

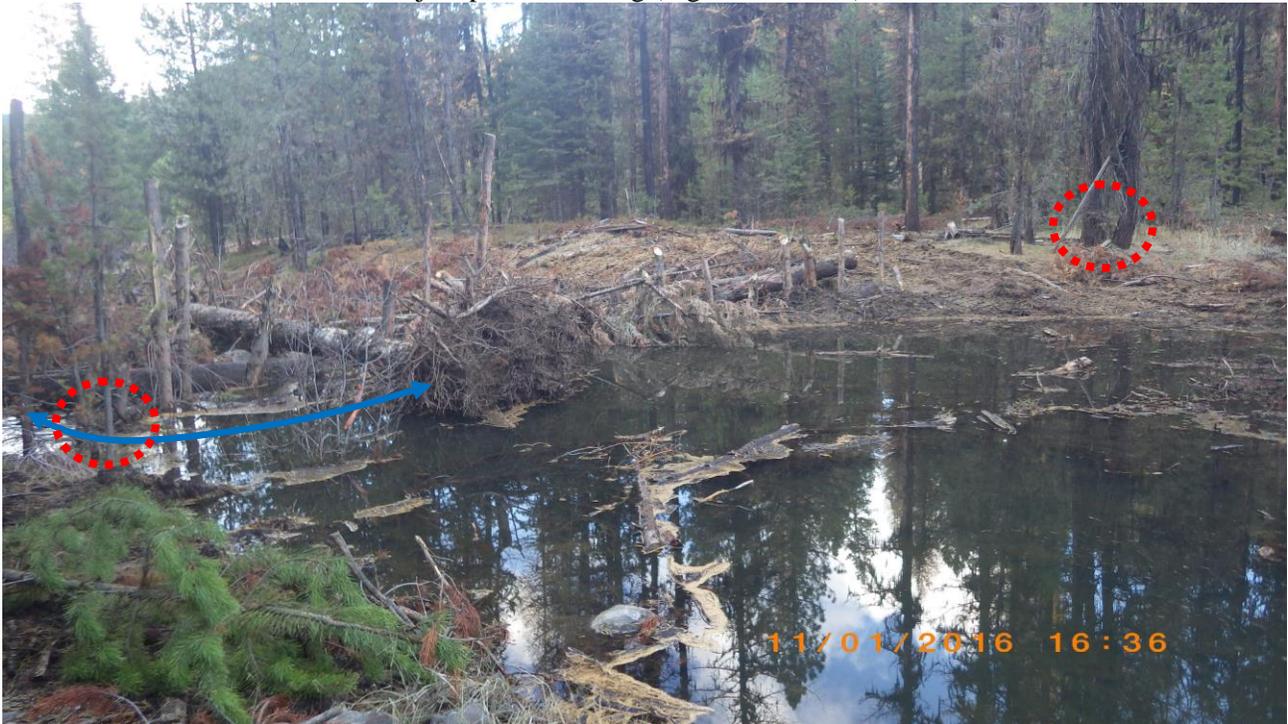
Figure 27: Completed beaver dam analogue with wood jam (below) and trees with root wads locked into BDA posts. BDA locations were determined by valley pinch points and height of floodplain above channel (level of inundation) by BDA

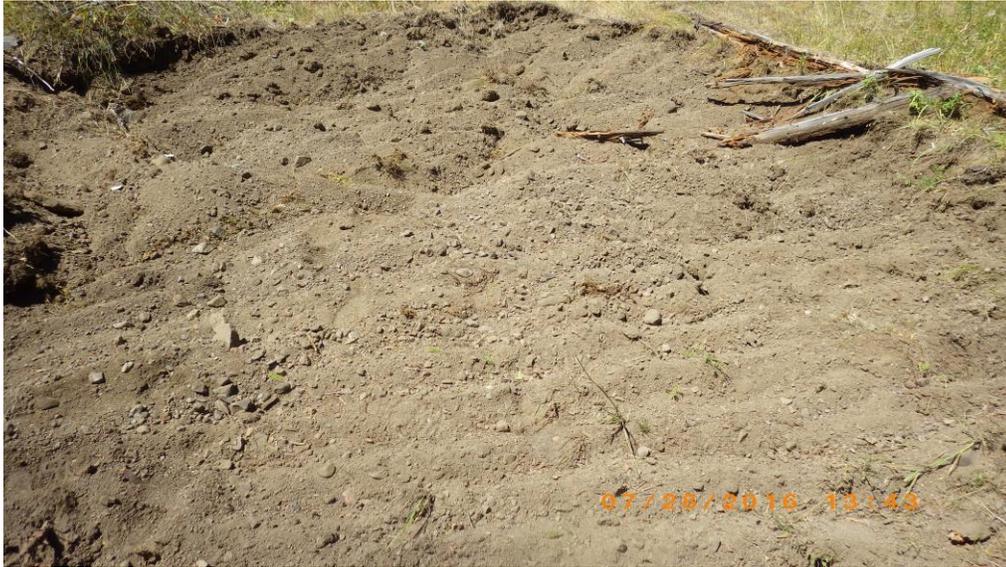
Figure 28: point bars and elevated bars associated with abandoned over flow channels (covered by mesic grasses) were scraped in several locations to facilitate recruitment of gravels and fine sediment during high discharge events

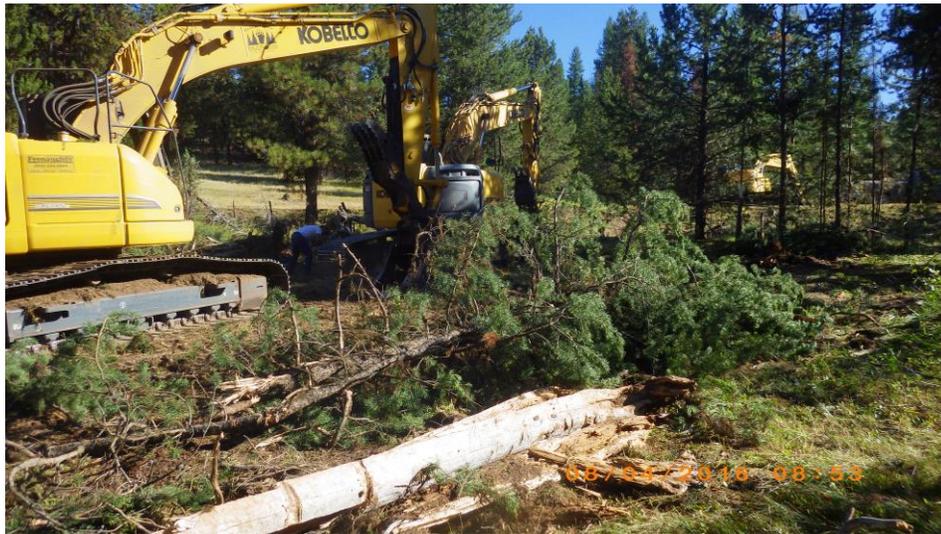
Figure 29: Three excavators were utilized for project. One excavator operator focused on tipping and small wood jams on over flow channels, other operator and excavator focused on tipping trees and large wood jams/legacy berm removal log weirs. The third smallest excavator was utilized solely for putting in BDA posts and was later brought back to complete BDA sealing and planting.

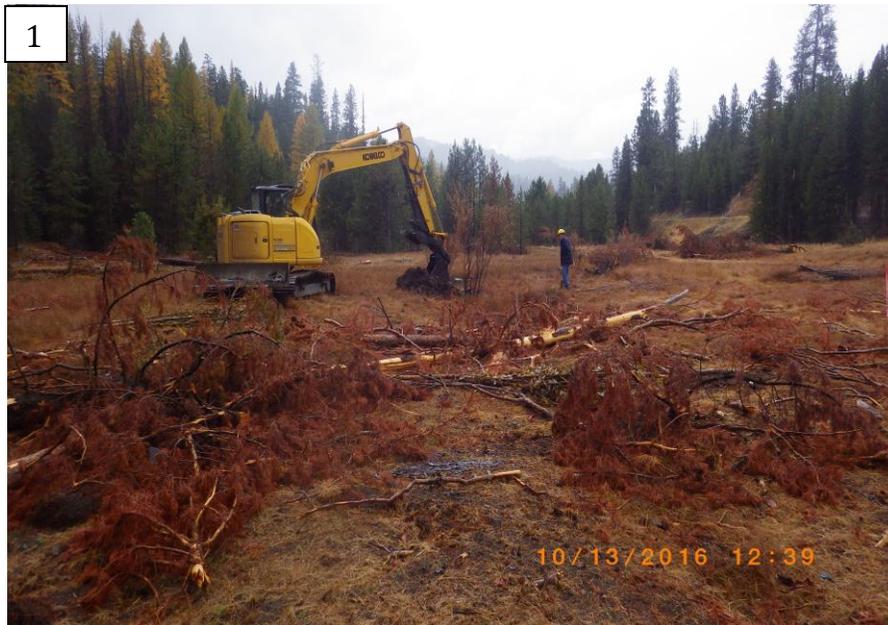
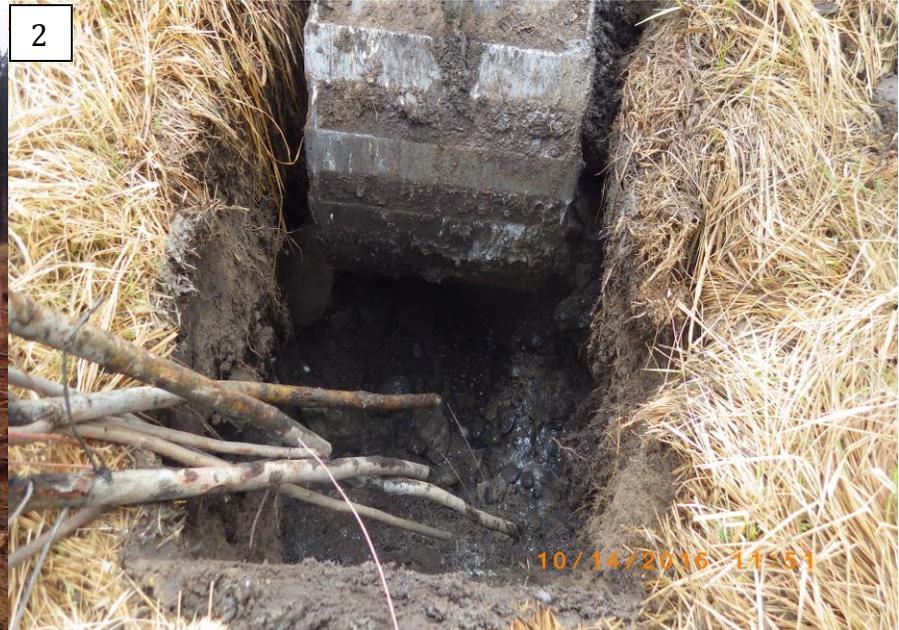
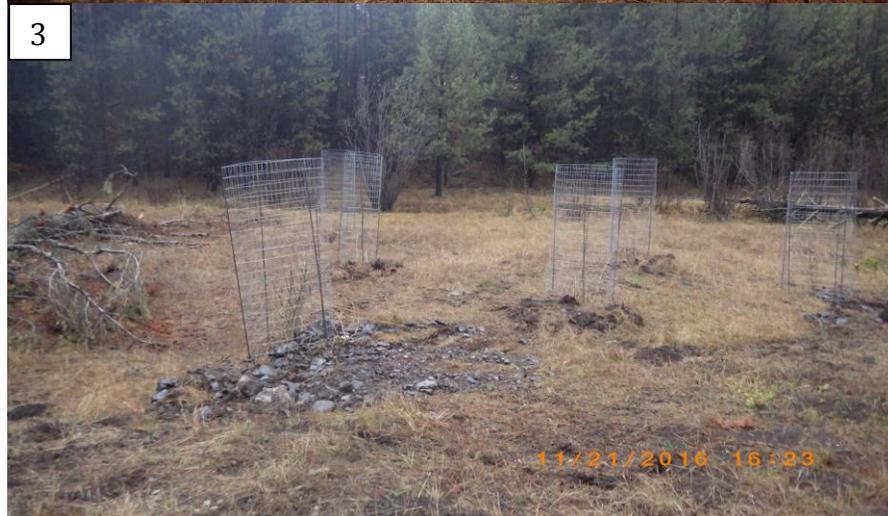
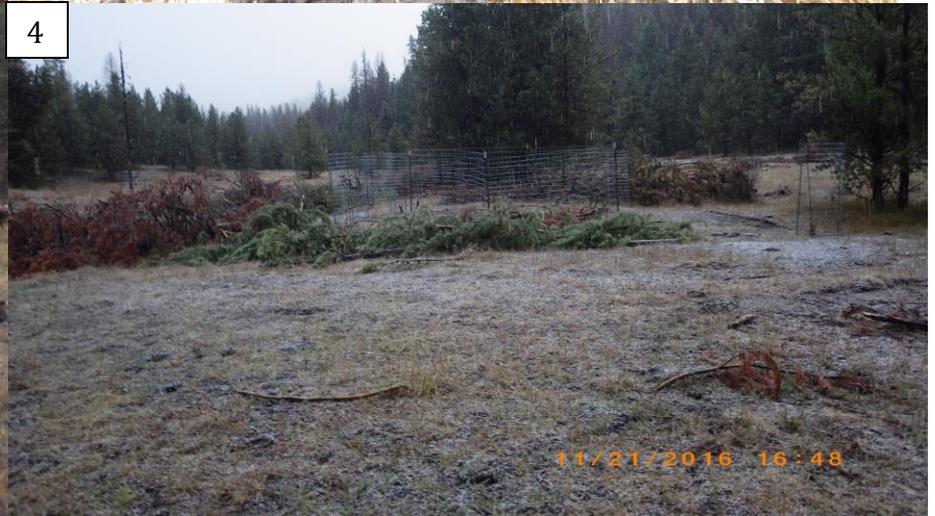
Figure 30: Planting willow clusters with an excavator bucket (1), close up view of bucket reaching water table (2), caged cottonwood clusters (3), Fenced willow “patch” with over flow channel (4)
