**Appendix E**  
***Post-Fire Vegetative Re-Growth in Riparian Areas***  
***Photographs***

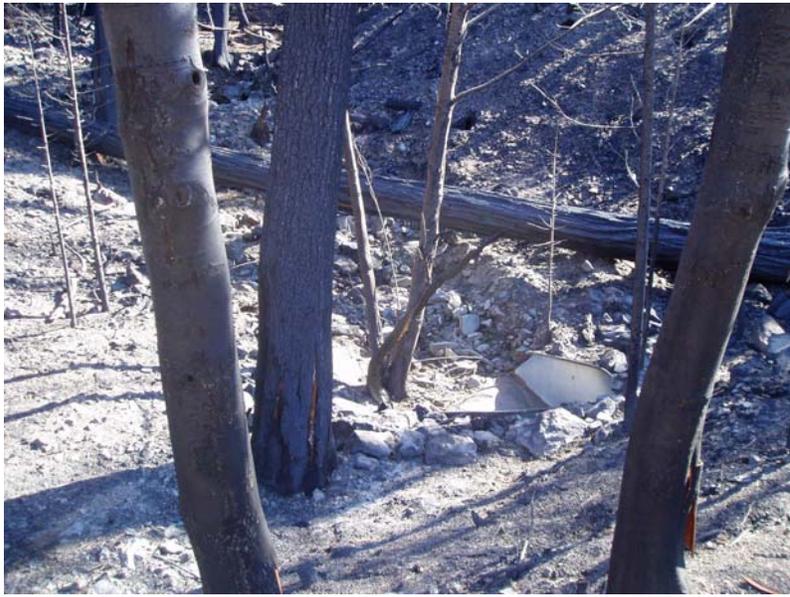
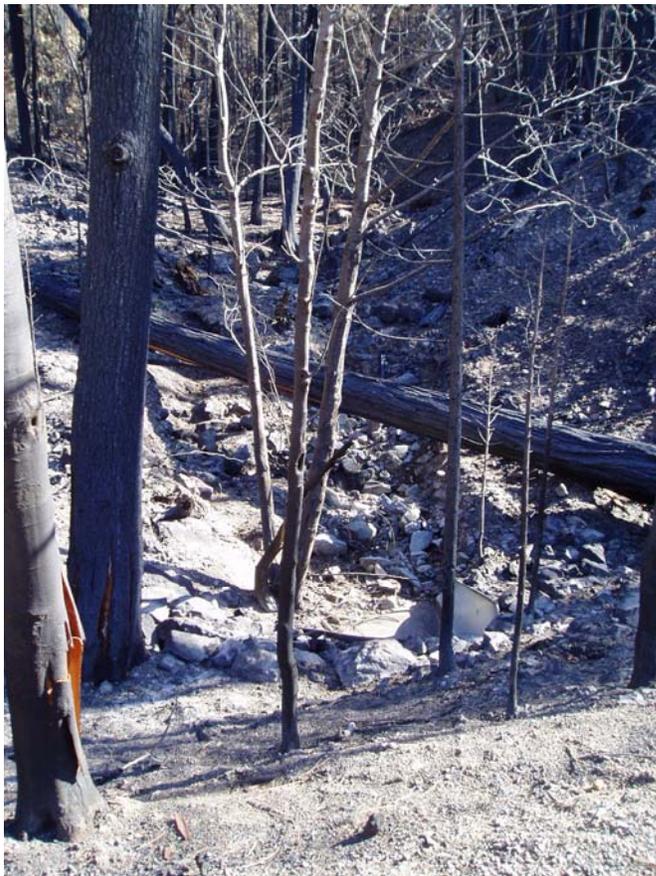
**Figure 1: Post-fire photos, taken November 2007, of the same intermittent stream above Road 29N46, within project unit 11b, in the Moonlight Creek watershed.**

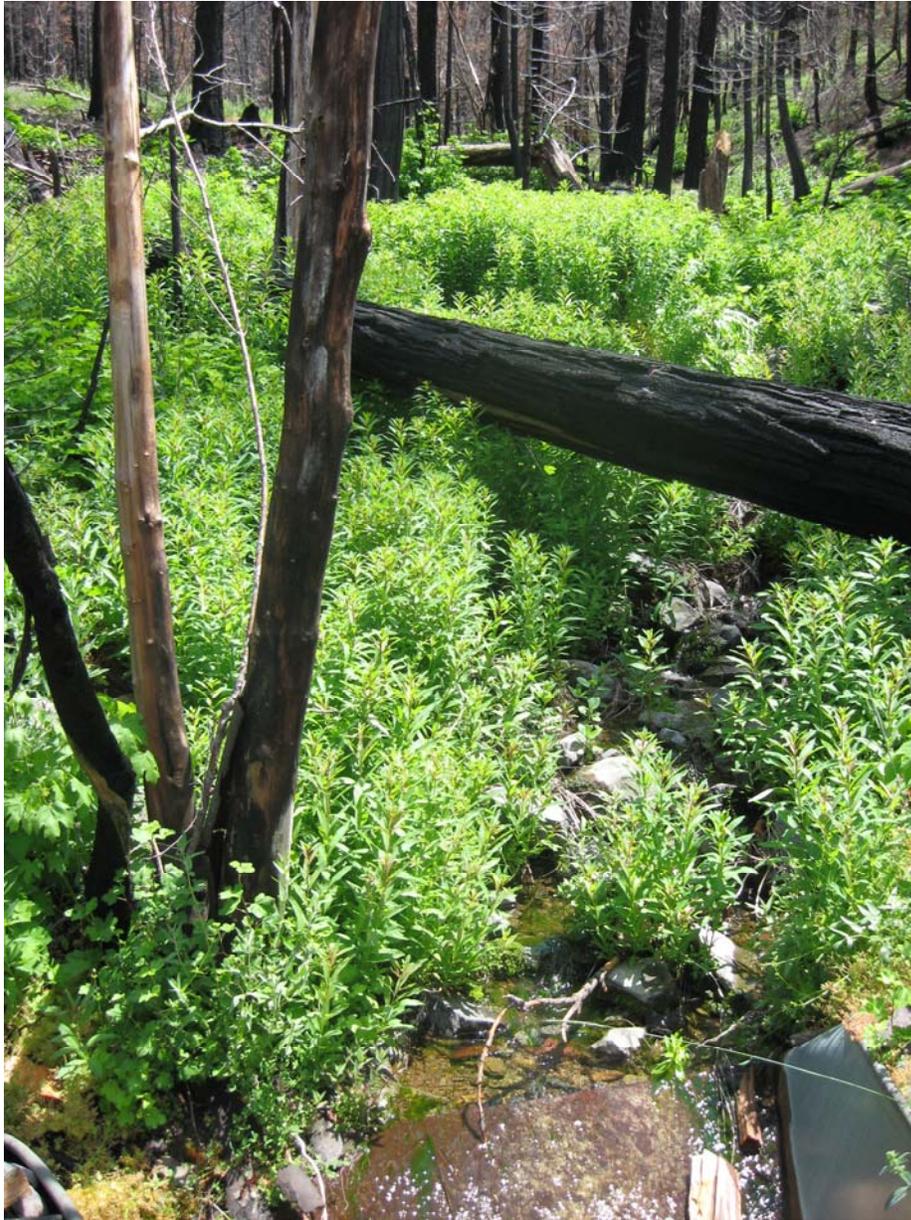
**Figure 2: Post-fire photo, taken June 2009, of the same intermittent stream in Figure 1. The downed log across the channel and metal culvert inlet section provide reference points. Post-fire riparian vegetation re-growth is robust and provides an effective buffer for erosion from adjacent project slopes.**
