APPENDIX A

IMAGES FROM THE GEOMORPHIC RECONNAISSANCE OF THE TAYLOR CREEK WATERSHED

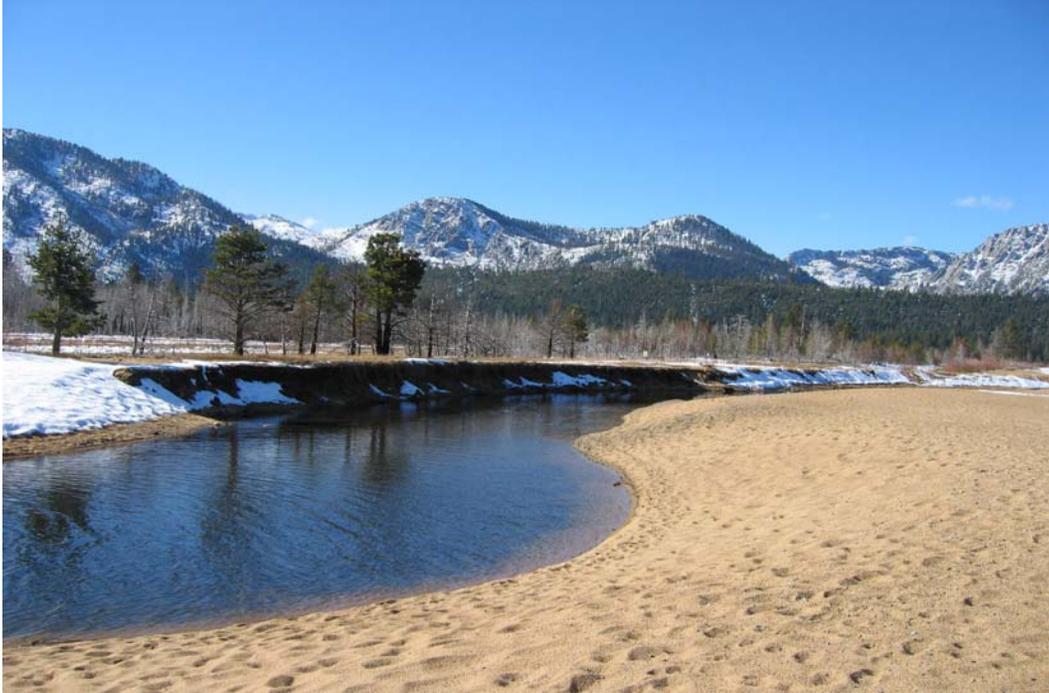
A1. Outlet of Taylor Creek

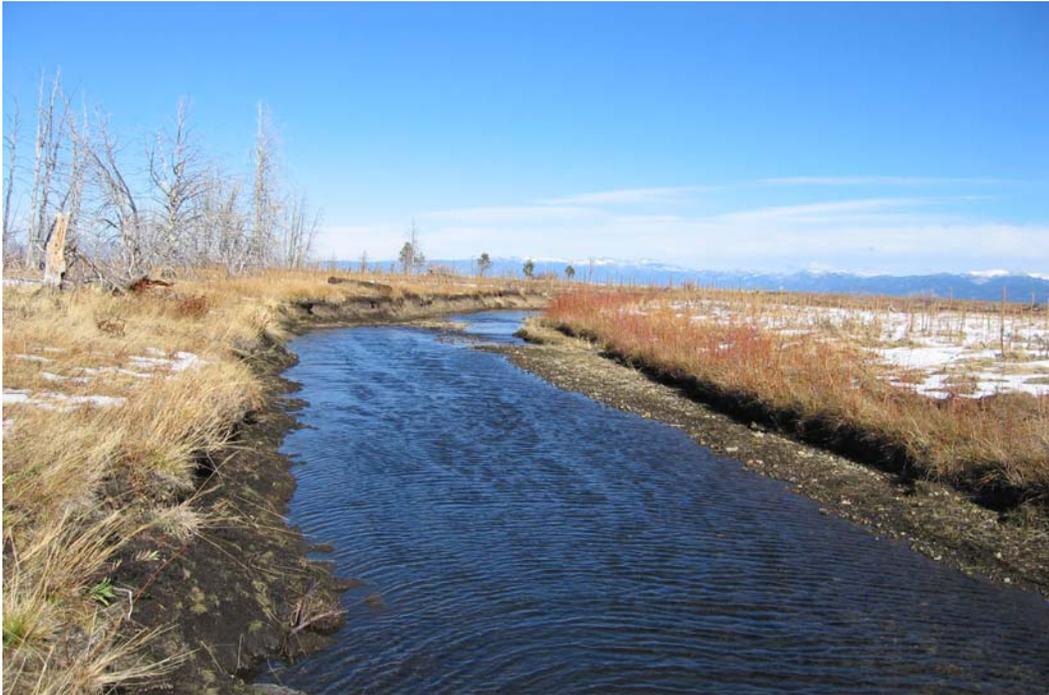
A2. Mainstem of Taylor Creek mid way through the wetland

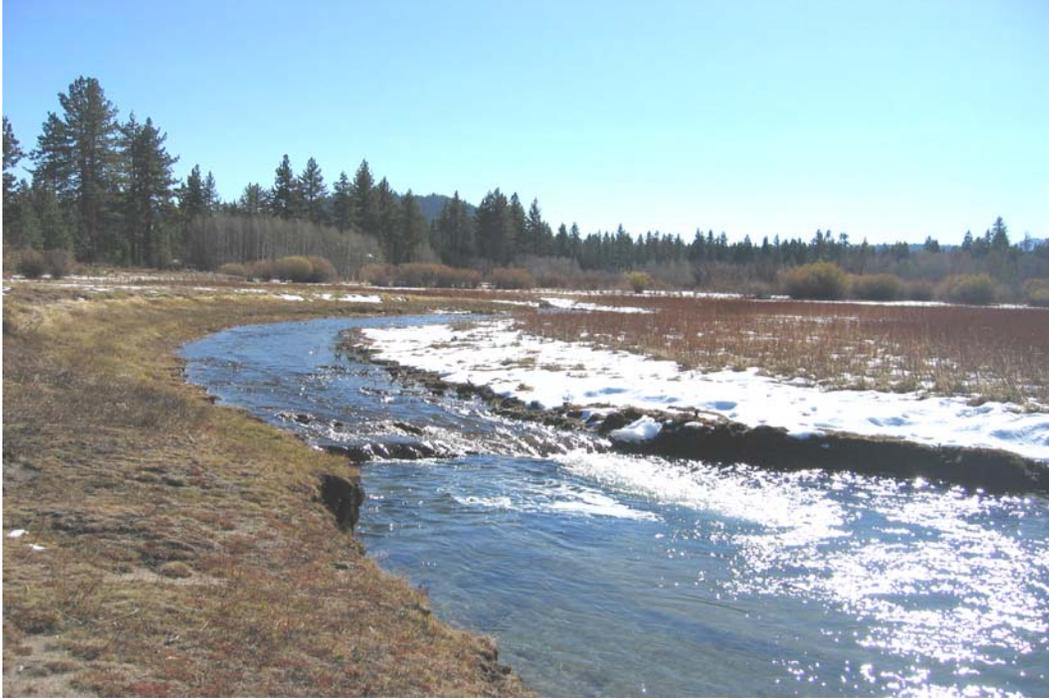
A3. Knickpoint on secondary (eastern) Taylor channel

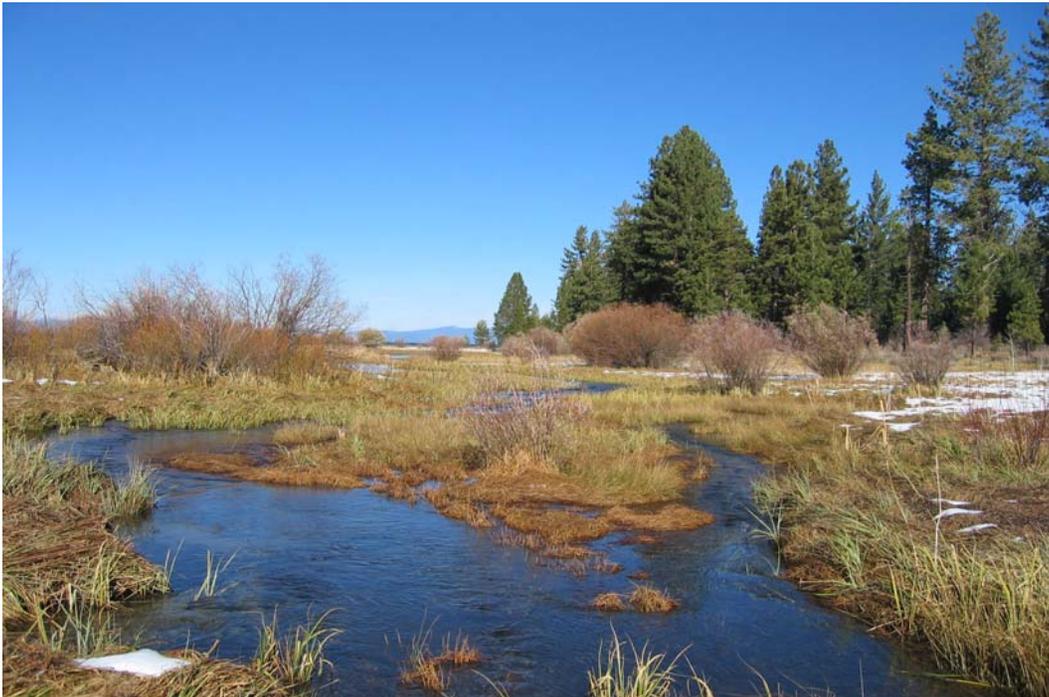
A4. Lower wetland area on eastern fork of Taylor Creek

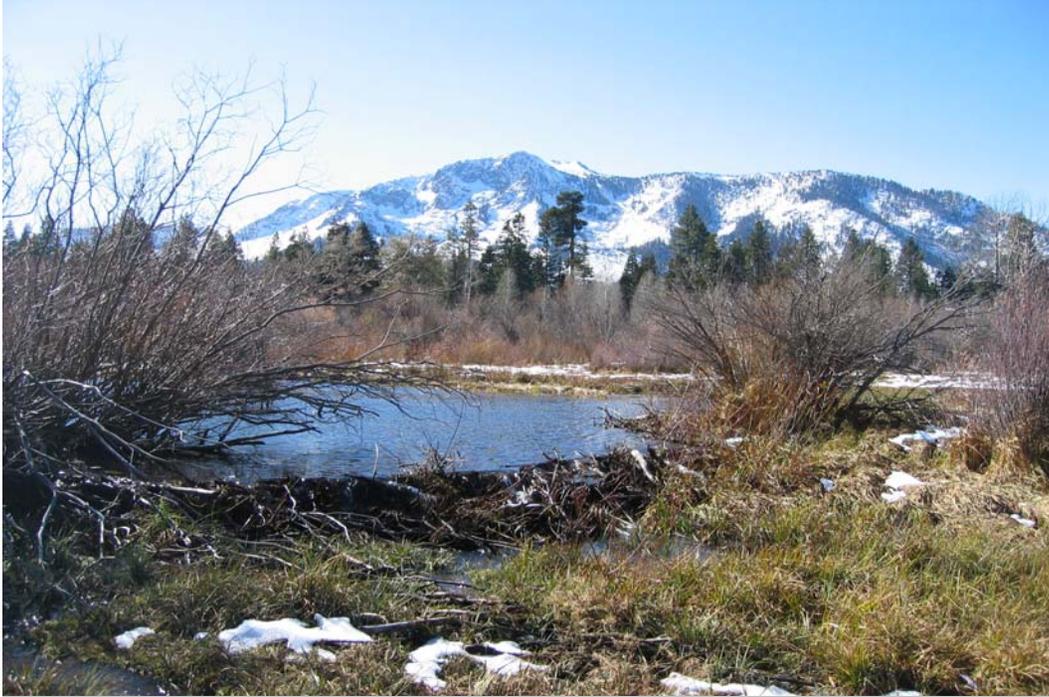
A5. Beaver dams on eastern fork of Taylor Creek

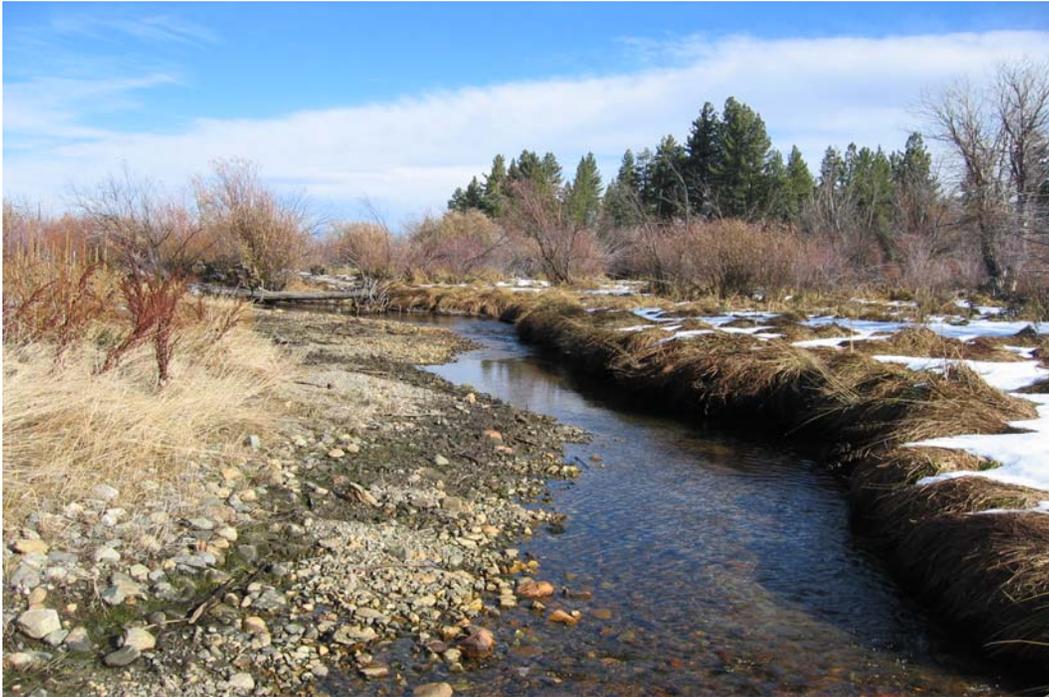
A6. Mainstem of Taylor Creek below the beaver dams

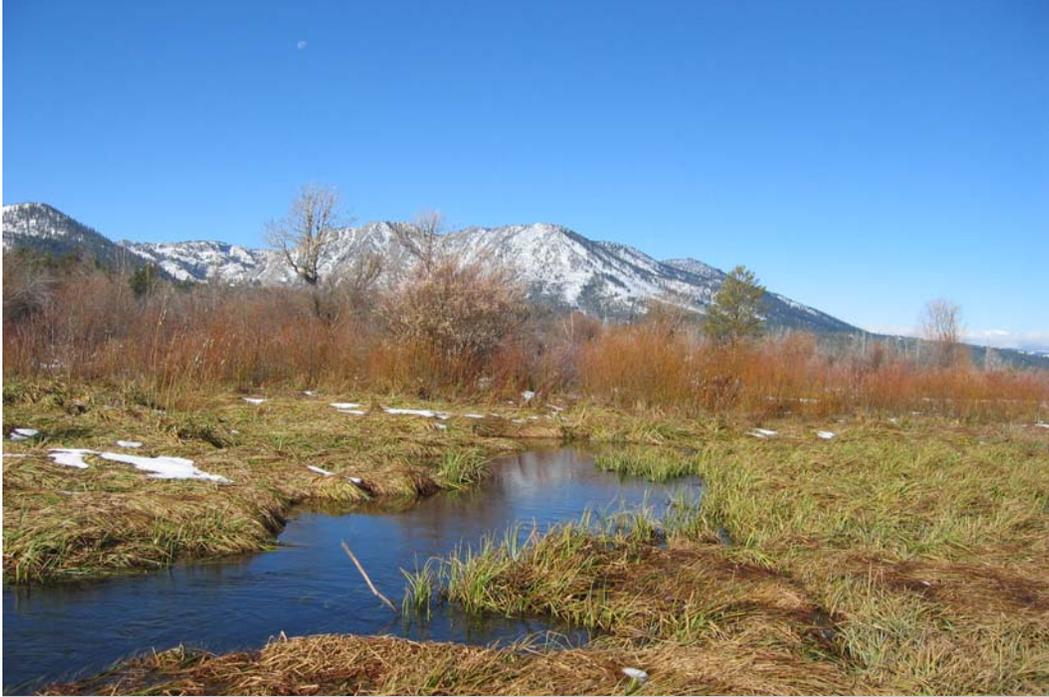
A7. Undersized distributary channel downstream of the upper Taylor Creek wetland

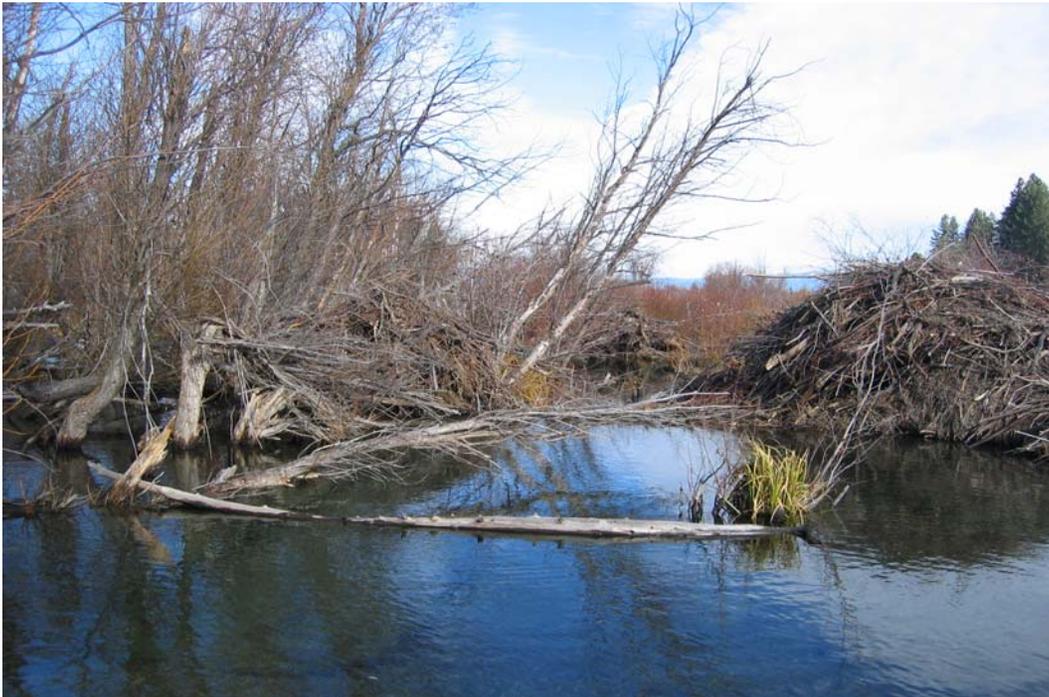
A8. Beaver dam and debris in the upper beaver dam wetland of Taylor Creek

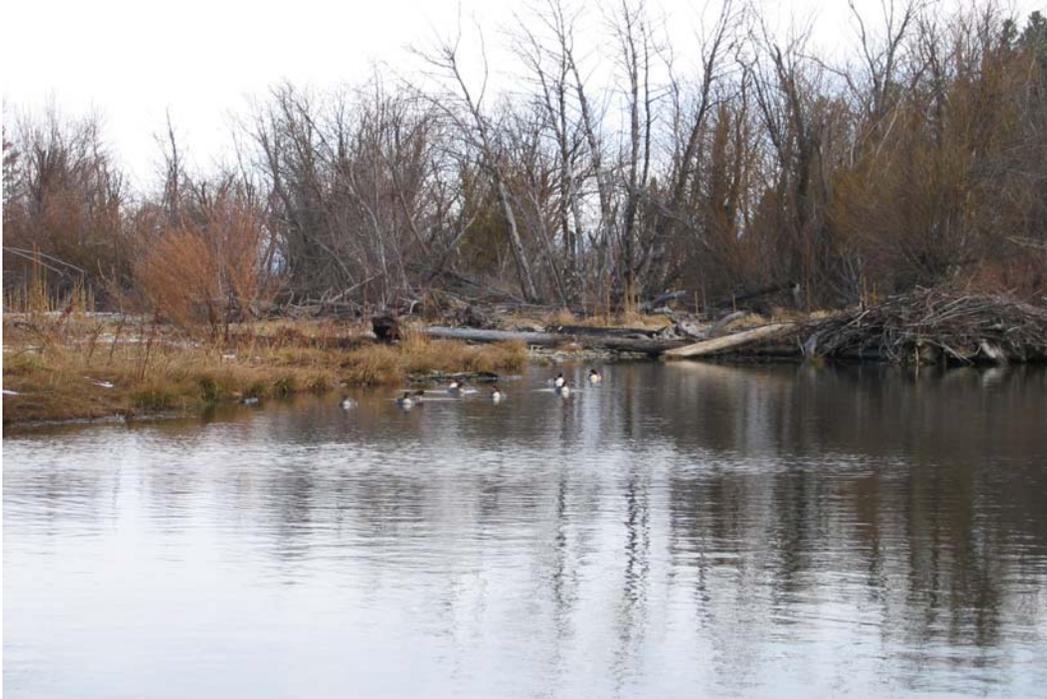
A9. Water backing up from the upper beaver dam area on Taylor Creek wetland

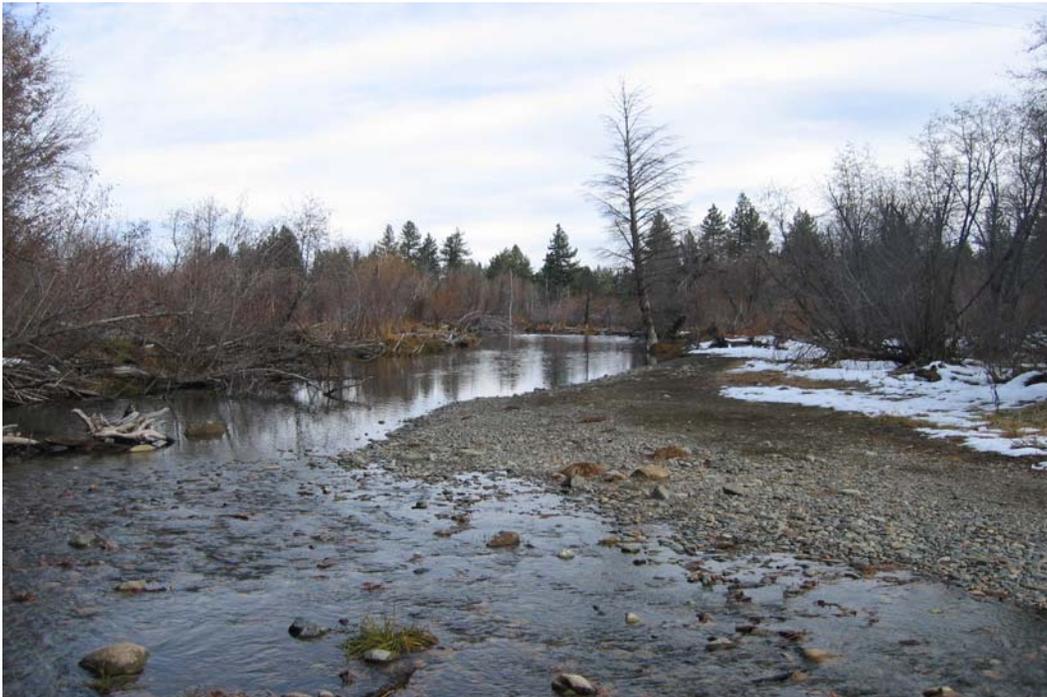
A10. Riffle-pool morphology on Taylor Creek between SR 89 and the upper wetland

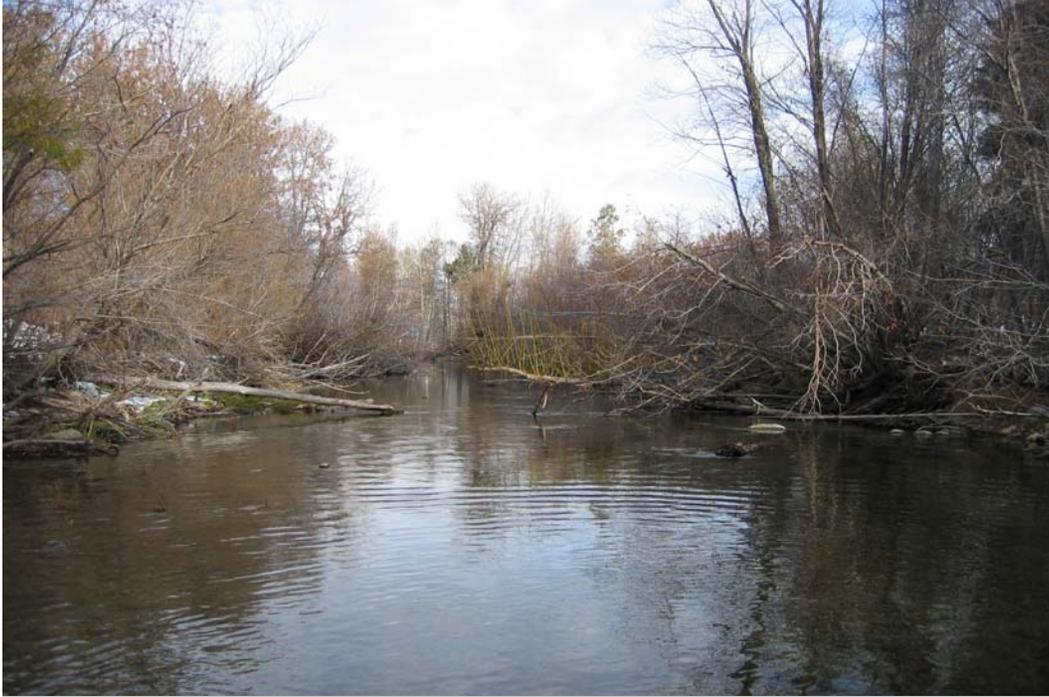
A11. Looking downstream on Taylor Creek from the SR 89 bridge

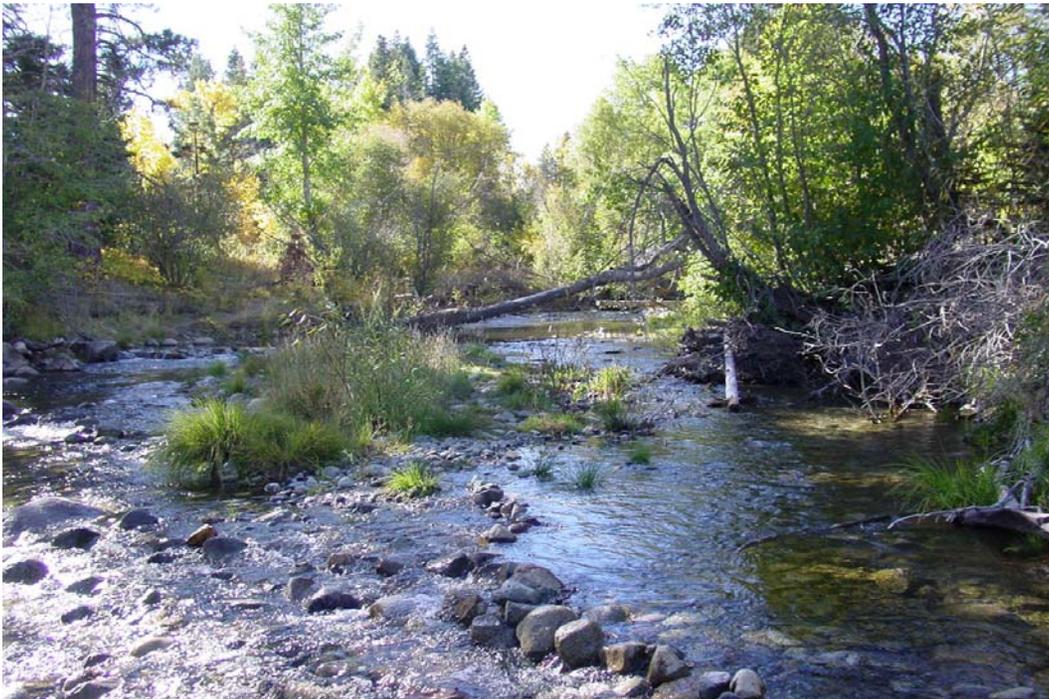
A12. Taylor Creek above the SR 89 Bridge

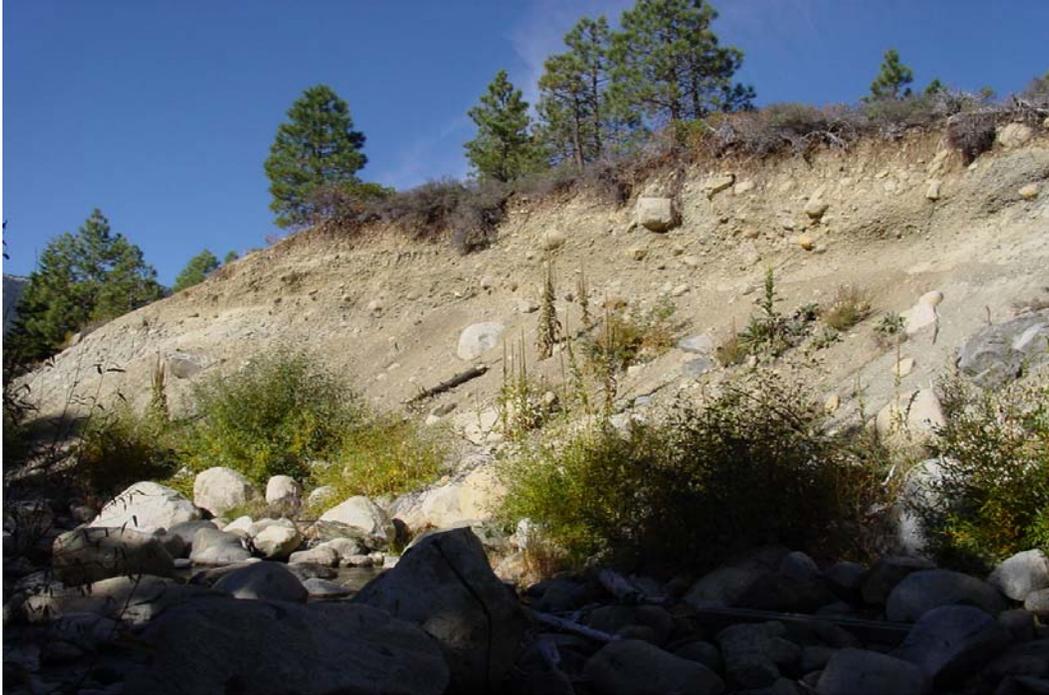
A13. Large eroding bend at the Sno Park on Taylor Creek

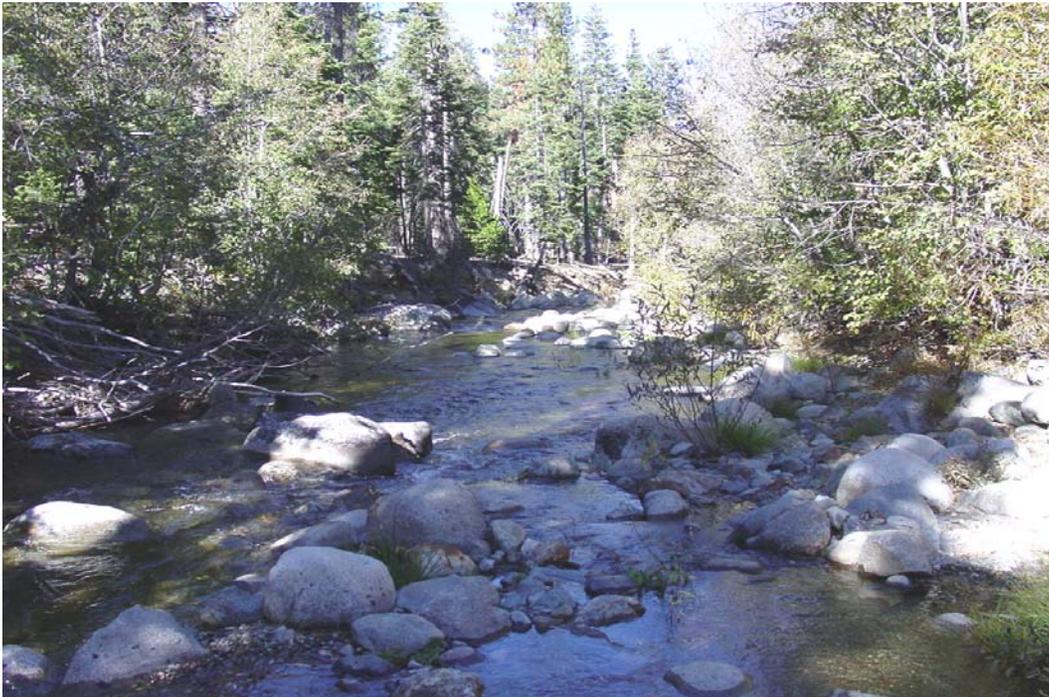
A14. Step-pool morphology and eroding outside bends on Taylor Creek above SR

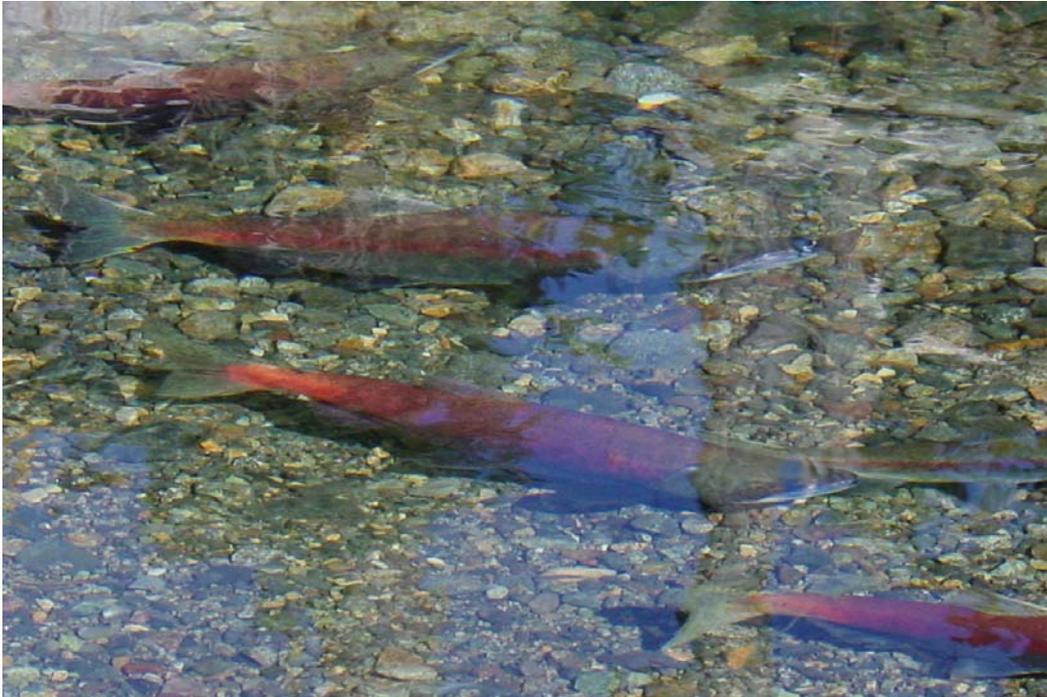
A15. Spawning gravel in a riffle-pool reach, mid section of Taylor Creek

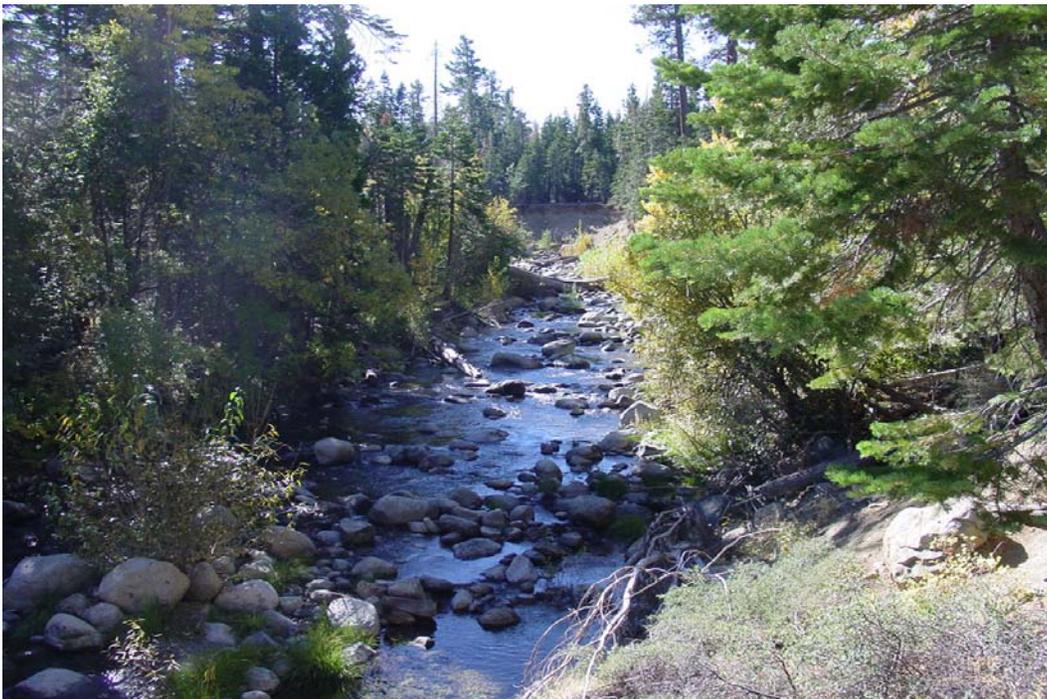
A16. Typical step-pool reach mid way between SR 89 and Fallen Leaf Lake

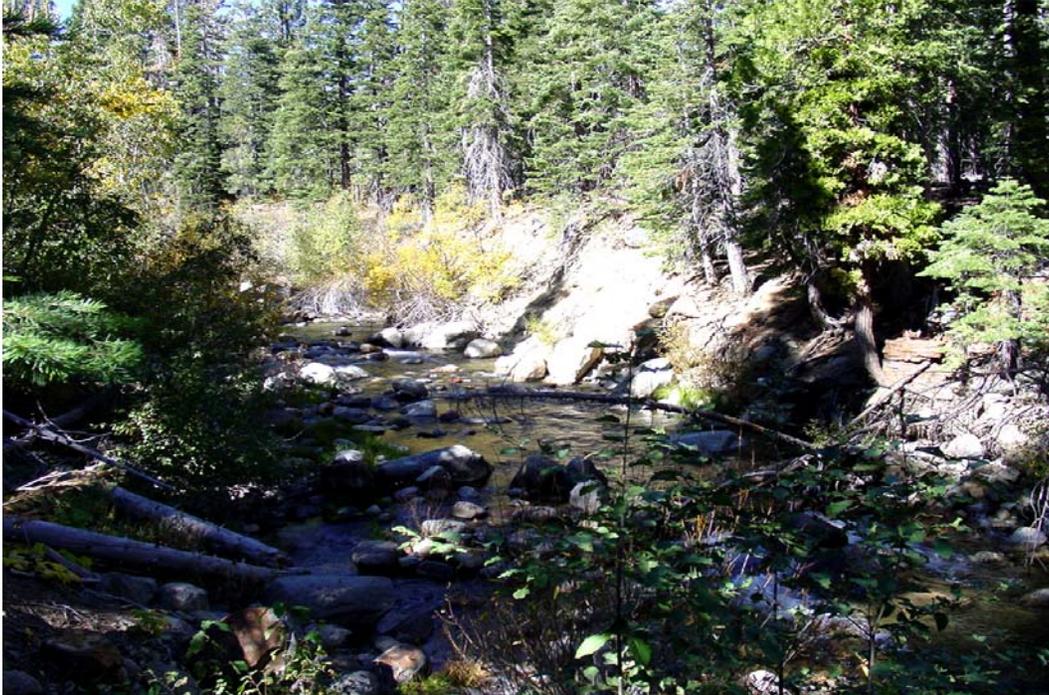
A17. Eroding outside bank on mid section of Taylor Creek

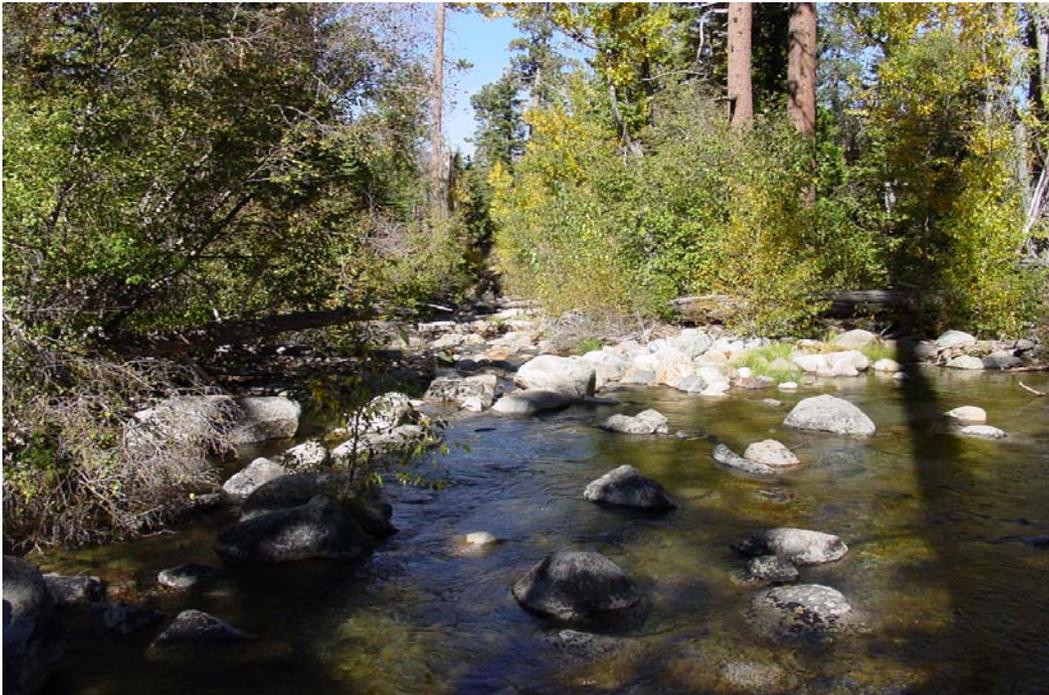
A18. Step-pool reach towards the upper end of the Taylor Creek reach

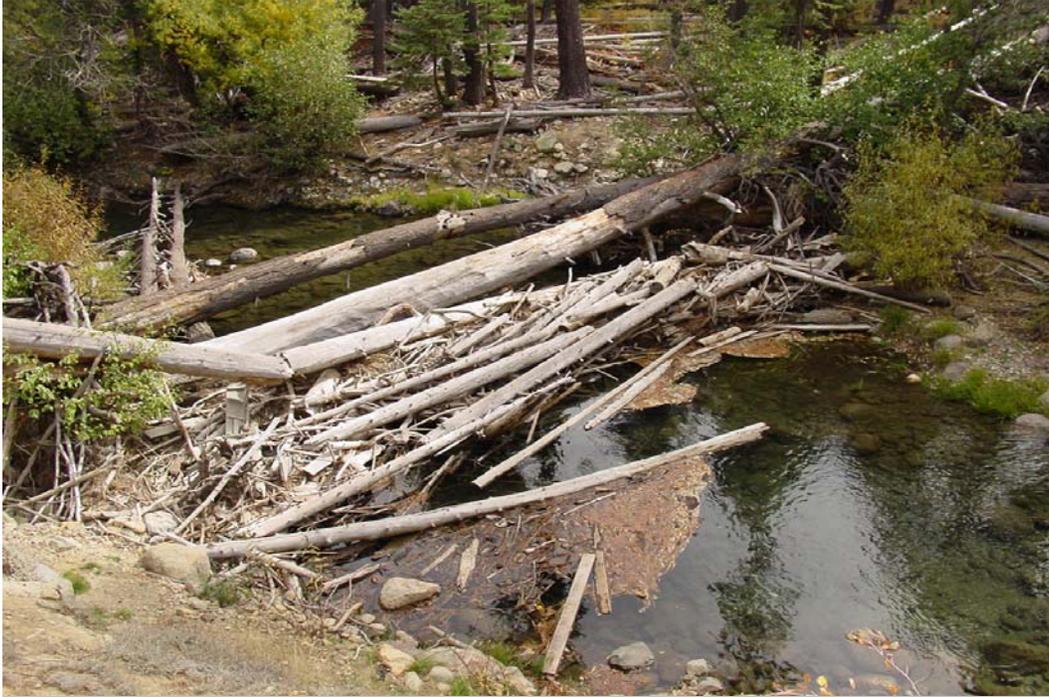
A19. Debris jam and impounded water on Taylor Creek below Fallen Leaf Lake

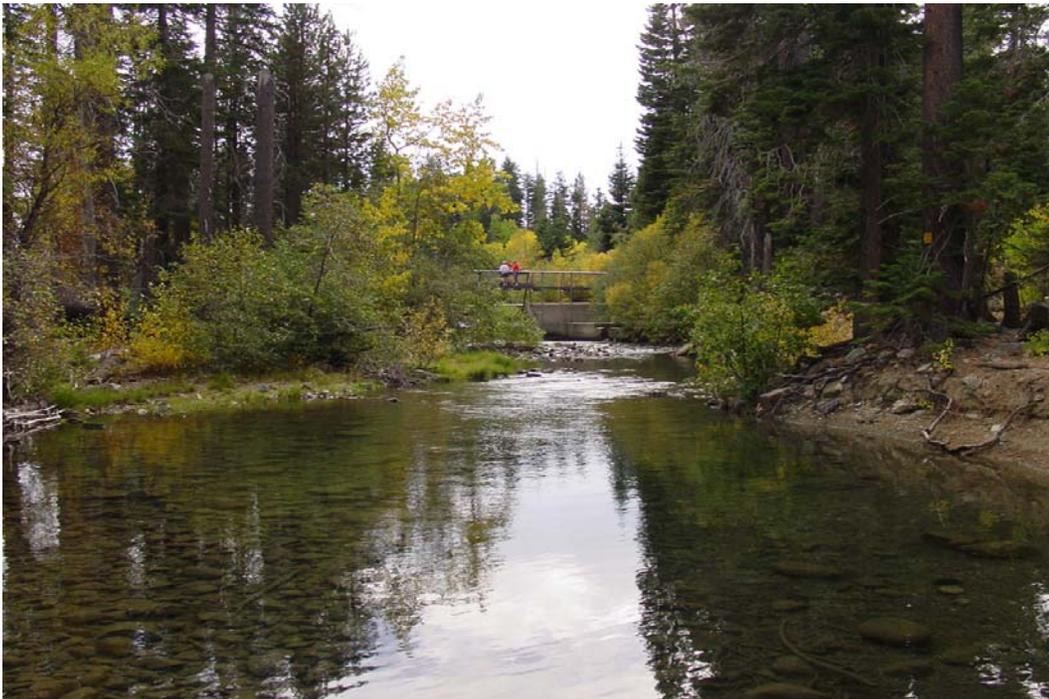
A20. Dam on Fallen Leaf Lake
