## **APPENDIX B**

**IMAGES FROM THE GEOMORPHIC RECONNAISSANCE OF THE  
TALLAC AND SPRING CREEK WATERSHED**

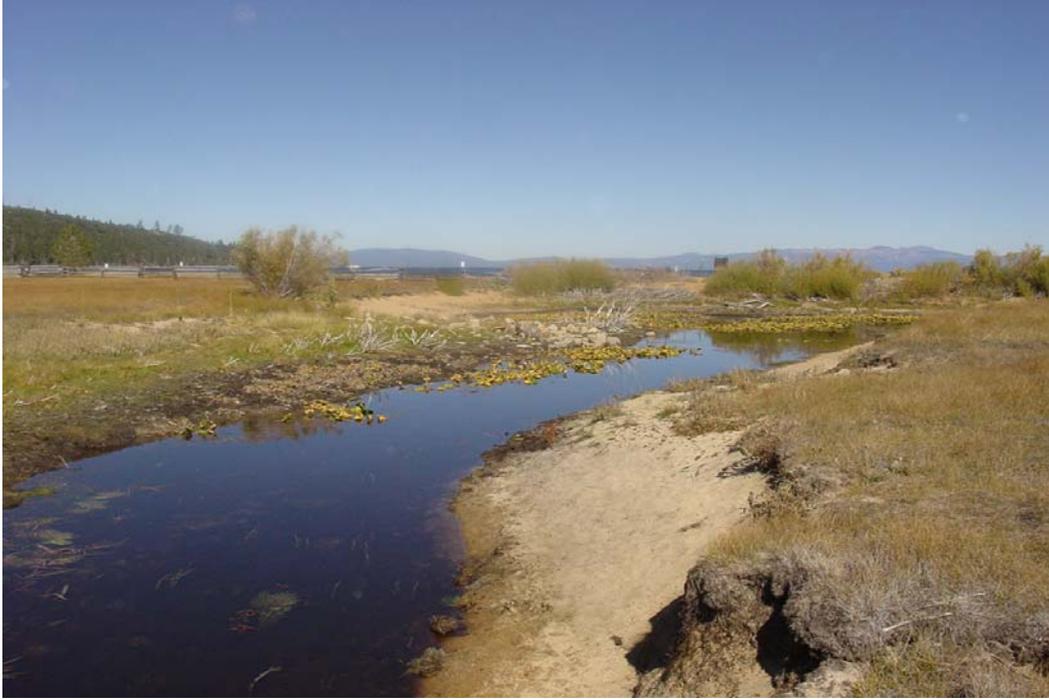
B1. Mouth of Tallac Creek showing slightly incised channel and eroding banks

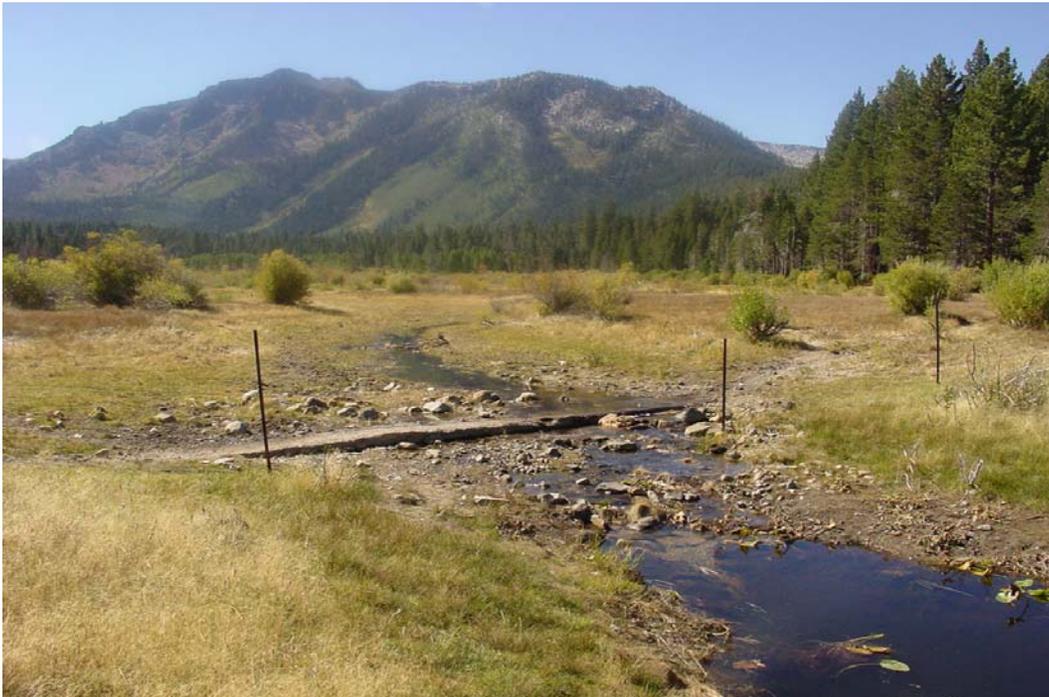
B2. Tallac Creek at the sewer line – this line acts as a grade control structure

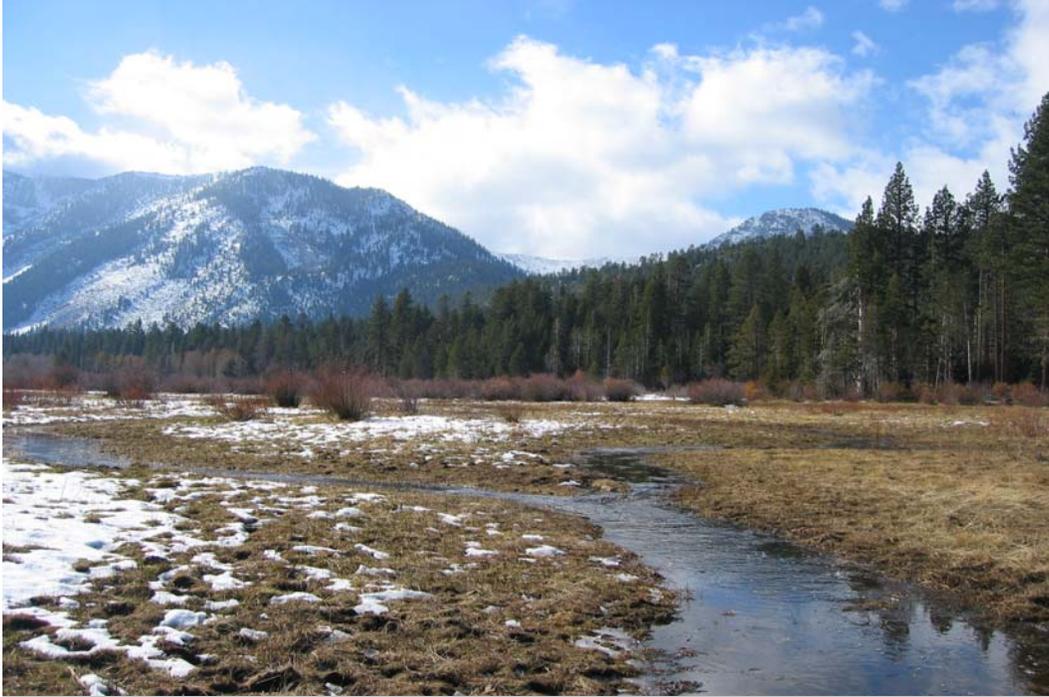
B3. Convergence of the Tallac Creek distributary channels in the lower wetland

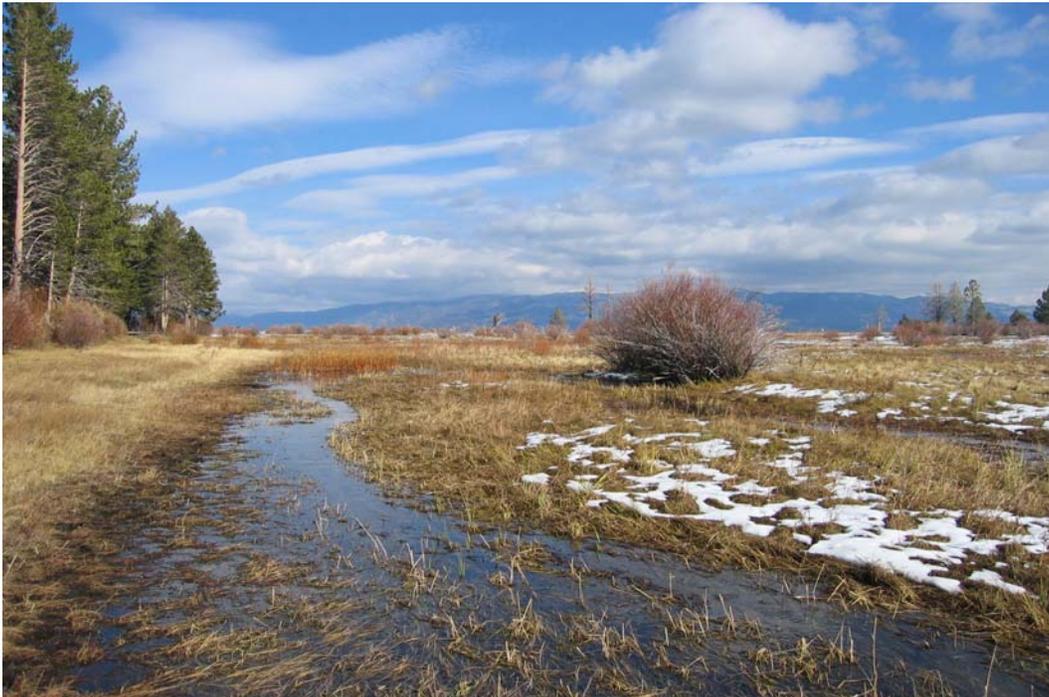
B4. Western-most distributary channel of Tallac Creek

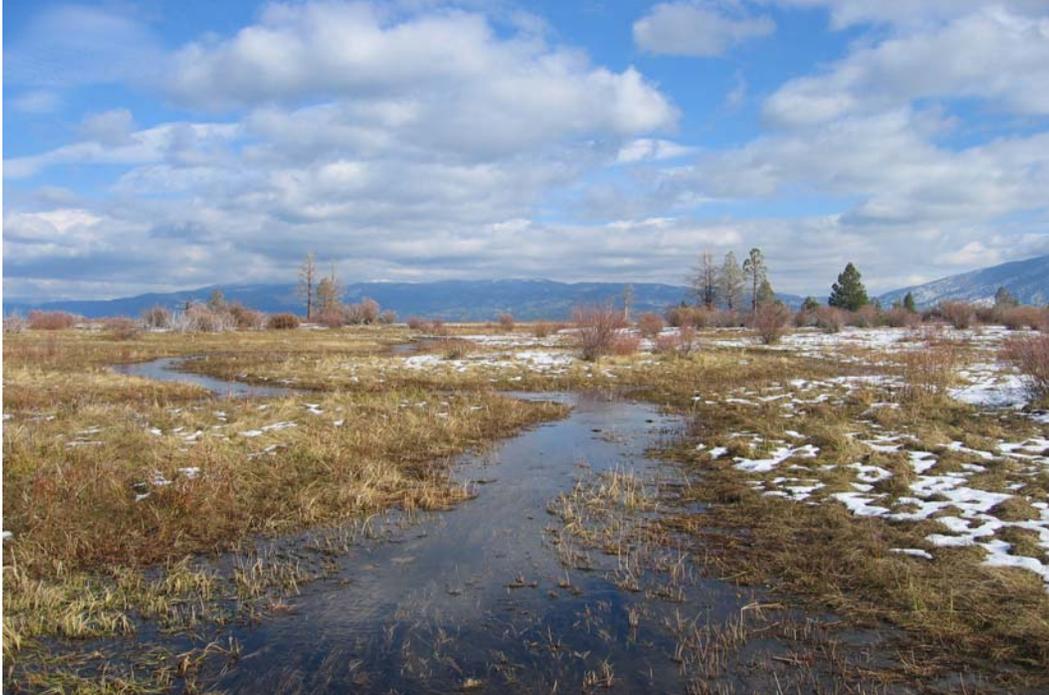
B5. The main channel in the lower Tallac wetland

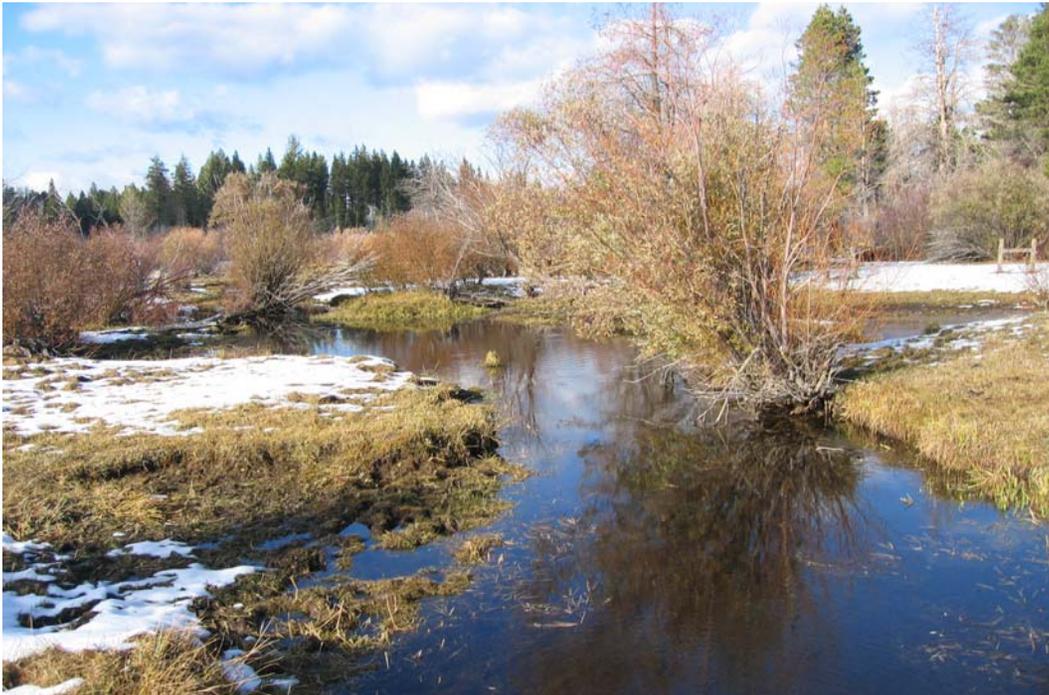
B6. Main channel of Tallac Creek in the wetland area

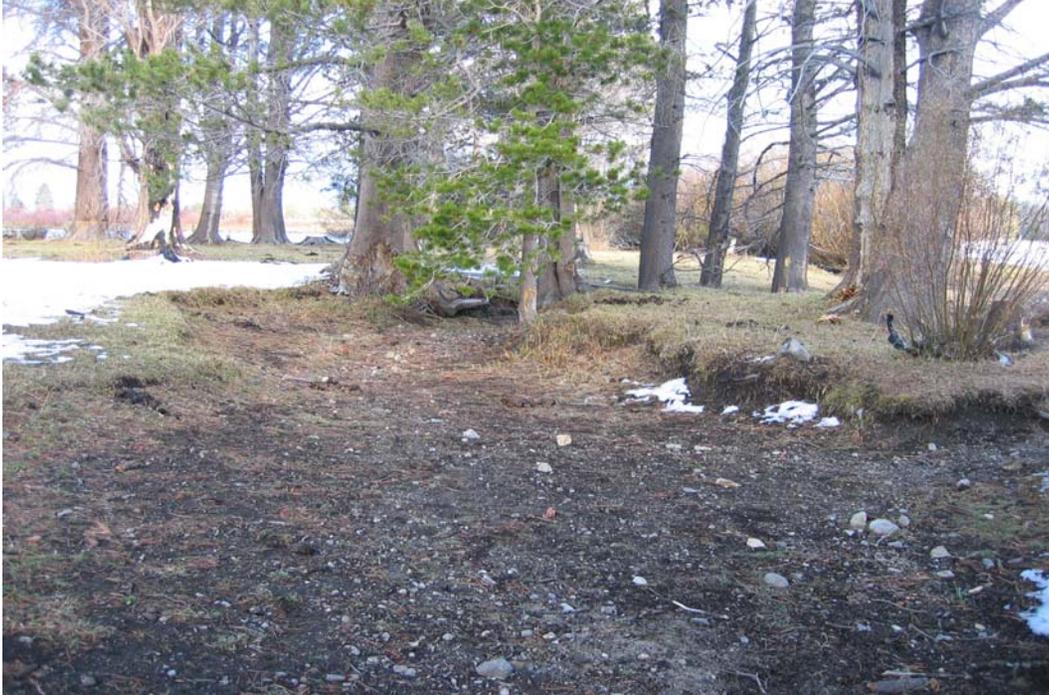
B7. High flow channel in Tallac Creek wetland

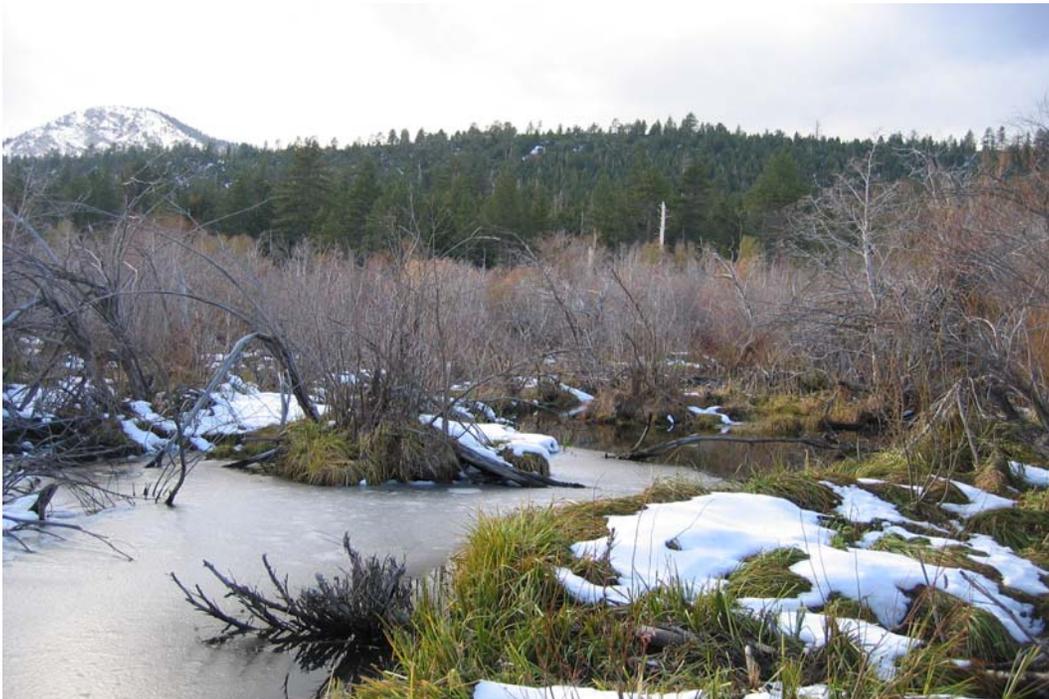
B8. Disorganized drainage and wetland in the lower beaver dam area of Tallac Creek wetland

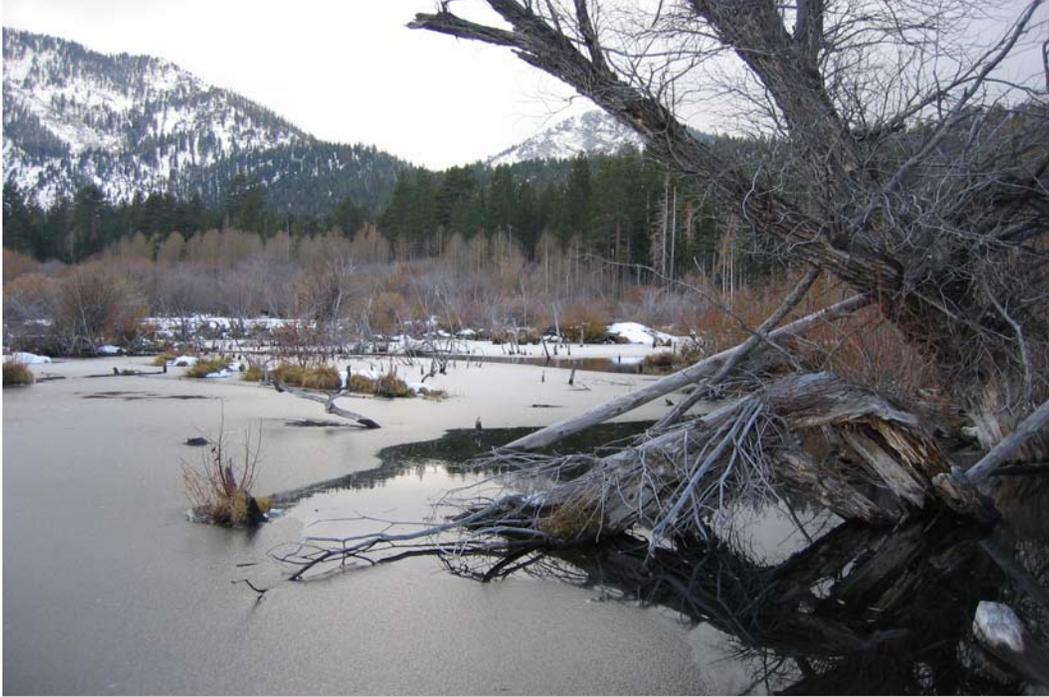
B9. The large beaver dam area of Tallac Creek wetland

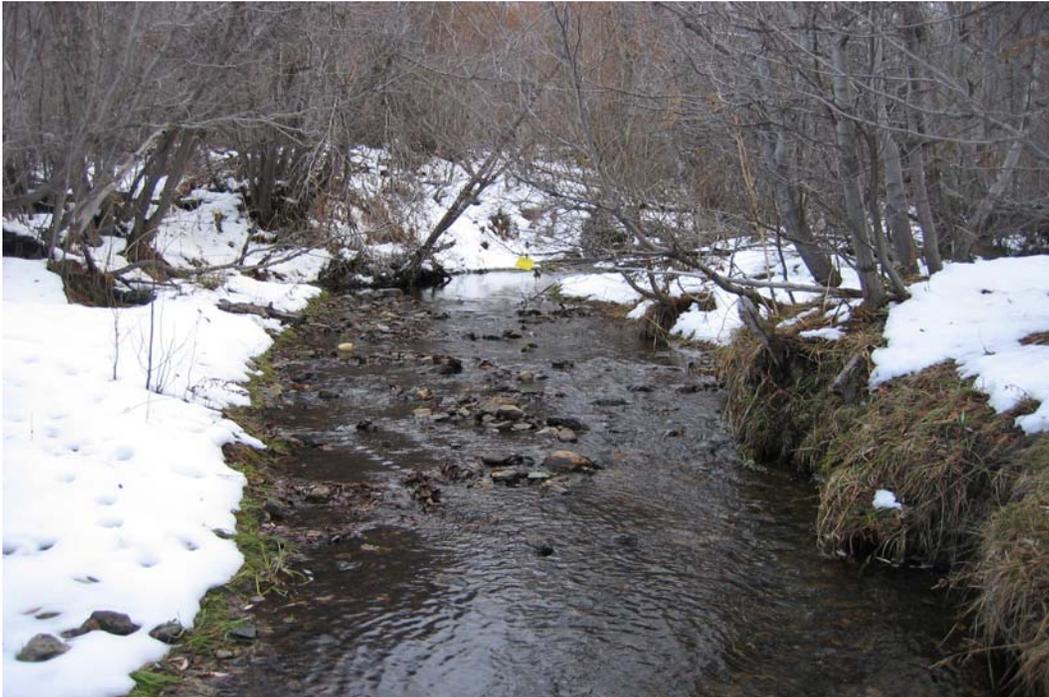
B10. Steeper riffle-pool channel in Tallac Creek between the beaver dams and SR 89

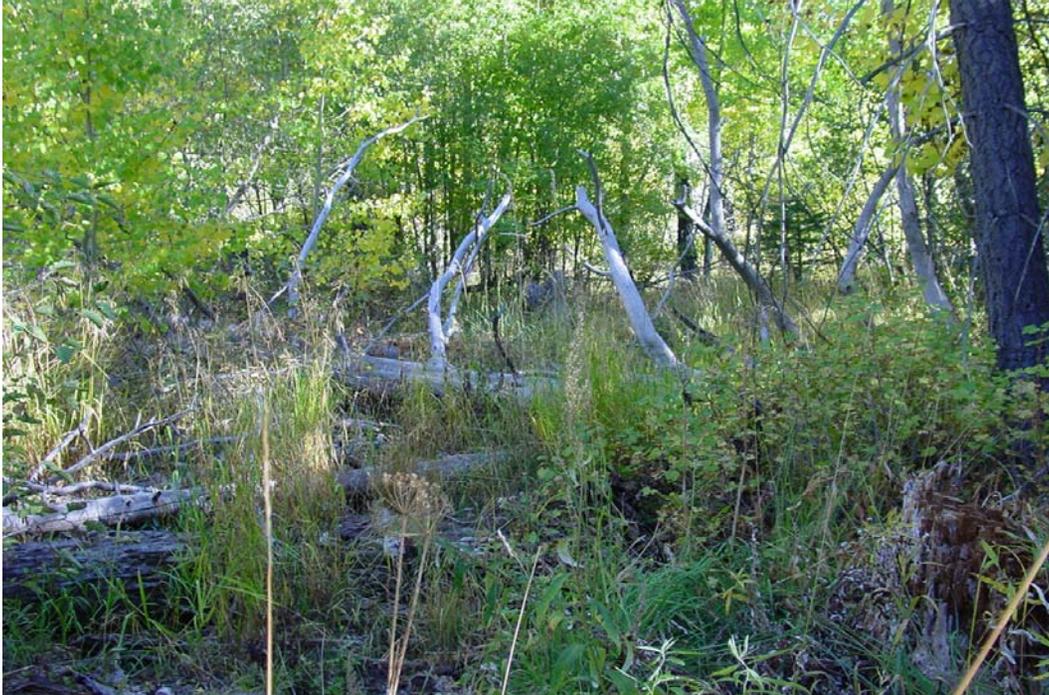
B13. Tallac Creek obliterated by debris flow material and vegetation

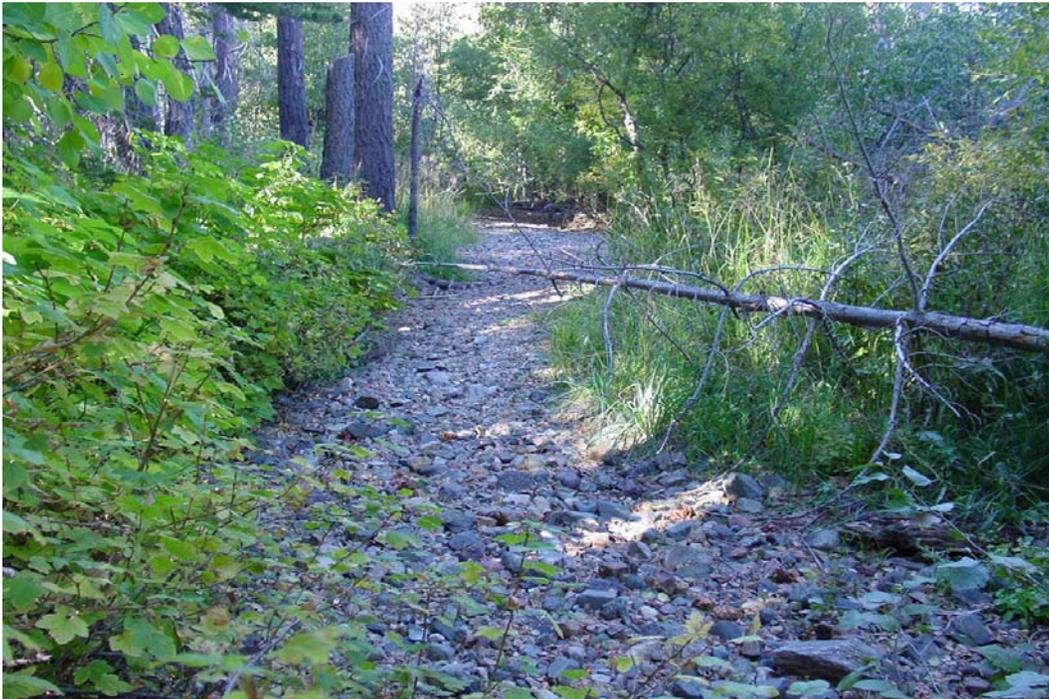
B14. Tallac Creek below the Spring Creek Rd culvert, showing debris flow deposits

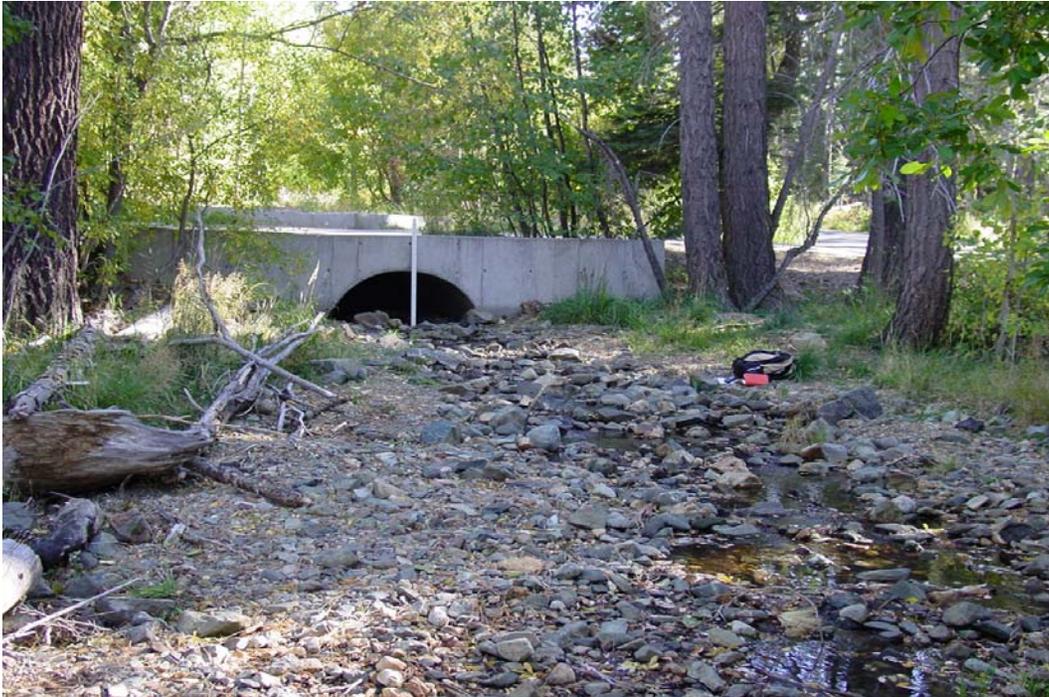
B15. Culvert at Spring Creek Rd showing debris flow deposits

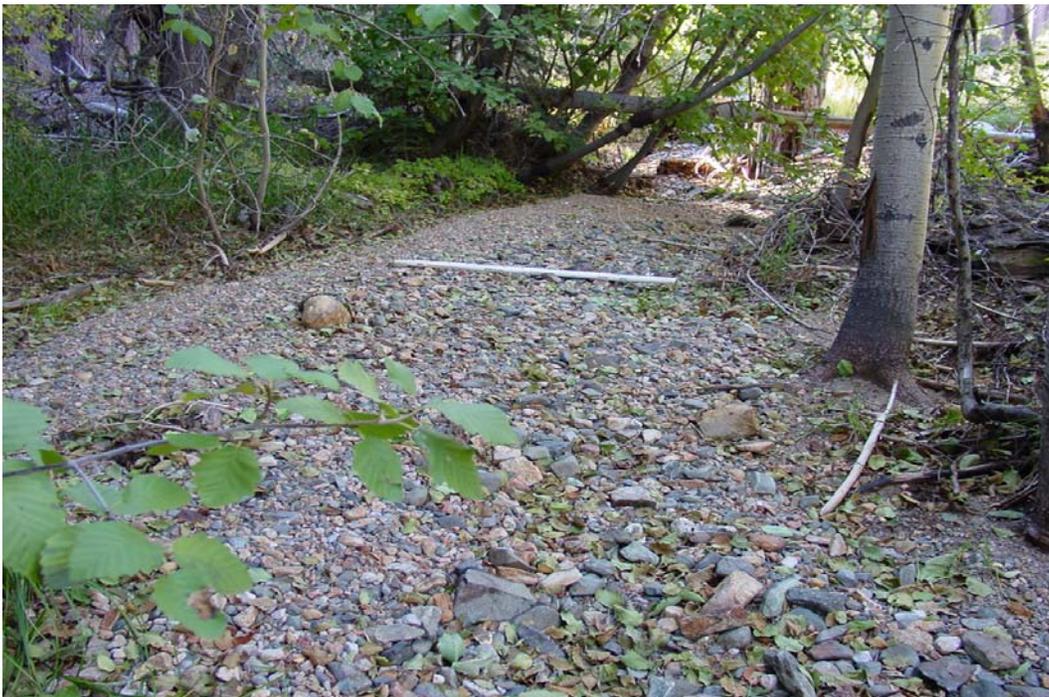
B16. Channel filled in with debris flow deposits above the Spring Creek Rd culvert

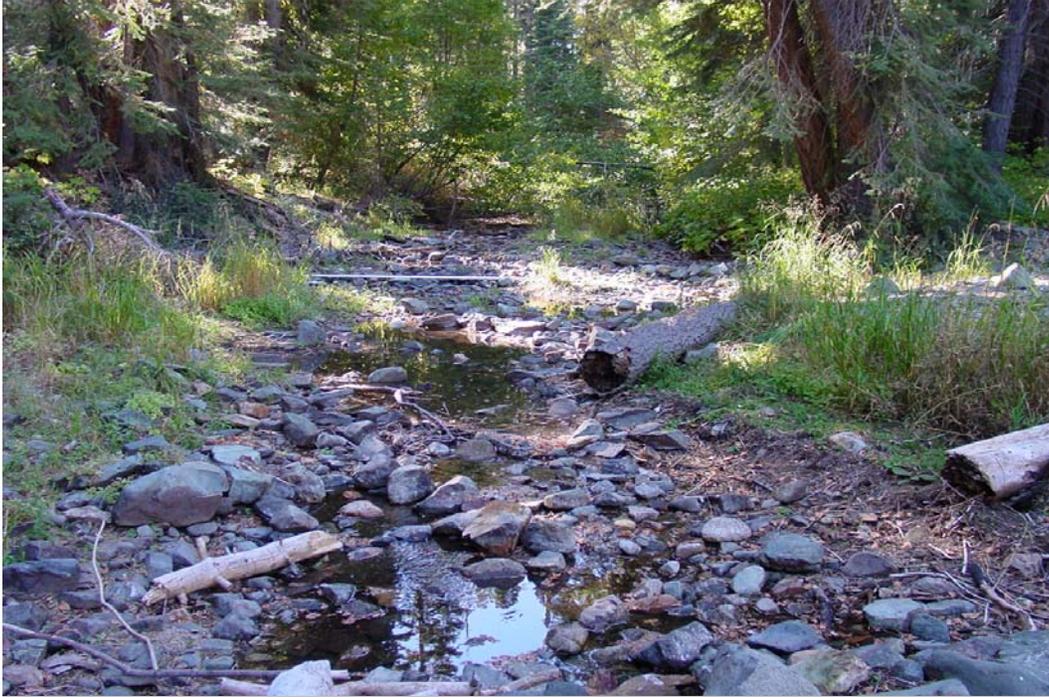
B17. Tallac Creek above the debris flow deposits – step-pool channel

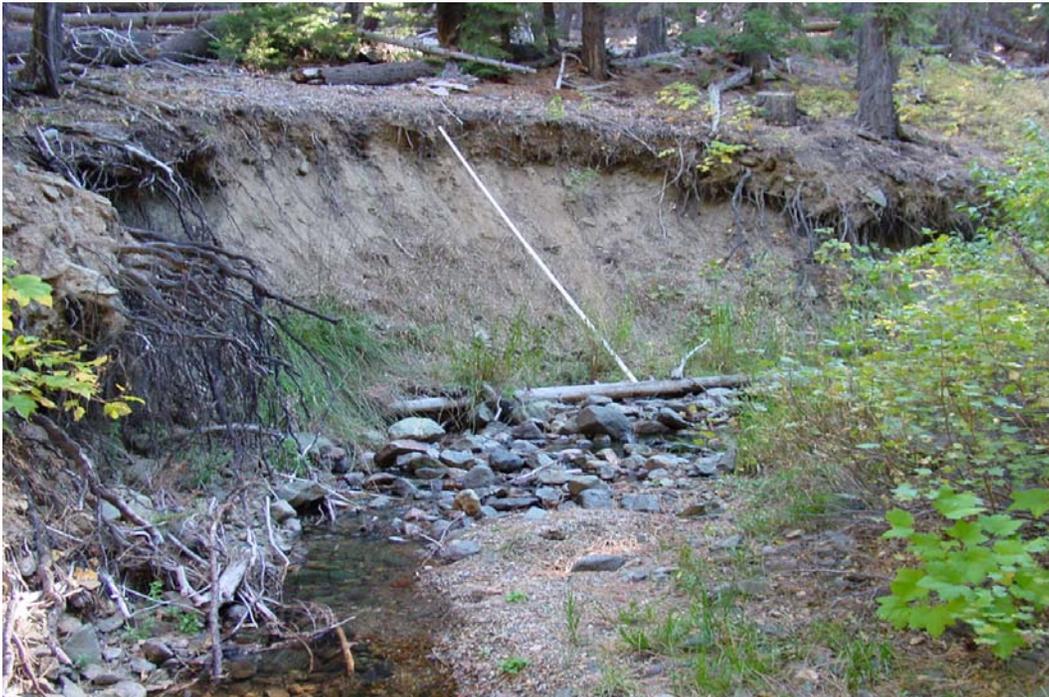
B18. Eroding outside bend in scoured reach alongside Spring Creek Rd (staff is 16 ft)
