# La Grande Ranger District Aquatics Program 2009-2010 Accomplishment Report

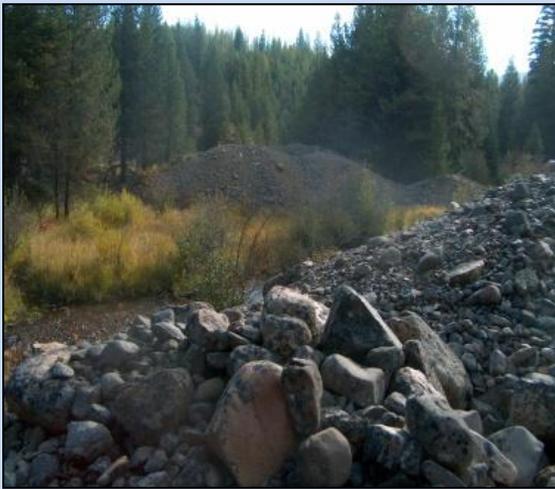
The Upper Grande Ronde River Mine Tailings Restoration Project was the most extensive project of the period. The influential impact on this section of river was the historic gold mining activities associated with Camp Carson Mining District. The mine tailings left behind from the gold dredge operation covered the Upper Grande Ronde River floodplain for 2.5 miles. As a result, aquatic habitat exhibited poor riparian growing conditions, hindered floodplain connection and functionality, a constrained stream channel, and reduced habitat diversity and complexity.

Mine Tailings in Floodplain

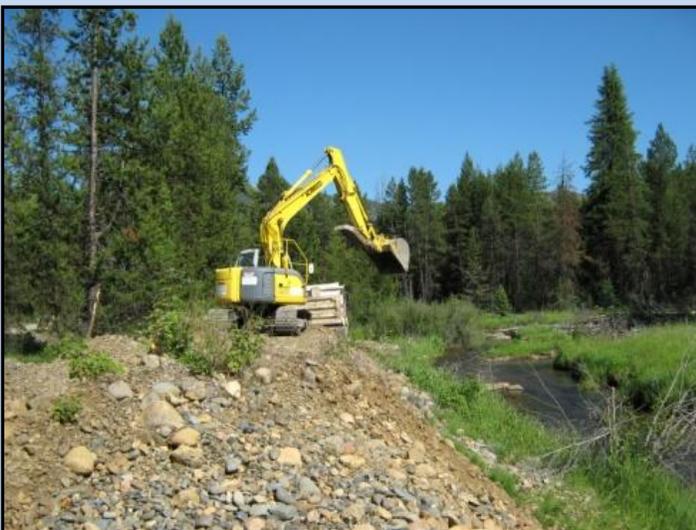
Before

### Removing Mine Tailings From Floodplain

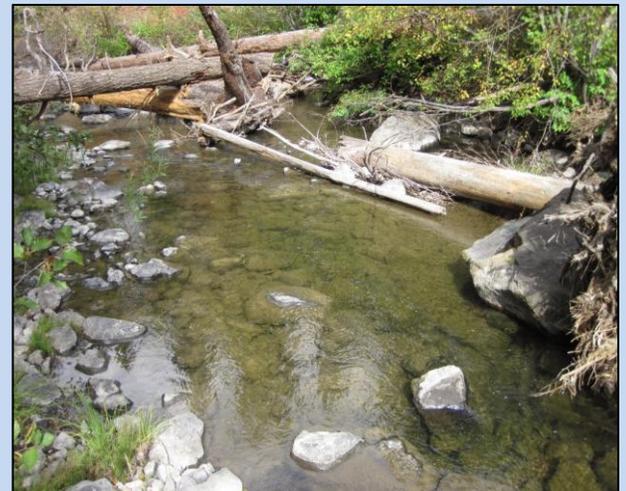
Site #29 Evidence of Pool Formation (July 2010)

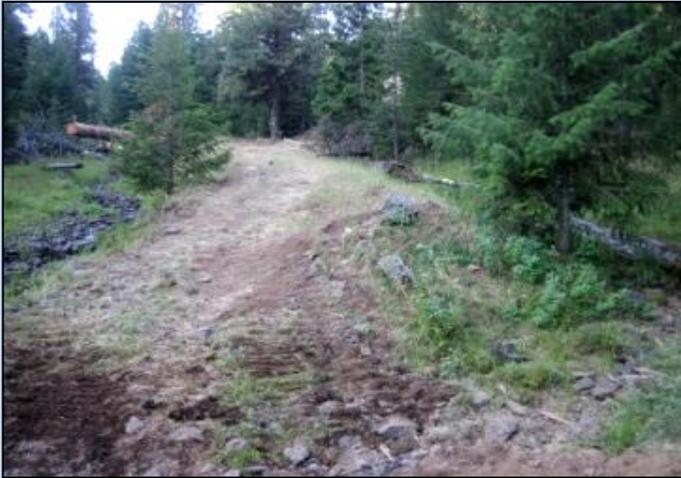
The Bear Creek Restoration Project took place on 7 stream miles within the Starkey Experimental Forest. A railroad grade, which later became a stream bottom road, restricted the channel, reduced floodplain function, and interfered with natural hydrologic conditions. Overstory timber harvest and past grazing practices also influenced habitat conditions. Restoration objectives were similar to the Upper Grande Ronde River and Fly Creek Restoration Projects.

Stream Side Road Before

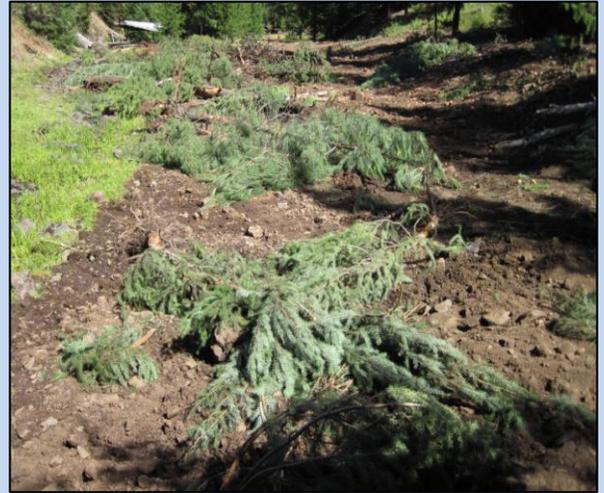
Road Re-Contoured

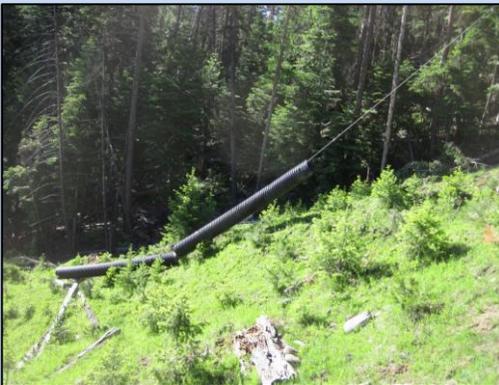
Removing Non-Functioning Pipe System

Project activities in 2010 involved placing brush and installing water bars on the hillslope to prevent erosion and provide microsites for conifer establishment. A non-functioning pipe system was removed, wood was placed within an incising intermittent channel, and motor vehicle access was blocked by a boulder barrier. Seven acres of slope stabilization was accomplished.

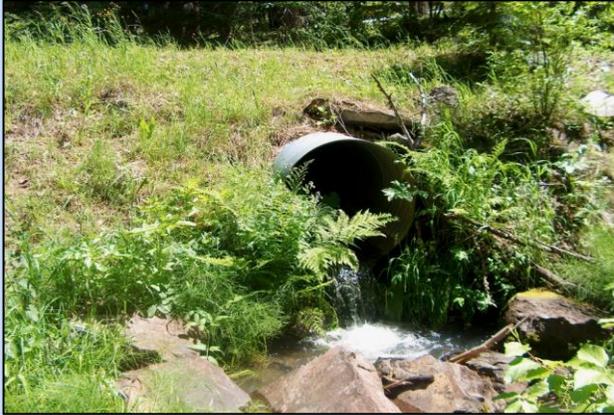
Scout Creek Culvert

The Scout Creek and Spring Creek Culverts were replaced to improve fish passage, improve the natural flow pattern, and reduce the risk of culvert failure. Both culverts replaced round culvert pipes with native streambed, concrete box culverts. The new box culverts are designed to pass 100 year flood events.

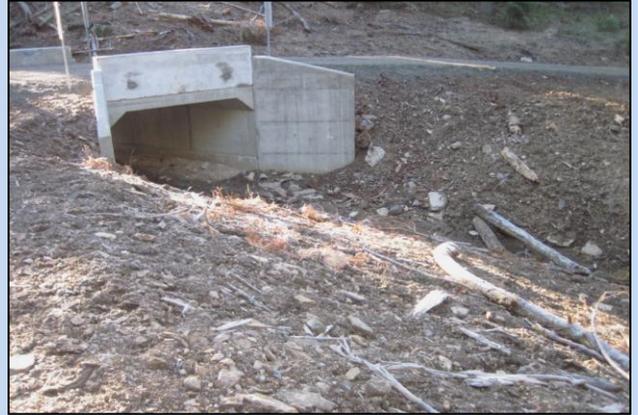
Scout Creek Replacement Structure
