VALLES CALDERA NATIONAL PRESERVE

Hydrology

Existing Condition Report

VALLES CALDERA TRUST

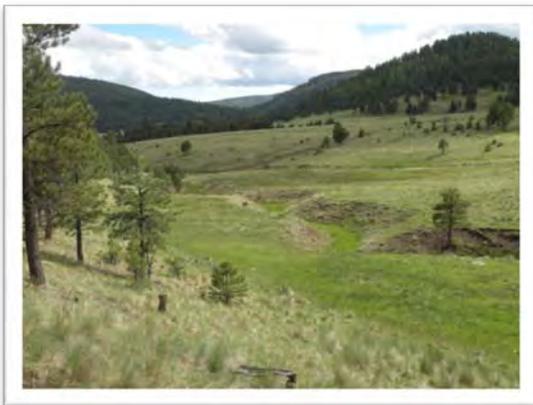
Figure 6 - San Antonio drainage, healing swale gully

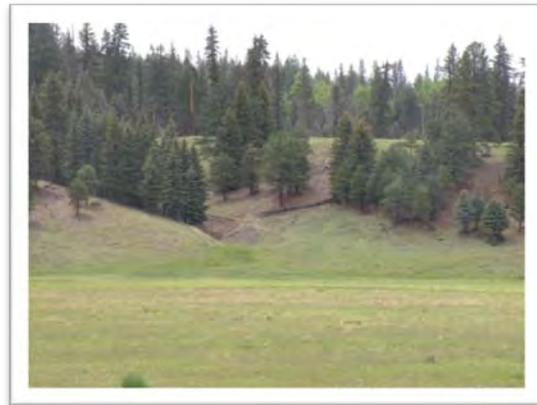
Figure 5 – San Antonio drainage, draw gully

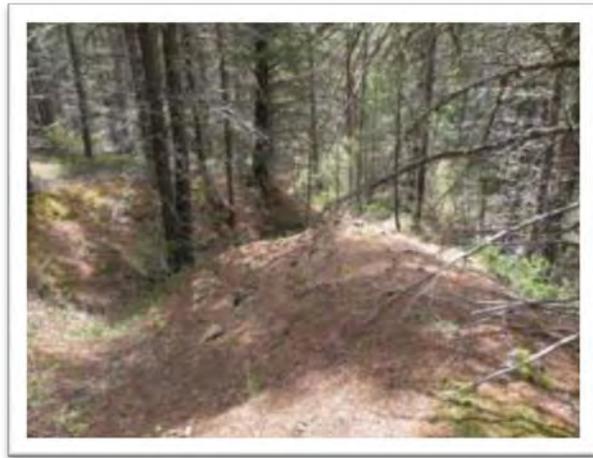
Figure 7 - Cerro del Medio slump topography in area of vitrified rhyolite.

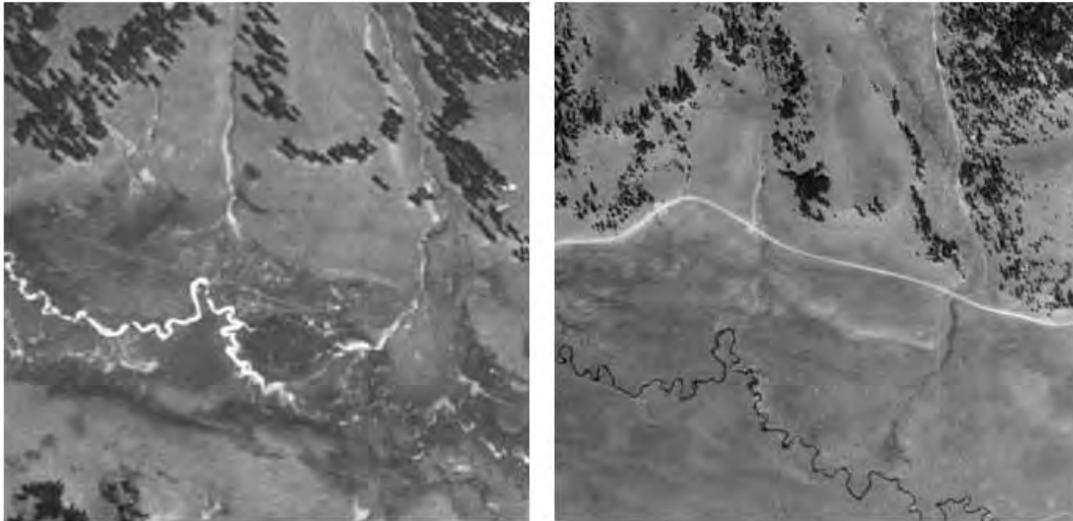
The 1935 aerial photographs show most if not virtually all of the present gullying. These features are visible as bright spots on valley bottoms and deposit fans indicating that at that time most were actively scouring (Figure 8). Many gullies also reached farther down slope and into valley bottoms than they do in the 1996 digital ortho-quads. These photos predate the industrial logging and road building and 1960's stock tank construction. In absence of other evidence it appears that the historic sheep grazing was the single most important management activity that contributed to gully starts. Based on the recent history detailed of the preserve, the sheep grazing was magnitudes greater than any of the livestock numbers in recent history. Also, conditions in 1935 would have already been influenced by 70 years of ranching.

Figure 8 - Aerial photograph from 1935 (left) depicts the initiation of gullies in the Valle San Antonio; Image on the right shows the same location in 1996

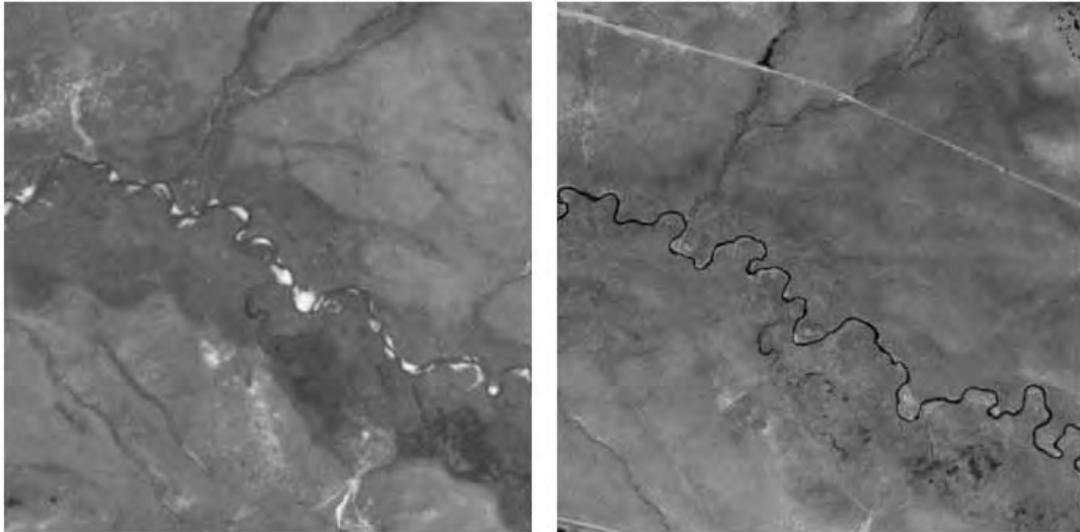
Figure 9 - Aerial photograph from 1935 (left) depicts channel degradation in the lower San Antonio likely caused by intensive grazing by sheep. The photo on the right is of the same location in 1996.

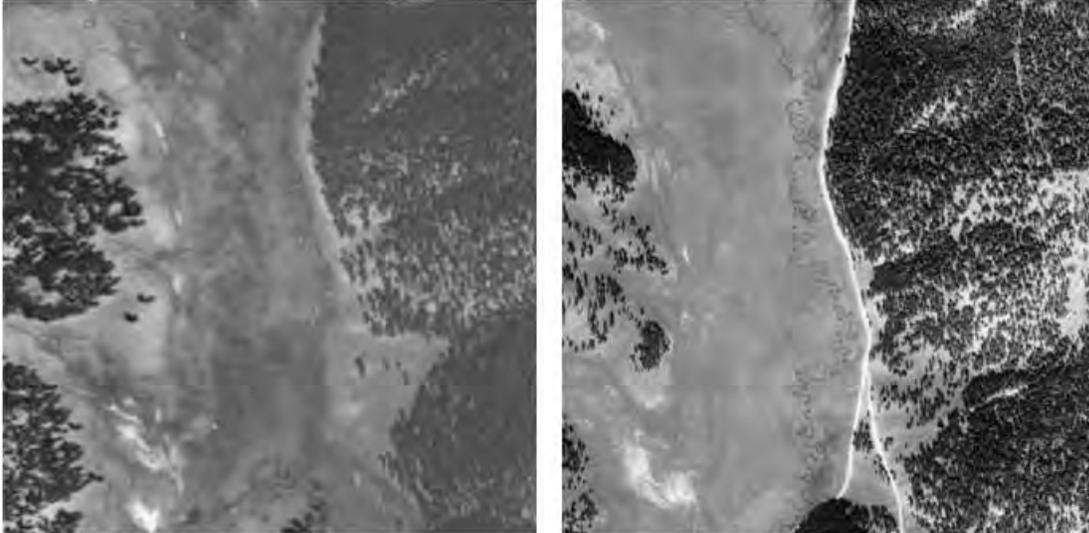
Lower Jaramillo Creek valley in the 1935 photographs shows a broad wet bottom, with multiple and barely discernible dark channel traces indicating a very dispersed flow through many very slightly incised channels possibly with partially vegetated bottoms, and as much flow likely as ground interflow as on the surface (Figure 10, left). By 1996 the valley section has a single thread channel (Figure 10, right). Ground observations have shown that the channel is also recovering from an over-widened, aggraded state.

Figure 10 - Aerial photograph from 1935 (left) depicts Jaramillo Creek in an over-widened, aggraded state. Aerial photograph from 1996 (right) shows the Jaramillo flowing as a single thread.
