Detail: Existing Condition

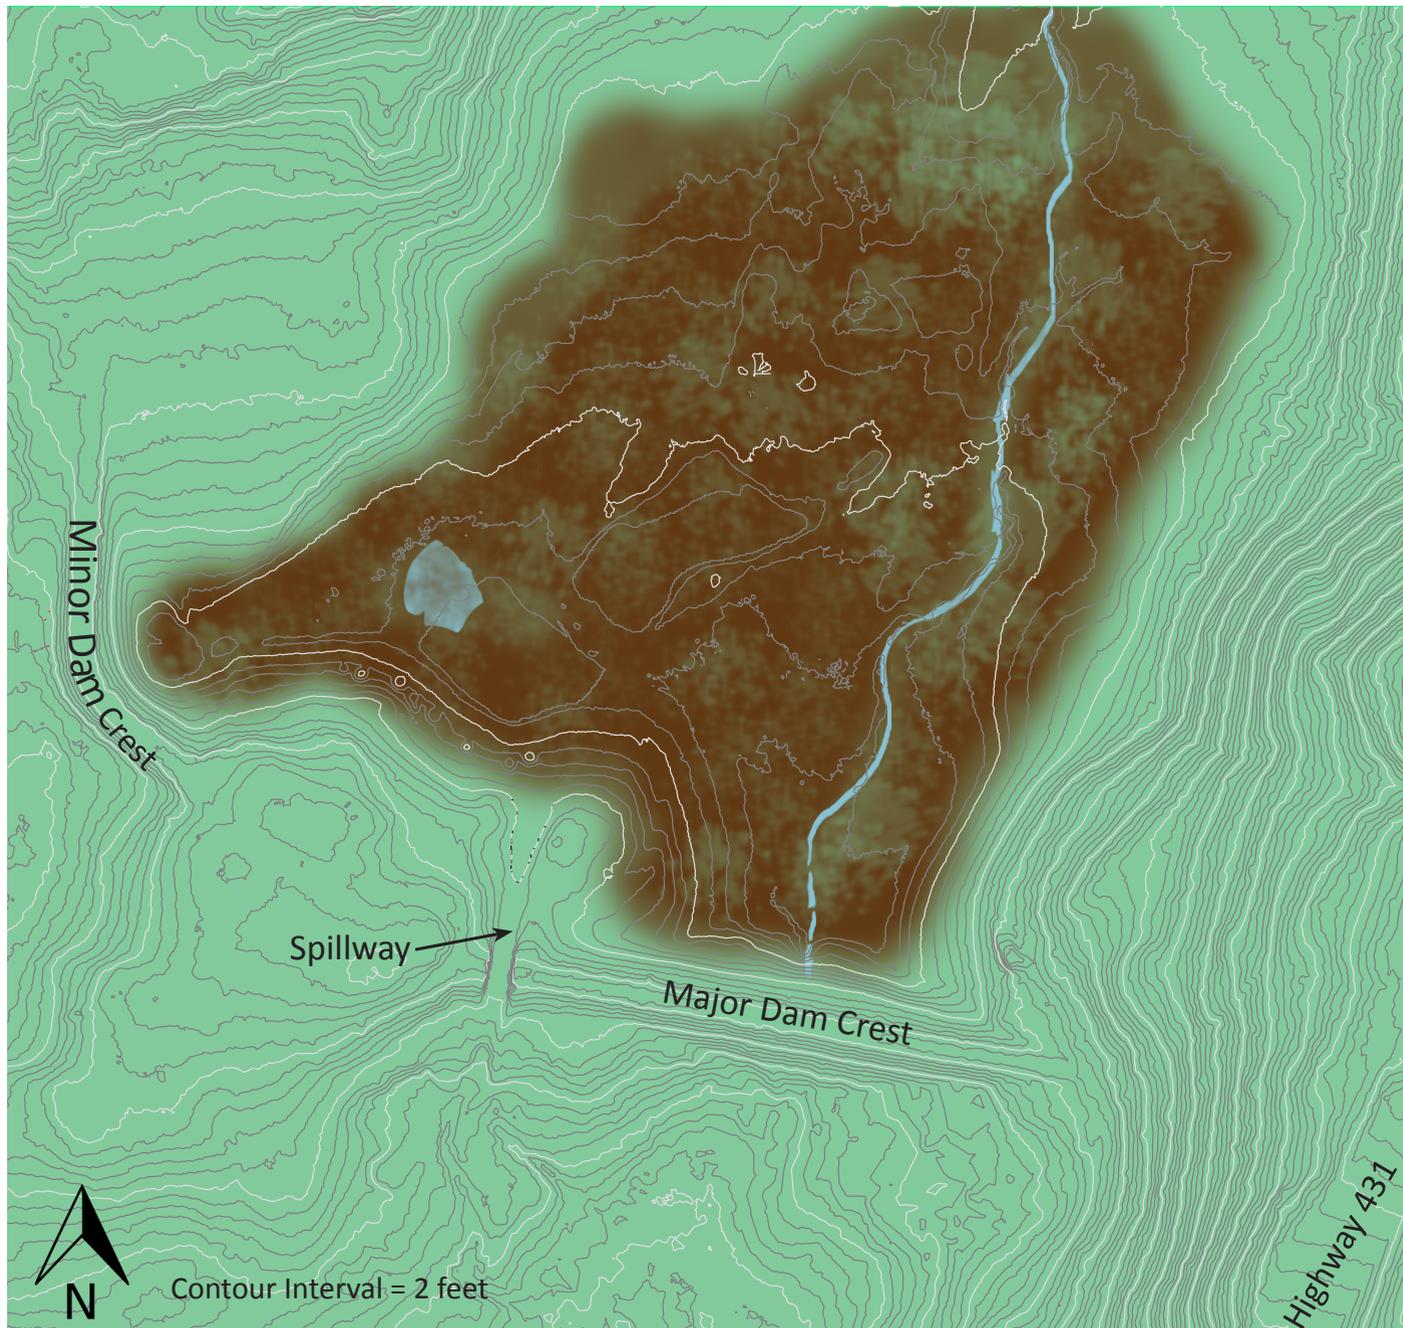
Existing Condition:

- Drained lake bed with incised channels
- High Hazard Dam remains
