Cookhouse Meadow Restoration

Five-Year Effectiveness Assessment

USDA Forest Service

November 2013

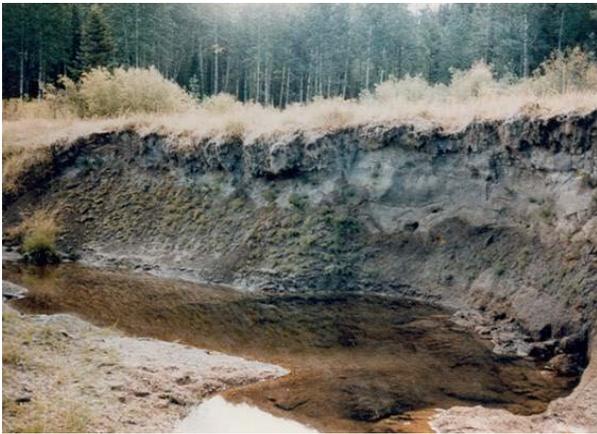
To improve grazing in the early 1900's, the stream channel had been moved from its historic location along the southern perimeter of the meadow to a new path through the middle of the meadow. The re-located channel was much straighter (less sinuous), which increased the velocity of the stream flowing through the meadow. The faster flows eroded the streambed, down-cutting and incising the stream channel deeply into the meadow. In many areas, the stream channel resembled a steep-walled gully much more than a natural watercourse (Figure 1).

Figure 1 Steep-walled streambank in 1981.

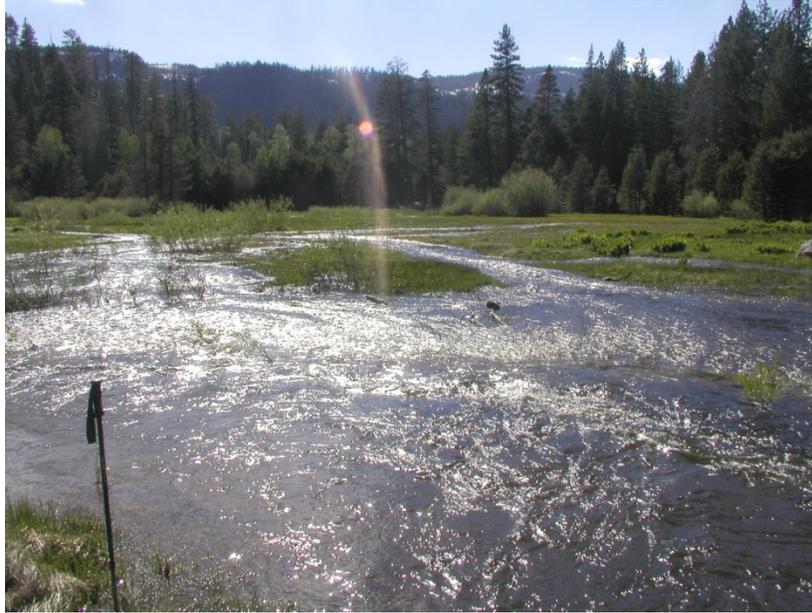
Figure 3 – June 21, 2011 view of channel and overbank flow at 75 cfs (facing downstream)

Observations and measurements were made on June 18-19, 2011, when gaged flow ranged from 50 to 60 CFS, which is twice the bank full discharge. Floodplain and channel margin deposits were identified visually as fresh surfaces forming a veneer over the previous year's vegetative growth. We also identified newly deposited sediments accumulating along channel margins.

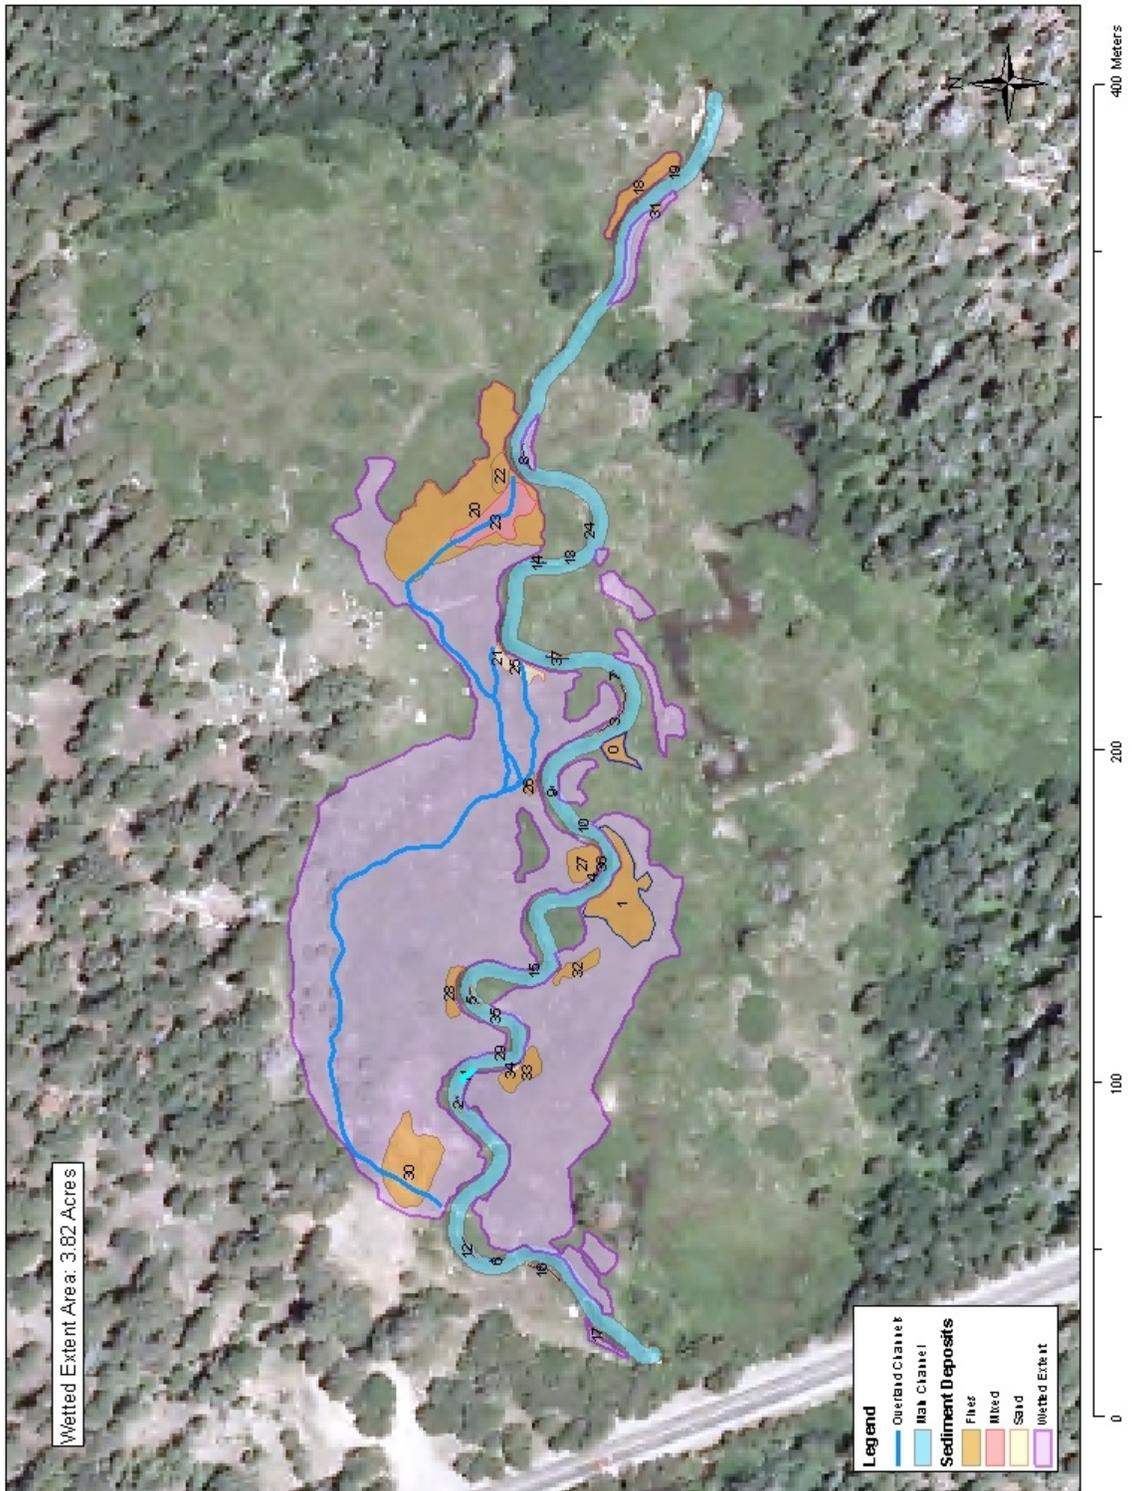
Mapping results (Figure 7) indicate the wetted extent as a result of the restored stream overbanking (ponding and over bank flow) was 3.82 acres at twice the bank full discharge (60 cfs). Total area of sedimentation identified was approximately 0.69 acres, and the depth of deposits ranged from 0.001 to 0.6 meters (Appendix B: Table 1 & 2). Lab analysis (Appendix B: Table 1) indicates that sand was the dominant particle size for channel margin samples and silt was the dominant particle size for floodplain samples. Utilizing the sediment volume field data and DRI particle distribution analysis (Appendix B: Tables 2, 3) we estimate 16.5 tons of sediment deposited in the channel margin and 39.7 tons deposited in the floodplain, of this the silt/clay fraction was 4.1 tons on the channel margins, and 20.7 tons on the floodplain.

Figure 7 – Cookhouse Meadow Wetted Extent and Sediment Deposits (June, 2011)

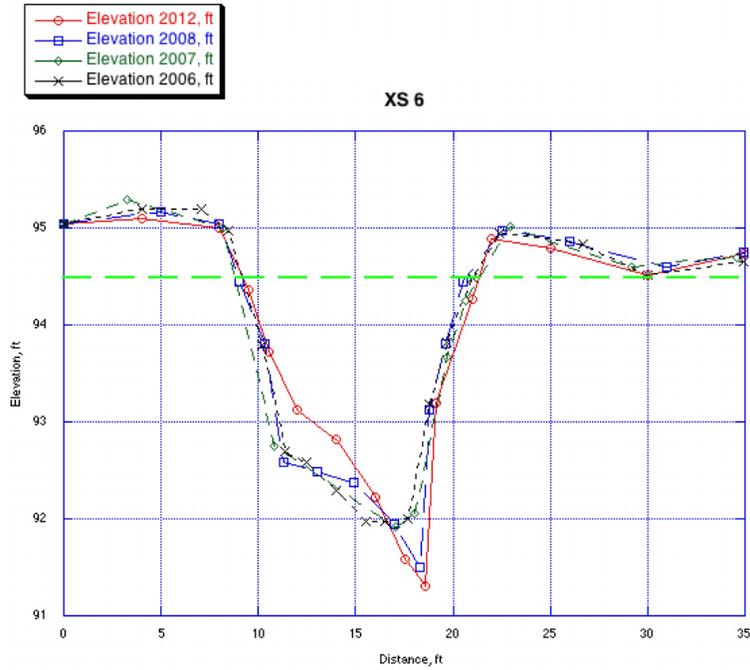
Results of Alticks analysis shows channel forming processes resulting in net aggradation, mostly in the form of point bar accretion (Figures 8 and 9).

Figure 8 – Magnitude of Point Bar Accretion at XS 6, mid-project. The green dashed line is the elevation where cross section shape analysis begins

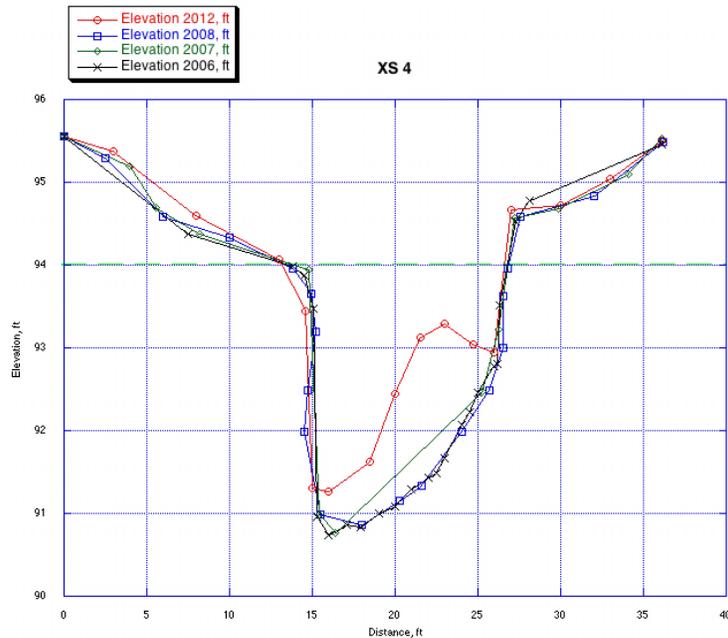
Figure 9 – Magnitude of Point bar accretion at XS 4, downstream end of project. The green dashed line is the elevation where cross section shape analysis begins

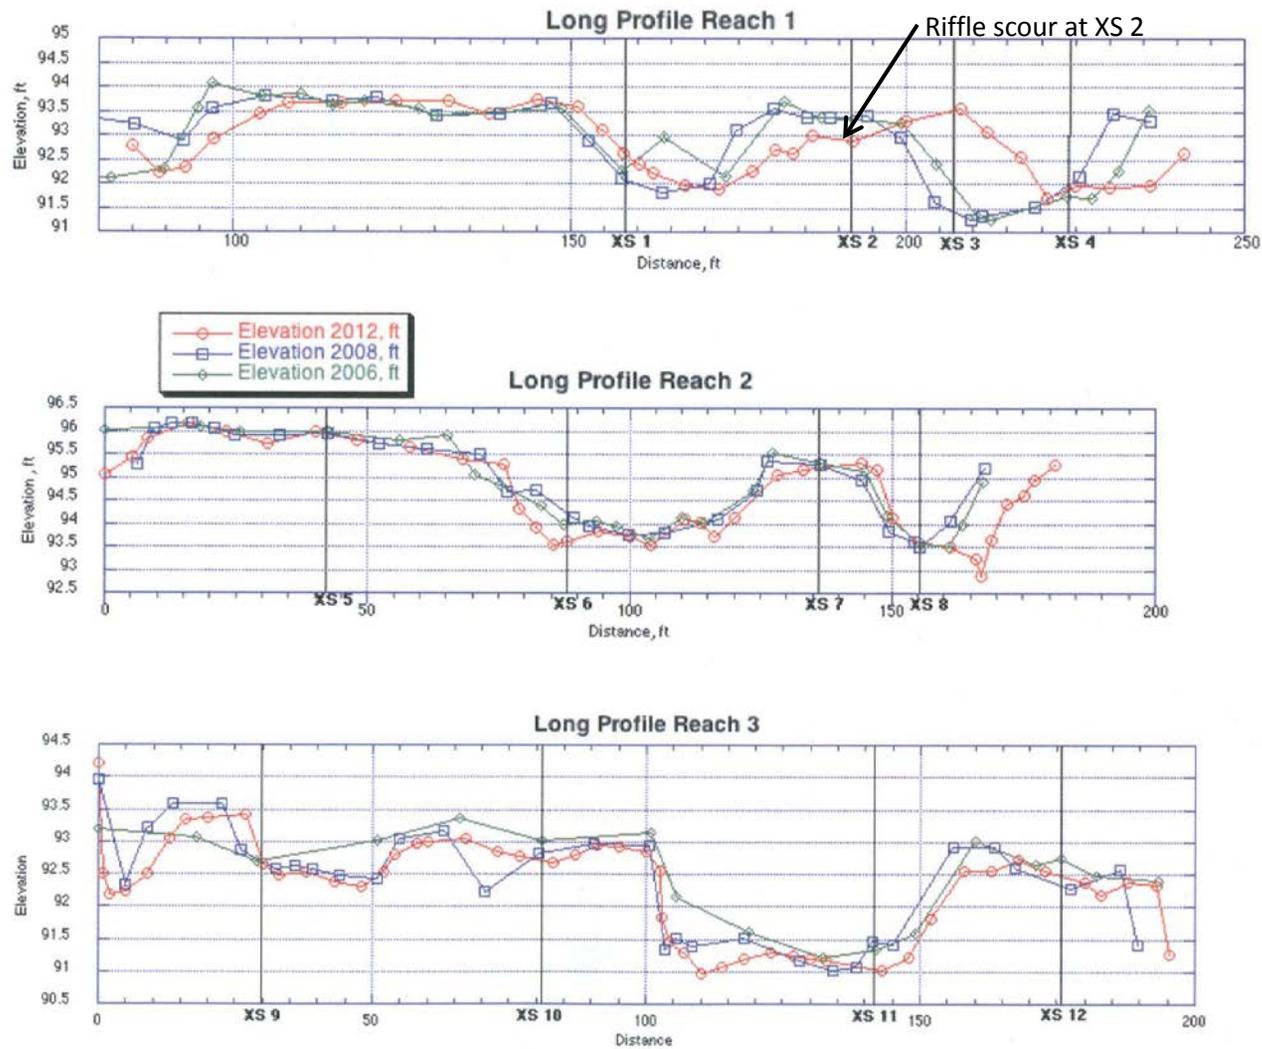
Figure 10 illustrates the change in overall thalweg elevations. The thalweg is the deepest point of the channel at any given point. Plots show that minor changes in the thalweg have occurred since 2008, with one noticeable area of riffle scour to a downstream shift in pool – riffle position as shown in the Reach 1 thalweg survey. Change in mean bed elevation (Figure 11) shows net aggradation of the channel since 2008, once again mostly in the form of point bar formation. The photo in Figure 12 illustrates this process of point bar formation.

Figure 10 – Big Meadow Creek thalweg measurements (from Altick, 2012)

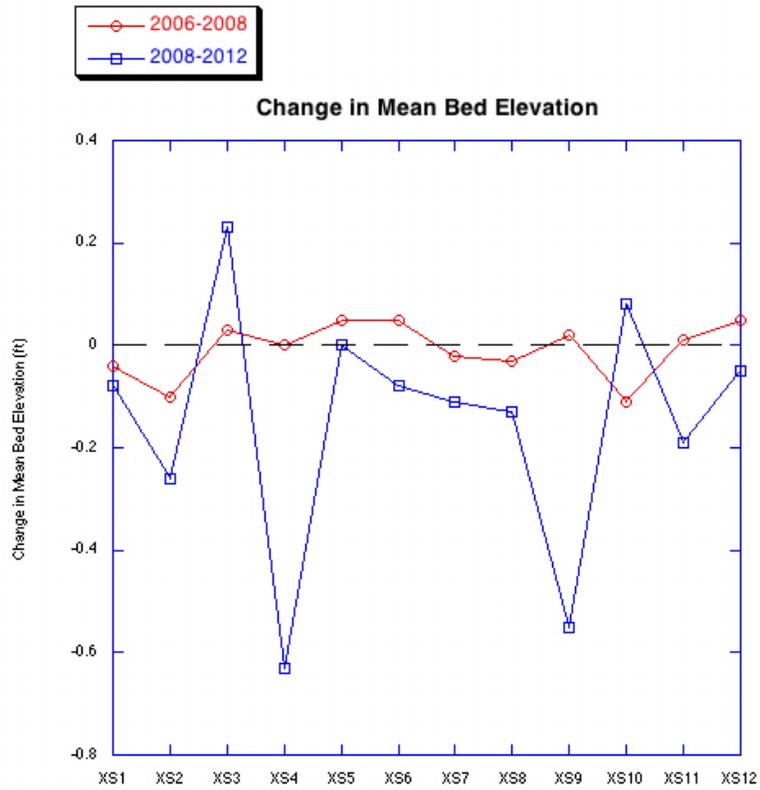
Figure 11 – Change in Big Meadow Creek mean bed elevation (from Altick, 2012). Negative values indicate loss in area (aggradation), positive values indicate increase in area (degradation).

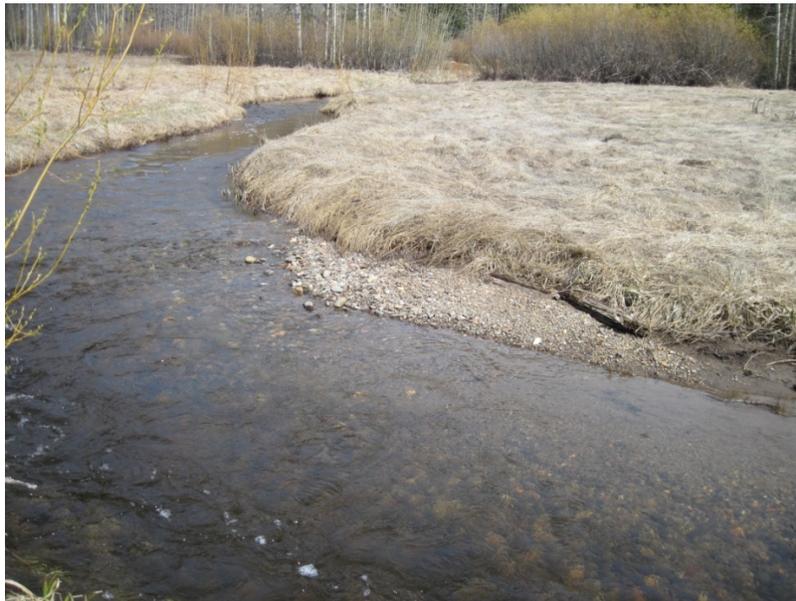
Figure 12 – Point bar formation in Cookhouse Meadow in May, 2012

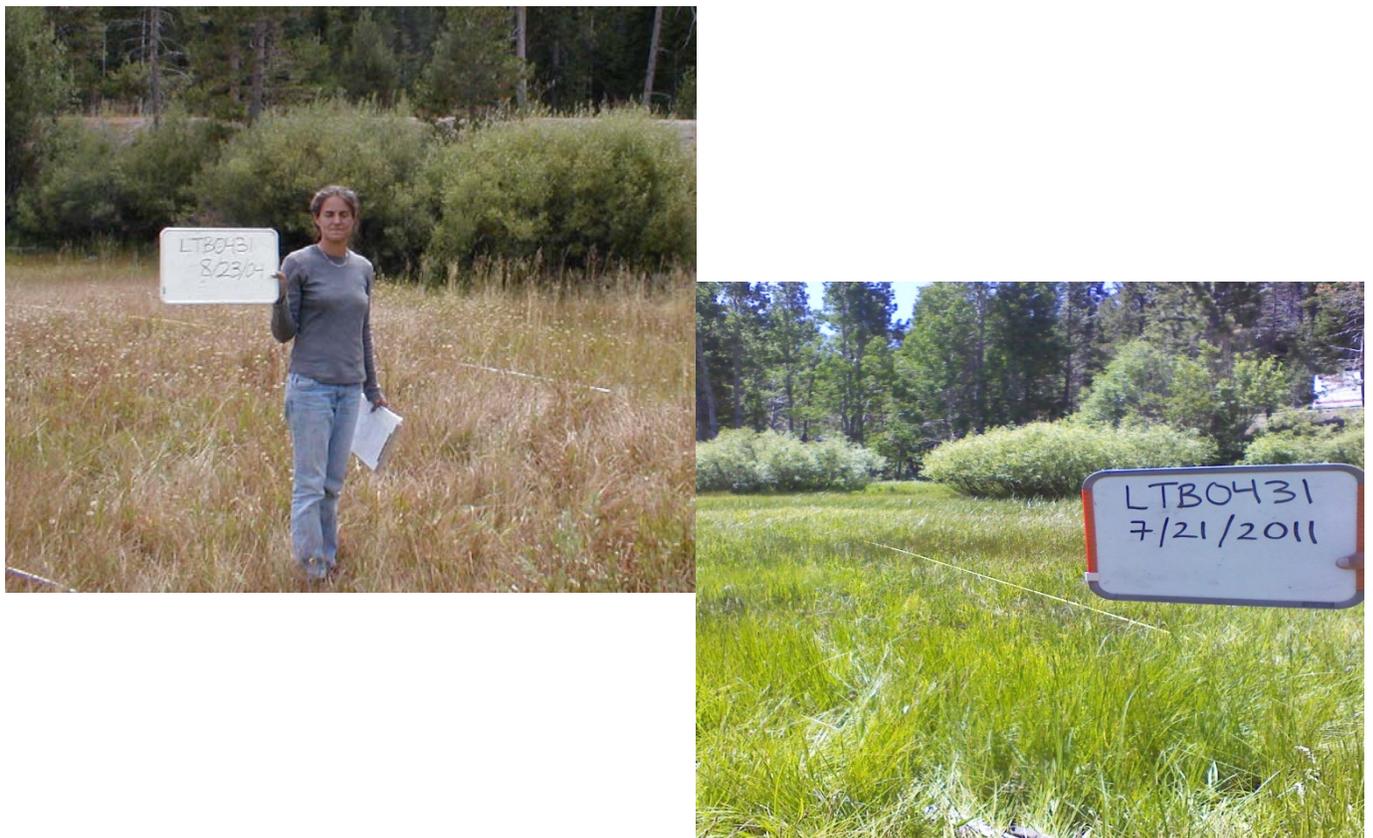
Quantitative and qualitative (Figure 16) results suggest there has been an increase in meadow species indicative of wet meadow conditions. Future monitoring could determine if either conifer encroachment or increasing frequency of *Poa pratensis* continues; this may provide some insight into management consideration for future projects. Potential considerations could include better sub-soiling of compacted soils to reduce conifer encroachment and potentially increase the spread of sod or native seed within the project area to reduce *Poa pratensis*.

Figure 16: Cookhouse Meadow Vegetation Monitoring Plot #0431 (2004, 2011).
