Fisheries Monitoring Results 2006-2009

Prepared by: J. Greenway, Fisheries Technician

Reviewed by: Caleb Zurstadt, West Zone Fisheries Biologist

December 17, 2009.

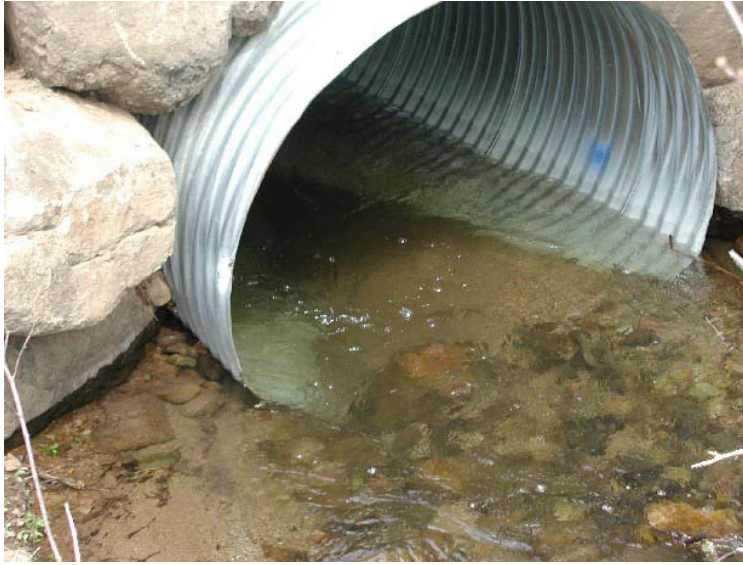
Figure 86. Culvert outlet on Fourth of July Creek. Photograph is looking at outlet pool where numerous fish were observed in 2007.

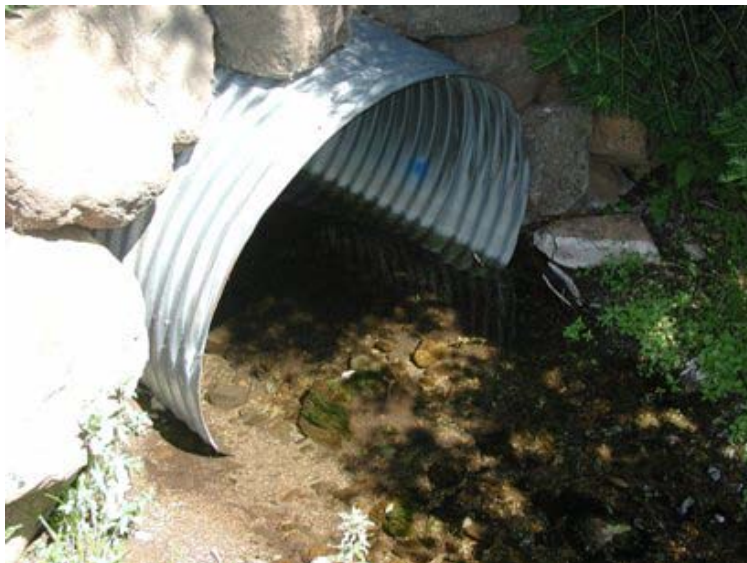
Figure 89. Culvert outlet on Fourth of July Creek. Photograph is looking at outlet pool where numerous fish were observed in July of 2008.

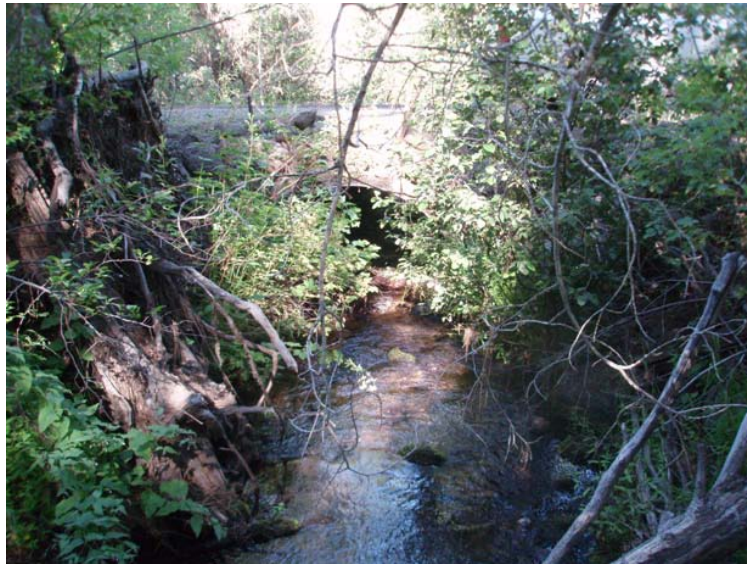
Figure 117. Culvert on FS Road at the Fawn Creek Crossing, looking at the inlet prior to replacement on July 20, 2009.

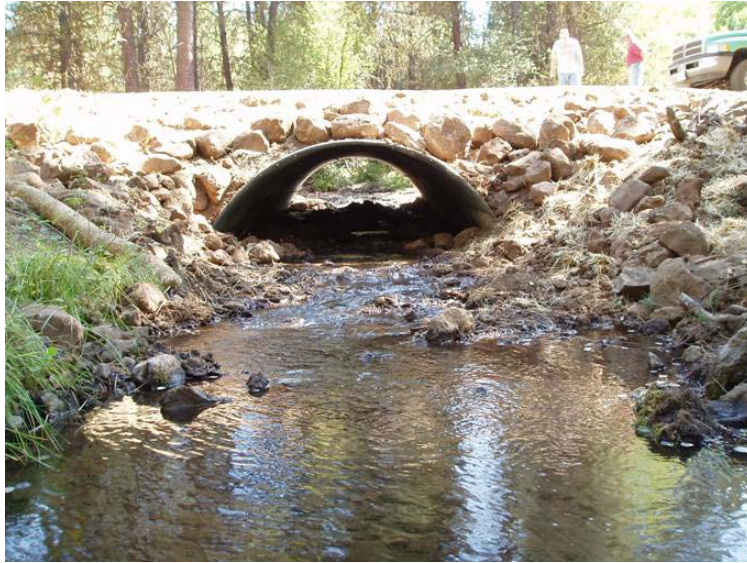
Figure 119. Culvert on FS Road 143 at the Fawn Creek crossing, looking at the outlet after replacement.

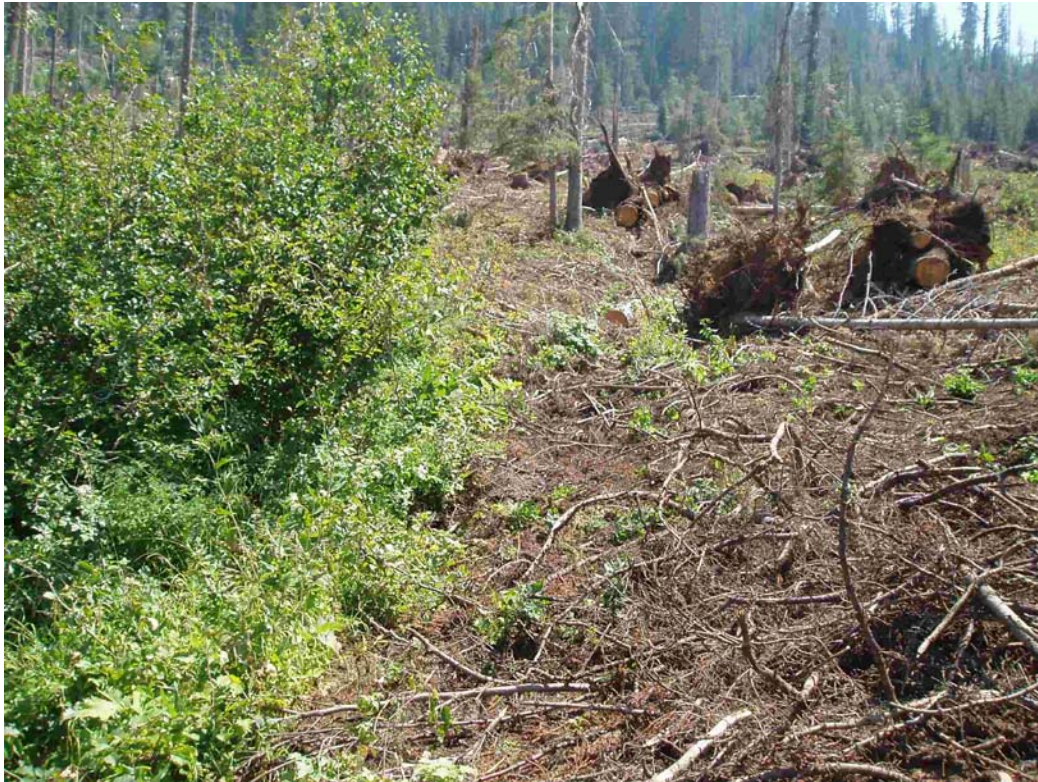
Figure 1. Post logging photograph of unmapped RCA in unit 4 where trees were removed.

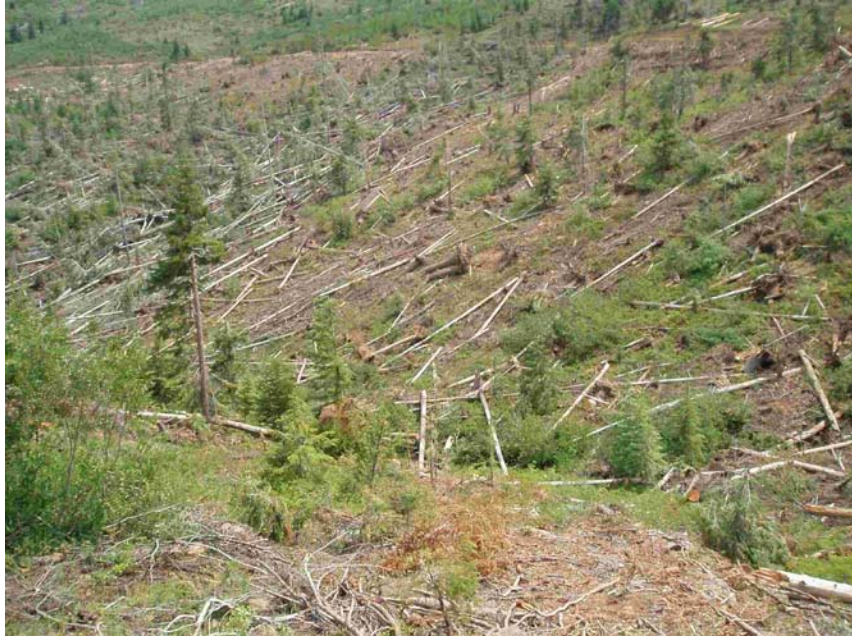
Figure 2. Post logging photograph of unmapped RCA in unit 4 where trees were removed.

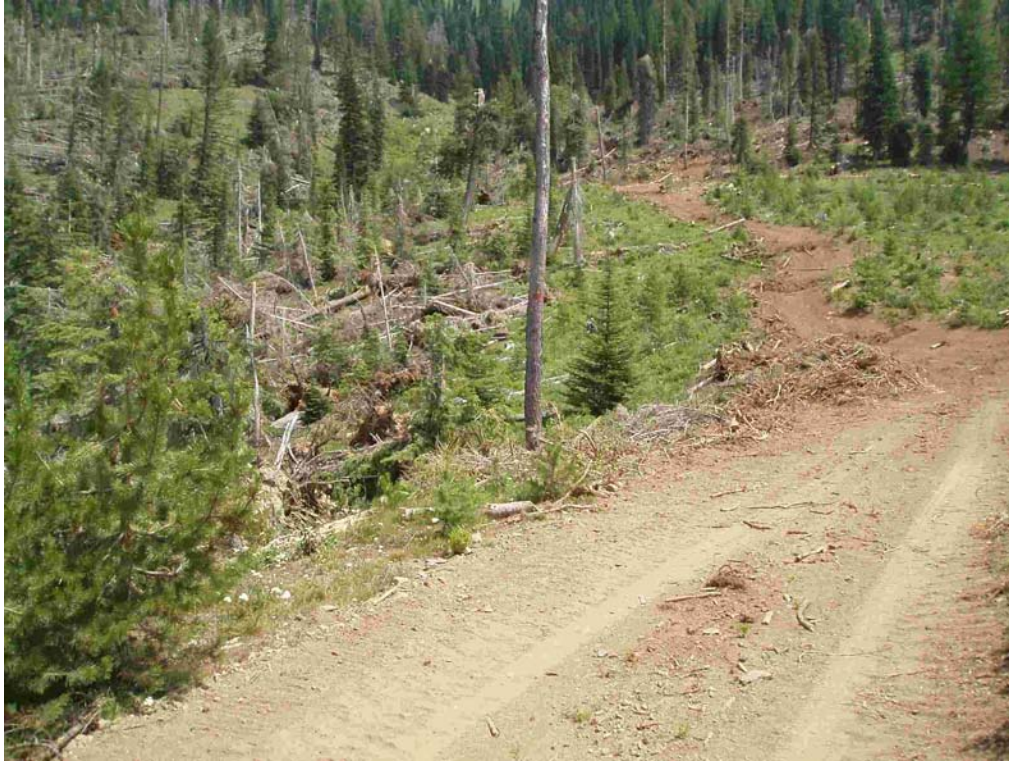
Figure 4. Bear South unit 1 RCA. Trees were removed from the outer 120 ft of a 240 ft RCA buffer on Bessie Gulch, but machinery remained outside of the 240 ft buffer.

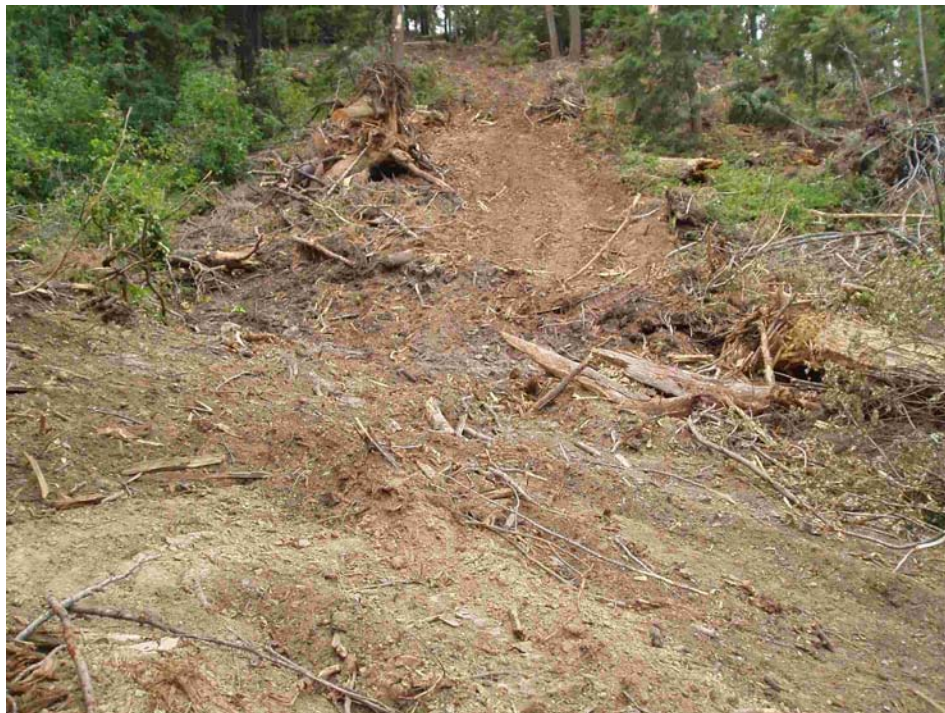
Figure 5. Skid trail within 160 ft of Mickey Creek.

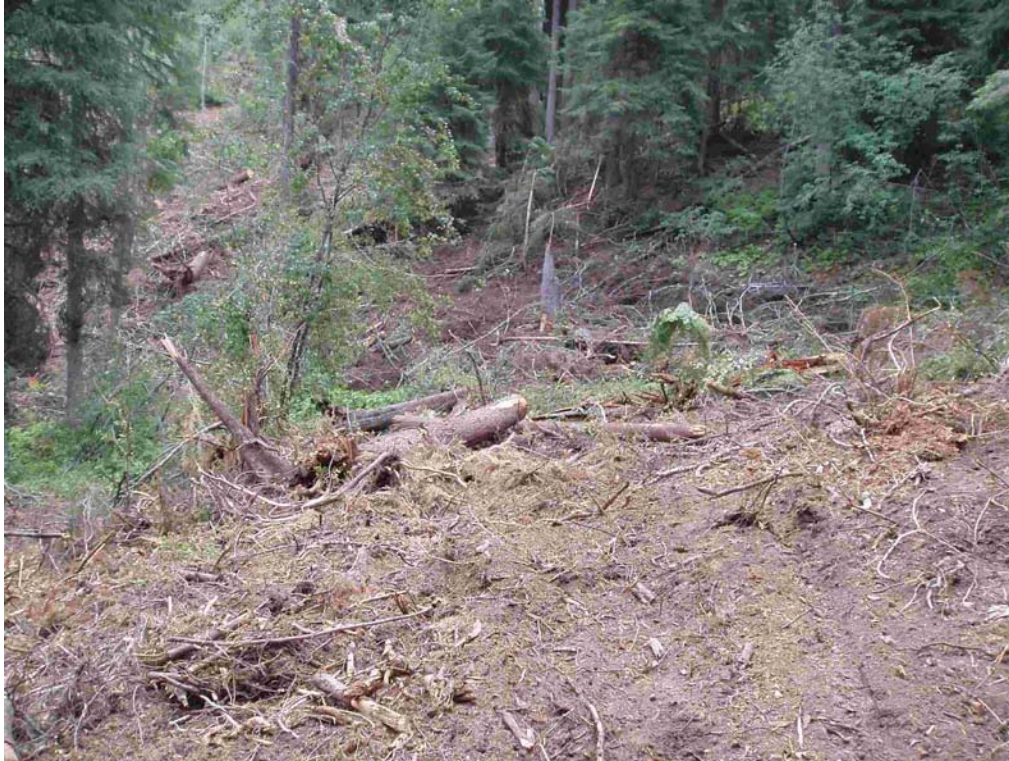
Figure 6. Skid trail across RCA of an unmapped intermittent channel. Channel is in center of the photo.

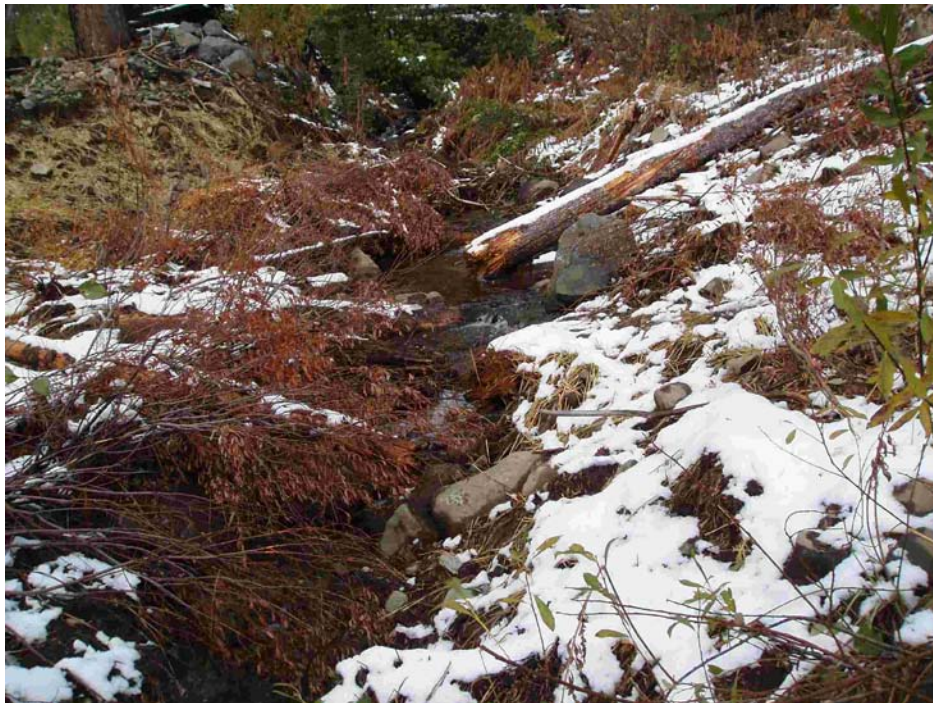
Figure 9. Wesley Creek culvert removal and channel rehabilitation.

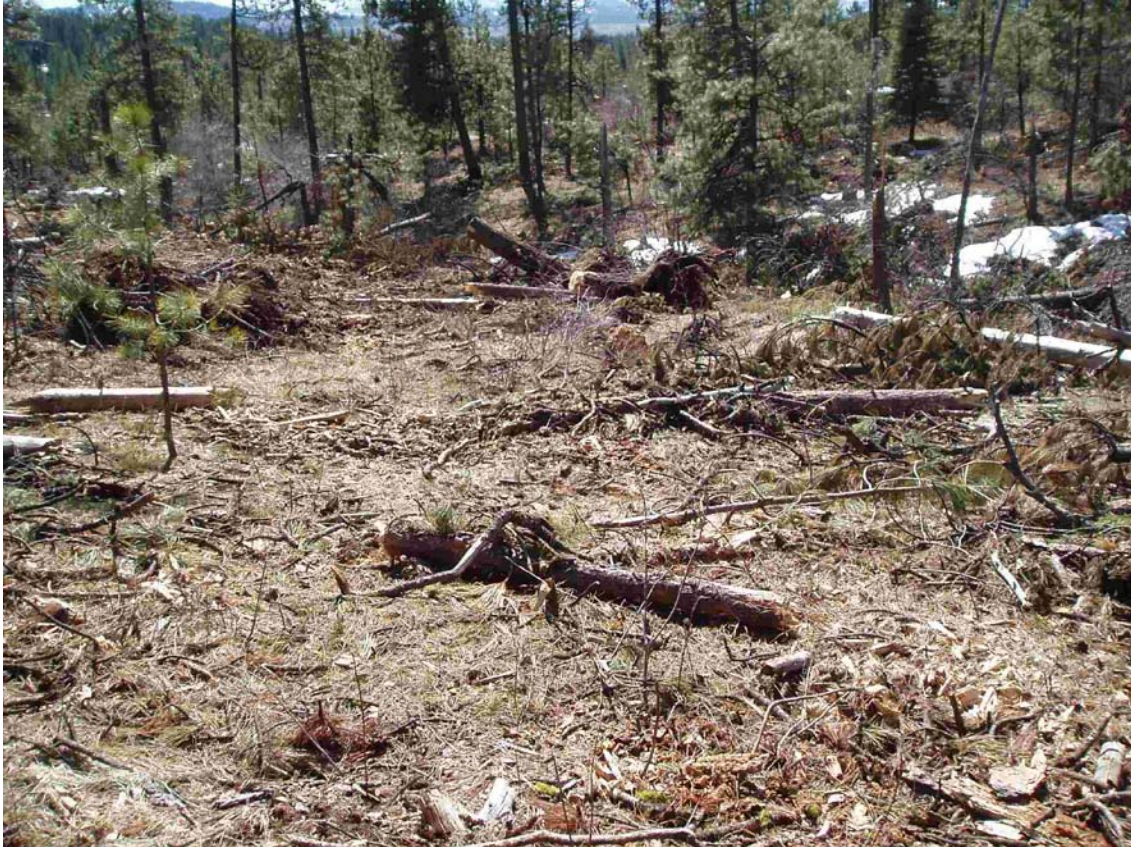
Figure 10. Tributary to Bear Creek culvert removal and channel rehabilitation.

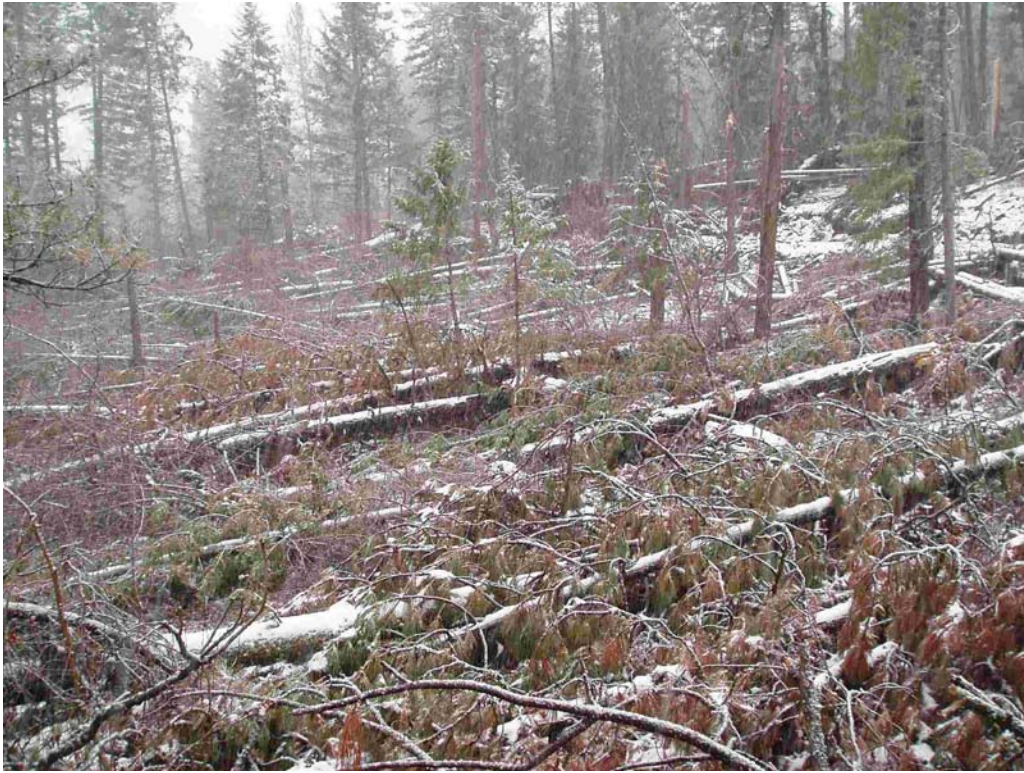
Figure 11. RCA in Bear West where over snow skidding occurred. Little to no soil disturbance was observed.

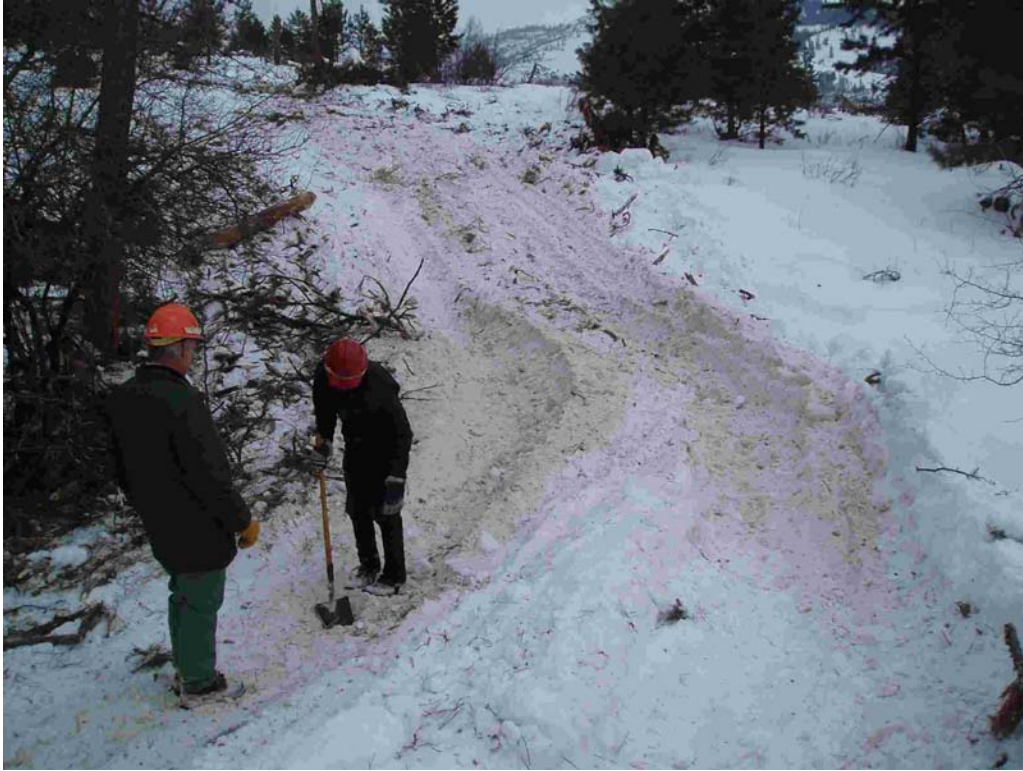
Figure 15. Snow bridge on intermittent channel at old road ford in unit 12 after snow melt. See Figure 14 for pre-snow melt.
