# Ecological condition of the East Fork of the Gila River and selected tributaries: Gila National Forest, New Mexico

Robert D. Ohmart<sup>1</sup>

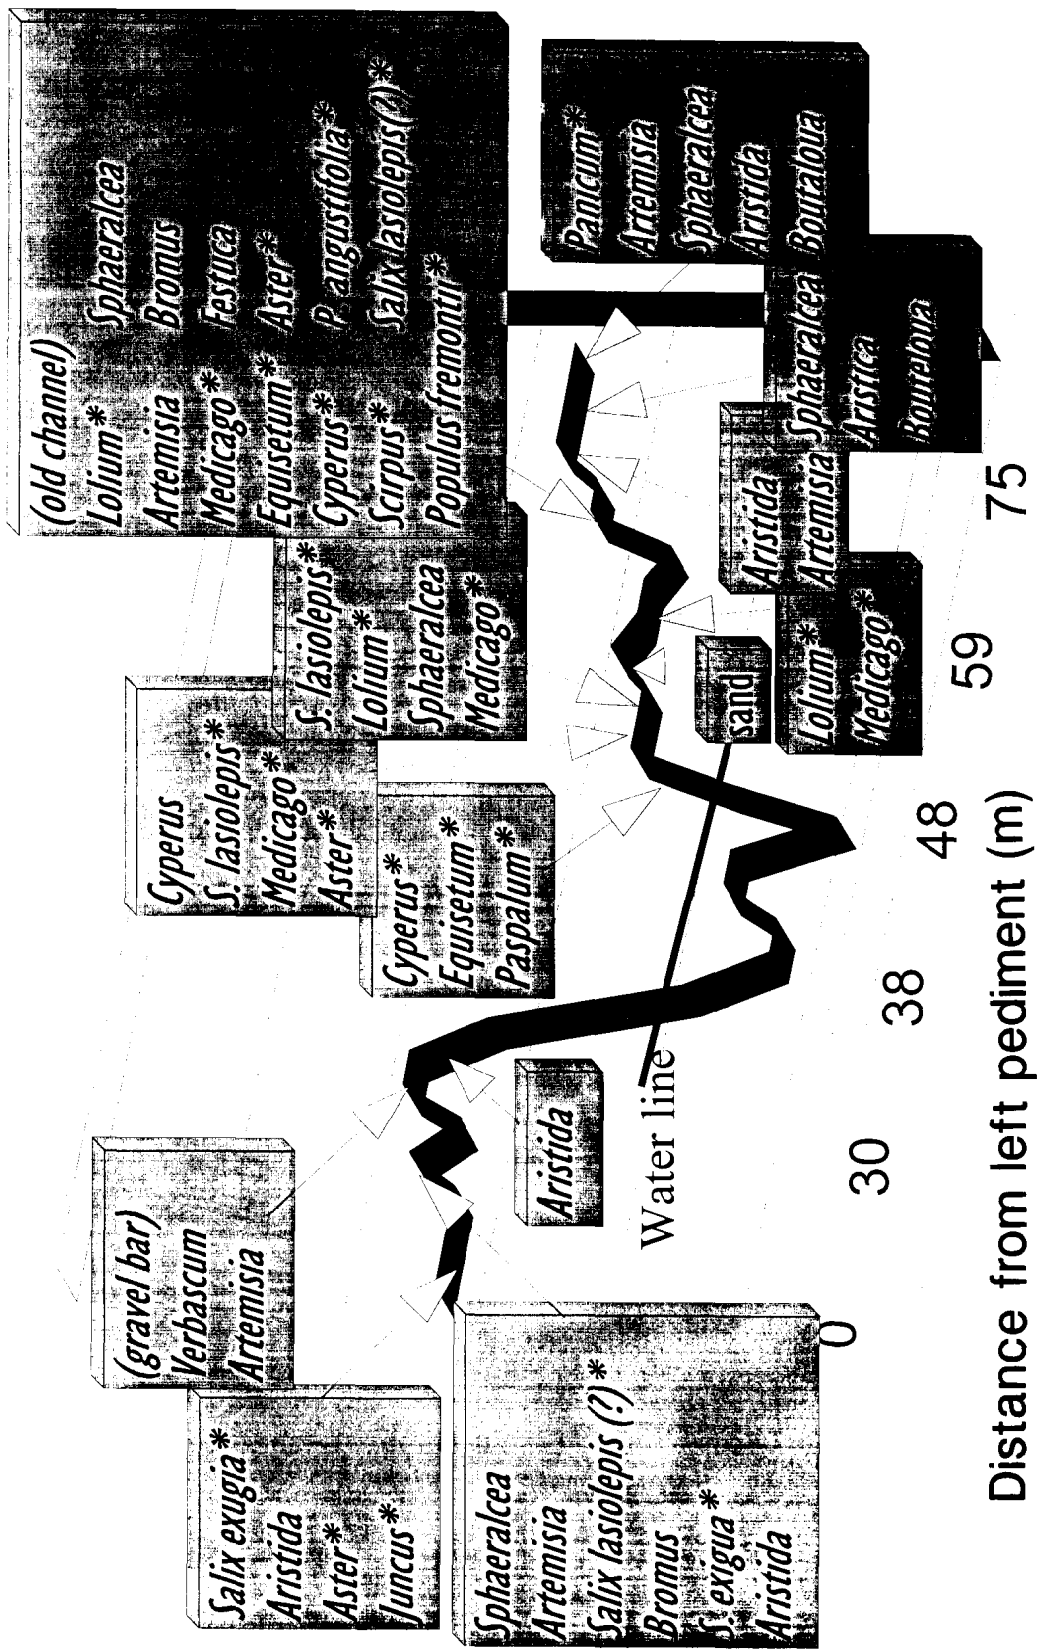
The floodplain was subdivided into 13 segments from left to right along the cross-section (fig. 1). Each segment represents an area either where there was major topographic or vegetational change across the floodplain. In figure 1 it can be seen that the river (old channel) had moved toward the left pediment about 26 m. The left bank is a high gravel bar and supports scattered nonriparian plant species. The right bank and segments up to and including the old channel are presently the primary floodplain and of the 26 species in these segments, 22 are riparian plant species.

Channel incisement has lowered the water table across the floodplain, consequently, second terraces (two leftmost segments and three rightmost segments) seldom receive overbank watering and groundwater table recharge except in large flood events. Of the 20 species occurring in these segments only 6 were riparian species. Vine mesquite (*Panicum obtusum*) occurred as a relict producing occasional seed heads. Willows (*Salix* spp.) reached their maximum densities in the outermost segments near the mountain pediments where soil moisture levels are maintained by surface runoff. Numerous upland species have invaded these segments.

Figure 1. Plant species distribution along a cross-section of the East Fork of the Gila River, Gila National Forest, New Mexico.
