**Resurrection Creek  
Stream Channel and Riparian  
Restoration Analysis  
River Kilometer 8.0 – 9.3**

**Resurrection Creek  
Stream Channel and Riparian  
Restoration Analysis  
River Kilometer 8.0-9.3  
*October 1, 2002***

*Brian Bair, Paul Powers, Anthony Olegario*

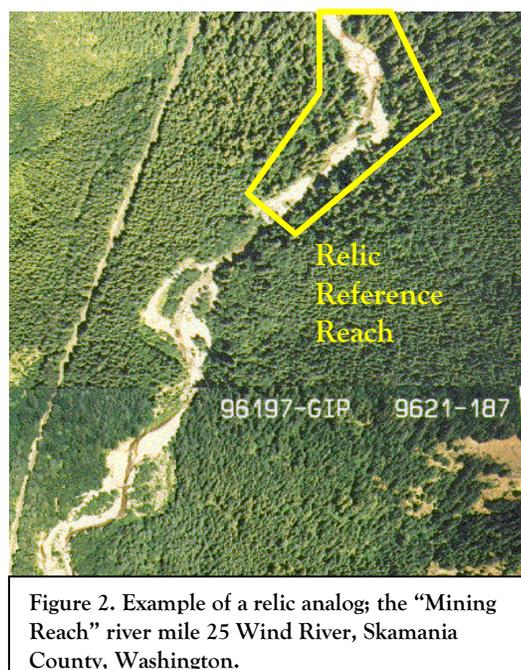
Figure 2. Example of a relic analog; the “Mining Reach” river mile 25 Wind River, Skamania County, Washington.

The definition of a reference reach or relic analog used for this analysis is: *an undisturbed reach of stream that possess similar channel morphology, hydrology, sediment regime and biota relative to the disturbed site to be analyzed, rehabilitated or restored* (Figure 2). The goal is to find a reference reach that contains the same riparian eco-class, slope, discharge, and sediment budget and channel confinement or entrenchment up-stream of the disturbed reach. The riparian vegetation composition and structure, thalweg slope, bank full width, average depth, belt width, entrenchment and large woody debris (LWD) within the reference reach are measured to compare and contrast the existing conditions within the disturbed reach and to develop restoration templates, goals and objectives (Figure 3).

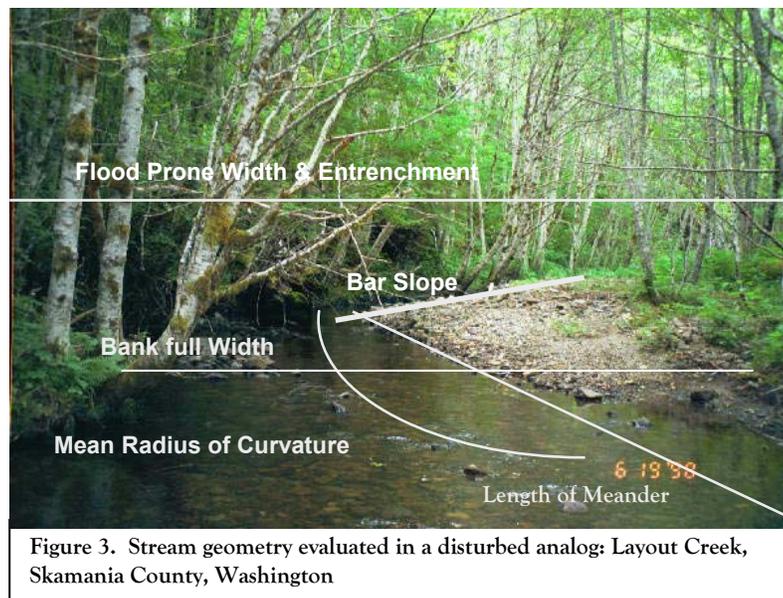
Figure 3. Stream geometry evaluated in a disturbed analog; Layout Creek, Skamania County, Washington

Disturbed analogs are usually found in small segments within the reach in need of treatment. Typically they are formed by remnant debris, cohesive soils and/or recovering riparian areas with good root structure. Figure 3 depicts derived values in a potential disturbed analog.

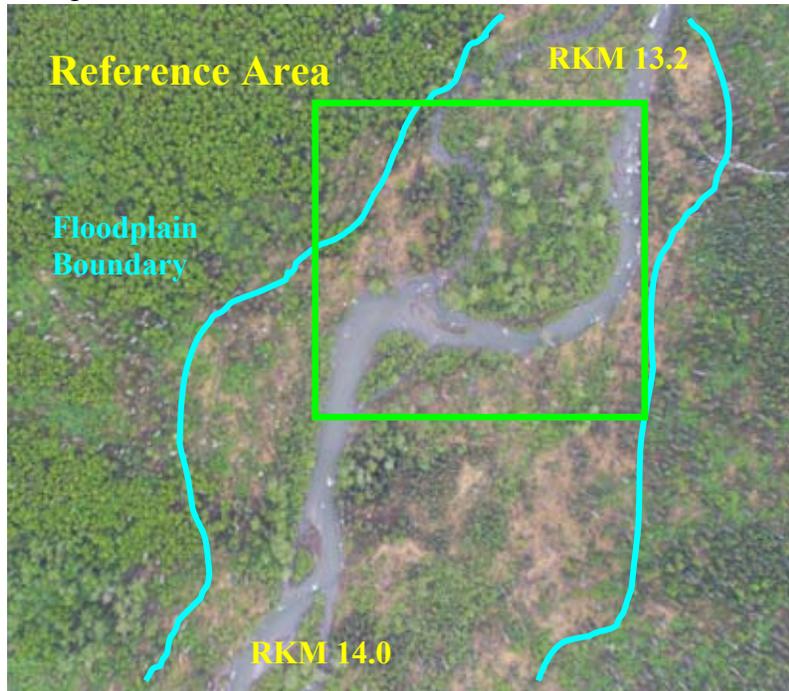
**Photo 1. Aerial ortho-photo of the reference reach, river kilometer 13.2 Resurrection Creek, Kenai Peninsula, Alaska.**

The reference reach is located at river kilometer 13.2-14.0, approximately 3.5 kilometers upstream of the project area (photo 1). The reference reach drains approximately 31,433 hectares and is predominantly a C channel under the Rosgen classification system (Rosgen, 1994). Chugach National Forest personnel selected this site as a reference reach due to the mature riparian vegetation, existing floodplain and associated off channel characteristics. Morphometry values in this report differ from those presented in Blank's 2002 draft report. The differences in values are largely attributed to the scale and degree of resolution within the surveyed area. This survey focused on the upper meander bend and side channel due to vegetation maturity and stable channel characteristics. Forest archaeologists have documented mining in the reference reach in the early part of the century. However the tailings were not piled and did not alter floodplain elevations nor restrict the channel from its original floodplain. Therefore we considered this reach a relic reference reach.

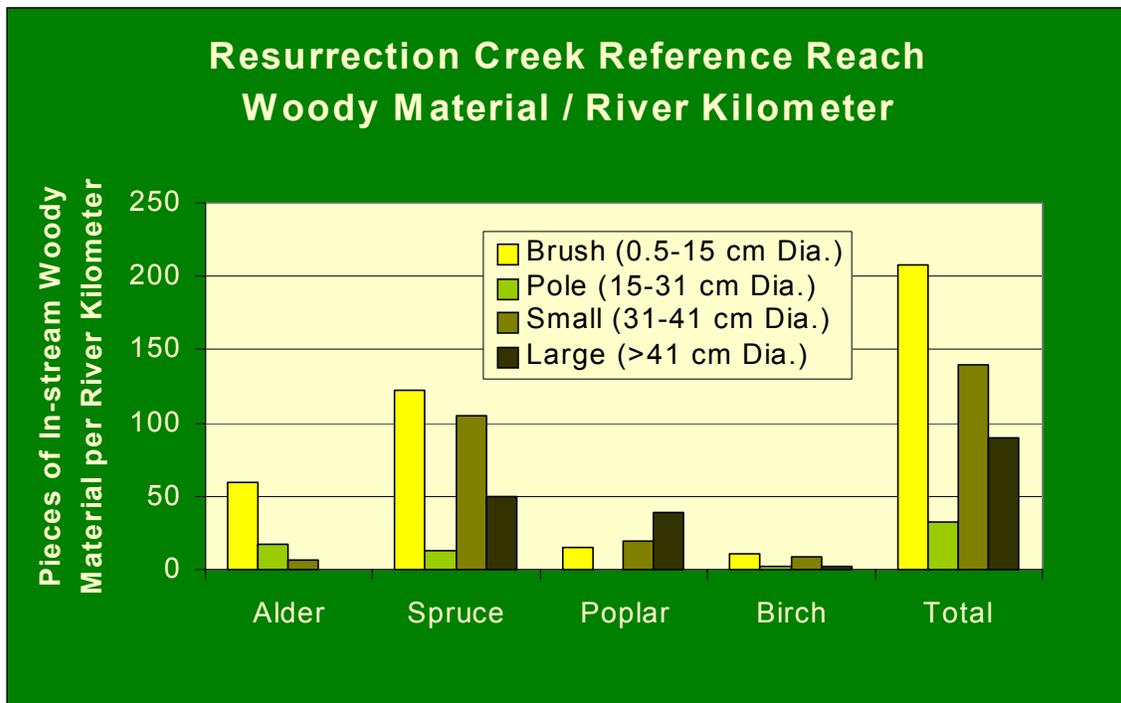
**Figure 6. Number and species of in-stream woody material per river kilometer within Resurrection Creek reference reach bankfull channel, Kenai Peninsula, Alaska.**

The reference reach is located in an unconfined alluvial valley, which is evidenced by the floodplain width/bankfull width or entrenchment ratio of 8:1. The bankfull width to depth ratios ranged from 35-40 in the reference reach and was on the high end of the spectrum for Rosgen C channels. This may be partially due to the relatively high amount of large woody material found within the bankfull channel or high sediment loads. Large in-stream woody material >31cm in diameter totaled 214 pieces per river kilometer in the reference reach which formed numerous braids and maintained perennial side channels characteristic of alluvial fans or Rosgen D channels. The wood within this reach created and maintained an extremely diverse array of aquatic and terrestrial habitat (see photo 2). One large logjam moderated flow into a perennial side channel that contained the majority of pink, chinook and coho salmon spawning habitat within the reach. Pebble counts, ocular estimates and contour maps were used to estimate the quantity of spawning gravel within the reference reach. Approximately 1,100 m<sup>2</sup> was estimated in 0.42 river kilometers of the reference reach. This is thought to be a relatively conservative estimate due to the fact that a significant portion of the relief channel, which possessed the most of the spawning gravel, was covered by ice at the time of the survey. Other dispersed concentrations of in-stream wood protected islands of vegetation, dissipated flow and initiated fine sediment deposition on the floodplain. Photo 2 and figure 6 depicts the character, number and species of in-stream woody material per river kilometer within Resurrection Creek reference reach bankfull channel.

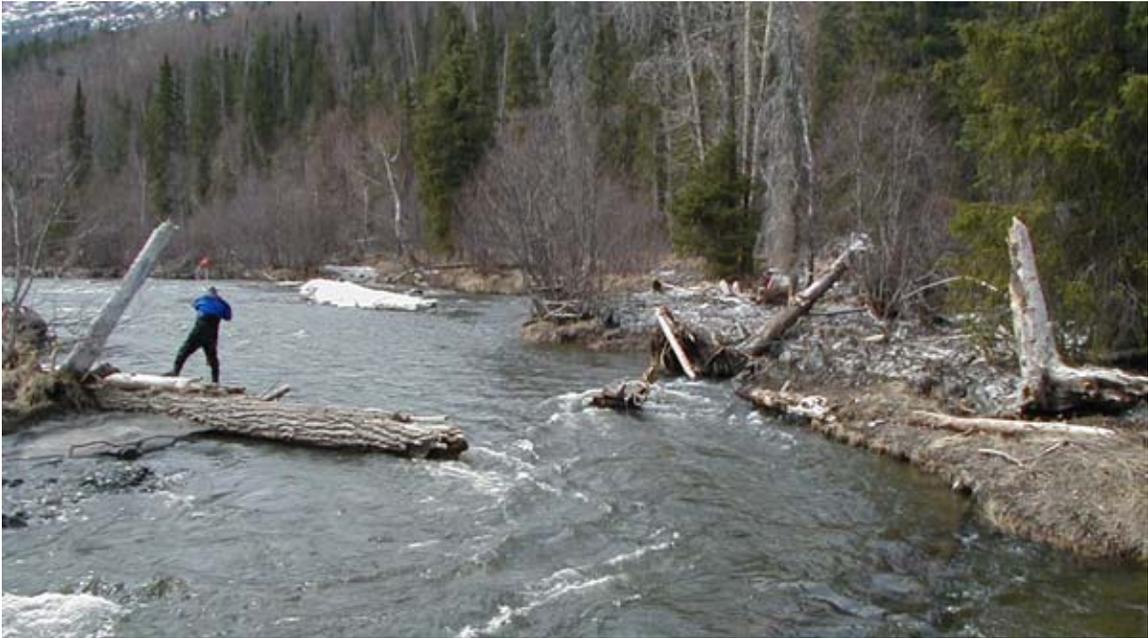
**Photo 2. Photo of typical in-stream woody material within the Resurrection Creek reference reach bankfull channel, river km 13.4 (looking up-stream) Kenai Peninsula, Alaska.**

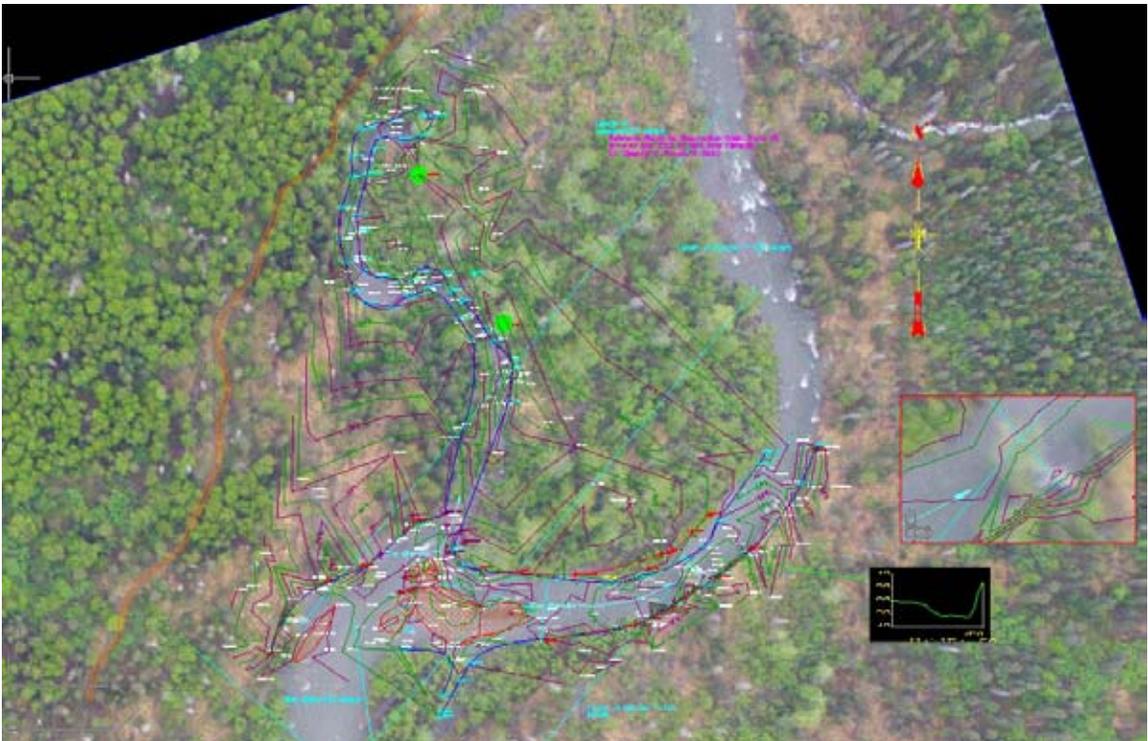
**Figure 5. Aerial photo and contour site map overlay for 2002 reference reach survey, Resurrection Creek, Kenai Peninsula, Alaska.**

Meander lengths were measured in the field, taken off of AutoCAD contour maps and low elevation aerial ortho-photos (Figure 5).

Six meander lengths were measured in the reference reach. Length of meander values ranged from 116 – 146 meters and averaged 131 meters. These measured values were evaluated against calculated values generated from cross-sectional data and then applied to Williams (1984) channel geometry equations. The equation selected for this evaluation is based on stream channel cross-sectional area:

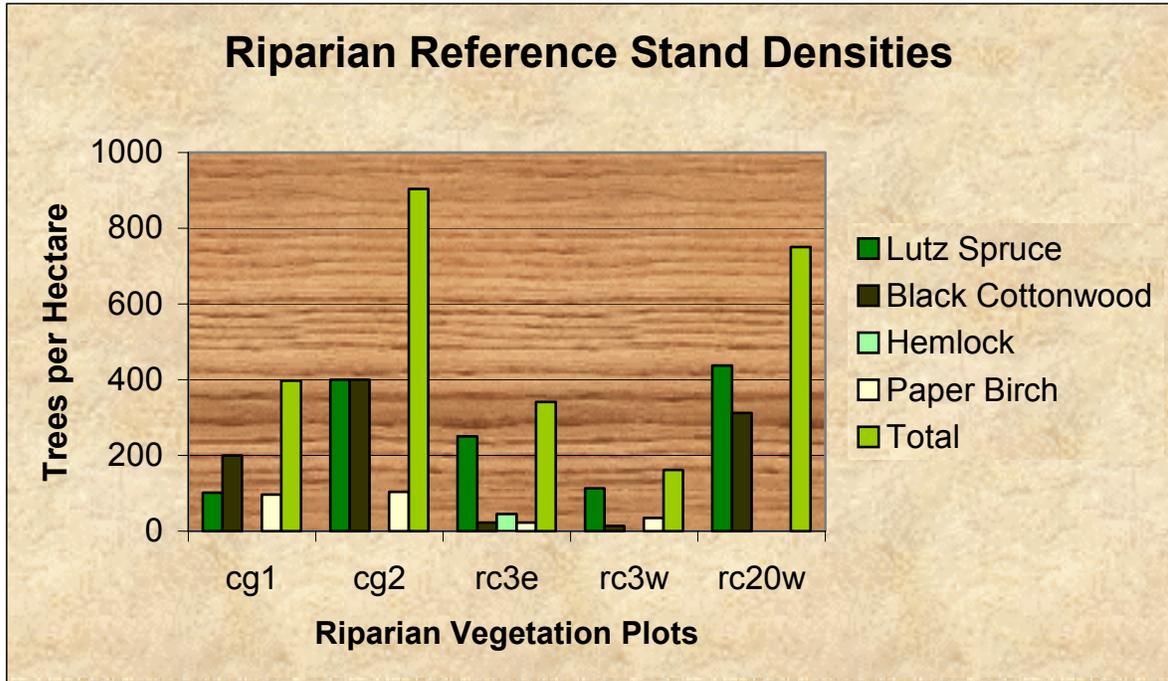
**Figure 7. Tree densities by species observed within the Resurrection Creek reference reach riparian vegetation plots, May, 2002 survey, Kenai Peninsula, Alaska.**

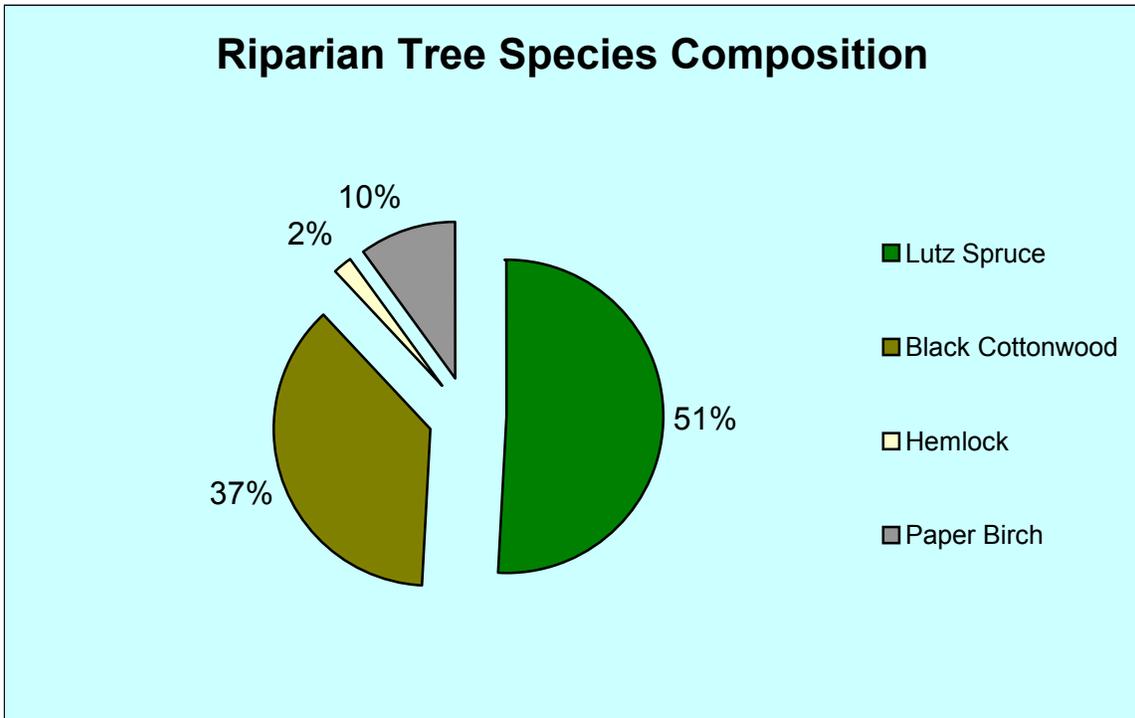
**Figure 8. Riparian tree species composition within the 2002 Resurrection Creek reference reach riparian vegetation plots, Kenai Peninsula, Alaska.**

There were observed differences in stand structure between the 1995 study and the 2002 riparian surveys. The 2002 riparian stands surveyed contained 51% Lutz spruce, 37% black cottonwood, 10% paper birch and 2% hemlock (figure 8). The 1995 study documented that Lutz spruce was the dominant tree species and comprised 93% of the stands. This difference in species composition may be partially attributed to the differences in upland and riparian vegetation composition. The differences in species composition may also be partially responsible for the differences in diameter structure between the 1995 report and the 2002 riparian survey. Fifty-one percent of the trees in both the burned and unburned areas of the 1995 study were composed of saplings 0-22 cm in diameter at breast height (dbh). In the 2002 survey 50% of the trees were also in the Seedling/Sapling class (0-15 cm dbh), which closely approximates what was found in the 1995 study (figure 9). However the riparian stands surveyed in 2002 contained higher densities of larger diameter

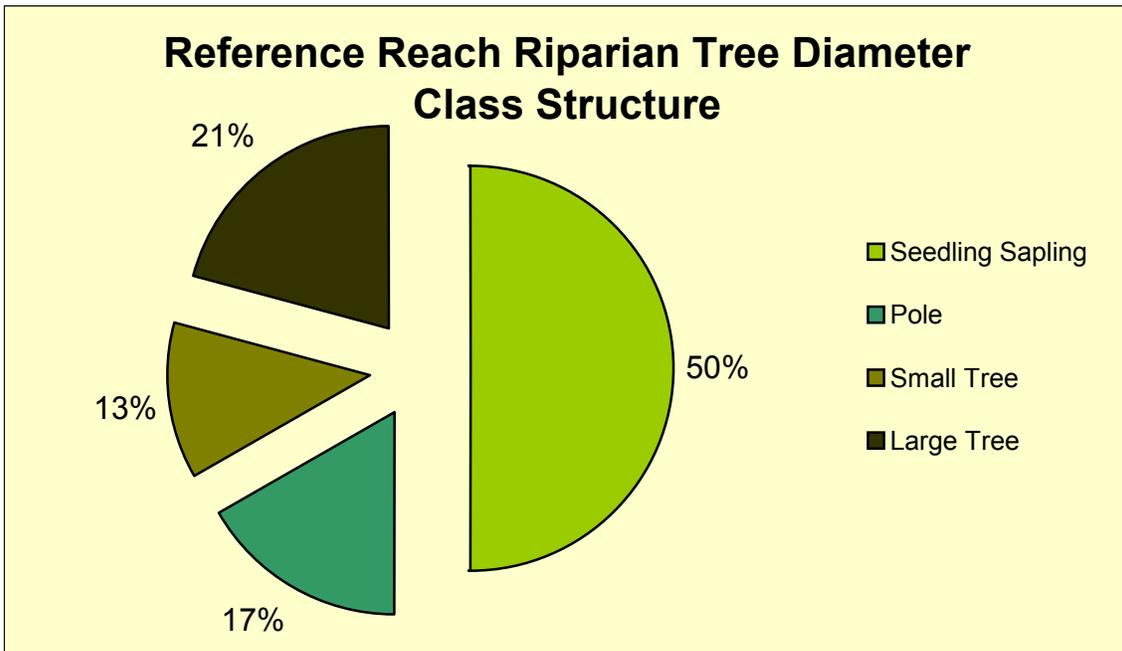
**Figure 9. Riparian tree diameter class structure within the 2002 Resurrection Creek reference reach riparian vegetation plots, Kenai Peninsula, Alaska.**

\* Seedling/Sapling = 0-15 cm diameter, Pole = 15-31 cm diameter, Small Tree = 31-41 cm diameter and Large Tree >41cm diameter.

trees (>31 cm dbh). Thirty-four percent of the trees measured in the 2002 riparian survey were in the small and large tree classes (>31cm dbh), the majority of which were black cottonwood. Whereas only 18% of the trees observed in the 1995 study were found to be >31 cm dbh, the majority of which were Lutz spruce. Snags and coarse woody debris levels within the 2002 reference reach plots ranged from 0-79 and 51-469 pieces per hectare respectively (figure 10). Due to the extent of beetle kill within the reference area these values may represent the extremes in natural variability.

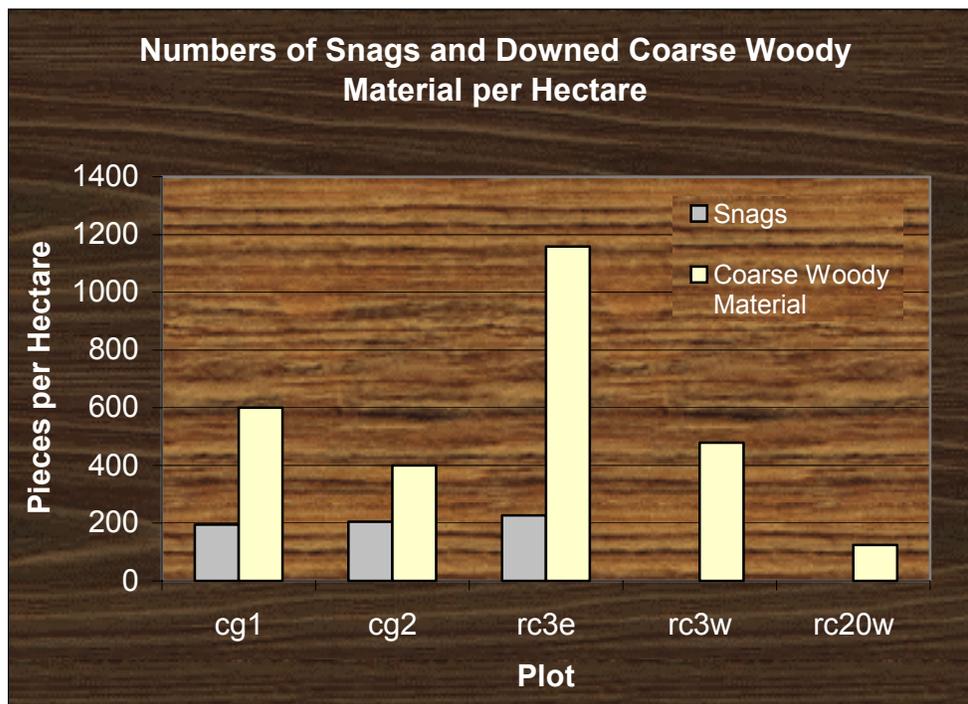
**Figure 10. Snag and coarse downed woody material densities within the 2002 Resurrection Creek reference reach riparian vegetation plots, Kenai Peninsula, Alaska.**

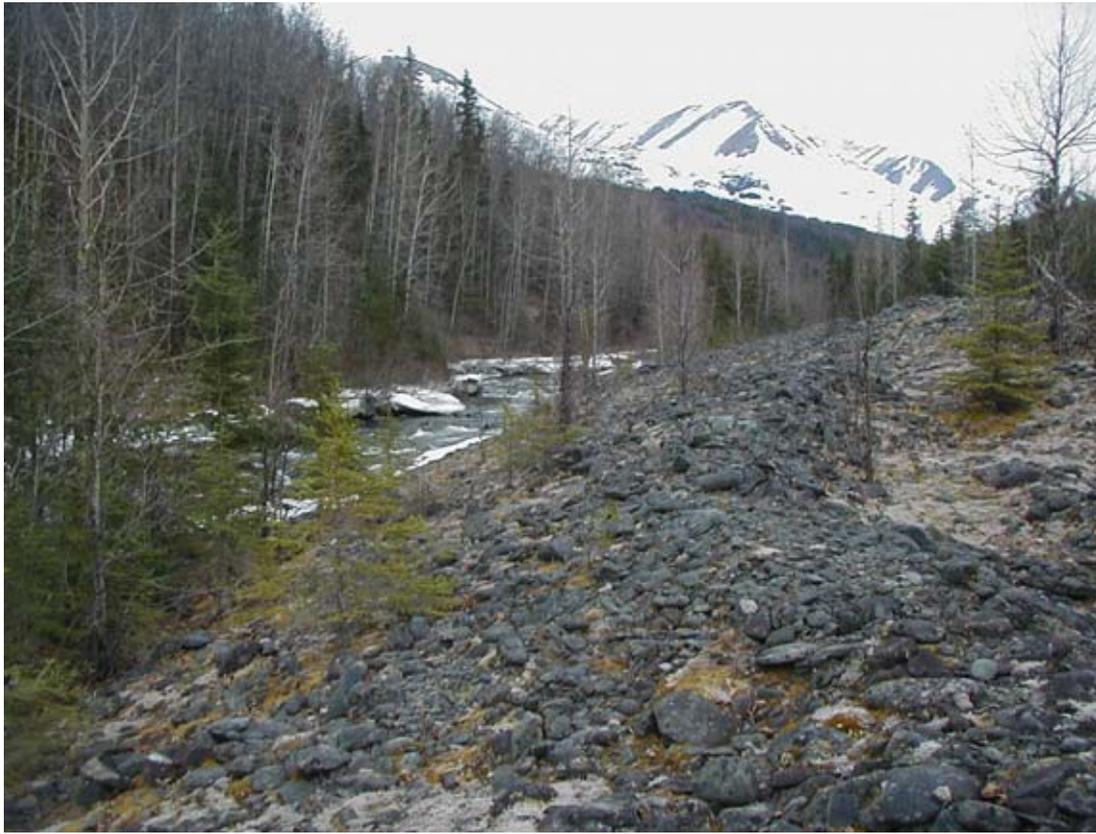
**Photo 3. Photo of mine tailings and stream channel confinement in Resurrection Creek project area, river km ~10, Kenai Peninsula, Alaska. *Photo Olegario***

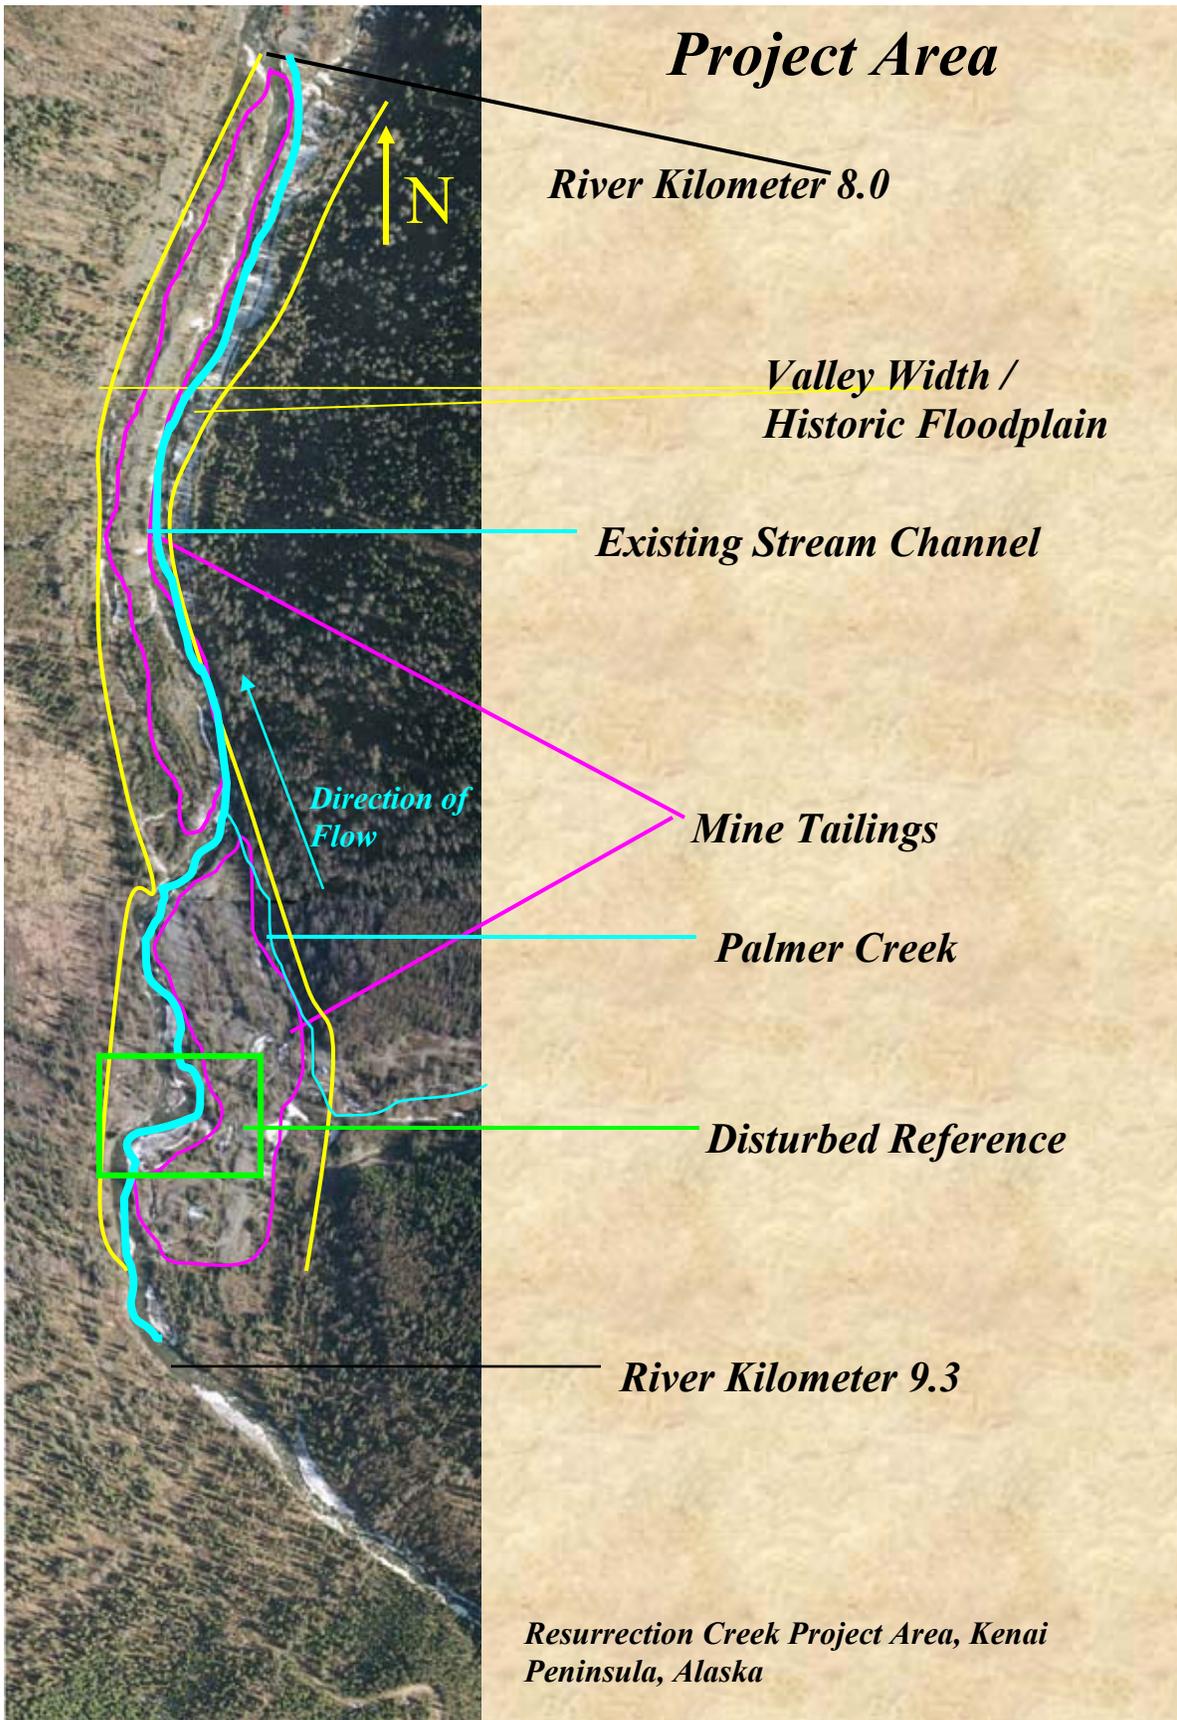
Figure 11. Resurrection Creek project reach area map Rkm 8.0-9.3.

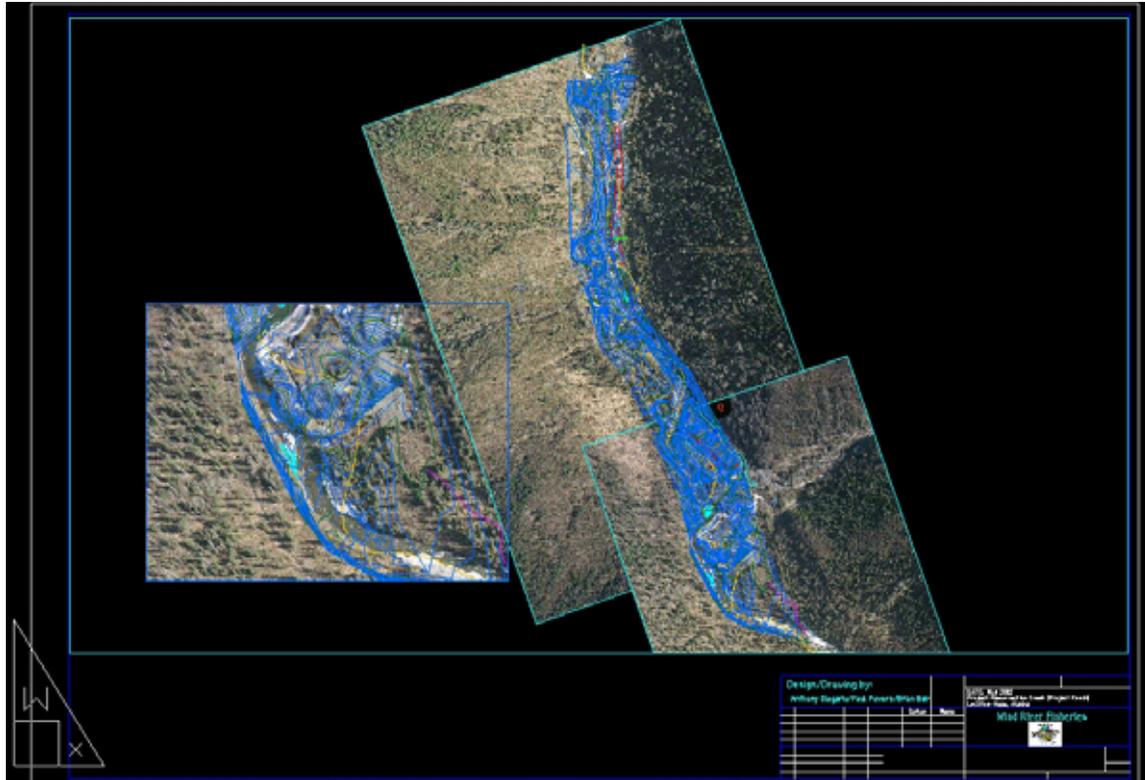
**Figure 12. Aerial photo and contour site map overlay for 2002 project reach survey, Resurrection Creek, Kenai Peninsula, Alaska.**

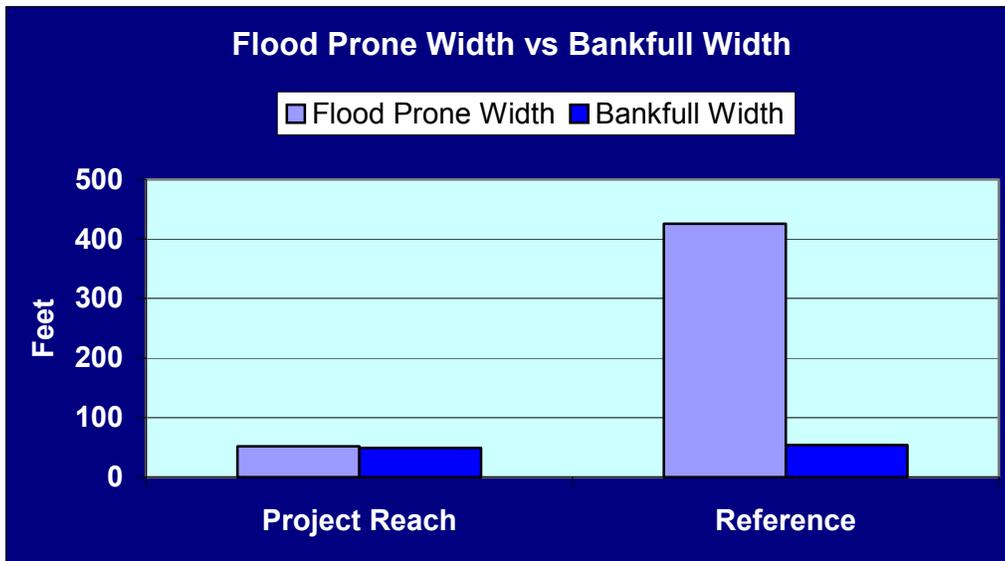
**Figure 13. Flood prone and bankfull widths for the disturbed project area and reference reaches of Resurrection Creek, Kenai Peninsula, Alaska.**

The project area and reference reach have similar valley slopes and widths. However the two reaches are vastly different systems in both form and function. The differences in bankfull width/floodplain width graphically illustrate the constriction of the stream channel and loss of floodplain due to the mine tailings (figures 13 & 14). The reference reach has a floodplain width eight times the normal bankfull width of the stream channel during flood flows  $>Q_3$ . When floods occur they spread out over the floodplain, which allows the stream to disperse, dissipate and reduce stream power. Inundation of the floodplain also augments and fertilizes riparian areas by depositing fine sediment and organics. Sheet flow across the floodplain also creates a complex of side channels and off channel habitat that are critical for salmonid spawning and rearing.

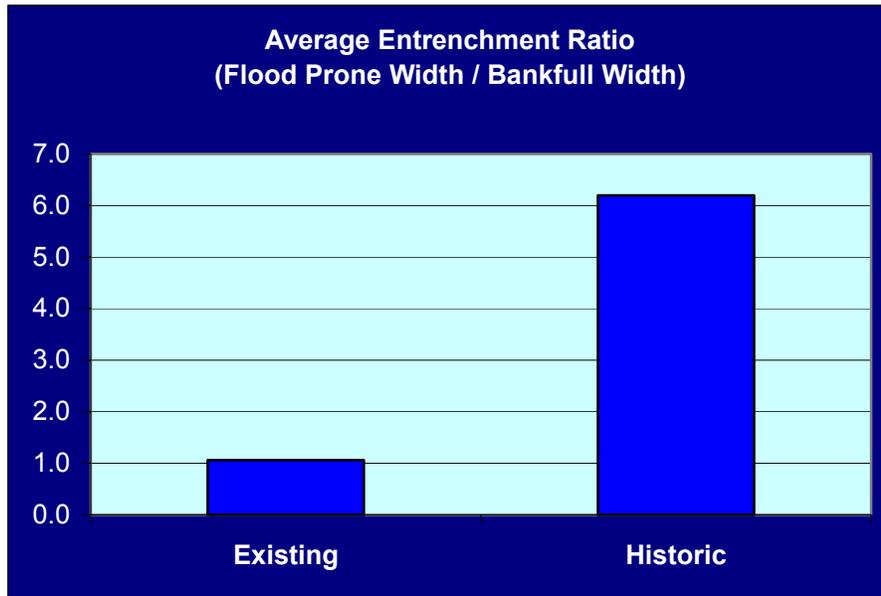
**Figure 14. Average existing and historic entrenchment ratios for the project area of Resurrection Creek, Kenai Peninsula, Alaska.**

In contrast to the reference reach, the tailings piles within the project area confine all flood flows into a single thread channel roughly the same size as the normal bankfull channel. The tailings piles are essentially functioning as dikes that cutoff the flood flows from the original floodplain. Water velocities accelerate as they are compressed through the constricted channel concentrating the stream’s energy on the streambed, simplifying substrate and degrading the channel. Sediment and nutrients are transported through the project area depriving riparian areas of soil and nutrients, which in turn retards disturbance recovery and natural succession. Recent restoration work has reconnected a fraction of the historic salmonid off channel rearing habitat but the vast network of side channels has been either buried by the tailings or cutoff from the main channel.

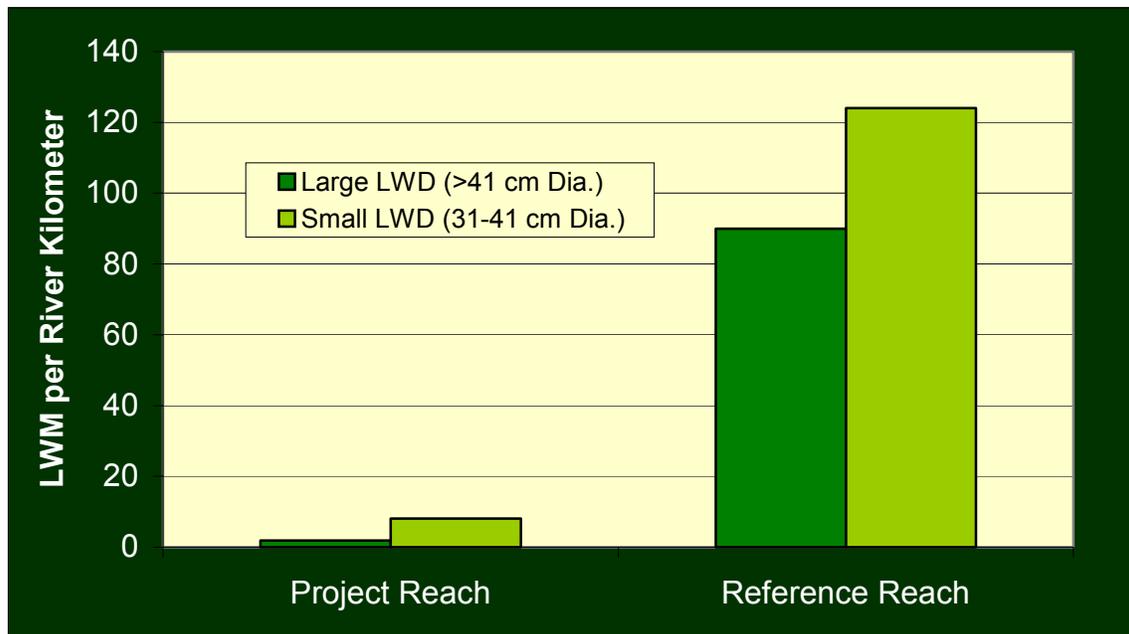
**Figure 15. Number of in-stream woody material per river kilometer within the bankfull channel of Resurrection Creek reference and project reaches, Kenai Peninsula, Alaska.**

The loss of organic input and nutrients within the project area is apparent when the quantities of large in-stream woody material within the reference reach are compared to that of the project reach. Ten pieces of large wood greater than 31 cm in diameter per river kilometer were found within the bankfull channel of the project reach whereas 214 pieces per river kilometer observed in the reference reach (figure 15). Chugach National Forest and Seward Ranger District personnel installed the majority of wood observed in the project reach for fish habitat enhancement. The effect of channel constriction by the mine tailings route large woody material and other organics such as salmon carcasses through the project reach during peak flow events much like a log flume.

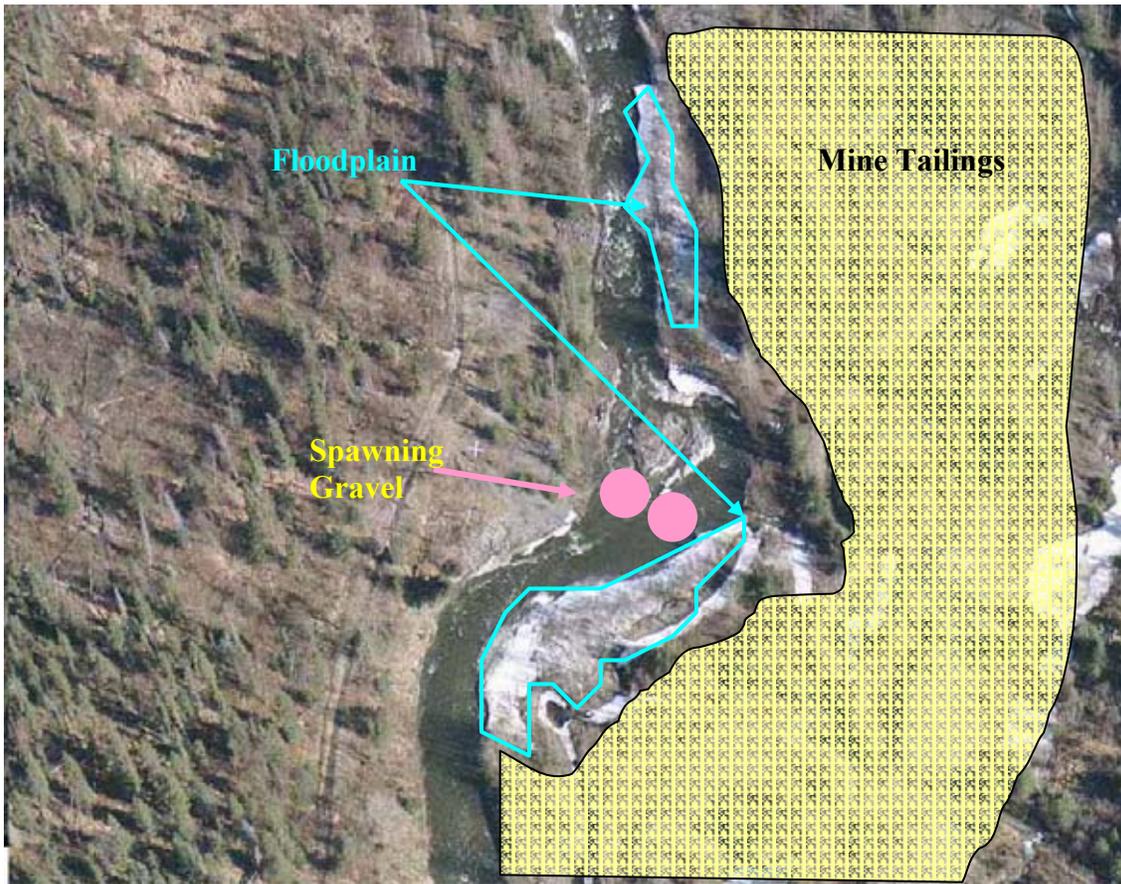
**Figure 16. Location of spawning gravel and floodplains Resurrection Creek disturbed reference reach (~Rkm 9), Kenai Peninsula, Alaska.**

Pebble counts and ocular estimates were used to estimate the quantity of spawning gravel within the project reach. Approximately 160 m<sup>2</sup> was estimated in 1.3 river kilometers of the project reach. The spawning gravel was isolated to one small patch in the disturbed reference area at approximately river kilometer 9. The spawning gravel existed in the only section of the project area where the stream was not entrenched and had access to a defined floodplain (figure 16). The reference reach contained 85% more spawning gravel per kilometer than the project area (figure 17).

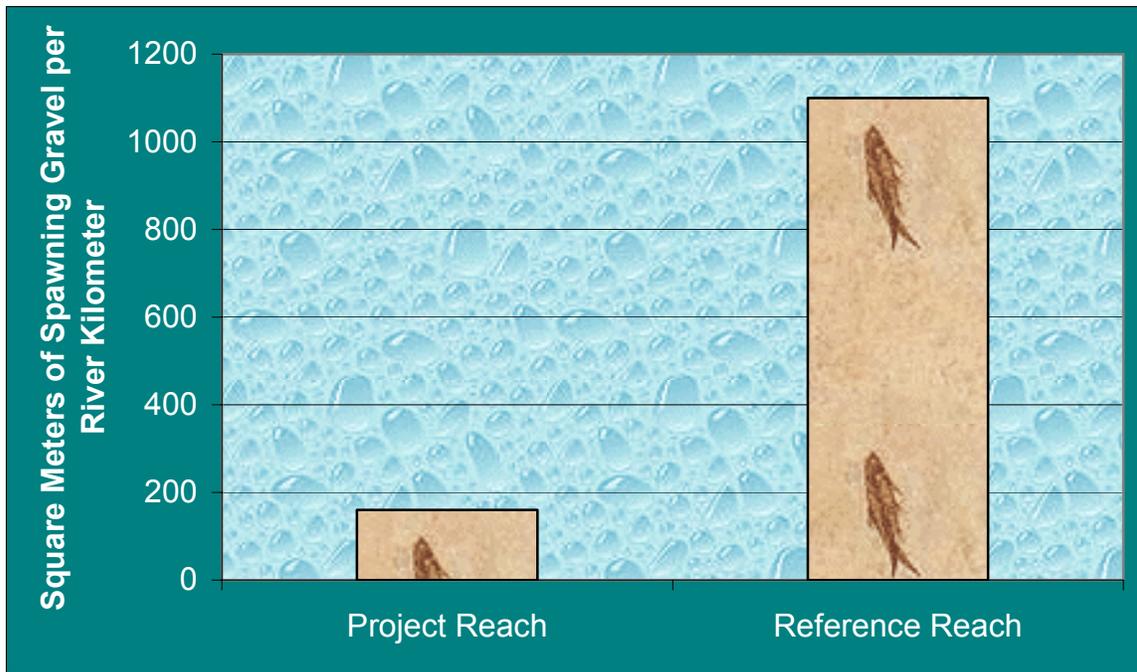
**Figure 17. Square meters of spawning gravel per kilometer for the Resurrection Creek project and reference reaches, Kenai Peninsula, Alaska.**

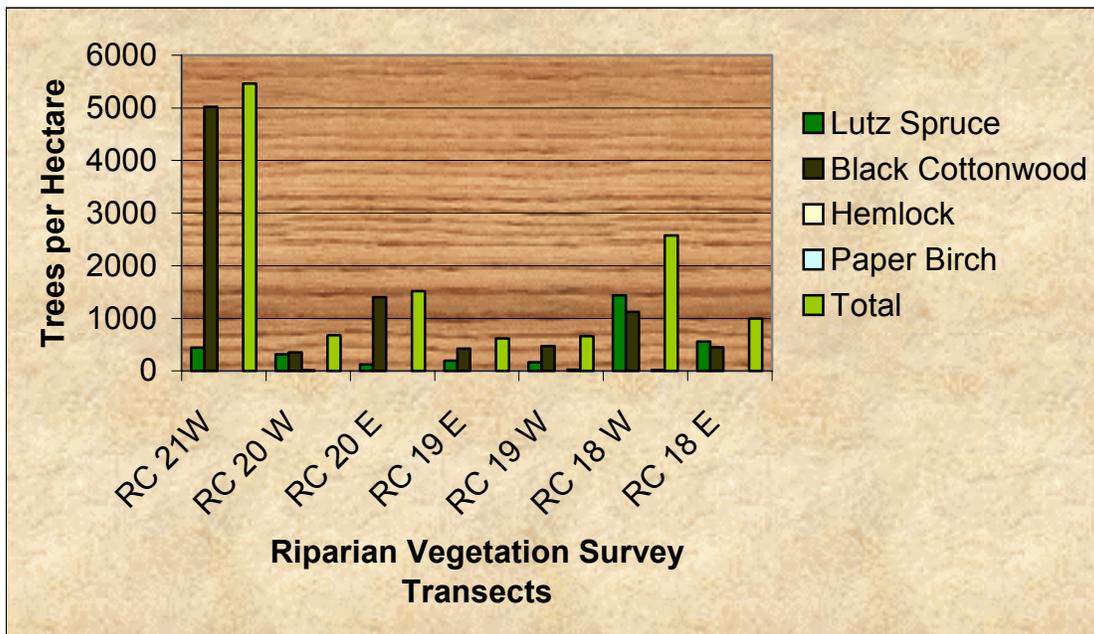
**Figure 18. Tree densities by species observed within the Resurrection Creek project reach riparian vegetation plots, May, 2002 survey, Kenai Peninsula, Alaska.**

The mine tailings occupy 54% of the floodplain and riparian area. The tailings are composed of coarse substrate, which holds little moisture, nutrients or fine soils to support the historic riparian vegetation. Hence riparian vegetation in the project area differed dramatically from both the reference reach and the Holsten, Werner and Develice (1995) study. Total tree densities averaged 1,786 trees per hectare with a range of 615-5,461 (figure 18). Tree densities within the 2002 reference reach surveys and the 1995 study found 511 and 563 trees per hectare. Survey transects RC 21 W contained extremely high tree densities (5,461/hectare) and was composed primarily of “dog hair” stands of cottonwood. Stocking levels were evaluated without RC 21, however densities were still double (1,174 trees/hectare) of what was observed in the reference area. Riparian tree species composition in the project area also differed radically from the reference reach vegetation. The reference reach riparian stands surveyed contained 51% Lutz spruce, 37% black cottonwood, 10% paper birch and 2% hemlock (figure 19). Whereas the project area was composed of 74% cottonwood and 26% Lutz spruce with birch and hemlock making up only a fraction of a percent of the various stands composition. Stand structure was also extremely different within the project reach with 86% of the trees surveyed were in the seedling sapling class and no large trees observed (figure 20). With the relatively young age of existing stands within the project area it was not surprising to see that snags and downed wood were virtually absent (figure 21).

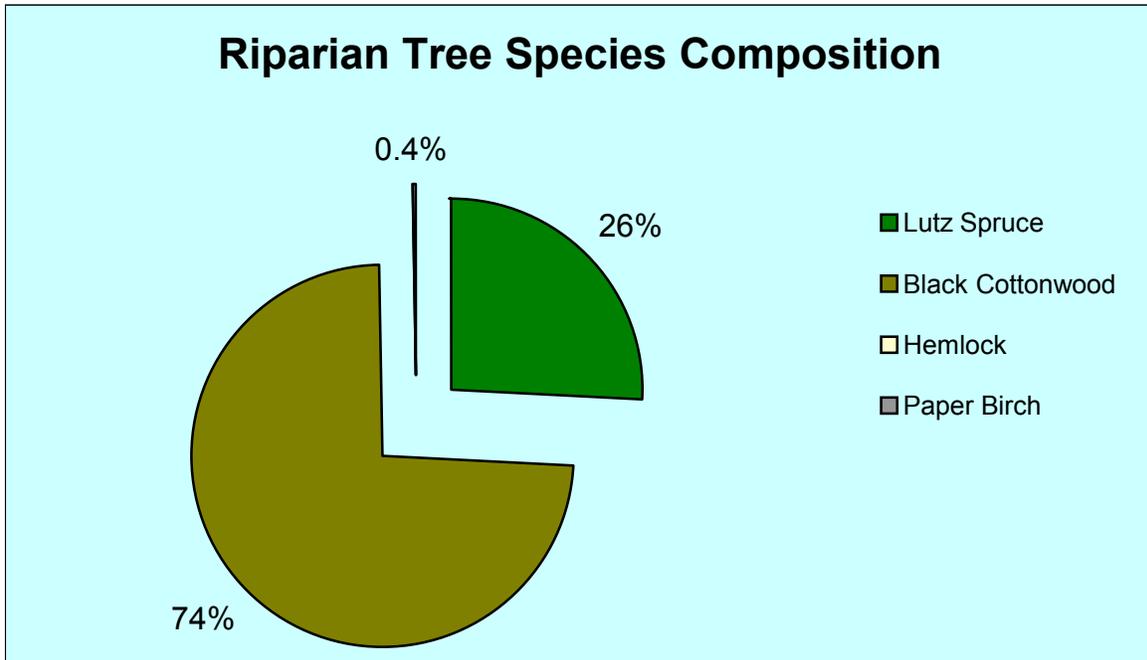
Figure 19. Riparian tree species composition within the Resurrection Creek project reach riparian vegetation plots, Kenai Peninsula, Alaska.

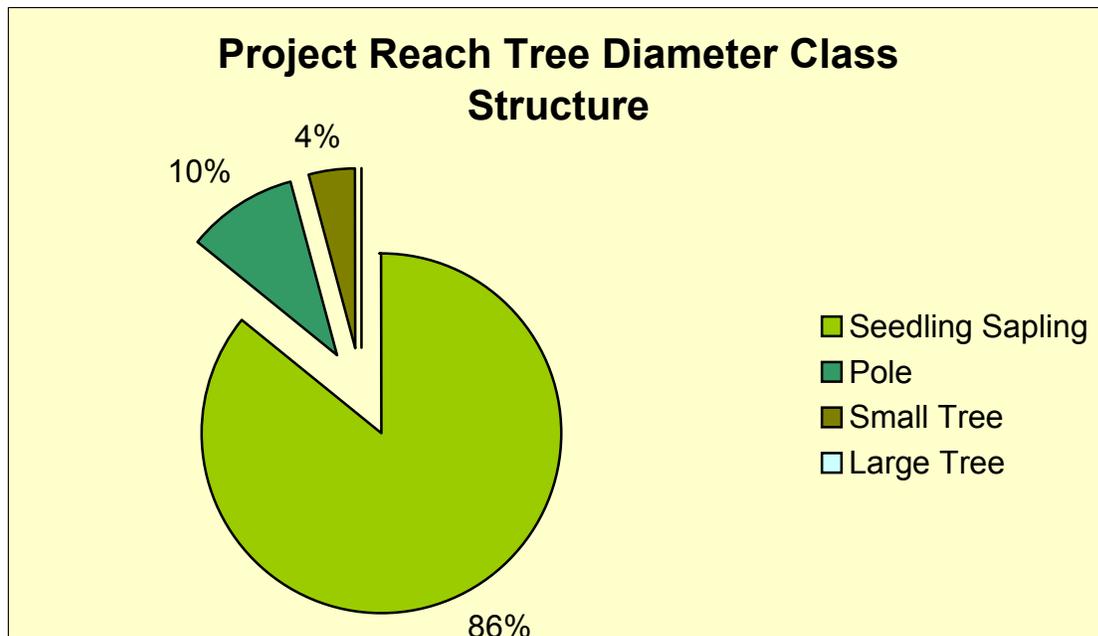
Figure 20. Riparian tree diameter class structure within the Resurrection Creek project reach riparian vegetation plots, Kenai Peninsula, Alaska.

\* Seedling/Sapling = 0-15 cm diameter, Pole = 15-31 cm diameter, Small Tree = 31-41 cm diameter and Large Tree >41cm diameter.

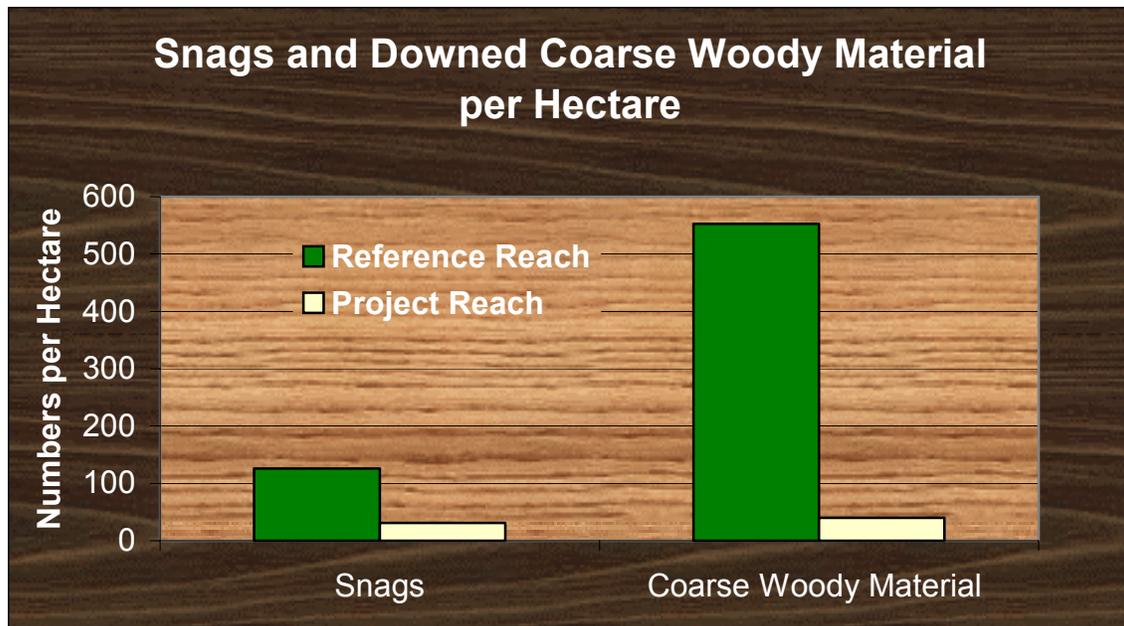
**Figure 21. Snag and coarse downed woody material densities within the reference and project reaches of Resurrection Creek riparian vegetation plots, Kenai Peninsula, Alaska**

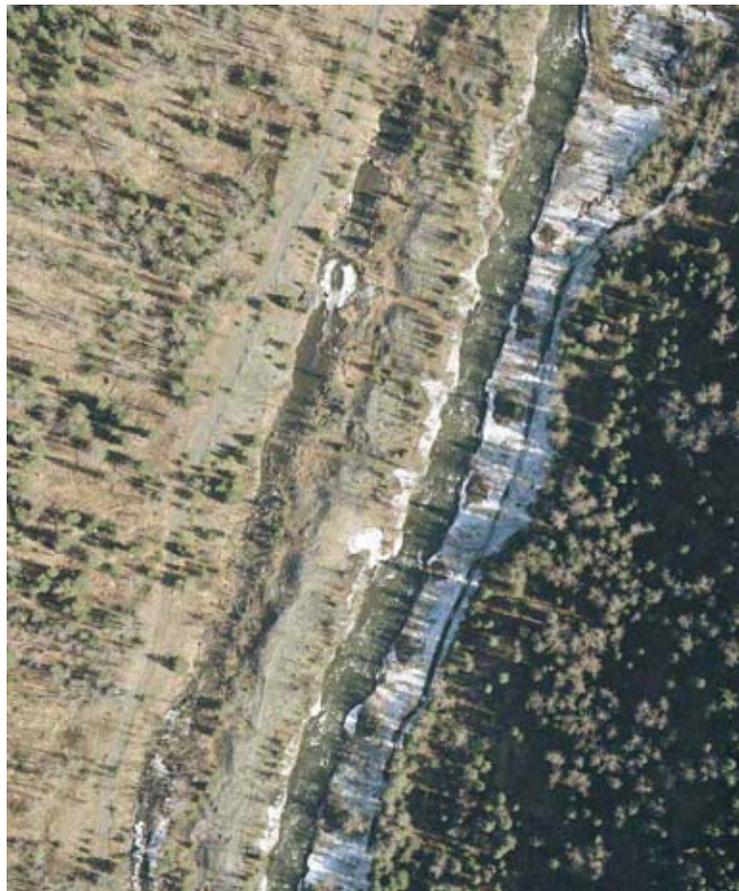
**Photo 4. Resurrection Creek river kilometer ~8.1-8.6, Kenai Peninsula Alaska.**
