**Resurrection Creek  
Stream Channel and Riparian  
Restoration Analysis  
River Kilometer 8.0 – 9.3**

**Resurrection Creek  
Stream Channel and Riparian  
Restoration Analysis  
River Kilometer 8.0-9.3  
*October 1, 2002***

*Brian Bair, Paul Powers, Anthony Olegario*

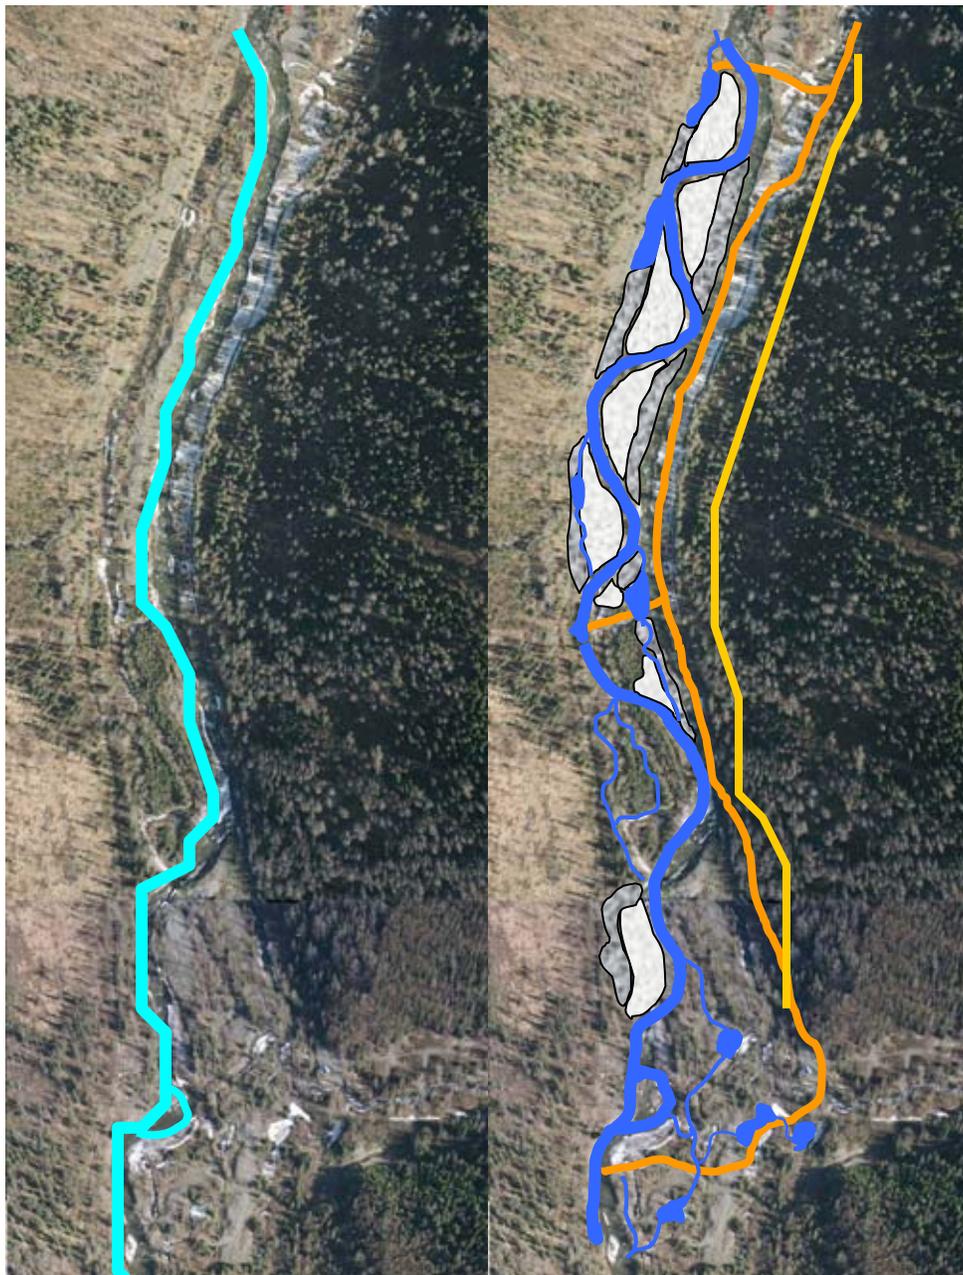
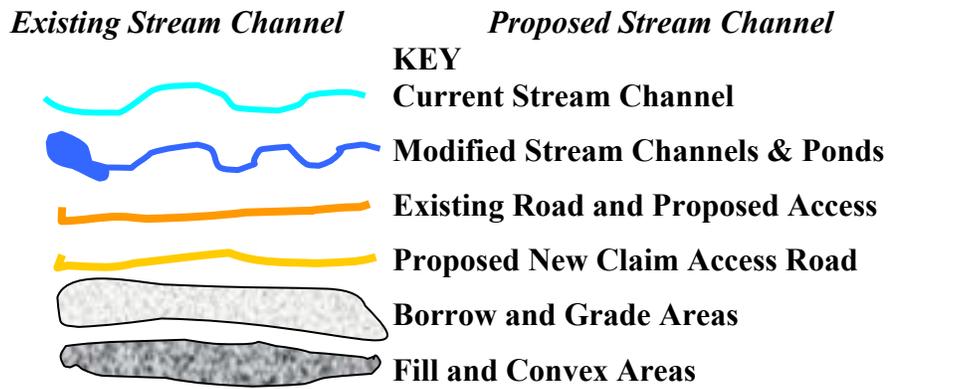
<b>Project Valley Length</b>	<b>1,305 meters</b>
<b>Valley Slope</b>	<b>1.7%</b>
<b>Restored Valley Width</b>	<b>115-145 meters</b>
<b>Proposed Channel Thalweg Length</b>	<b>1,743 meters</b>
<b>Elevation Drop</b>	<b>22.3 meters</b>
<b>Proposed Channel Thalweg Slope</b>	<b>1.3%</b>
<b>Rosgen Channel Type</b>	<b>C3</b>
<b>Bankfull Width</b>	<b>17 meters</b>
<b>Bankfull Ave. Depth</b>	<b>0.8 meters</b>
<b>Width/Depth</b>	<b>22</b>
<b>Riffle Slope</b>	<b>1.5%</b>
<b>Proposed Sinuosity</b>	<b>1.3</b>
<b>Large Wood/km</b>	<b>90-125</b>
<b>Restored Entrenchment ratio</b>	<b>6-7</b>
<b>Pools/Kilometer</b>	<b>13</b>
<b>D84</b>	<b>260mm</b>
<b>Length of Meander</b>	<b>160-220 meters</b>
<b>Belt Width</b>	<b>100-140 meters</b>
<b>Ave. Bed Shear Stress</b>	<b>10.3-12.2Kg/m<sup>2</sup></b>

**Figure 22. Alternative B conceptual design and comparison of existing conditions for Resurrection Creek project area, Kenai Peninsula, AK.**

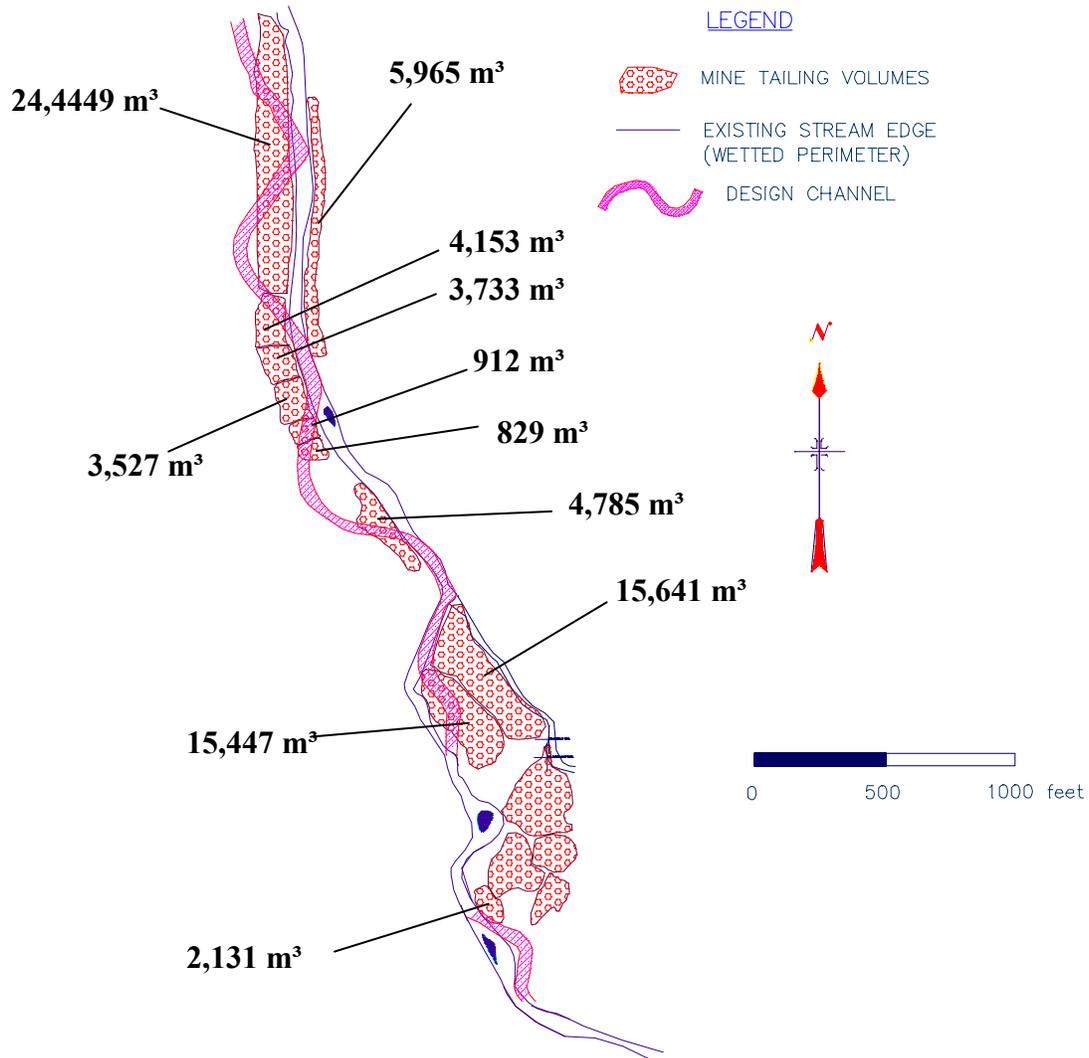
**Figure 23. Mine tailing volumes, existing and designed stream channel for Alternative B, Resurrection Creek, Kenai Peninsula Alaska.**

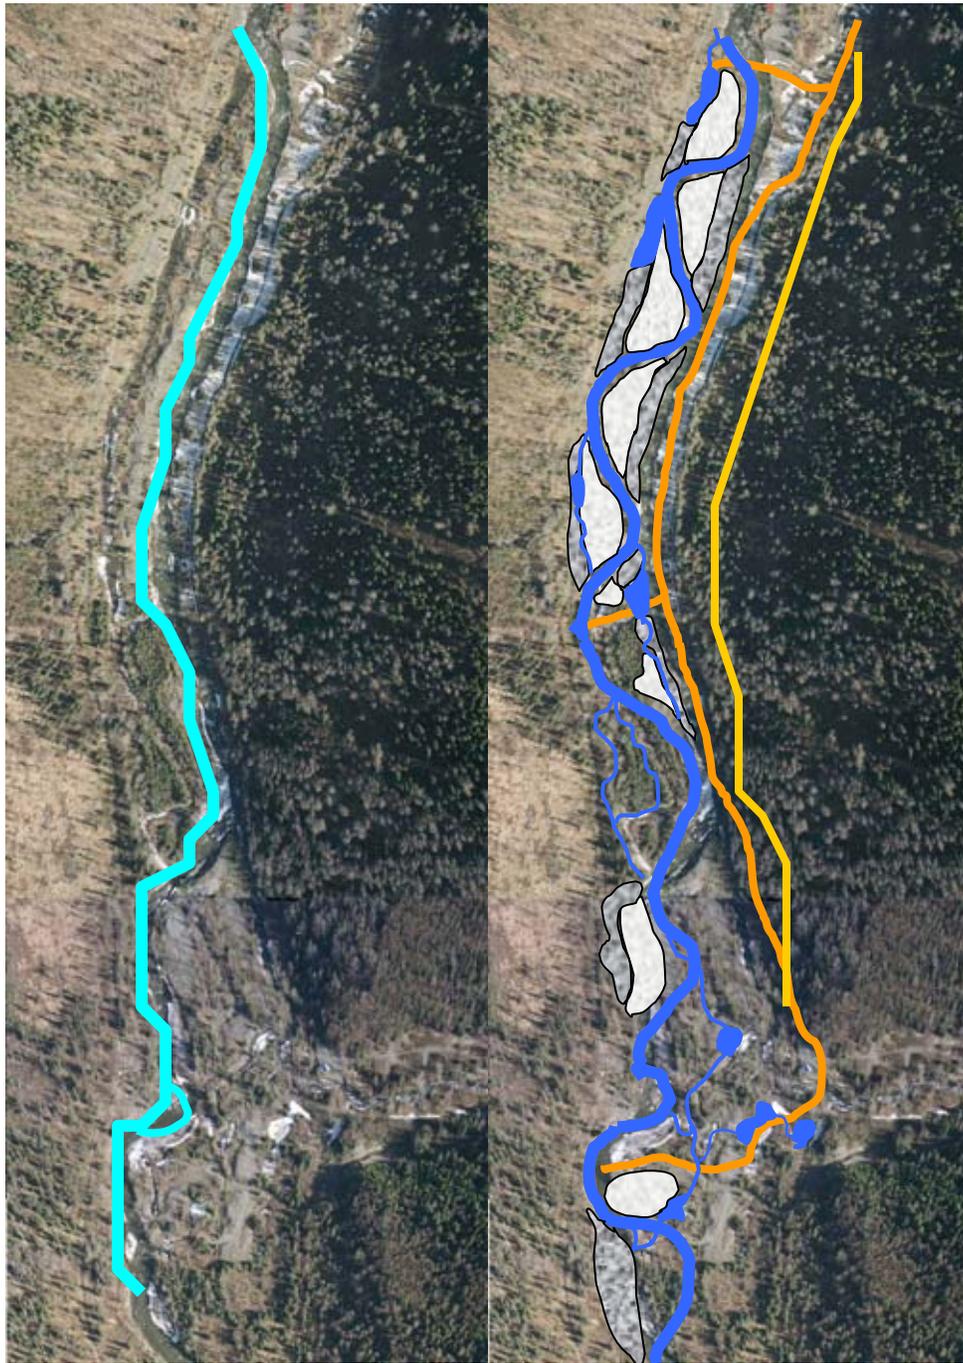
Project Valley Length	1,305 meters
Valley Slope	1.7%
Restored Valley Width	115-145 meters
Proposed Channel Thalweg Length	2,015 meters
Elevation Drop	22.3 meters
Proposed Channel Thalweg Slope	1.1%
Rosgen Channel Type	C3
Bankfull Width	17 meters
Bankfull Ave. Depth	0.8
Width/Depth	22
Riffle Slope	1.5%
Proposed Sinuosity	1.5
Large Wood/km	90-125
Restored Entrenchment ratio	7-9
Pools/Kilometer	14
D84	260mm
Length of Meander	160-220 meters
Belt Width	100-140 meters
Ave. Bed Shear Stress	8.8-12.2Kg/m <sup>2</sup>

**Figure 24. Alternative C conceptual design and comparison of existing conditions for Resurrection Creek project area, Kenai Peninsula, AK.**

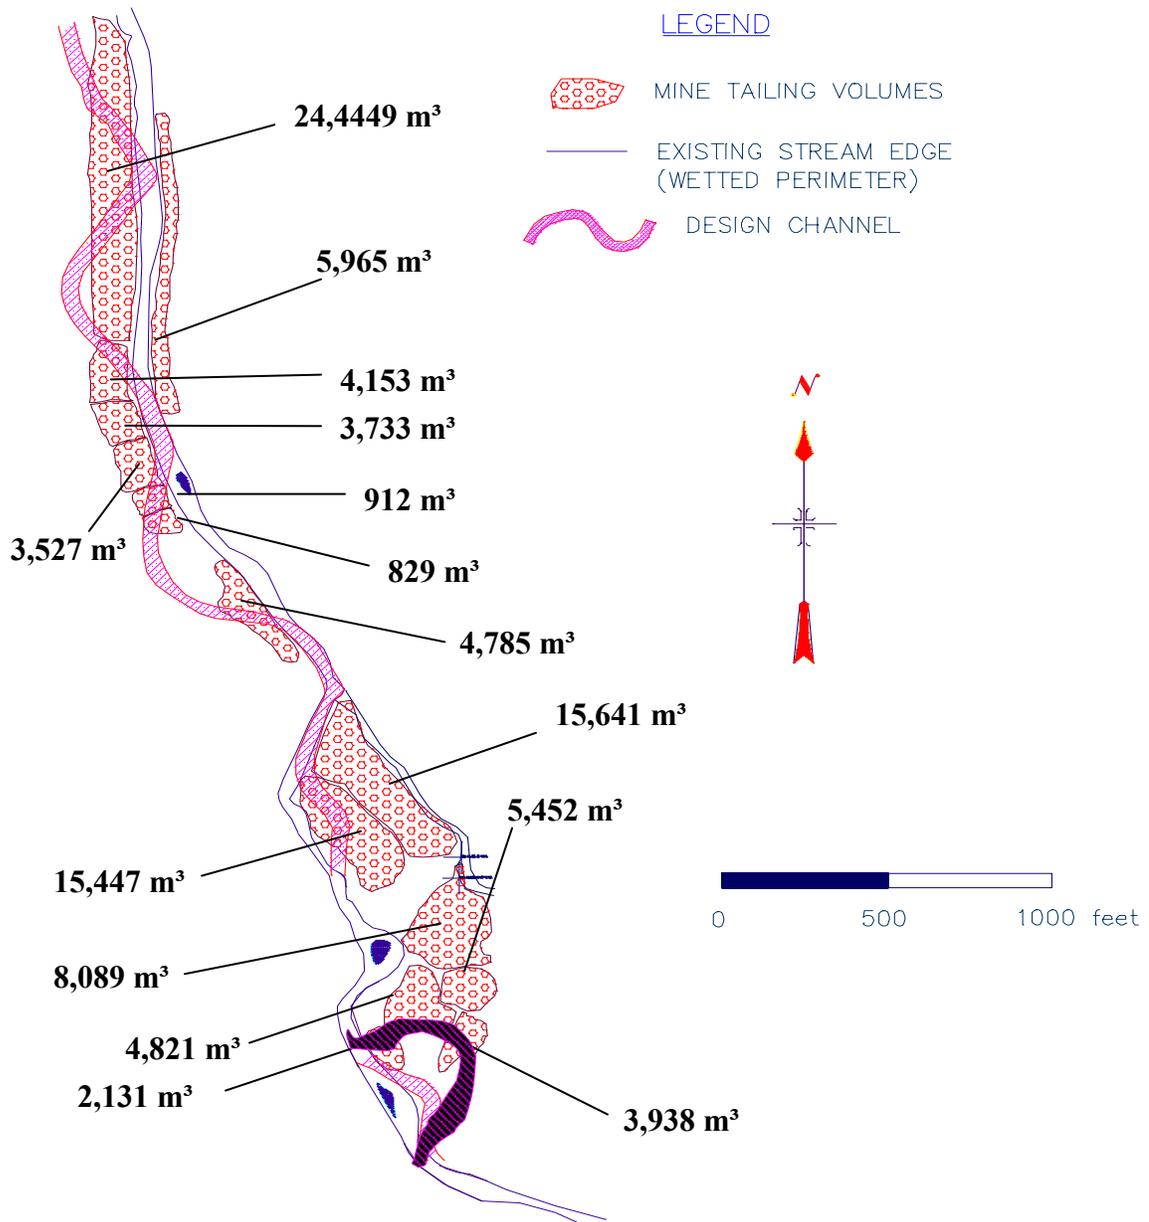
**Figure 25. Mine tailing volumes, existing and designed stream channel for Alternative C, Resurrection Creek, Kenai Peninsula Alaska.**

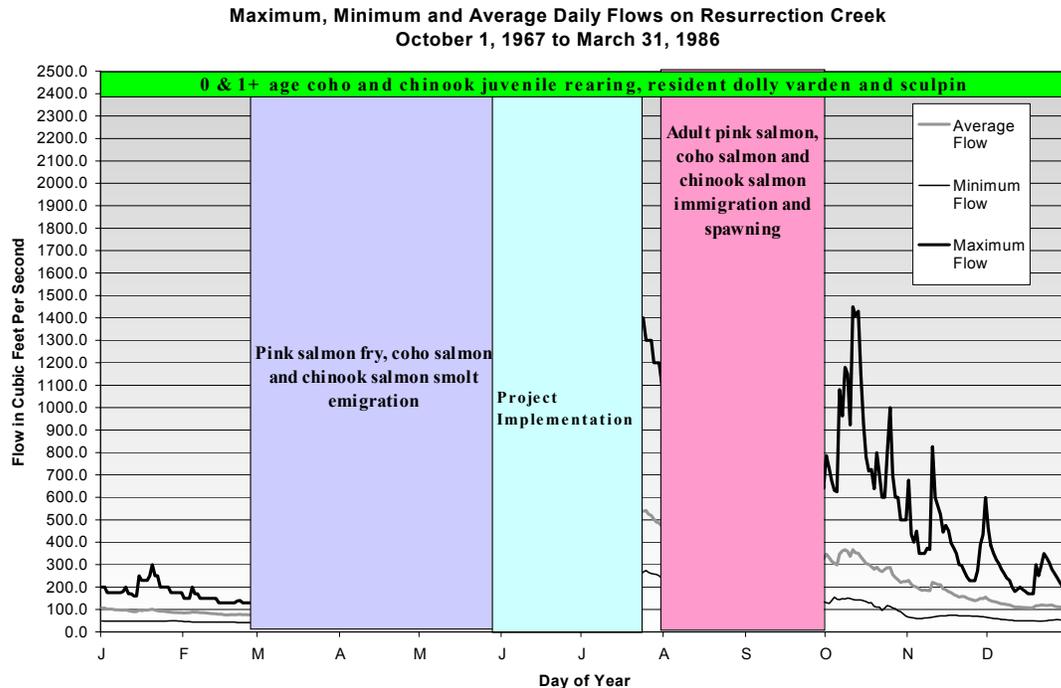
**Figure 26. Maximum, minimum and average daily stream flows relative to salmonid life history and project implementation timeline for Resurrection Creek, near Hope, Alaska.**

impacts to pink salmon, coho salmon, chinook salmon and resident dolly varden char, mountain whitefish and scuplin in their susceptible early life stages (egg to fry). In addition, the in-stream implementation phases of this project would occur post fry and smolt emigration and prior to adult salmon immigration and spawning. During implementation (4-5 weeks), de-watered sites would be electro-shocked after push up dam construction to remove any fish stranded behind the impoundment. The majority of fish would be removed from the dewatered area and moved up river before fill and grade. Direct impacts within the project reach would be limited to age 0 and 1+ chinook salmon and coho salmon, resident dolly varden and scuplin.

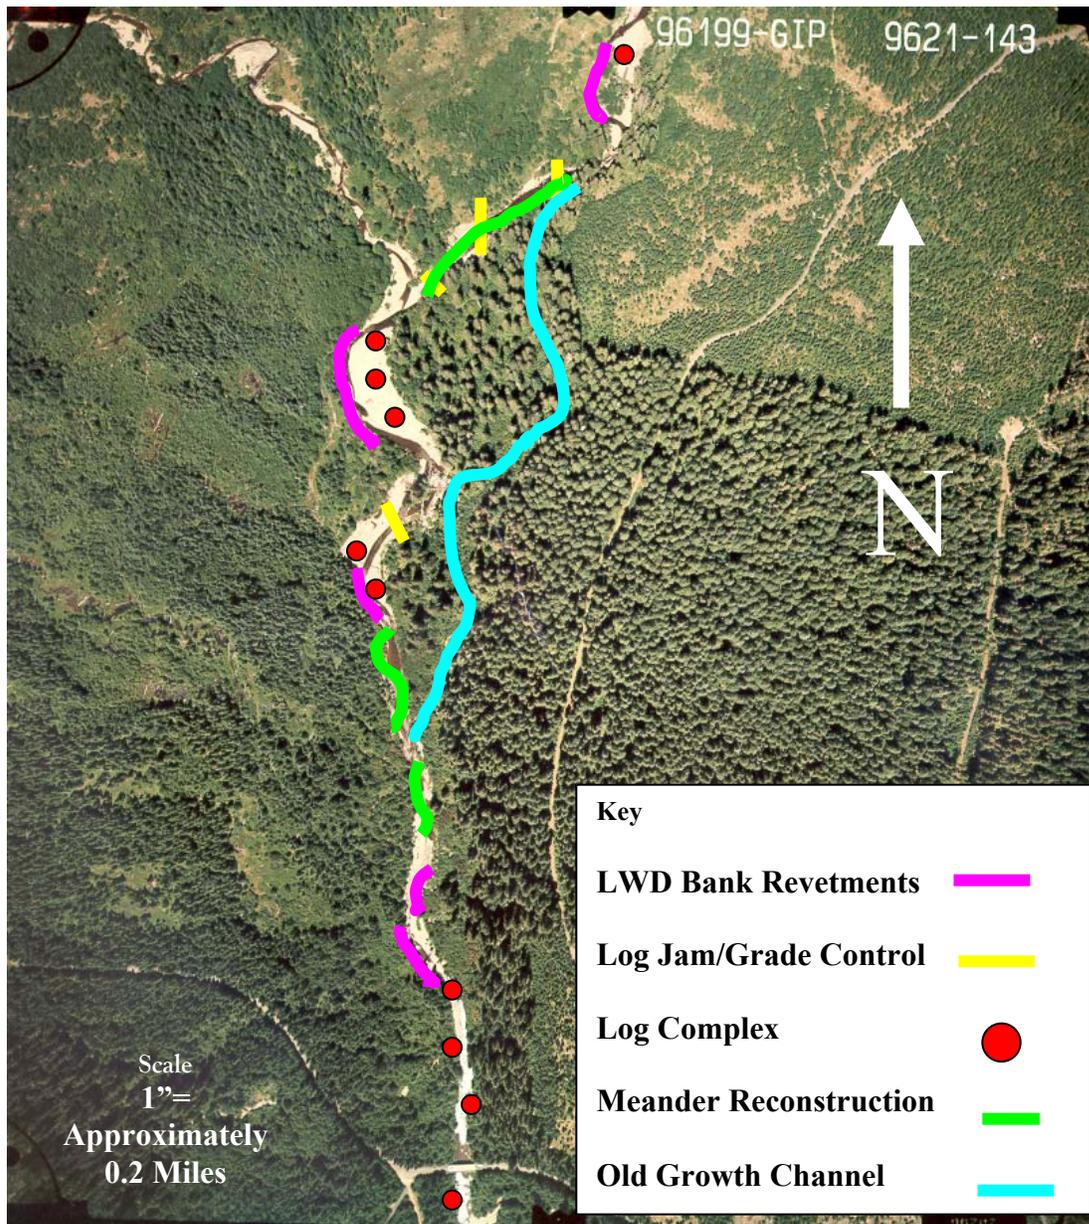
**Figure 27. Trout Creek Restoration project site map, T.4N., R.6E. Section 13, Skamania County Washington.**

The 1996 Trout Creek Old Growth Reach Restoration project in Washington State is similar in nature to what is proposed for Resurrection Creek. This project involved reconnecting 1.2 kilometers of an Old Growth stream channel to the main stem of the stream. This project entailed reconstructing stream channels, constructing large rock and log complexes to aggrade the streambed and reconnect the floodplain network and old growth channel (see figure 27 and photos 5 & 6).

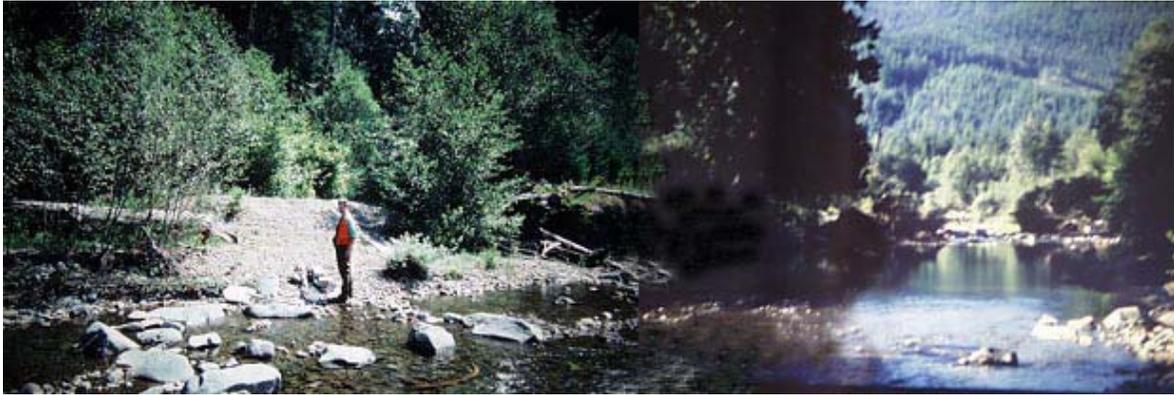
**Photo 5.** 1995 Photo of the entrance to the Trout Creek old growth channel, Skamania County, WA. A logjam that was thought to be a migration barrier was removed in 1981. The removal of the logjam initiated the channel to “down-cut” or degrade approximately five feet below the original bed elevation. As the channel degraded the connectivity with the flood plain and the last remaining old growth reach in Trout Creek was abandoned. (Photos Bair)

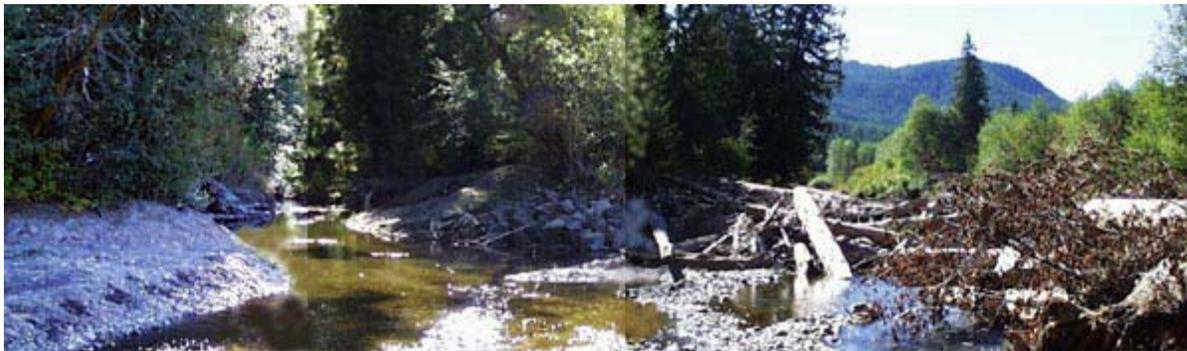
**Photo 6.** 1999 Photo of the entrance to the Trout Creek old growth channel after restoration of logjams. Stream bed was aggraded over four feet to regain connectivity with flood plain and reactivate 0.8 of a river mile of pristine habitat.

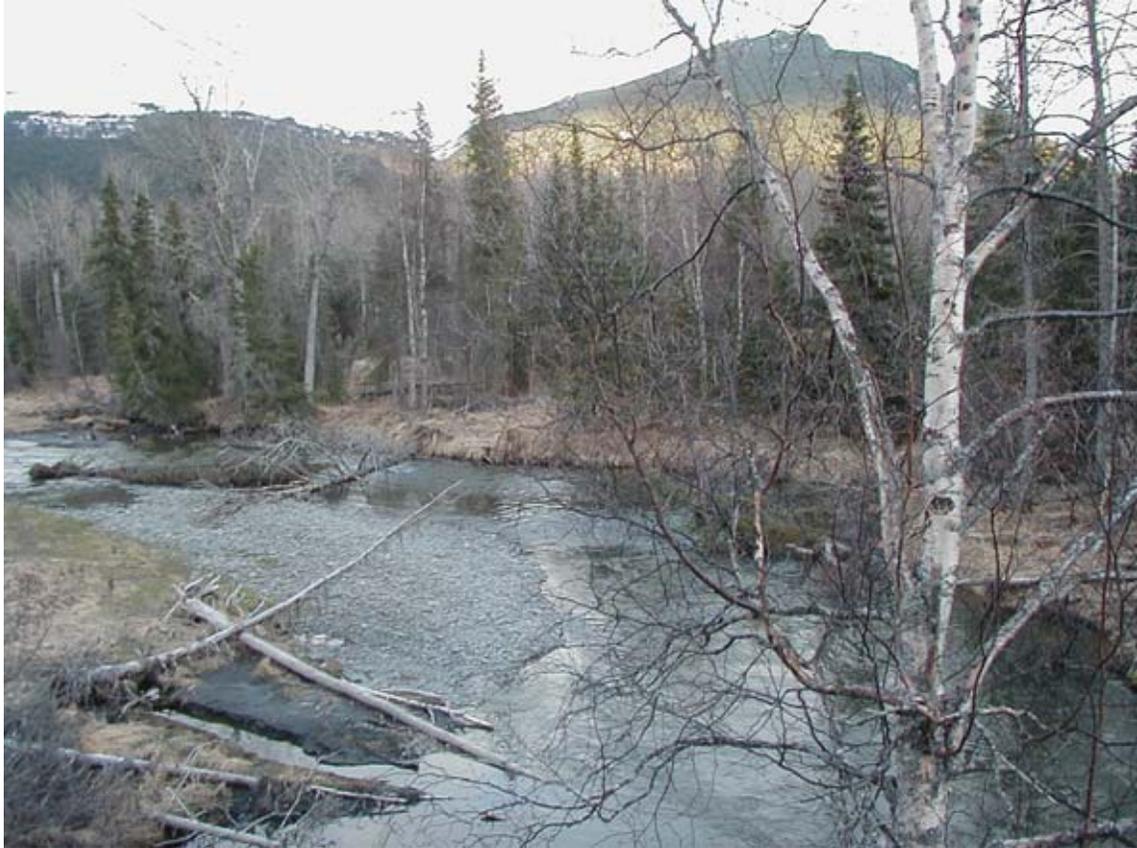
**Photo 7. Desired future condition for Resurrection Creek in the year 2065. (Quartz Creek looking up-stream, Kenai Peninsula Alaska)**
