## Ferguson rock slide buries California State Highway near Yosemite National Park

**Abstract** During spring 2006, talus from the toe area of a rock-block slide of about 800,000 m<sup>3</sup> buried California State Highway 140, one of the main routes into heavily-visited Yosemite National Park, USA. Closure of the highway for 92 days caused business losses of about 4.8 million USD. The rock slide, composed of slate and phyllite, moved slowly downslope from April to June 2006, creating a fresh head scarp with 9–12 m of displacement. Movement of the main rock slide, a re-activation of an older slide, was triggered by an exceptionally wet spring 2006, following a very wet spring 2005. As of autumn 2006, most of the main slide appeared to be at rest, although rocks occasionally continued to fall from steep, fractured rock masses at the toe area of the slide. Future behavior of the slide is difficult to predict, but possible scenarios range from continued scattered rock fall to complete rapid failure of the entire mass. Although unlikely except under very destabilizing circumstances, a worst-case, rapid failure of the entire rock slide could extend across the Merced River, damming th

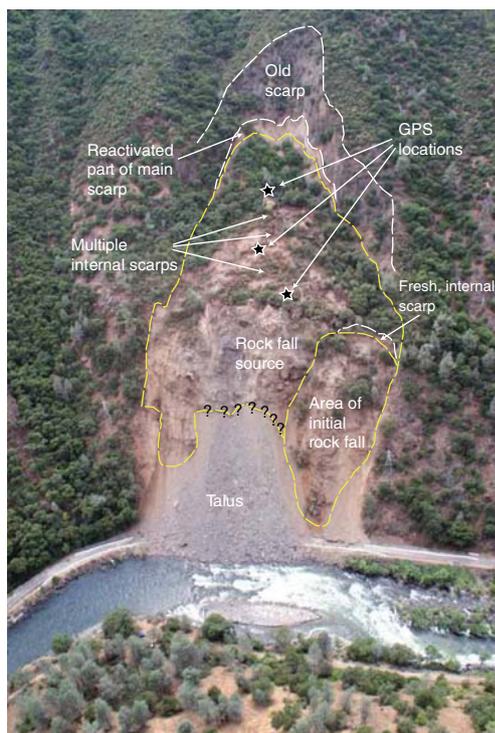
**Fig. 2** Oblique aerial photograph of Ferguson Rock Slide. Dashed yellow lines indicate extent of the rock slide based on visual inspection. Rock-fall source area, talus, new scarps, and locations of GPS instruments are indicated. Photo taken on June 13th, 2006

(Fig. 2). Immediately downslope of this area, the surface steepens from approximately  $35^{\circ}$ – $40^{\circ}$  to greater than  $50^{\circ}$ . This area is the source of most of the rock fall that forms the talus slope that has buried the highway and extended into the river. This steep rock-fall source area may reflect a local steepening of the basal failure surface. The distal portion of the landslide is a steep ( $\sim 42^{\circ}$ ) talus slope of about 100 m length (Fig. 2). Talus fragments are coarse and range between gravel and pebble sizes to boulders larger than cars. Fragment shape is typically bladed prismatic and highly angular.

The basal shear surface of the rock slide appears to toe out below the steep, disrupted rocks at the head of the talus slope but also appears to extend farther downslope to near the bottom of the slope as if its dip steepens in the direction of the toe (see Fig. 2). The right side (looking downslope) of the slide toe has shed enough rock debris recently to exhume what appears to be a shear surface in this area.

Sheared slide material resting over intact bedrock is clearly visible on the lower right margin of the slide (Fig. 4). Where the basal failure surface is exposed in the lower right section of the rock-slide toe (Fig. 4), it is parallel to an intact rock-bedding or joint surface dipping at approximately 50° toward the Merced River. The left side of the slide toe is the area where rock fall was first noticed in April 2006. This part of the slide mass may be a separate rock slide as evidenced by the scarp at its head (Fig. 2).

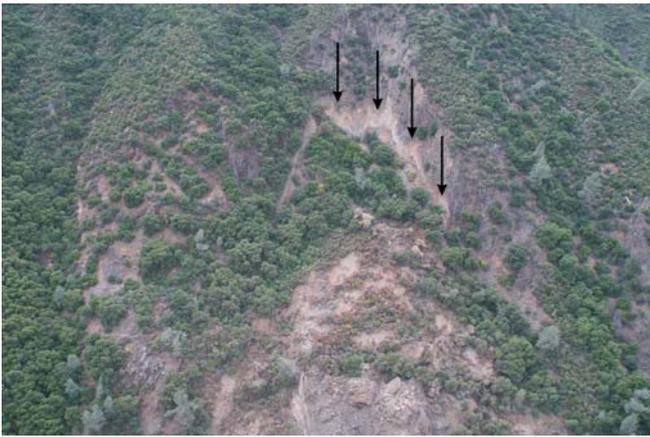
**Fig. 3** Fresh displacement on older headscarp of Ferguson Rock Slide (arrows)

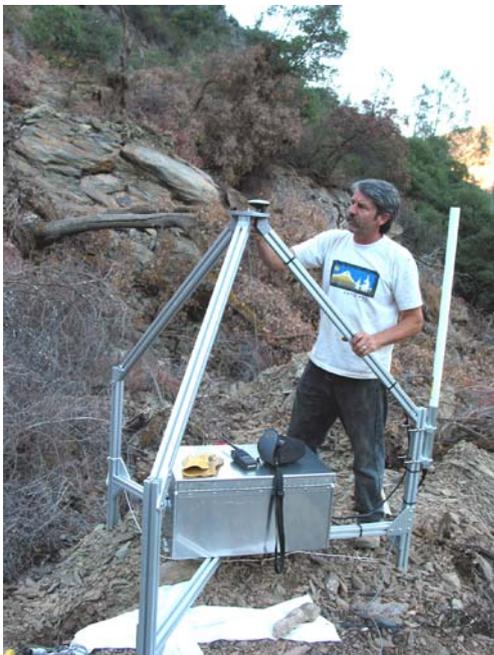
**Fig. 6** GPS spider monitoring device with accompanying unidirectional geophone to measure displacements of the main slide mass and vibrations due to rock-slide movement

Movement of the main slide mass drives much of the rock-fall activity at the toe. Studies have shown that rapid landslide movement may be preceded by gradually accelerating movement (Terzaghi 1950; Varnes 1983; Voight 1989; Fukuzono 1990), and that repeat surveying can detect this acceleration. Displacement of the Ferguson Rock Slide is monitored by monthly total station surveys of monuments located on the slide by Caltrans. Changes in the rate of movement, including acceleration, are monitored by three Global Positioning System (GPS), single frequency (L1) receivers packaged into tripod-like spider units initially placed on the slide mass by helicopter (Fig. 6). This monitoring system, developed by the USGS, (LaHusen and Reid 2000), can detect sub-centimeter displacements by differentially processing GPS satellite observations against those from a nearby USGS-installed reference station. GPS spider units have been used successfully at Mount St. Helens to monitor lava-dome growth. At the Ferguson Rock Slide, data from the GPS receivers are usually transmitted hourly via radio telemetry; location solutions are automatically computed in near real time and available to USFS, Caltrans, and USGS personnel via the Internet. In addition, each

spider unit has a uni-directional geophone buried 20–30 cm in the slide. These geophones can detect strong ground vibrations associated with rapid slide movement (LaHusen 2005). The availability of near-real-time displacement data can enable rapid response to slide changes (Reid et al. 1999). During the relatively dry winter/spring of 2007, most of the slide mass showed little movement. However, GPS spider unit A, located on an outer slide block, showed continued slow displacement. Three-dimensional components of displacement from this unit are shown in Fig. 7. Here, the mass moved more than 2 m eastward and about 2.5 m downward between October 2006 and August 2007.
