# Land and Resources Management Plan Monitoring and Evaluation Report

## Cleveland National Forest Fiscal Year 2008

# **Cleveland Land and Resources Management Plan Monitoring and Evaluation Report**

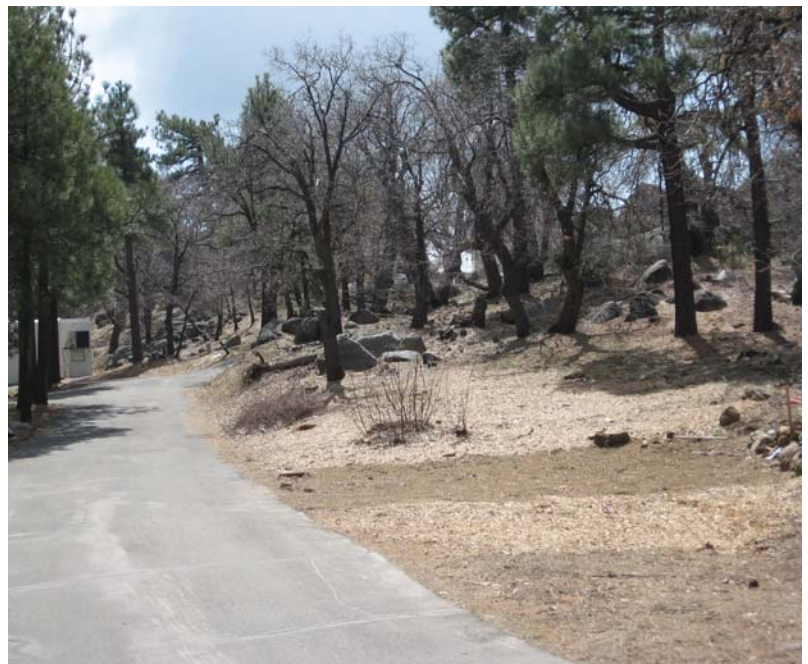
##### ***Hazardous fuels reduction (100-ft. clearance -- SDSU observatory)***

*The Forest works to help create defensible space around substantial structures. This project provided clearance around observatory infrastructure.*

Down woody material was piled and chipped. Prescribed fire treatments were not applied. A locked gate prevented public from entering the area to remove down wood material for firewood, reducing utilization.

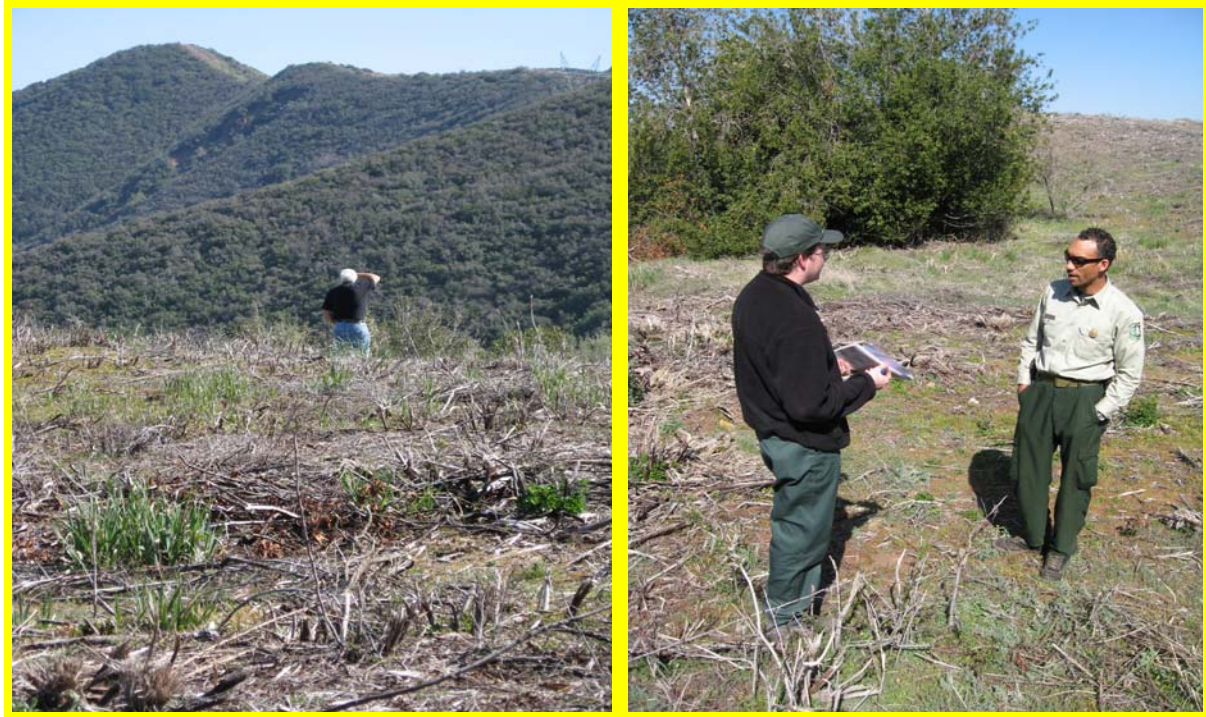
*Left: Background shows landscape where fuelbreak is located. Foreground shows that there is sufficient groundcover.*

- Update the NEPA decision including documentation of consistency with the 2006 LRMP and inclusion of a list of any approved resource actions (e.g. add Tecate Cypress action to decision), with maps. List all approved resource actions together in the decision document; carry these actions forward into burn plans.
- Continue project implementation as funding/conditions allow. Update barriers as need be over time to limit OHV access.

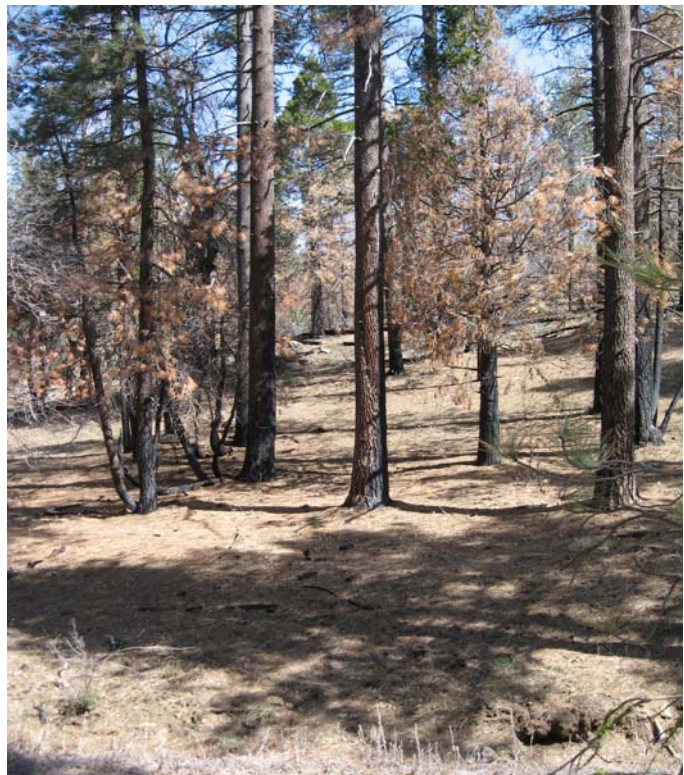
The burn was well executed. The burn and intensity met the objectives as planned. A cool, slow backing fire was used to burn down into riparian areas. Ground cover and in some cases lower limbs burned. The prescribed post-fire heritage resources monitoring and survey was completed and a site was found.

*Historically fires occurred more frequently in the conifer forests. Less frequent fire and high fuel loads makes widespread high severity crown fire, deforestation and/or structure damage more likely. Treating the conifer forest on Laguna Mountain introduces fire back into the ecosystem and creates defensible space around the structures.*

- Update the NEPA decision including documentation of consistency with the 2006 LRMP
- The implementation was well done. Continue project implementation as funding/conditions allow.
- Emphasize these kinds of treatments in montane conifer with missed fire return intervals as they are consistent with the LRMP and they have a wide range of public support.
- Consider using photo points for before/after comparisons.

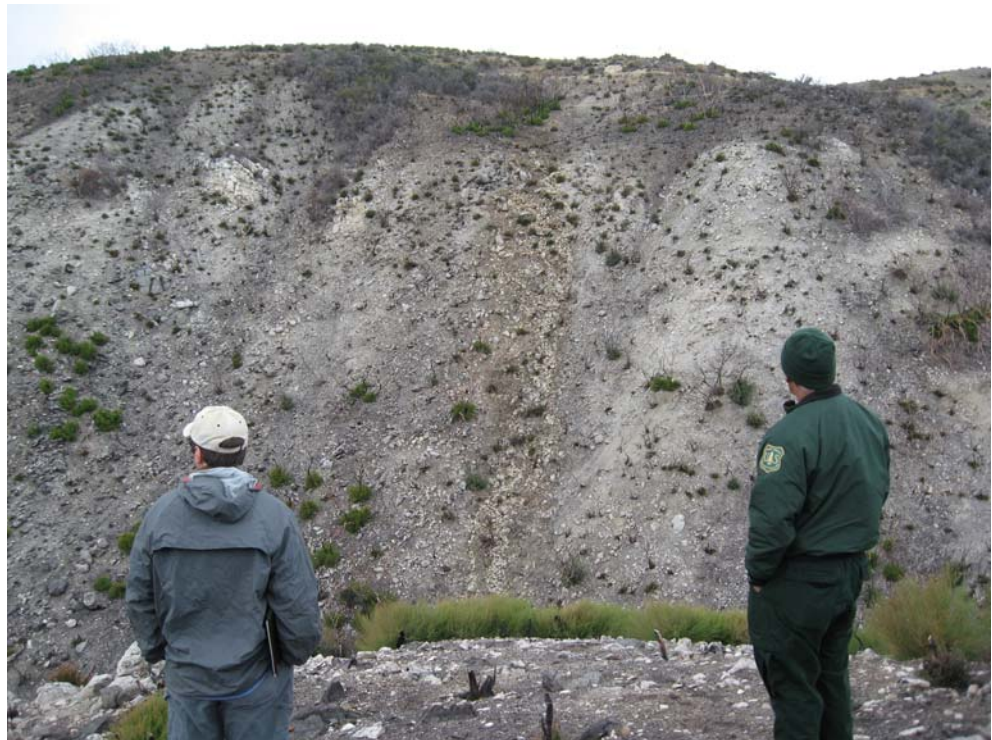
*This fuelbreak along the Aguanga Ridge is maintained to help hold fires and keep them from burning into the forested and inhabited areas on Palomar Mountain.*

- The updated NEPA decision should define all approved actions including specialist mitigation in order to help carry forward measures from planning to decision to implementation.
- Carry forward all approved actions in the decision into the burn plan (including project map and any maps associated with sensitive areas to be treated differently). For example, the burn plan prescription should reflect soil and water protection considerations and describe BMP objectives.
- Specialist reports should be specific in their prescriptions such that the needed actions are understood and carried out by the on-the-ground implementers. In this case the BE needs to better define what is meant by "protect".

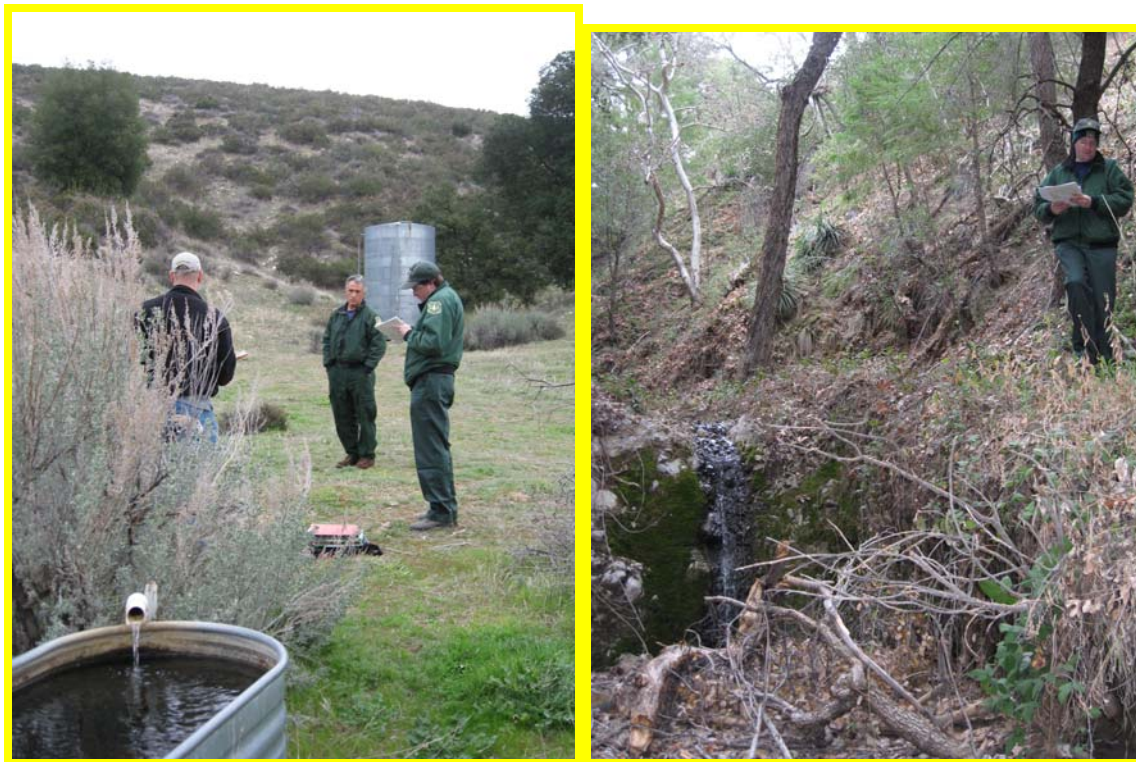
Effectiveness protocols are being met for groundcover, rilling, bank stability, floodplain erosion, riparian vegetation, and herbaceous vegetation. There was a water trough being fed by a water tank that was filled by a spring. The water trough was continually draining through a point source discharge to the surface. In effect, the spring in the upper canyon was being continually diverted and drained to the lowland. Inspecting the spring area indicated that there was a reduction in soil saturation and vegetation near the spring.

*Left: Water improvements on the Warner Ranch allotment.  
Right: Team hydrologist monitoring the spring above the allotment.*

- Per the BMPEP report it is recommended that the water trough have an added float valve so when the trough is full, the system stops flowing. A NPDES permit may possibly be needed for outlet pipe on water trough.
- There should be a check of the State database to determine if there is a standing water right to the spring. There should also be a gauge added to determine the total usage of the livestock on the Forest spring.
- Manage off-road use and potentially pave with asphalt up to location of water trough
- To continue success, maintain periodic evaluation of area to ensure accuracy of annual operating instructions

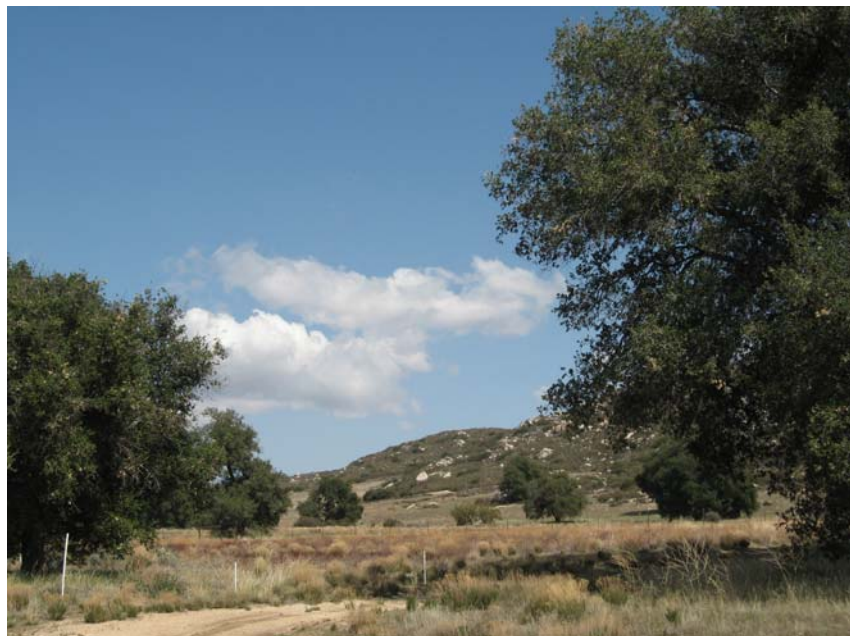
*View of  
Portion of  
Laguna  
Allotment*

Range allotments on the Cleveland National Forest are managed to standard by local staff. LRMP standards and site specific requirements are incorporated into the permits. When problems are identified, the Forest works with the permittee through their annual operating plans. The allotment is managed via term permit and annual operating instructions. Threatened and endangered species are managed via the permit, which requires avoidance of arroyo toad habitat. No grazing is allowed in portions of Kitchen Creek due to endangered species concerns. Cattle are kept from the riparian area using herding and natural barriers.

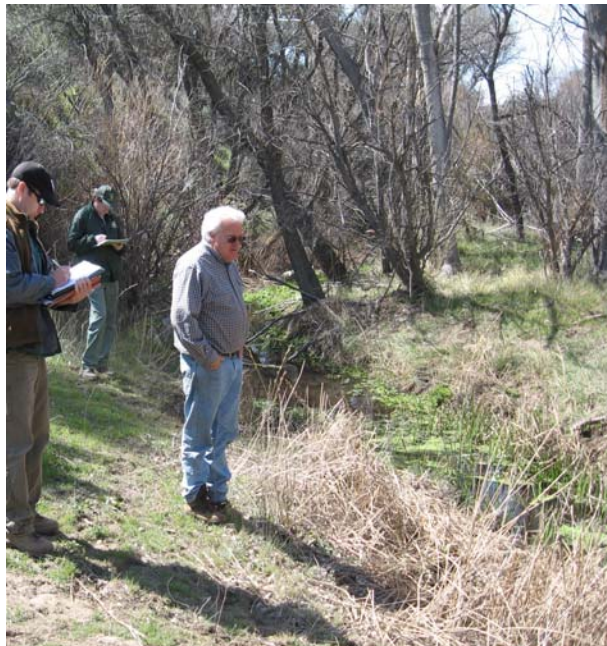
*The condition of the riparian area was evaluated and found consistent with the Land Management Plan. Here the team monitors the Narrows.*

The Narrows was inspected for streambank stability. There was much evidence of human traffic and less so of livestock traffic. The monitoring team observed that livestock get into the stream in the vicinity of the Narrows, possibly because a salt lick was located in the uplands near the stream. Within the area of the crossing, there is a 300 foot wide area where less than 30% of the streambanks are stable. But once the livestock is across the creek, the streambank is stable for the hundreds of feet. Overall, the 80% stability requirement is met. Groundcover and vegetative age class requirements are met.

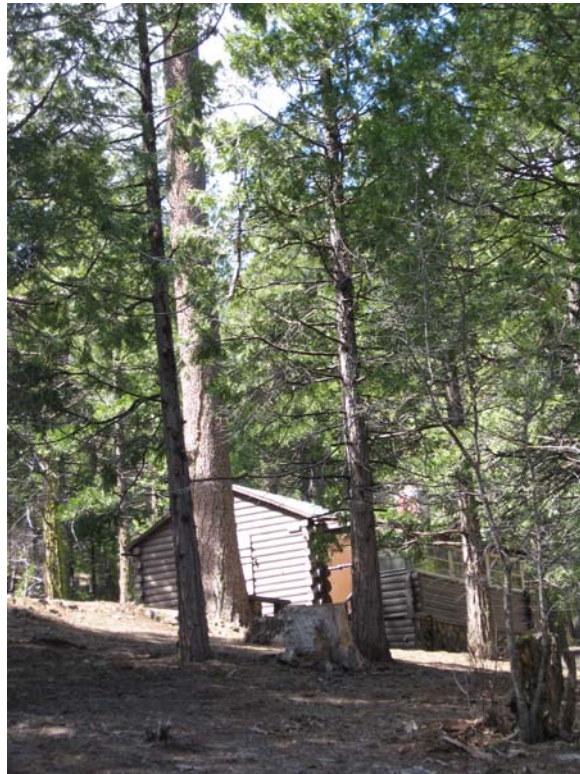
*One of the  
cabins in the  
Escondido  
Recreation  
Residence  
Tract.*

The monitoring team visited the project site on March 12, 2009, to review consistency with the Forest Land Management Plan. This tract, consisting of four cabins, is located west of Sunrise Highway in the Laguna Place on the Descanso Ranger District.

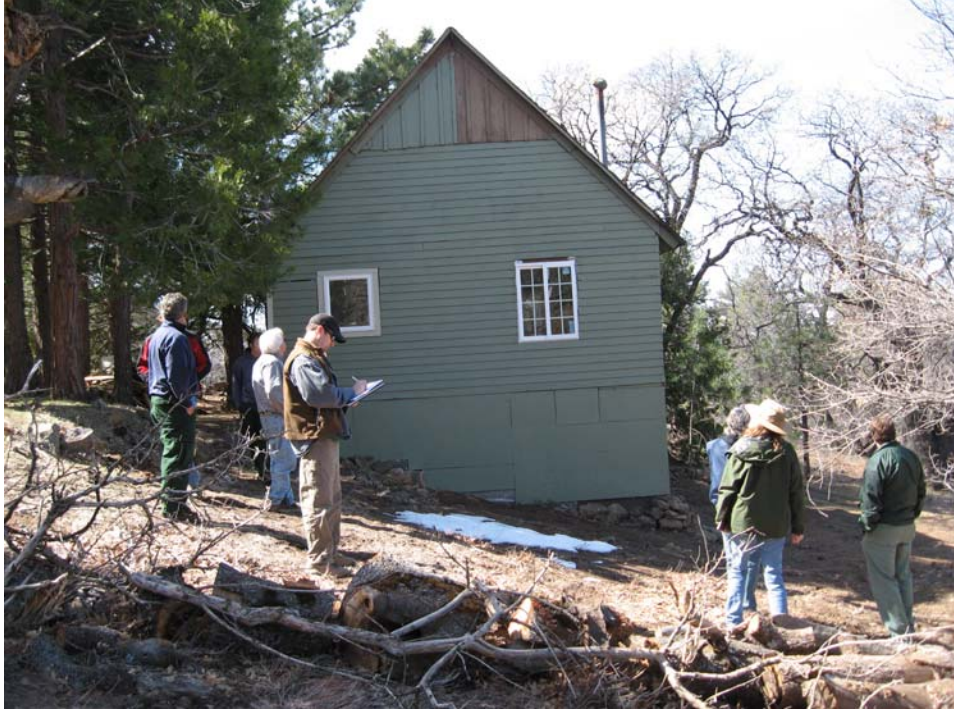
## ***Piedra Recreation Residence Tract***

*One of the cabins  
in the Piedra  
Recreation  
Residence Tract.*

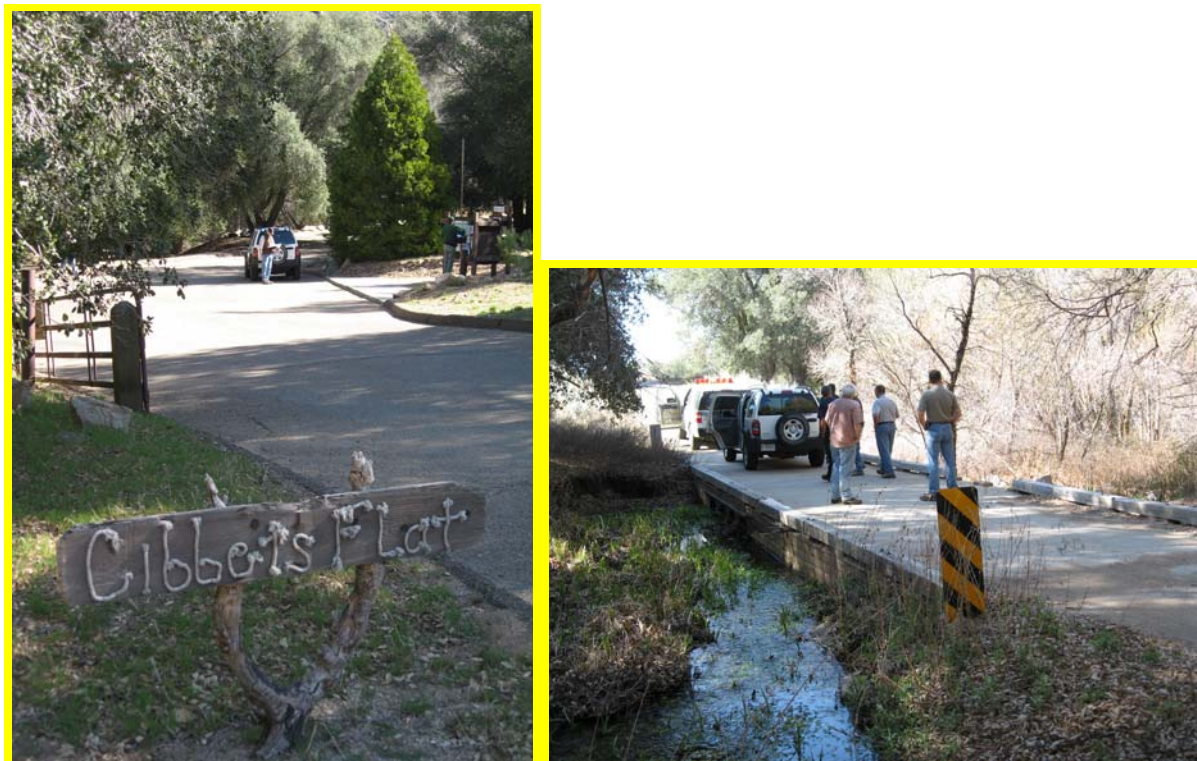
The water faucets at campsites #21, 22, and 23 are a minimum of 45 feet to the channel. Campsite #19 faucet was at 80 feet from the creek during the inspection, but only 20 feet from the high water mark. Campsite #21 also had rilling and exposed roots and delivery to the creek. There were no signs at the water faucets indicating that washing of dishes or food should not be done within 100 feet of the creek. Sediment reaches the channel and there is evidence that runoff from roads and trails reach the area within 100 feet of the creek. In addition, instead of just raking the area within 10 feet of the fire pits, in many cases the entire campsite was raked, contributing to bare ground of greater than 10%.

*Left: Entrance to Cibbets Flat.*

*Right: Wet crossing and riparian conservation area adjacent to the campground.*

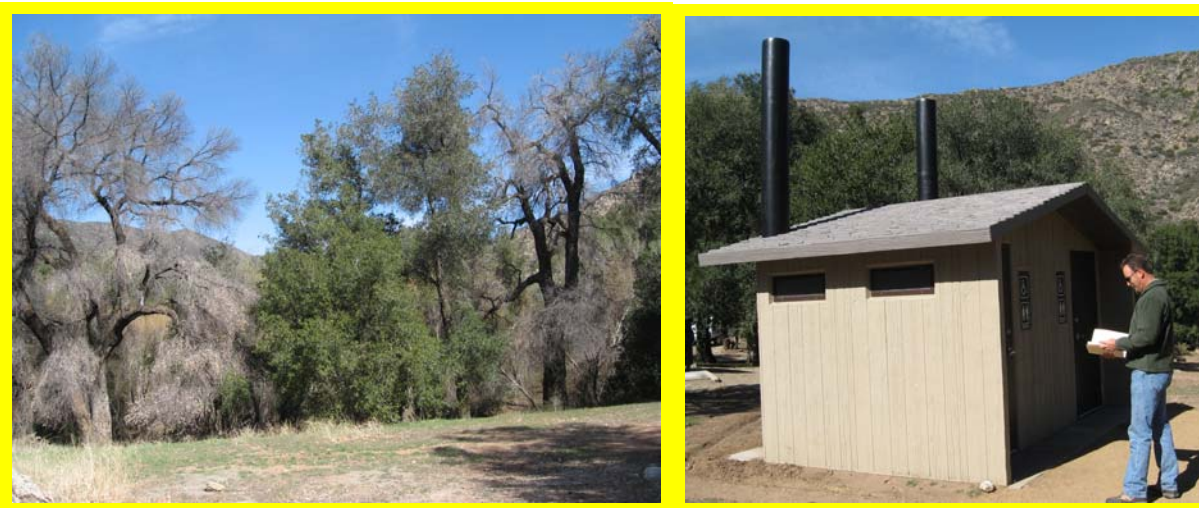
*Left: Dead and dying oak trees in the area.*  
*Right: Consistent with the Land Management Plan, the new restroom provides visitors with improved facilities while protecting resources.*

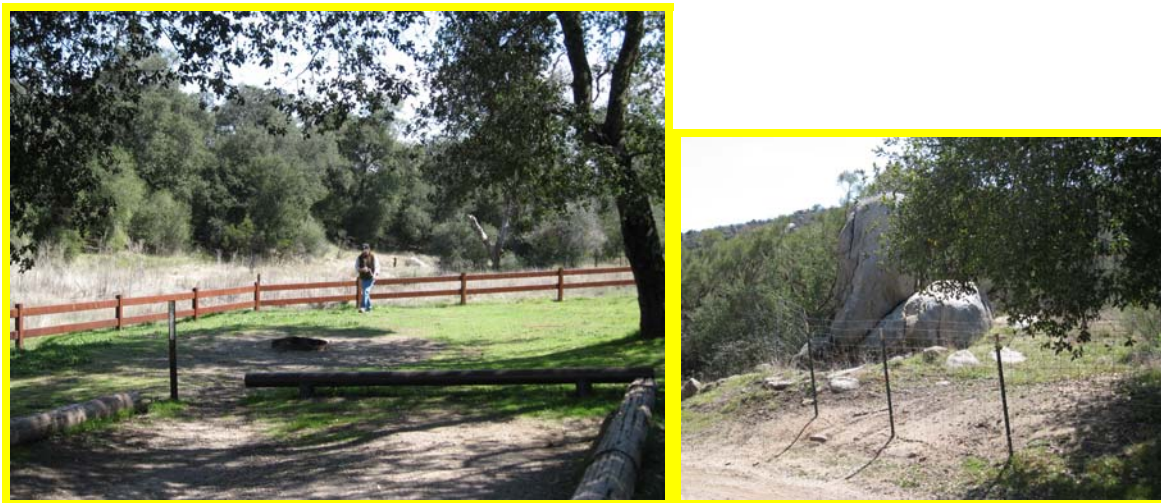
The monitoring team visited Bobcat Meadow Campground on March 11, 2009, to review consistency with the Forest Land Management Plan and also to evaluate the use of Best Management Practices (BMPs) for a recreation dispersed site (BMP R30). This campground is located in the Corral Canyon OHV Area in the Morena Place on the Descanso Ranger District and is operated by the Forest Service. Bobcat Meadow is a dry campsite with a single vault toilet used primarily by OHV enthusiasts. Recreation operation and maintenance is an ongoing activity.

*Left: Bobcat Meadow site.*

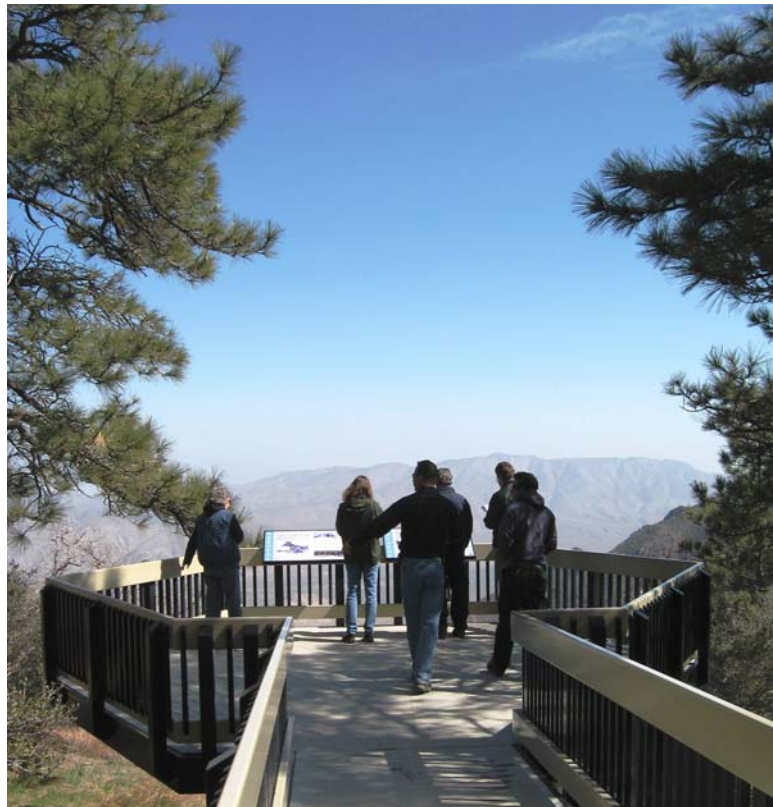
*Located just off Sunrise Highway  
on top of Laguna Mountain,  
Storm Canyon Vista provides  
forest visitors with a panoramic  
view of the desert.*

The project file contained the EA and the project design plans. The facility was designed and constructed to be compliant with the Americans with Disabilities Act.

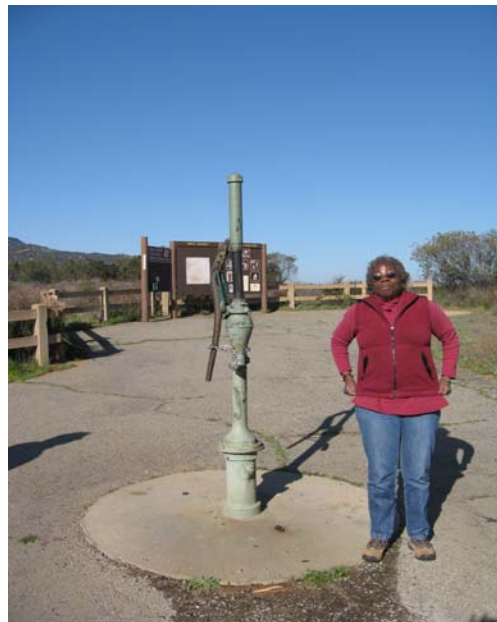
*Tenaja Trailhead provides parking, information and facilities for forest visitors seeking to hike and explore the San Mateo Wilderness*

The trailhead is an ongoing recreation activity; there are no planned projects regarding this use. The trailhead parking area was free of trash. The infrastructure is dated but functional. The facility was found clean. Barriers keep vehicles off the grass. Repairs are mostly adequate; however, two concrete posts (with rebar) that were installed to keep vehicles away from the water pump need to be reconstructed. Also, asphalt needs to be sealed to prevent degradation to parking surface.

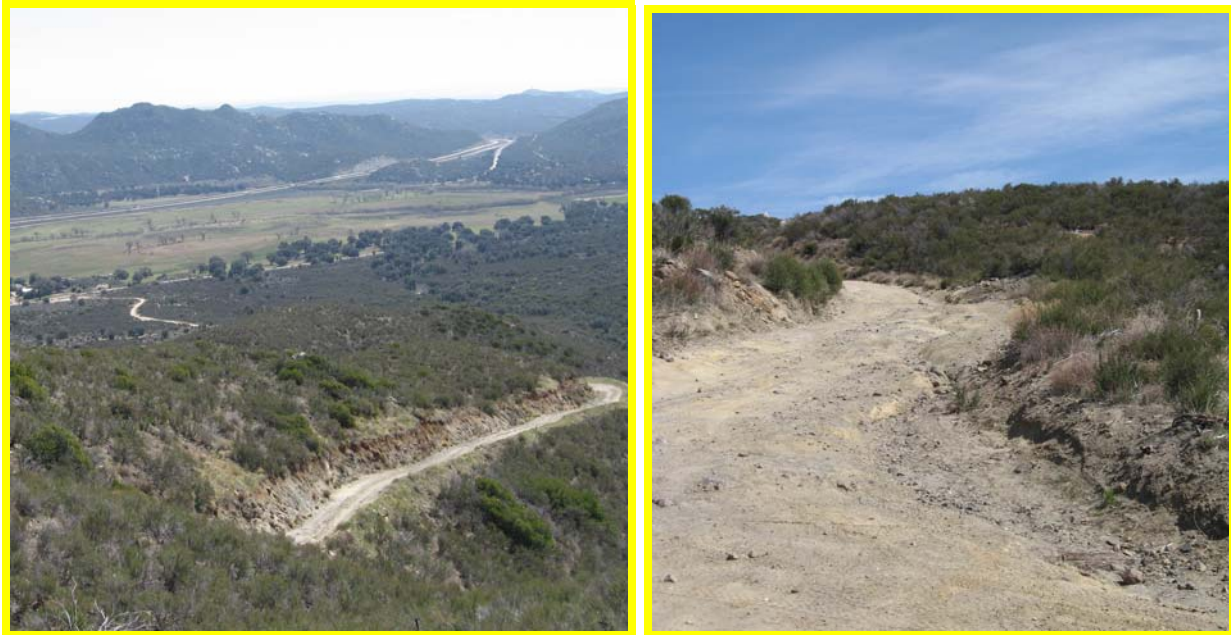
The state of maintenance of the road when monitored was not consistent with LRMP goals (5.1 - Improve watershed conditions through cooperative management; and 3.1 --Provide for public use and natural resource protection). Reduced budgets result in less maintenance of the road system. Monitoring by engineering and others has surfaced this issue, which is being addressed for this road but is likely to be an issue for other roads as well since budgets do not allow for annual maintenance. The problems with the effectiveness of BMPs on Bear Valley Road are

significant in nature, long in duration (2 years since last maintenance), and have near stream effects (large buffer). Maintenance on the current roadbed does not last long due to environmental circumstances. In situations where fire suppression in the area is required, activities will be limited to air attack until dozers can be brought on-site to make the road accessible to engines. Patrolling may be made more difficult by the sometimes poor condition of the road.

*Bear Valley Road, landscape and close up views.*

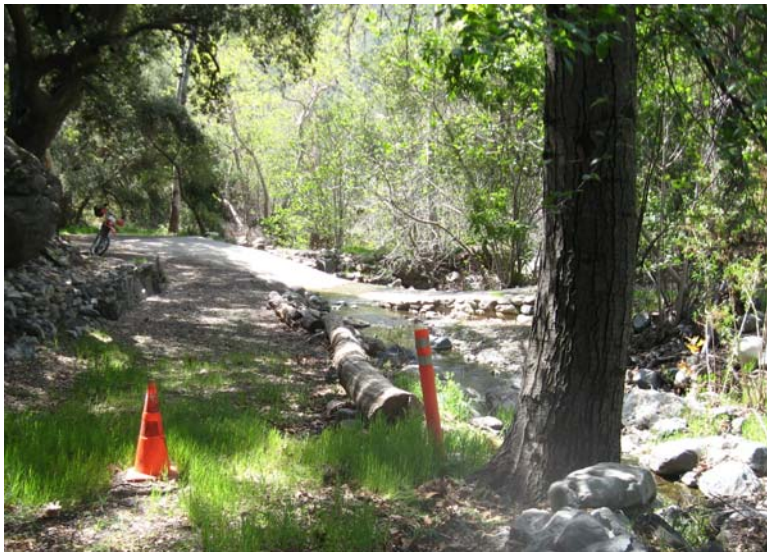
*This view of upper  
Holy Jim Road  
shows one of  
several wet  
crossings.*

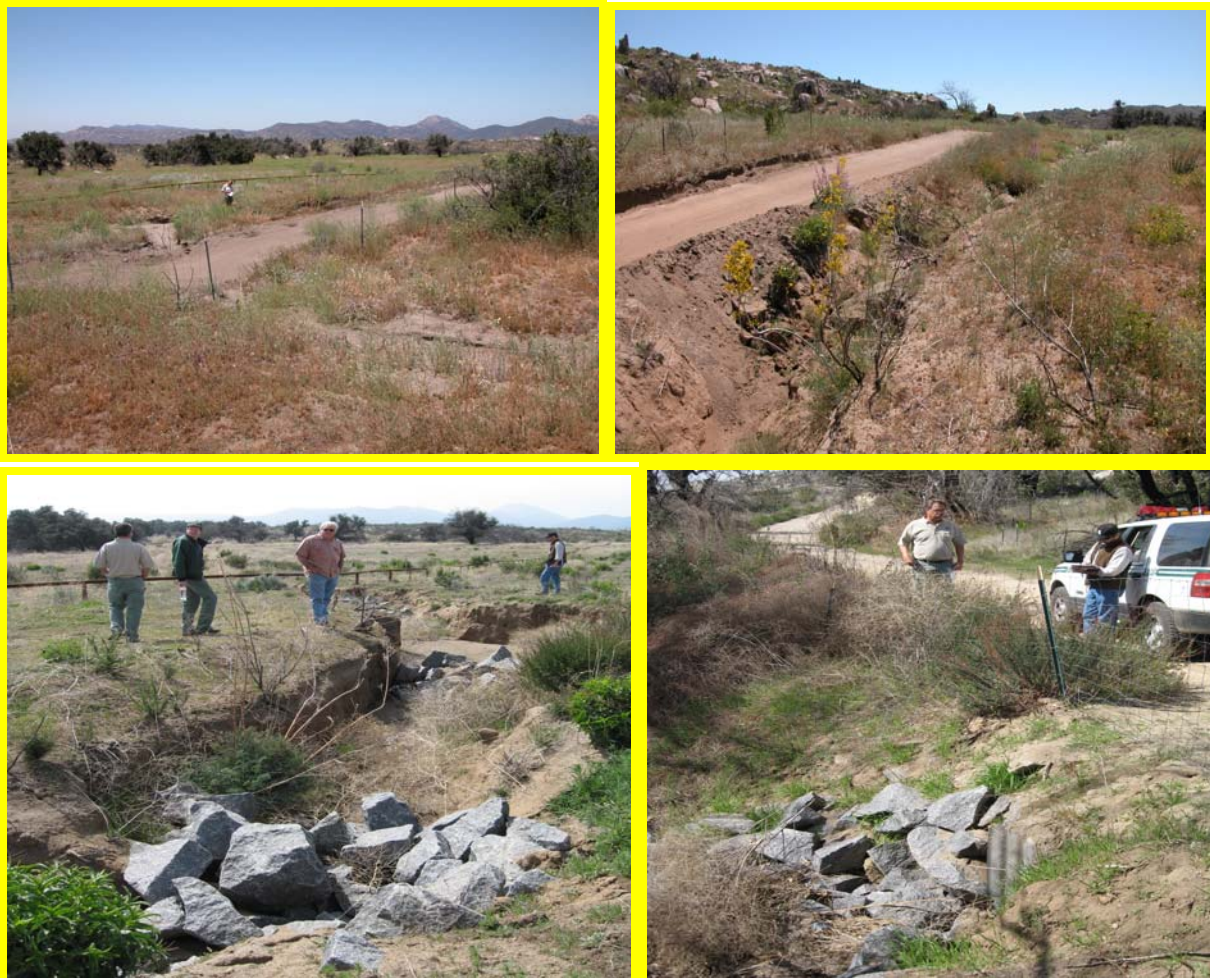
*Top L and R: Soil scientist prescribing treatment for a Watershed Improvement Need project (Before photos taken in June 2008 just off Skye Valley Road.*

*Bottom L and R: The following fall, rock was used to help stabilize this area.*

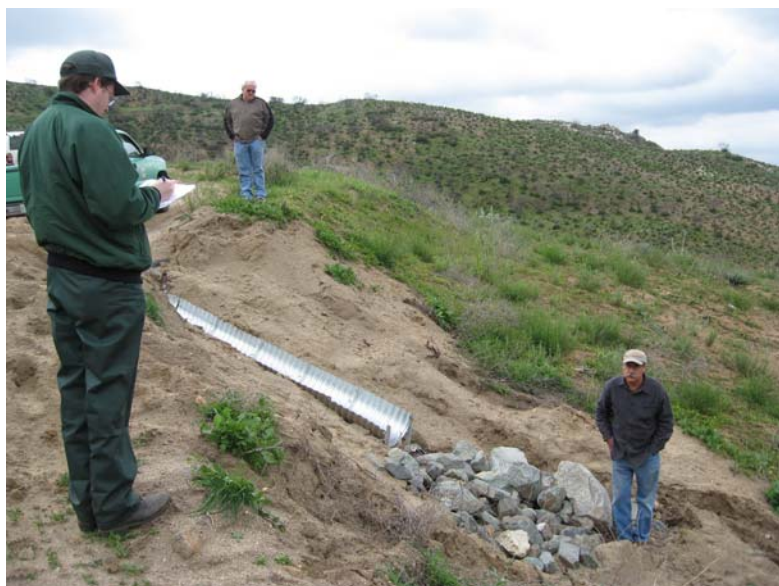
*Overside drain with  
rip rap below on  
Upper Santa Ysabel  
Road*

Maintenance was completed on the road from Fall 2008. The project objective included blading, fixing rolling dips and overside drains (OSDs), and adding energy dissipation rip rap below certain OSDs. The drains and OSDs were a part of burned area emergency response work associated with the Witch Fire. Most of the drains were functional and protected the environment as intended; however, some had severe scour. The scour may have been in existence for years prior to recent maintenance. The distance between two rolling dips was over 200 feet, leading to excessive rilling. In addition, some of the rolling dips were not correctly cut to the entrance of the OSDs. This led to up to 20 cubic feet of sediment eroding and scouring near the OSDs. Overall, the effectiveness protocol E08 was not met. Engineering staff on site during the monitoring noted that implementation monitoring was missed for the rolling dips that were not working correctly. One of the stream crossings (E09) had nearly 300 feet before an OSD, leading to approximately 20 cubic feet of sediment being delivered to the creek. The rip rap was placed correctly and was working. There was no evidence of sidecast material.

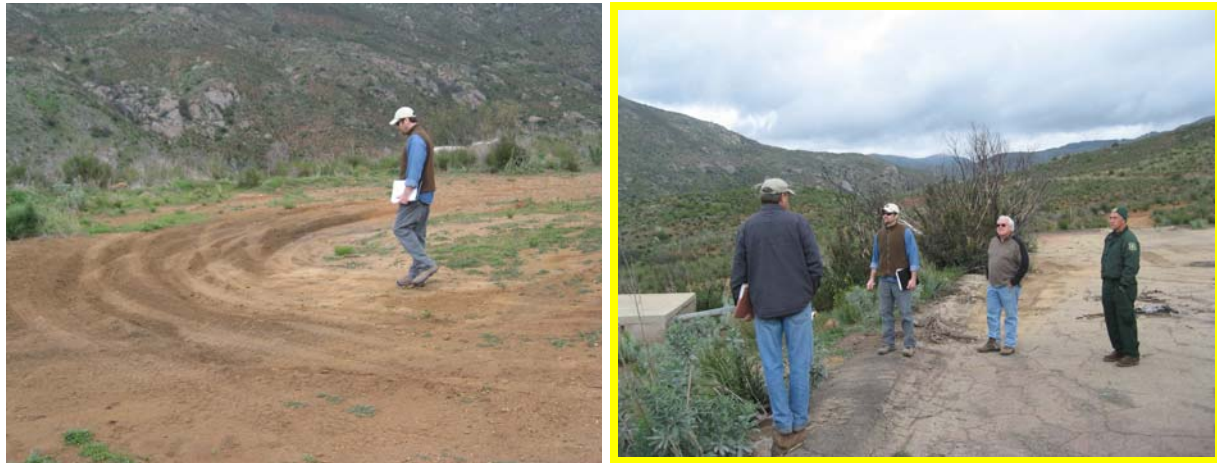
This “temporary” road was installed in the 1980s to provide access to a water development for fire fighting. No closure provisions were provided and the road was not added to the system. A helipad was also installed. The road was constructed before even the Forest’s first LRMP so it is not known if the project was implemented as designed. This dead end road also accesses a guzzler. Some unauthorized shooting is occurring especially at the end of the road. There is a riparian area below the road but the location of the site is far outside the perennial RCA of Temescal Creek. The road is only covered by the Forest Plan.

*Left: End of the road, where some unauthorized shooting is occurring.  
Right: The road has a water collection tank.*

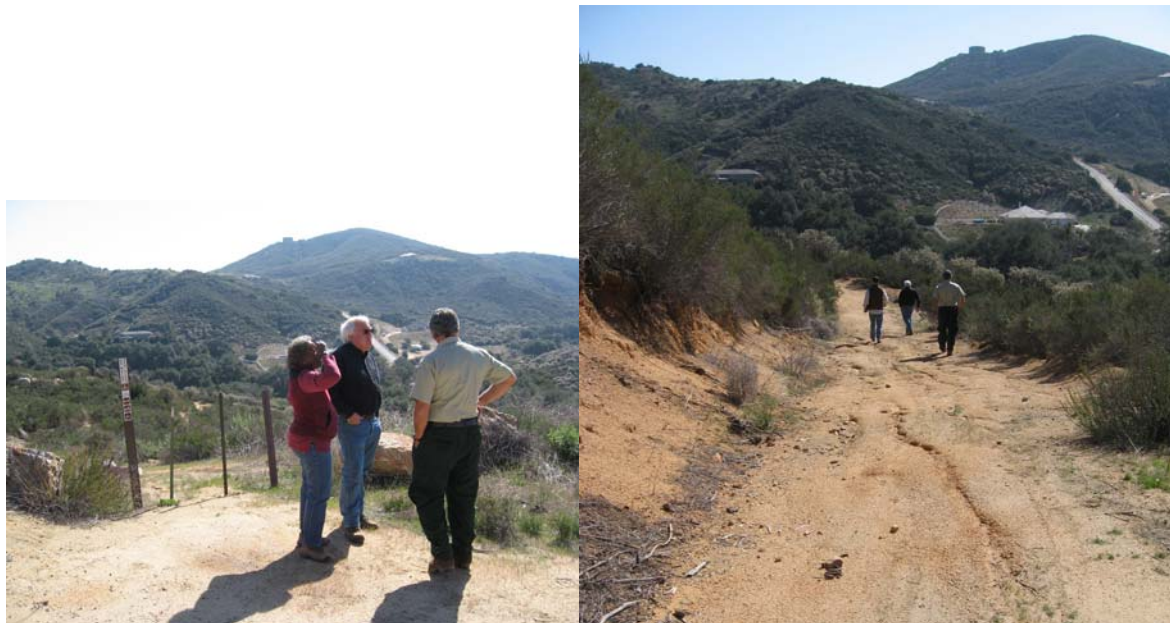
*Closed at South Main Divide Road, this non-system road continues downhill and eventually dead ends at private property.*

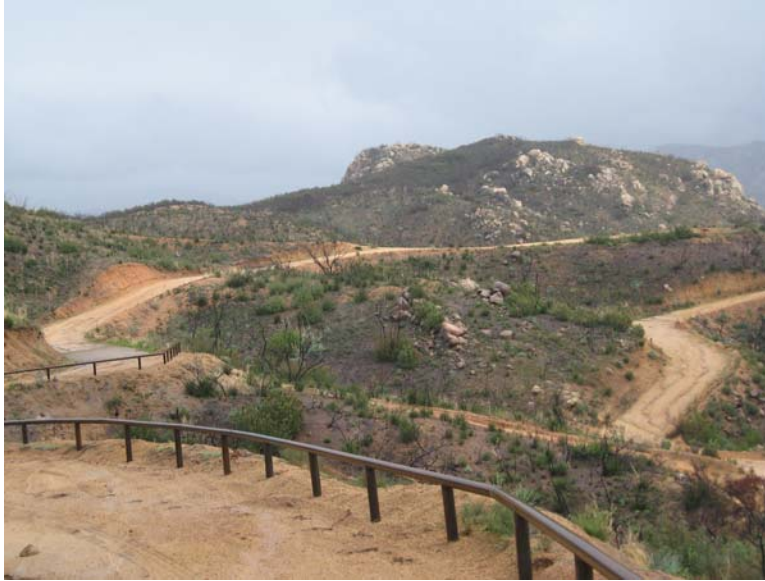
*In the Barbour Mountain area, road drainage was restored and barriers were installed in the burned area's open and accessible areas.*

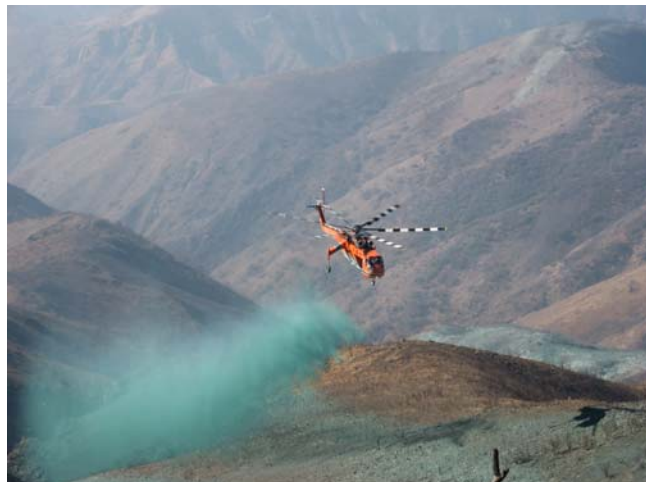
*Aerial application of hydromulch in the Santiago Fire burned area.*

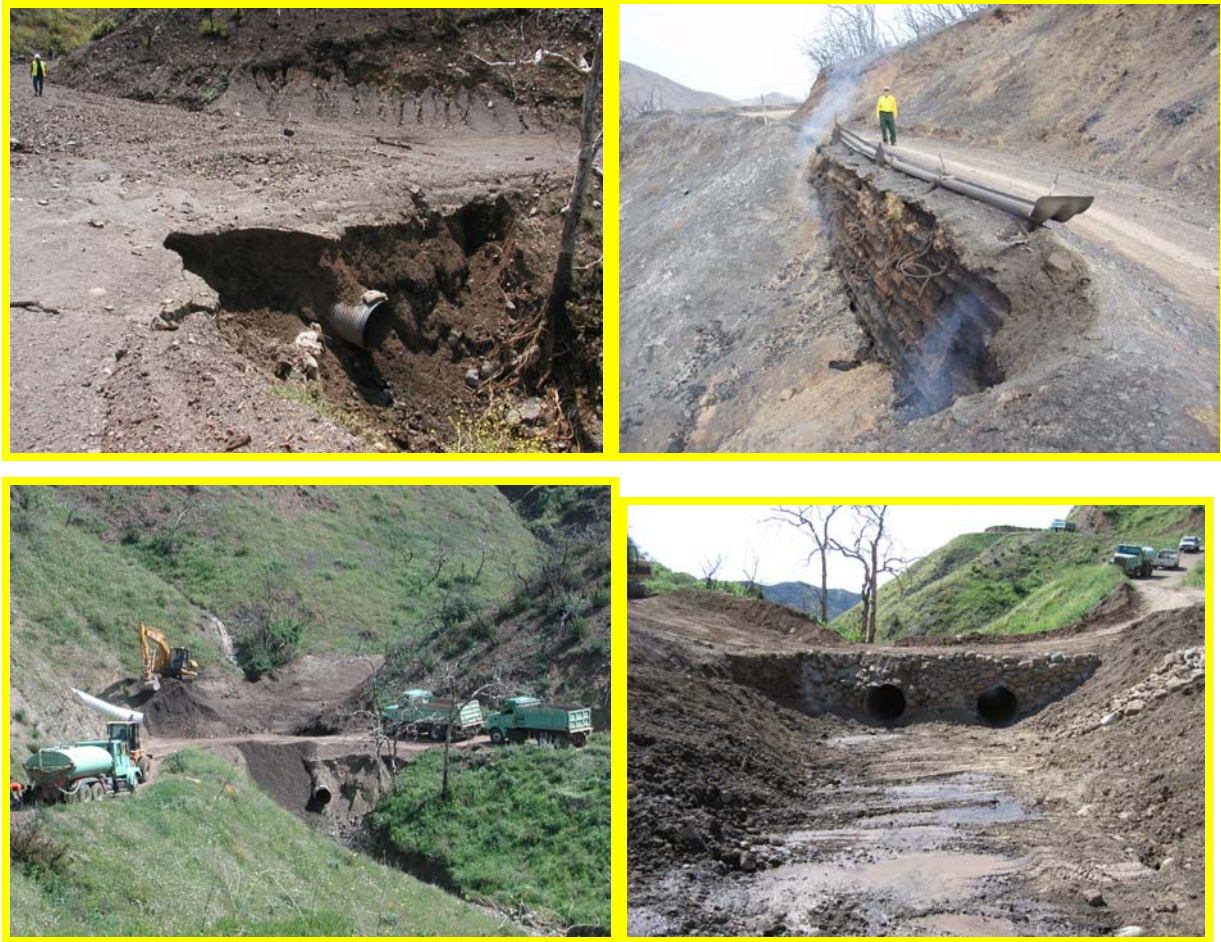
*The burned area had numerous non-functional or destroyed drains and road failures including a headwall (top left) and a crib wall failure (top right). Lower photos show downstream and upstream view of one of the larger projects implemented to restore drainage on Harding Truck Trail.*
