# Burned Area Emergency Rehabilitation Report (BAER)

**Battle Creek Fire  
September 2002**

Mystic District  
Black Hills National Forest

Battle Creek Fire, August 16 – 29, 2002  
Mystic Ranger District  
Bob Thompson, District Ranger  
Black Hills National Forest

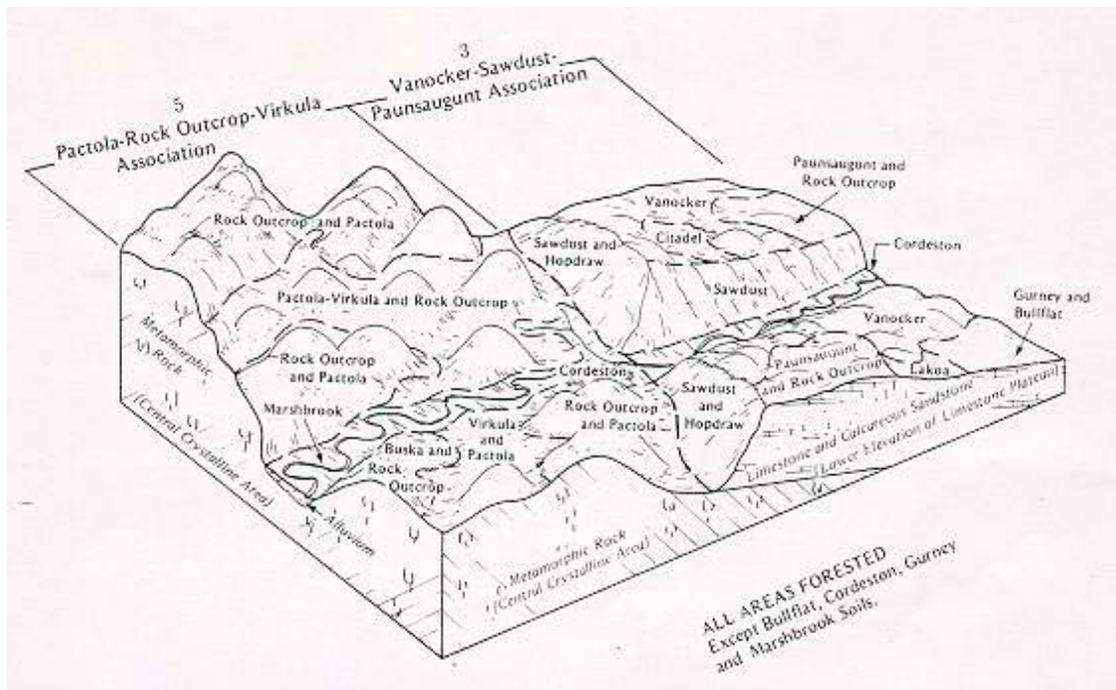
Figure 1. Cross Section of Geology, Physiography, and Soils

The Battle Creek Fire is located approximately 10 miles west of Rapid City, South Dakota. The small communities of Rockerville, Keystone, and Hayward flank its boundary. Most of the burned area is characterized by the mountainous topography of the Black Hills, with many areas containing steep slopes and narrow canyon bottoms (Figure 1. Cross-Section of Geology, Physiography, and Soils). The eastern third of the fire area is located in the steeply dipping plateau lands of the Deadwood, Minnelusa, and Madison Limestone and Englewood Formations. The western two-thirds are situated in the central crystalline area, comprised primarily of greywacke with lesser amounts of metamorphosed sedimentary rock outcroppings. Slopes range from nearly flat on the plateau-like ridge tops and grassy meadows to greater than 80% on the steep eastern slopes and canyon walls. Elevations of the burned area range from approximately 3650 feet in the southernmost tip of the fire to 5400 feet at the summit of Silver Mountain in the northwestern portion of the fire.

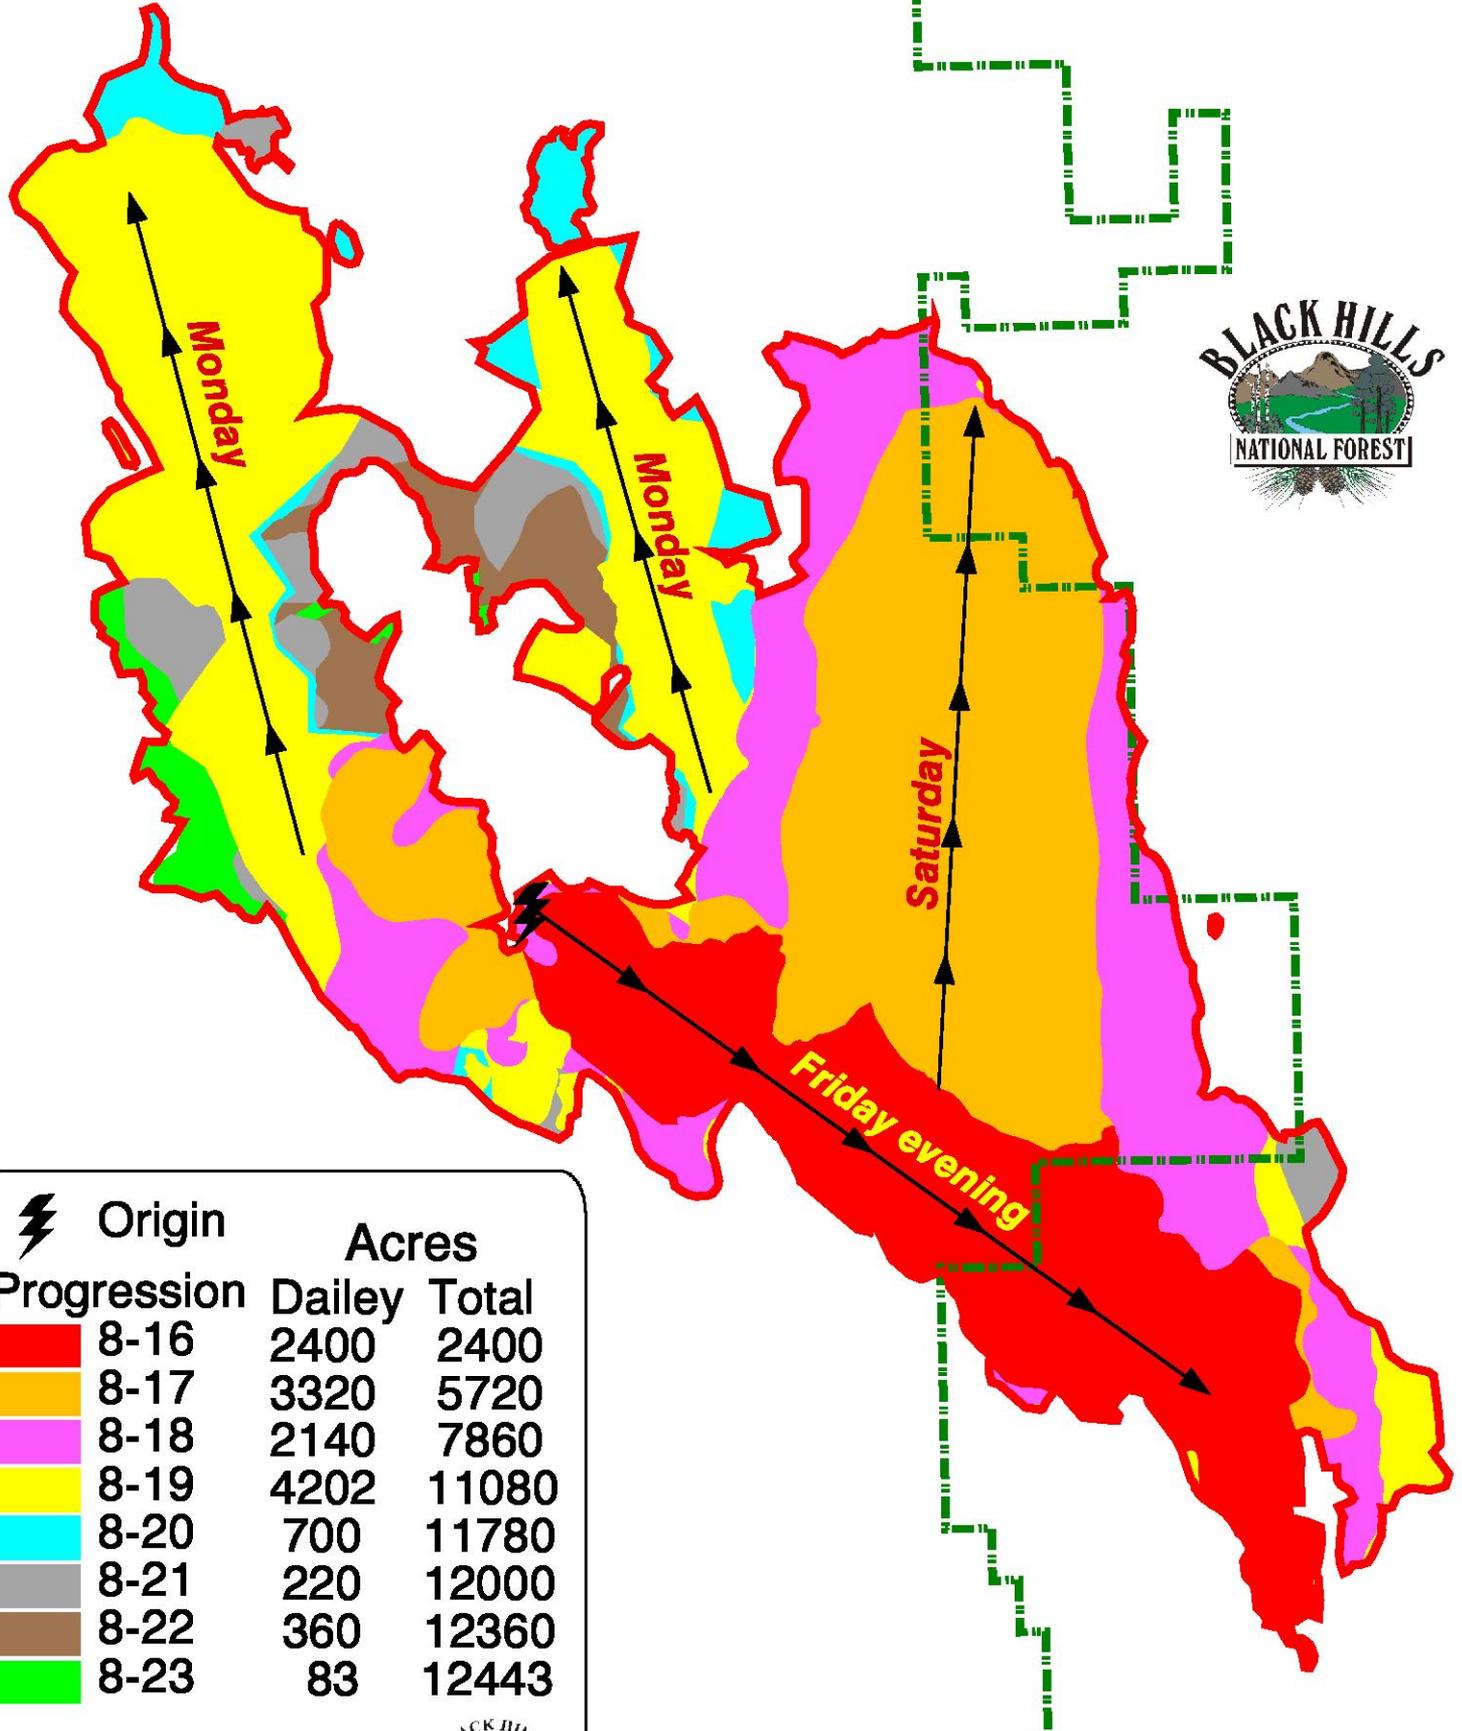
**Battle Creek Fire  
BAER Fire Progression Map** Appendix 1-b

⚡	Origin	Acres	
Progression	Dailey	Total	
<span style="color: red;">■</span>	8-16	2400	2400
<span style="color: orange;">■</span>	8-17	3320	5720
<span style="color: magenta;">■</span>	8-18	2140	7860
<span style="color: yellow;">■</span>	8-19	4202	11080
<span style="color: cyan;">■</span>	8-20	700	11780
<span style="color: gray;">■</span>	8-21	220	12000
<span style="color: brown;">■</span>	8-22	360	12360
<span style="color: green;">■</span>	8-23	83	12443

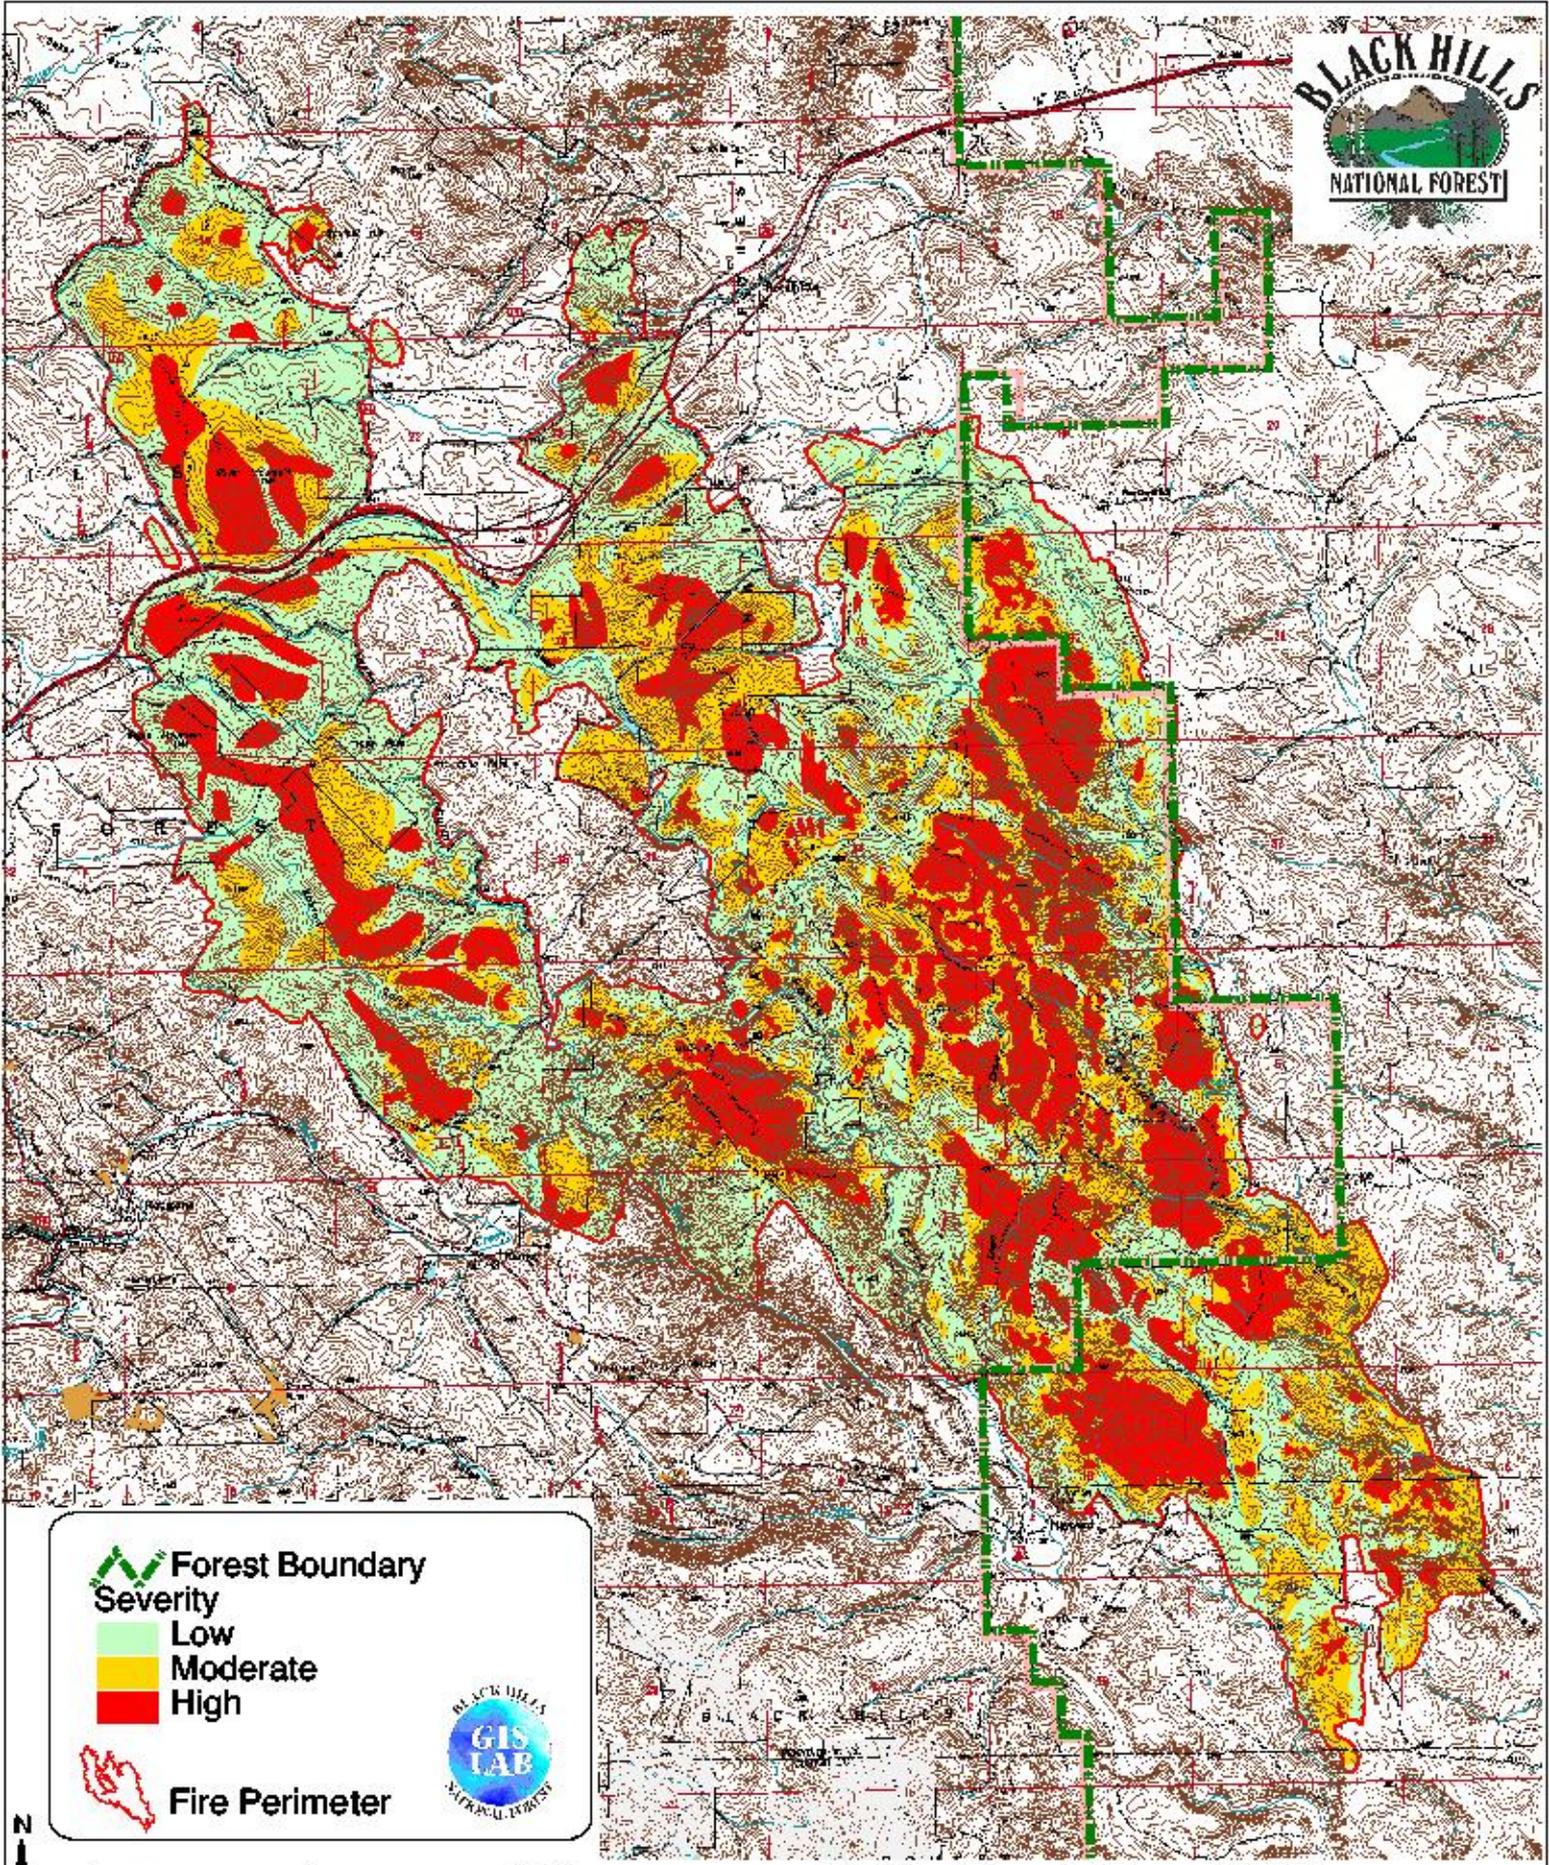
# Battle Creek Fire BAER Burn Severity Map

Table 9 displays a summary of burn severity acres and percentages by severity class for the Battle Creek Fire. A burn severity map is included in Appendix C.

<b>Burn Severity</b>	<b>Acres</b>	<b>Percent</b>
High	2,854	23%
Moderate	3,311	27%
Low/Unburned	6,285	50%
<b>TOTAL</b>	<b>12,450</b>	<b>100%</b>

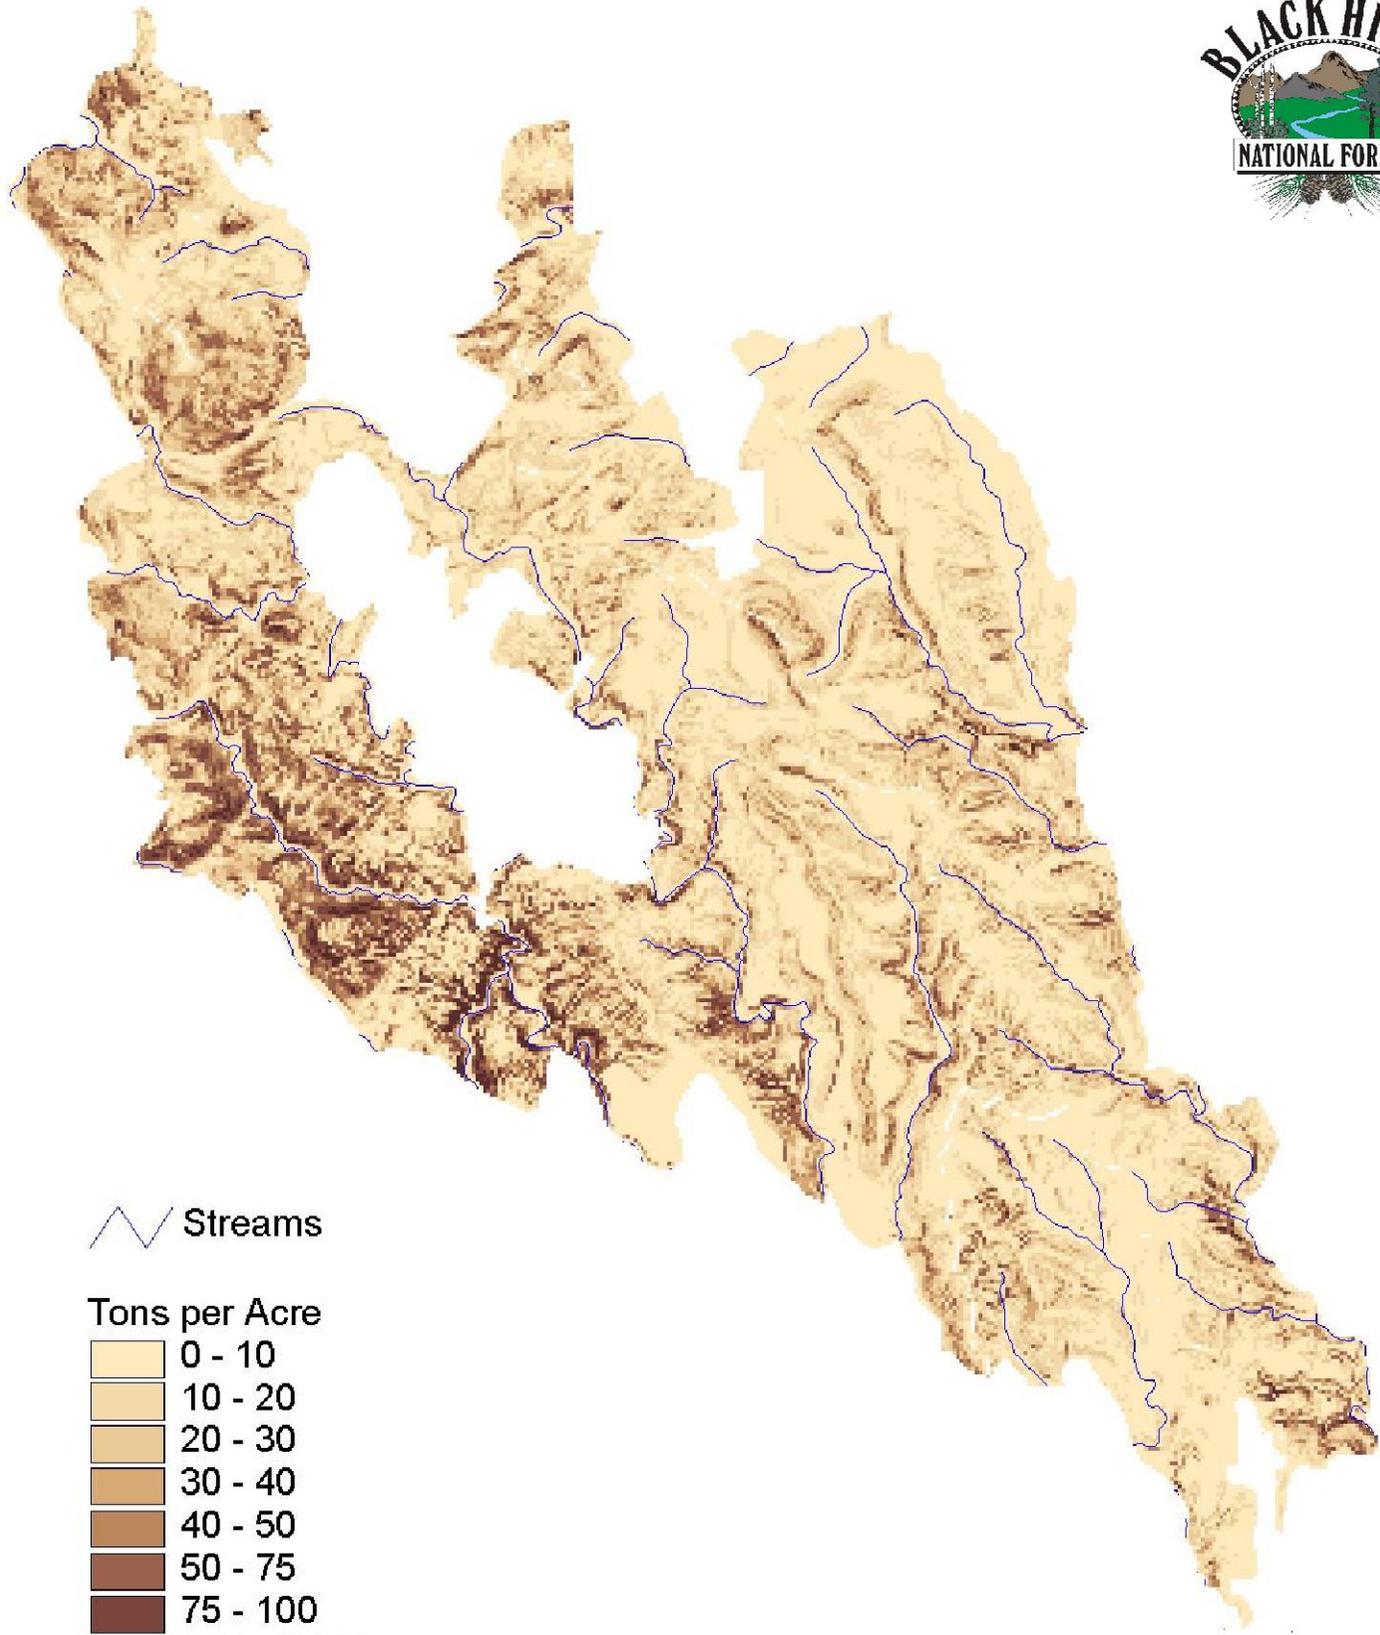
# **Battle Creek Fire Pre Fire Erosion Potential Map**

The results of the RUSLE model in ArcView, run for a short-duration thunderstorm (10-yr, 1-hour storm producing 2.0 inches) are presented in Appendices D and E, Pre- and Post-Fire Erosion Potential Maps. The maps indicate where the highest rates of erosion are likely to occur and helped watershed specialists identify hillslope treatment areas. It is important to note the *relative* increase in erosion between pre and post-fire, because of the error associated with the model (due to human inputs such as soil survey information, the burn severity map, and calculations of post-fire cover factors). Average annual rates of erosion potential (tons/acre) were calculated for 6 watersheds containing the burned area and are shown in Table 4. The average annual erosion potential across the entire analysis area is 63 tons/acre, which equates to 3/8 inch of soil loss across one acre. This is a three-fold increase over pre-fire erosion rates for the modeled storm.

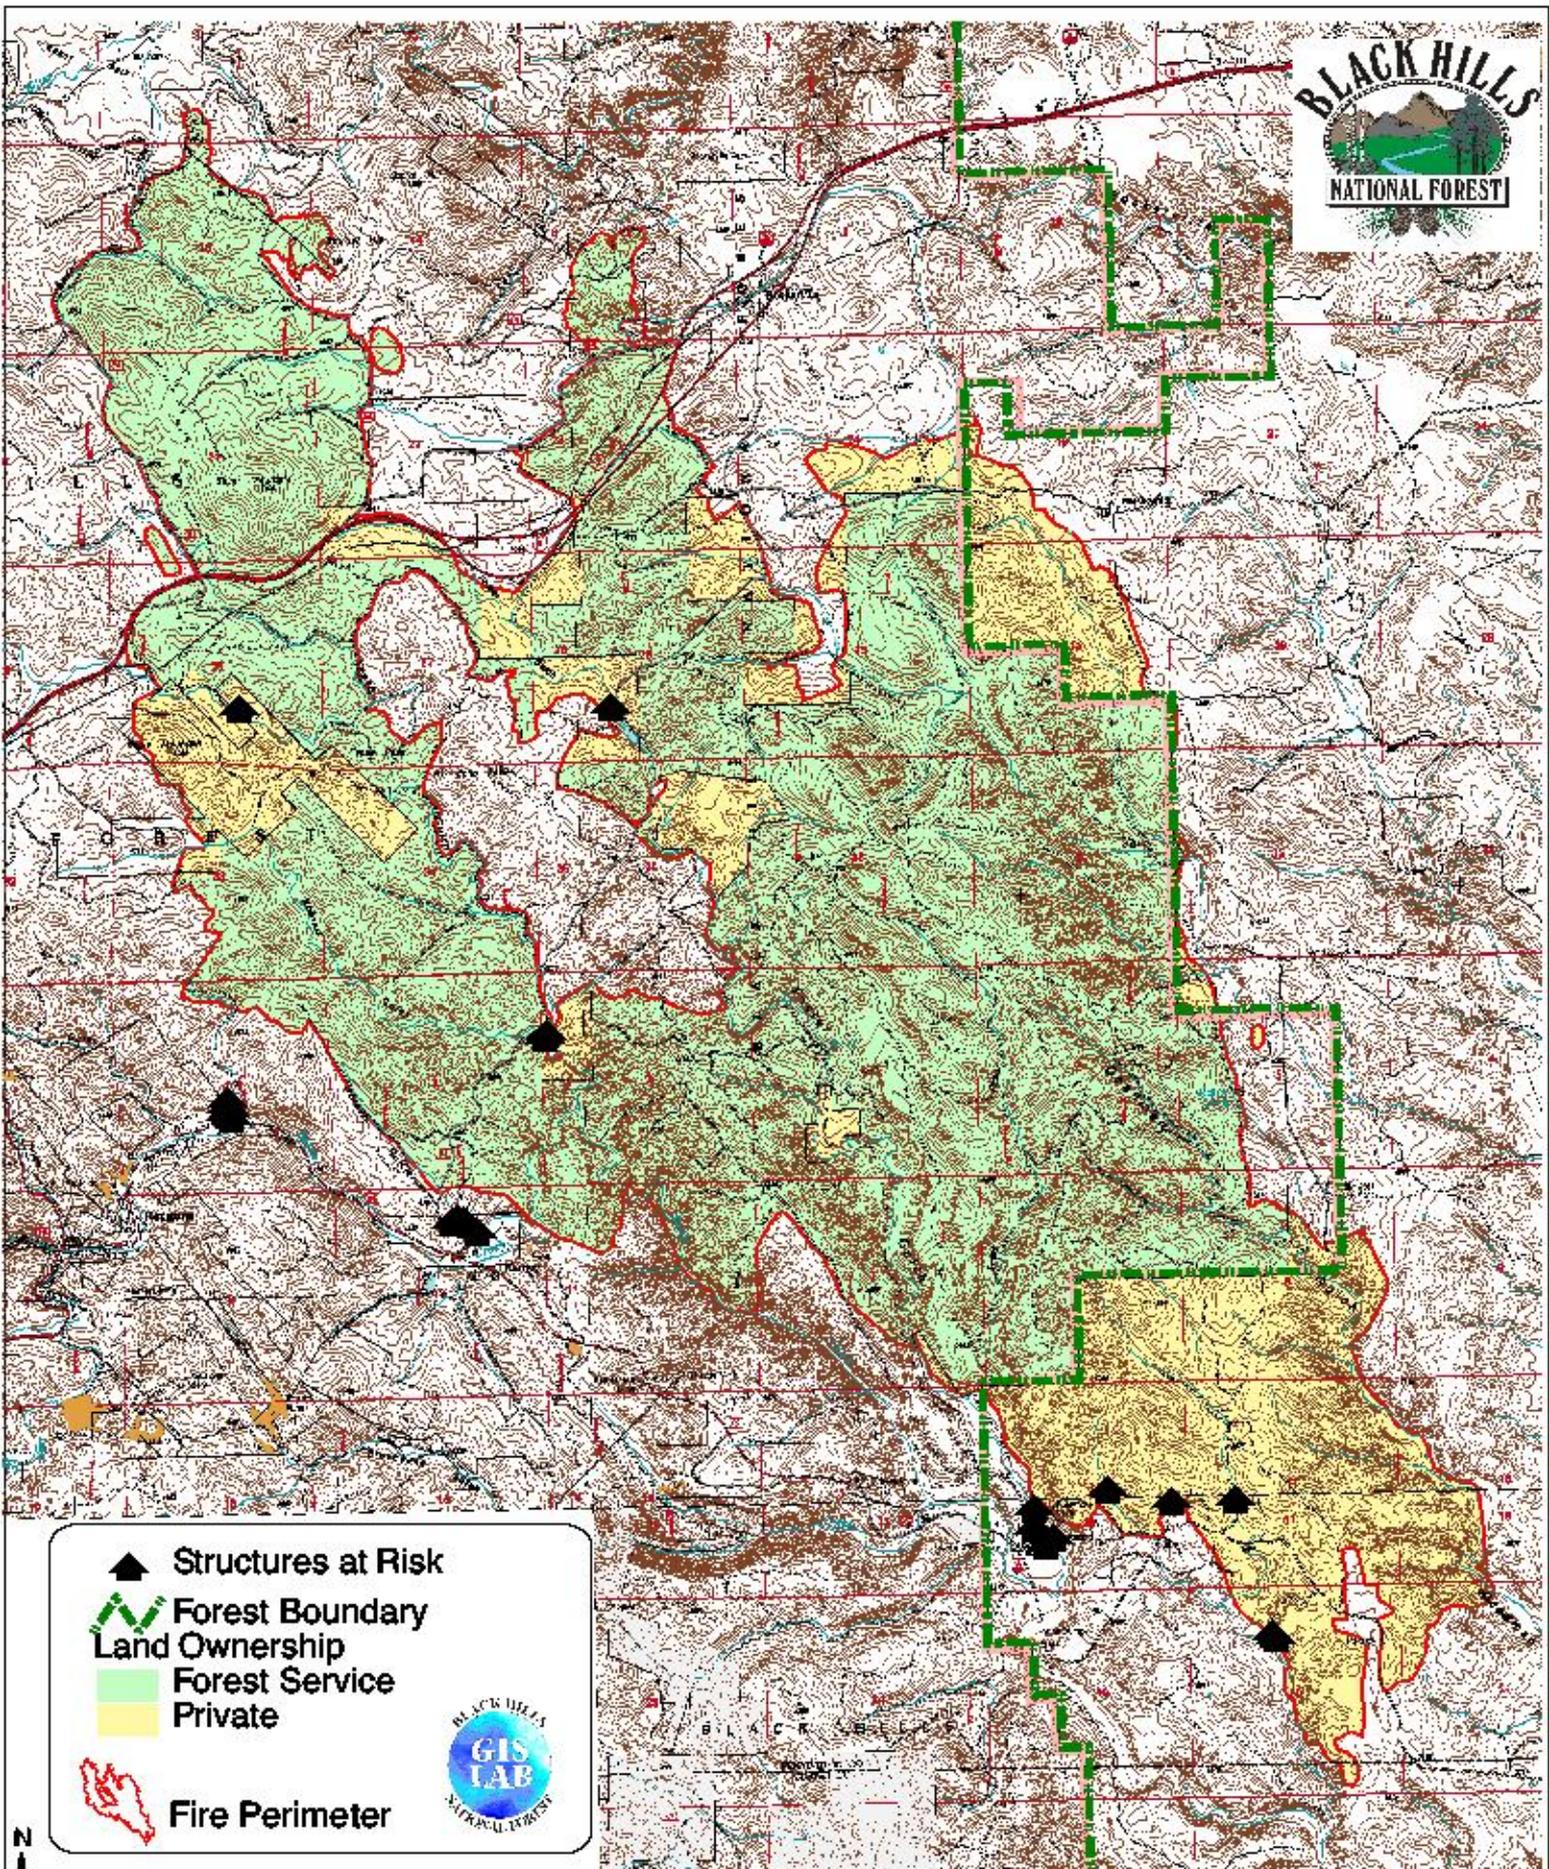
### Battle Creek Fire BAER Values at Risk Map

Table 11 – Values at Risk					
Map ID	Value At Risk	Channel Capacity cfs	Return Interval to Fill Channel	Potential Risk	Risk Process
S1	Residence – Klondike Road	NA	2-year	High	Flows from small drainage will damage house. House sits right in the path of the drainage.
S2	Outbuilding – Foster Gulch	Unknown	Unknown	Moderate	Flood flows could reach and surround outbuilding. Current occupants said there was about 12” of water in building during the '72 flood.
S3a	Residence – Children’s Home			Low	House is near floodplain.
S3b	Shop – Children’s Home	1127	5-year	Moderate	Flood flows from Tepee Gulch and Bobtail Gulch could damage shop.
S4a	Garage/Shop - Keystone			Low	Garage/Shop is near floodplain.
S4b	Residence - Keystone			Low	House is near floodplain.
S4c	Residence - Keystone	NA	2-year	High	Flood flows could damage house. House sits right in the bottom.
S4d	Residence - Keystone			Low	House is near floodplain.

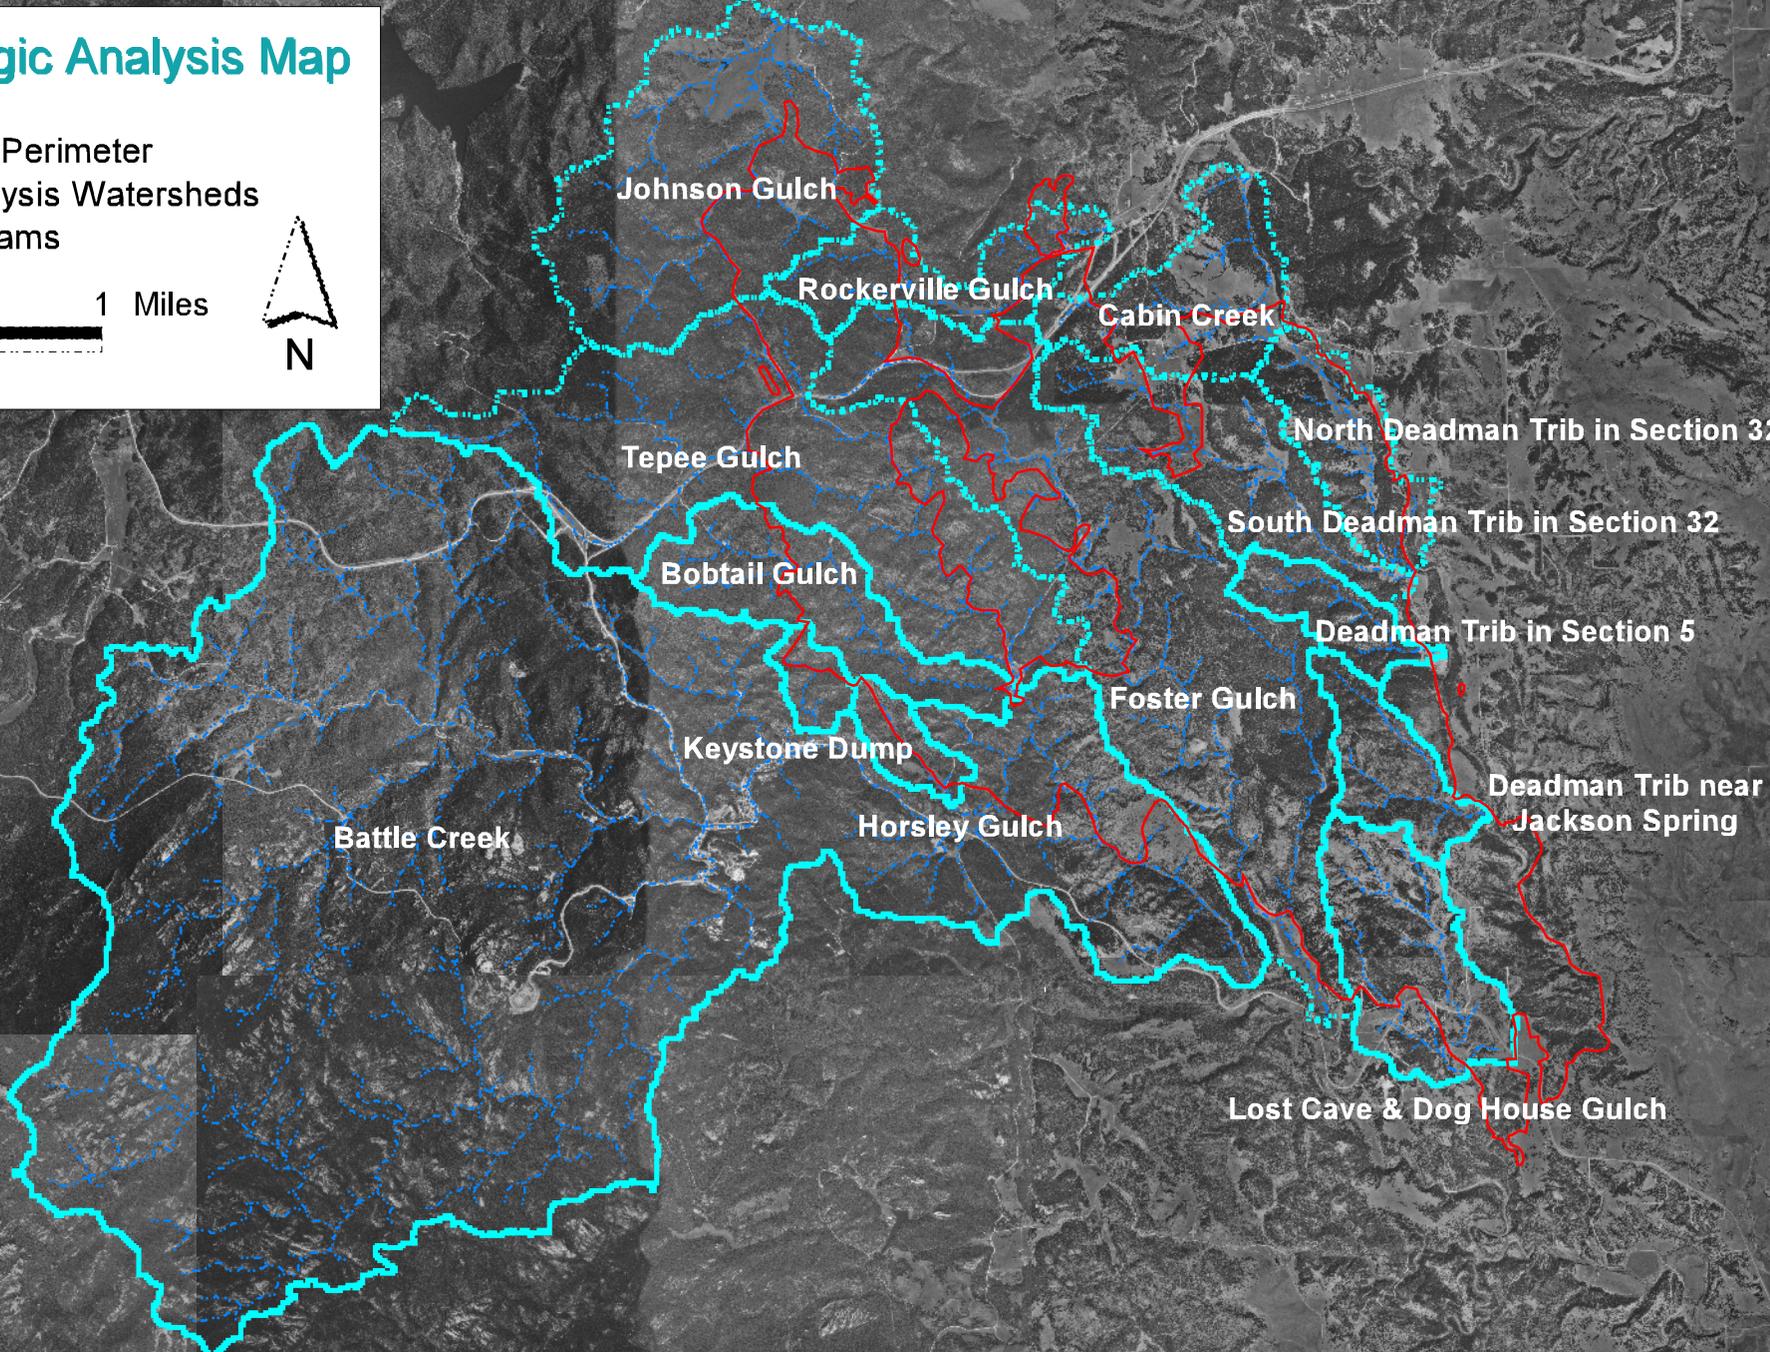
# Hydrologic Analysis Map

Table 2 shows the acres of each burn severity class in each analysis watershed. Please refer to the Appendix I for a hydrologic analysis map.
