**TECHNICAL ASSESSMENT AND SUPPORT
FOR WATERSHED MANAGEMENT, PLANNING AND TRAINING
FOR TONGA, COOK ISLANDS, SAMOA AND THE FEDERATED
STATES OF MICRONESIA, 25 JULY - 08 SEPTEMBER 2002**

**By
Jack Holcomb
James Denny Ward
USDA Forest Service**

**Forests and Trees Programme
Secretariat of the Pacific Community**

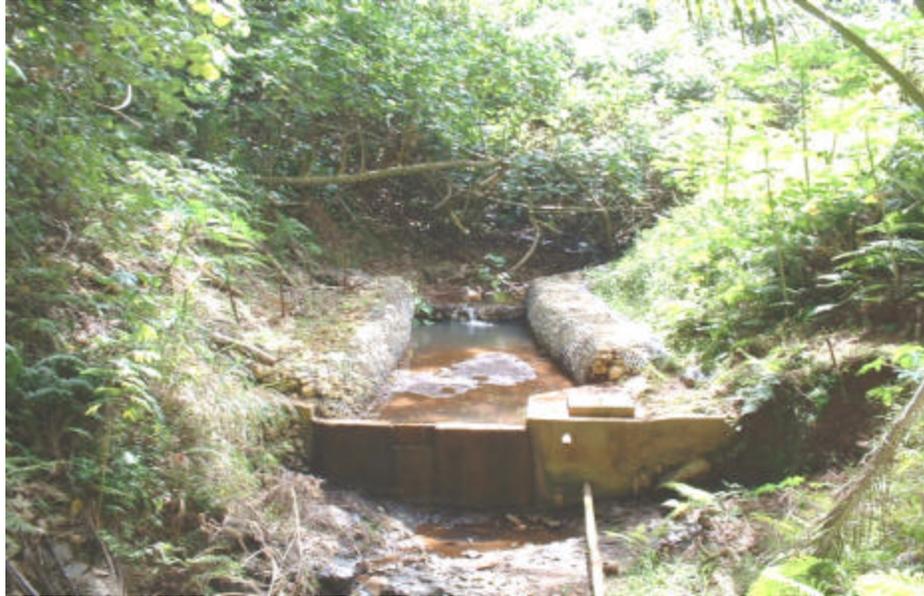
Our first field stop was the Oneroa (Keia stream) lower water intake. The intake was designed with a filter bed of gravel, fine sand and an upper layer of gravel as a filter bed that covered perforated pipes. The lower intake was, however, using surface water that was going straight into the delivery pipe. The intake surface was covered in thick silt and red clay. The sides were lined with well-placed gabions, which protected the intake structure. The McKean (1998) report indicated that this lower intake was around 80 meters. A priority for this intake should be to clean the filter beds. For all the intakes we visited on Mangaia we discussed the benefits of installing a layer of filter cloth (geotextile fabric) over the coarse gravel to protect the filter bed from accumulations of silt and clay. The filter cloth would allow water to pass through and help keep the filter beds clean requiring less maintenance. It would also be easier to clean the silt off of a smooth layer of filter cloth than from the top of coarse gravel.

Figure 1. Lower Keia Intake Oneroa

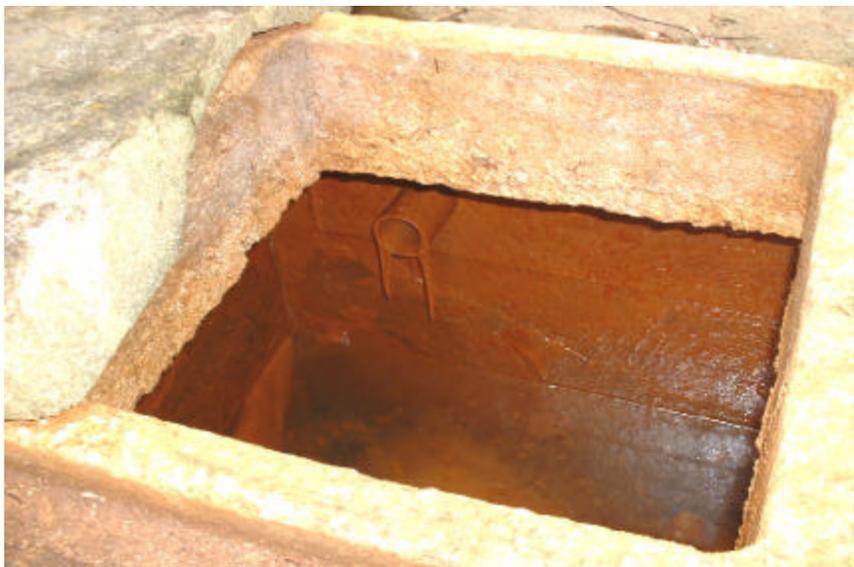
We next visited the upper Keia (Oneroa) intake. The intake cover was removed which revealed a great deal of sediment and red slime covering the overflow pipe. The stream just above the intake was rust colored indicating a great deal of sediment had been flushed down to the intake. This was probably due to continued erosion of the stream banks since a major storm that had occurred in December.

Figure 2. Keia upper intake cover removed showing poor water quality.

The intake filter beds should be replaced with clean sand and gravel and covered with a filter fabric as recommended for the lower intake. The water from the intake at the upper intake was flowing through the filter bed.

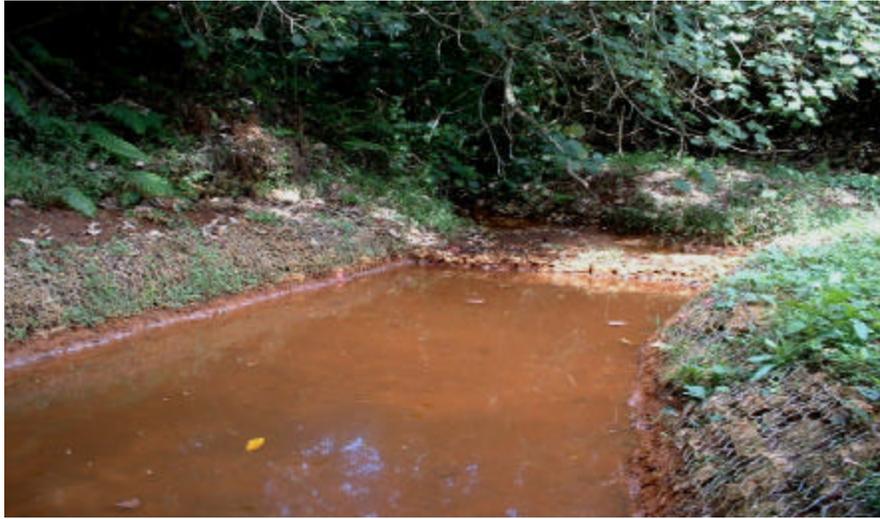
Figure 3. Keia upper intake filter bed showing poor water quality

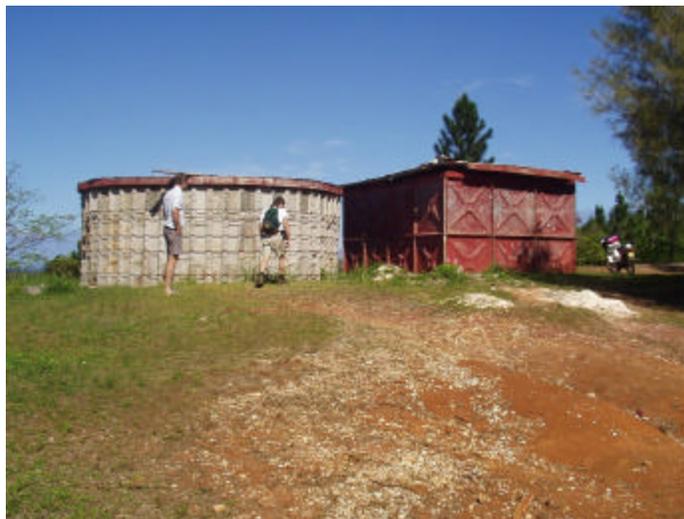
Water from the two Oneroa intakes (Keia stream) flow by gravity to a tank located downstream and above the taro fields. From here the water is pumped to a storage tank on the ridge top above to provide head to the village below. An additional tank that collects rainwater is adjacent to the collection tank. The storage tank below the intakes was filled to capacity and overflowing in a nearby taro field. A new pump that had been recently installed was running at the time of our visit. The two tanks above had a vertical capacity of approximately 2.4 meters and the tanks were just over a meter full. We believe that a higher capacity pump would deliver more water to the tank and prevent observed overflow losses from the lower tank.

Figure 4. Upper Keia storage tanks (red tank is secondary storage)

We also discussed improving efficiency of the pump by moving the upper storage tanks to a lower elevation. This could be done without a significant loss in hydraulic head.

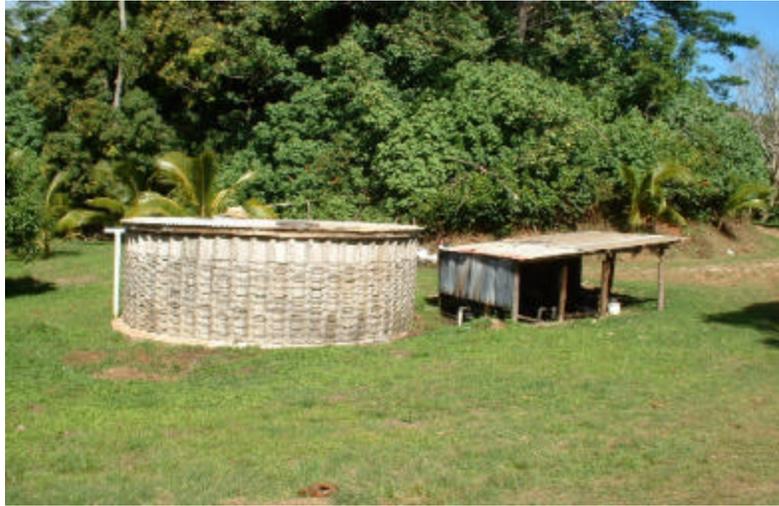
Figure 5. Keia lower storage tank and pump house

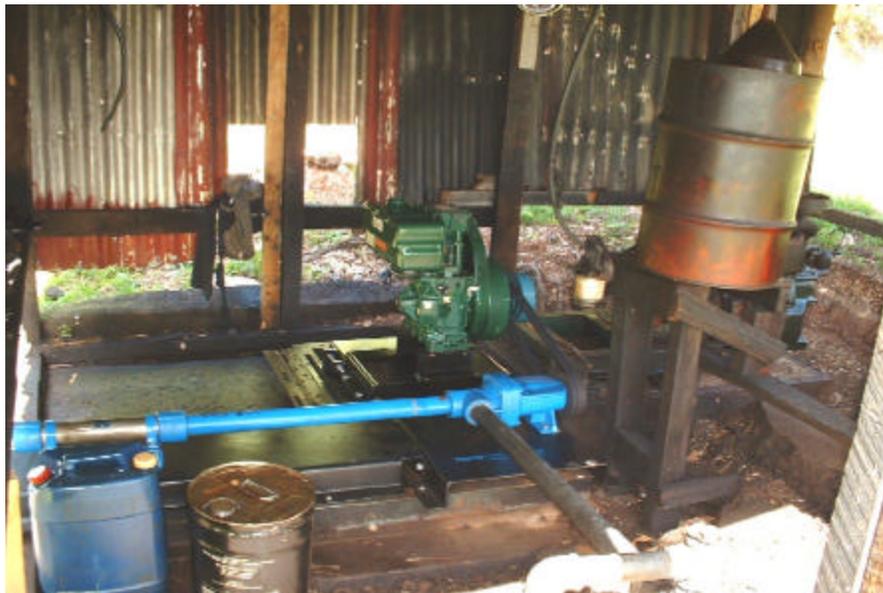
Figure 6. New pump near lower storage tank

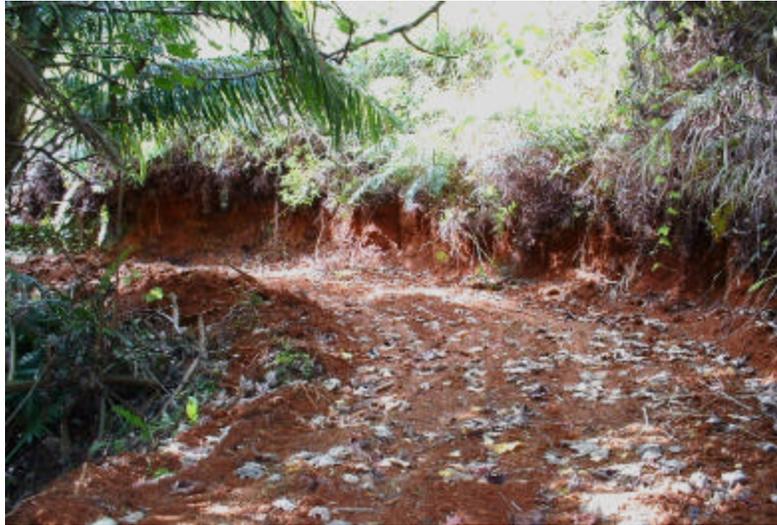
After the visit to Keia we traveled to the Veitatei intake site (Tipitaru stream). This intake serves the village of Tanarua even though it is in the Oneroa District. The road had been cleared for access (small slides that had blocked the road had been cleared (Figure 7).

Figure 7. Recently cleared road to Veitatei

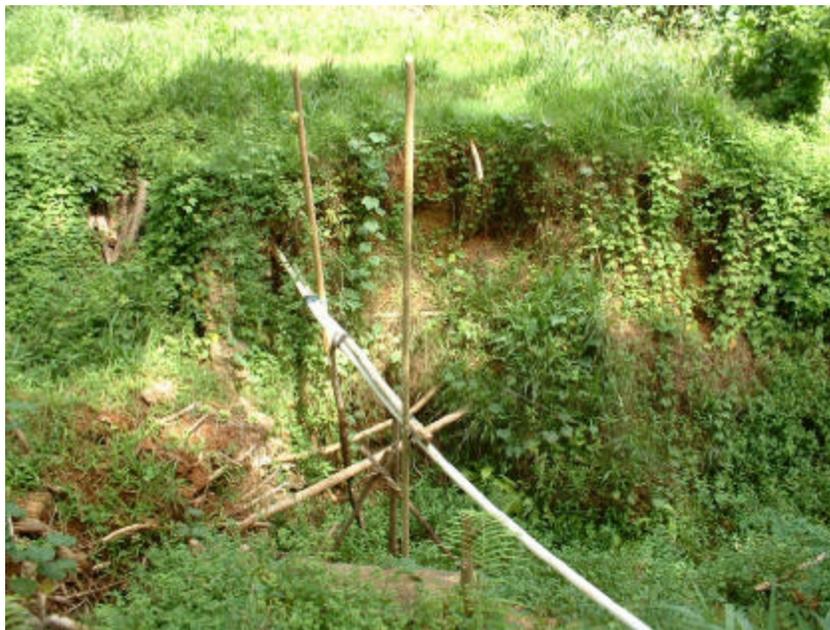
The Veitatei intake could not be located. We later found through discussions with the Mayor that it had been completely buried during the December storms. The intake was functioning at low pressure even though it had been buried. The water district manager indicated there were plans to clear the material from Veitatei and clean the other intakes by the end of October. Next, we drove the road that accessed the Karanga Intake (Vao Roa) water supply. The road was not passable due to the December storm that washed out a large culvert (1.2 meters) and severed the water pipe. The water pipe had been replaced but a new culvert will not be installed until October of 2002 (Figure 8).

Figure 8. Road to Karanga intake showing where culvert washed out.

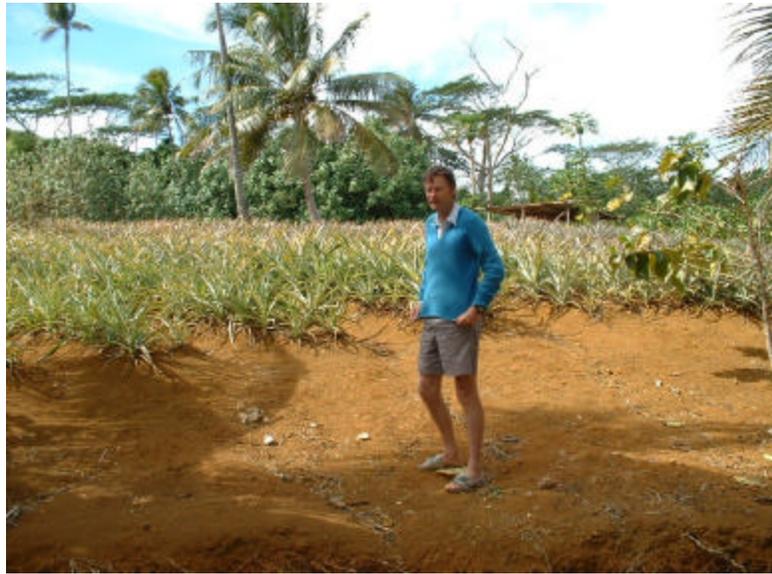
Figure 9. Recent pineapple field planted vertically above road is already showing signs of erosion.

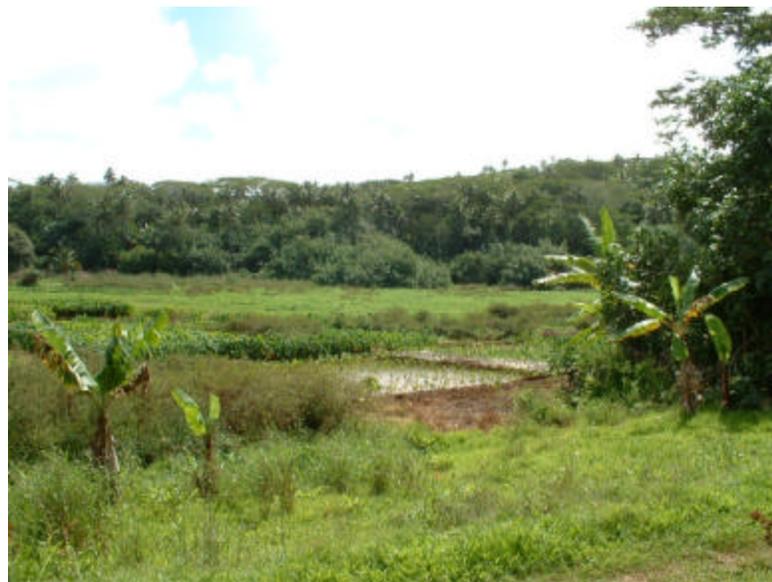
Figure 10. Typical taro field on Mangaia

The Karanga intake is inspected 2-3 times a month by walking the access road. The remainder of the afternoon was spent looking at pineapple fields, taro fields (Figure 10) and roads on the islands. Some recent pineapple fields are still being planted vertically instead of on the contour as shown in Figure 9 above. It was mentioned that the pesticide Paraquat was being used on the taro fields to treat competing vegetation and the farmers indicated it was a safe chemical to use. Paraquat is very poisonous and could be lethal if ingested.

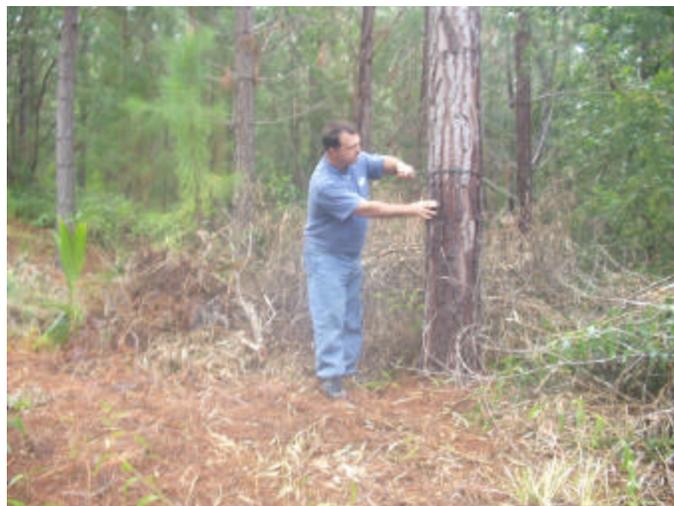
In discussing the pine plantations, Mayor Tangatakinu mentioned that the reforestation efforts were to prevent soil erosion with a secondary objective to harvest the pines as a commercial crop sometime in the future. Some areas could be thinned now but the major harvest should occur within five to ten years. Figure 11 shows the typical size of pines that have been thinned (approximate 40 cm in diameter).

Figure 11. Pine plantation on Mangaia Island after thinning

We suggested that before harvesting is done the island should develop a set of standards for harvesting to insure that logging is done in a manner to protect the resources on the island. They agreed that they do not want to end up with other erosion problem like the one that occurred in the pineapple plantations. We discussed the use of a portable mill and how it could be set up on site to avoid some of the environmental damage from logging. The mayor was told that a portable mill could cost in the range of \$25-\$30 thousand dollars (New Zealand currency). There is a good reference available for setting up a community-based timber harvesting enterprise (Salafsky, 1997). Pruning of the pines is currently underway. Pruning is labor intensive but will greatly increase the value of the trees (Figure 12).

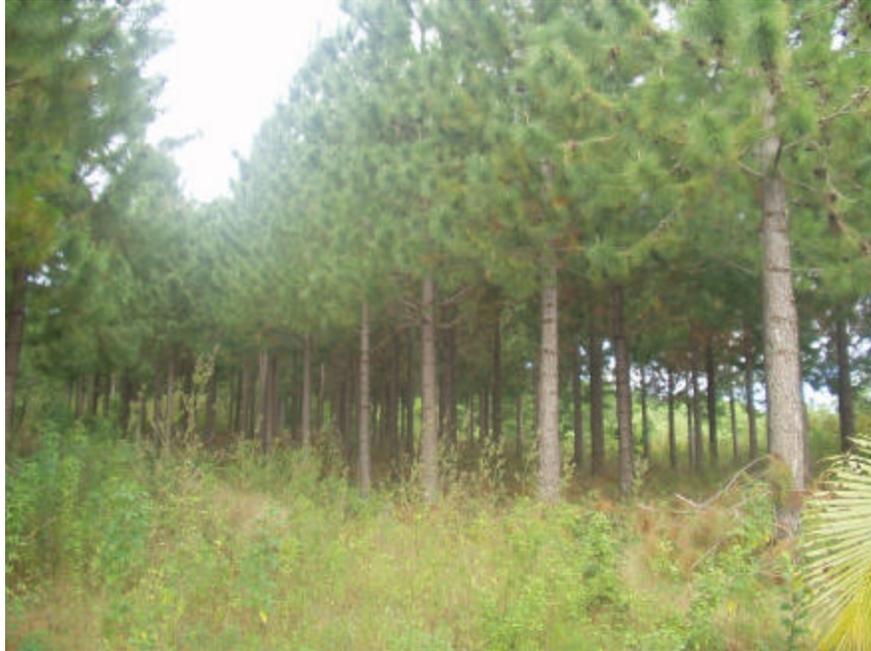
Figure 12. Recently thinned pine plantation on Mangaia

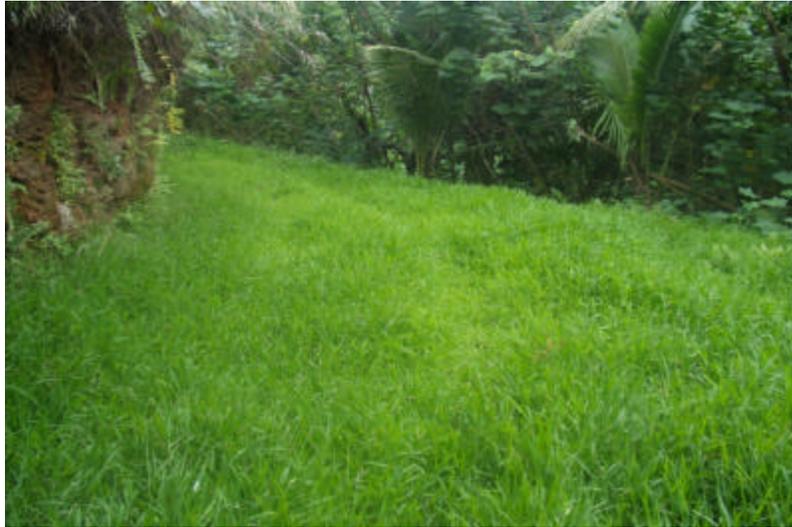
Following the meeting with the Mayor and Council members, Ora Harry, Island Construction Supervisor and Unlucky Tungata, Agricultural Officer, accompanied us on a field tour of the water intakes and upper watershed areas. Our first stop was to walk the road past the section where it was washed out by the December storm to observe the Karanga Intake structure. The road was well vegetated and grass was growing on most of the surface with little or no erosion (Figure 13).

Figure 13. Road to Karanga Intake stabilized by planting grass

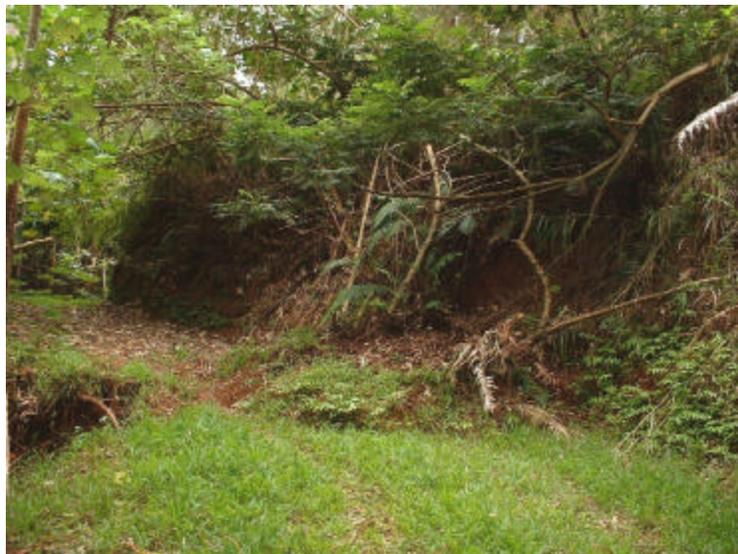
The cut banks were also well vegetated. The forest floor above intakes was covered with dense ferns under the planted pines. Some areas under the hibiscus trees were barren but there seemed to be little surface erosion from these areas. The major sedimentation in the stream seemed to originate from bank erosion and recent slides along the road (Figure14). The road will need to be bladed and stabilized and the banks will eventually heal themselves. This seems to be a natural process. The people are concerned about the Eucalyptus trees planted along the road to help stabilize the stream banks. They have heard that these trees use a lot of water thereby reducing the amount of water in the stream (Figure 15).

Figure 14. Slide on road to Karanga water intake

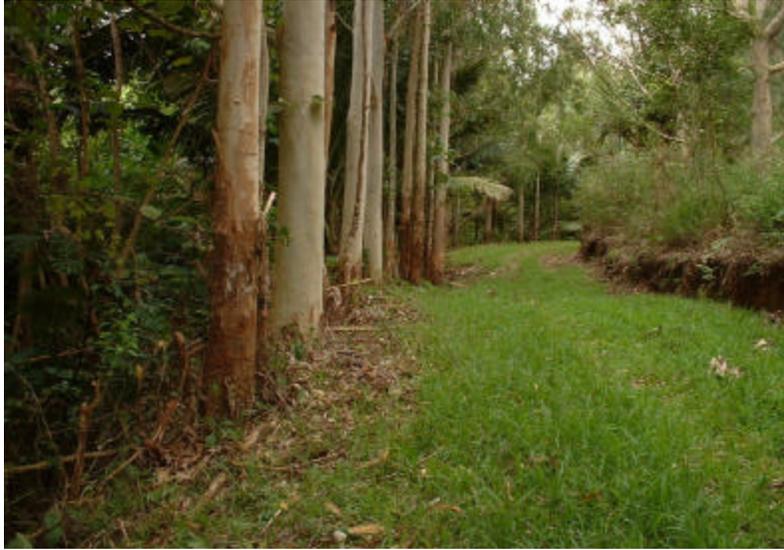
Figure 15. Eucalyptus Trees planted on Karanga Road

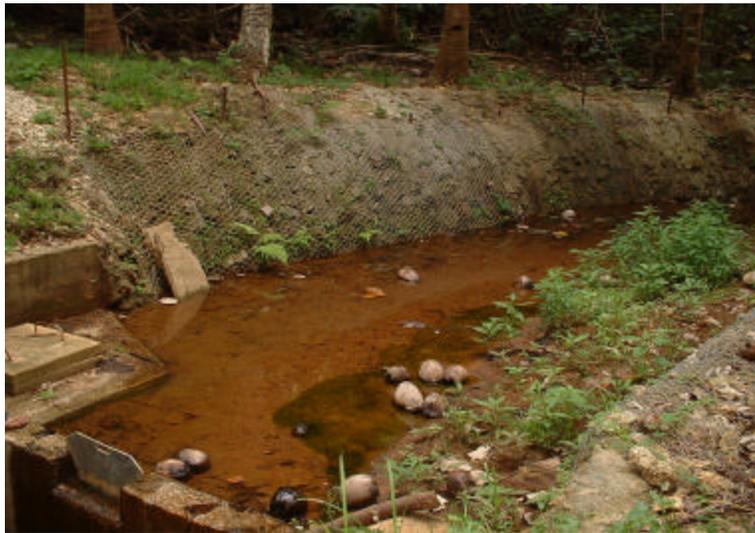
The Karanga intake was similar to the previous intakes we had observed earlier. There was silt deposition on the surface and the intake needed cleaning. Gabions placed on the sides of the intake were providing erosion control at the intake (Figure 16).

Figure 16. Karanga intake filled with silt from erosion

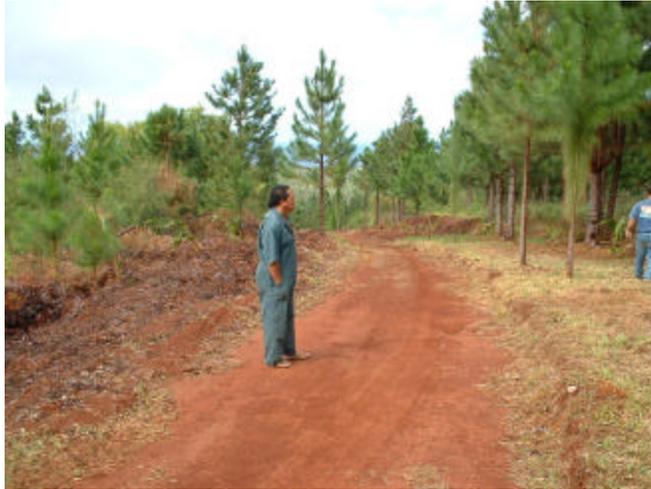
After leaving the Karanga water intake road we traveled to the town where we observed a recording rain gage designed to transmit data to Rarotonga. Ora indicated he has not seen the records and it is questionable if the rain gage is operational. We then visited the upper pine plantations (old pineapple plantations). The pine and fern have been successful in controlling erosion. Some of the old furrows were barely visible and groundcover is excellent as shown along the road in Figure 17.

Figure 17. Road through old stabilized pine plantation

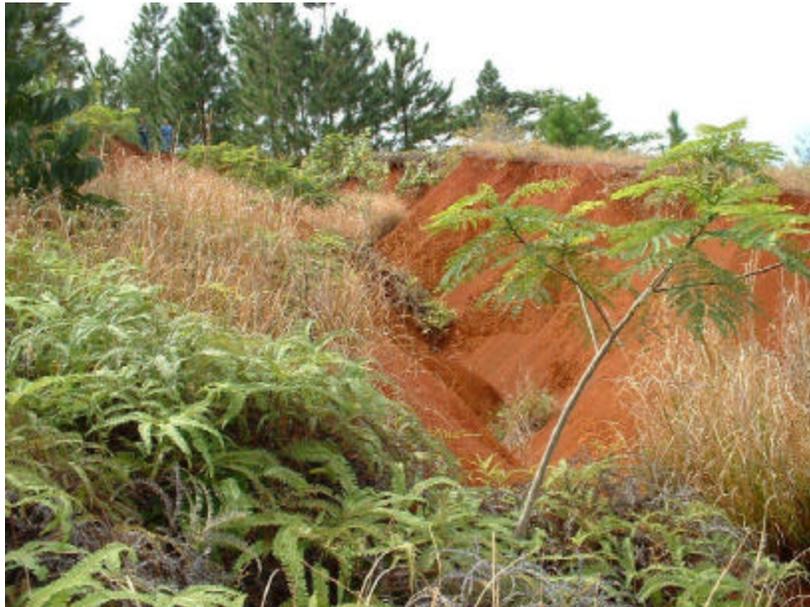
Figure 18. Large gully below road in process of stabilization

Most erosion problems occur on the roads that traverse the ridge tops. Much of this erosion could be corrected with proper drainage (dips and water bars) and some surfacing with rock in the through cuts. The pine and vetiver are working very well in the gullies.

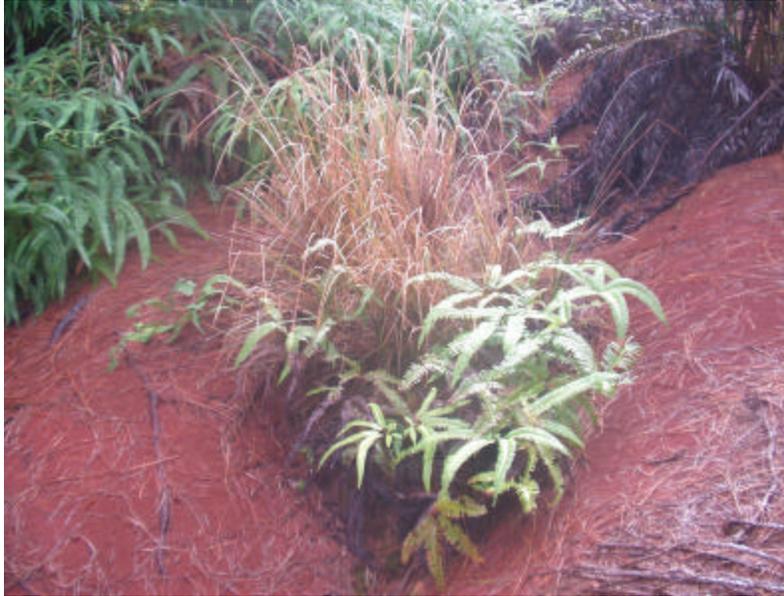
Figure 19. Vetiver grass and ferns in gully are slowing erosion

Erosion was controlled in the largest gully observed as indicated by the outlet onto a field of fern so there was no soil moving further down slope to a field of ferns as shown in Figures 19 and 20.

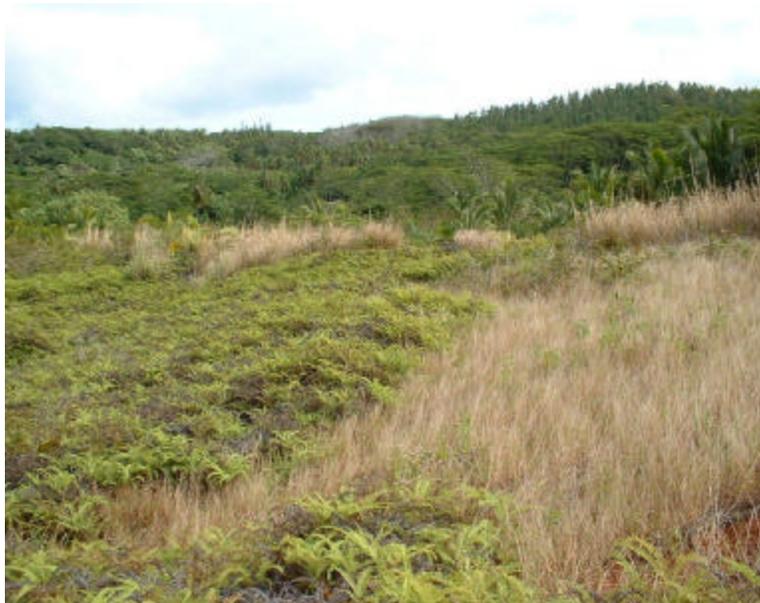
Figure 20. Outlet of large gully showing successful stabilization

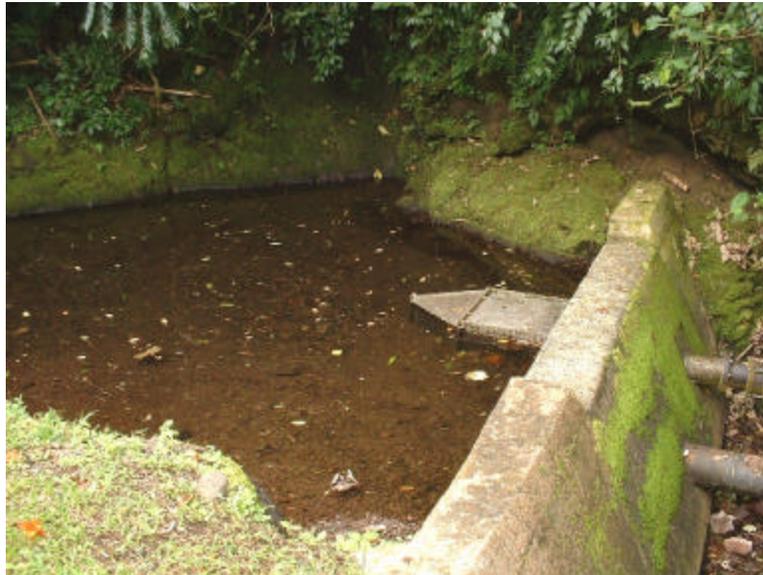
On 8-14-02 we left the island of Mangaia and flew to Rarotonga (via Auckland) where we were met by Sabati Solomone and others from the ministry of works. Daryl Rairi and Sabati Solomone gave us an afternoon field tour and explained the basic filtration process on Rarotonga, which consists of filter beds on the 6 intakes that serve the island (Figure 21).

Figure 21. Typical filter bed intake on Rarotonga (Tupapa Intake)

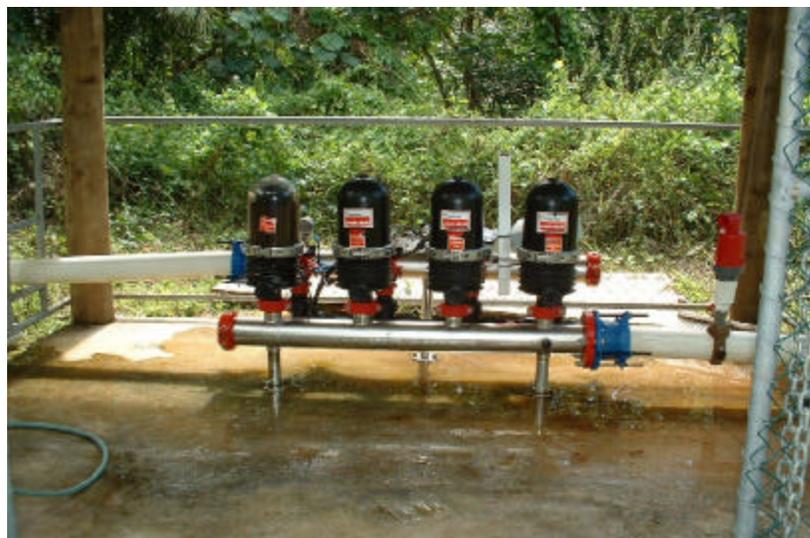
We visited the Tupapa intake that has been improved with a filtration system made of a series of ring filters (Figure 22). The system is on a trial basis and there are problems with sufficient pressure to backwash the filters so it is done manually.

Figure 22. Ring Filter system for Tupapa water system

There had been an attempt to move the filters down slope to get more hydraulic head but there was resistance from the downstream property owner to having the filters on her property. Bacteria and chemical tests are done approximately every 3 months. We discussed training needs and concerns about water contamination.

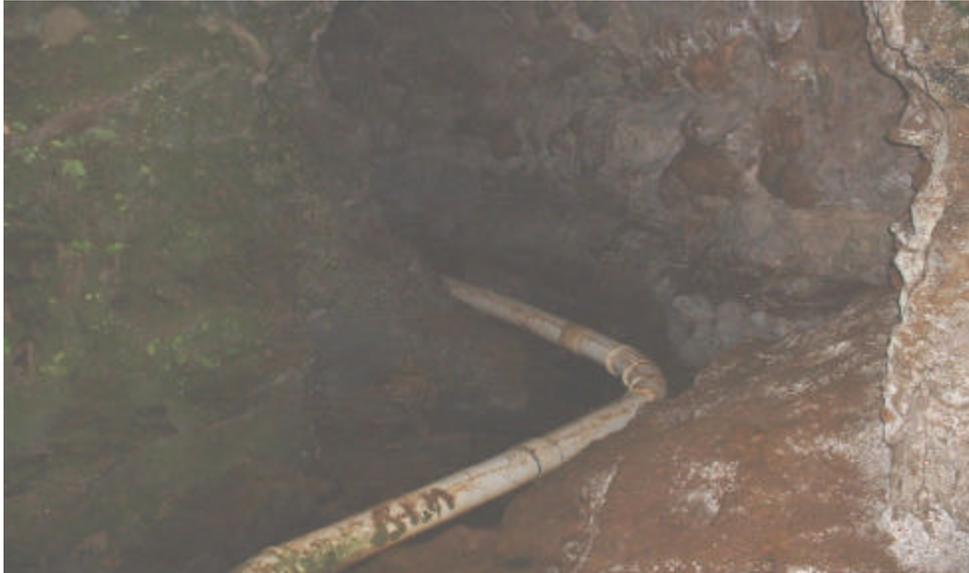
Figure 23. 'Eua upper water intake coming out of a cave

The upper intake however was deep inside a cave to avoid water contamination from bats (Figures 23 and 24). We were told that when it rains the water becomes so muddy that a valve must be shut off to avoid the water going into the town of 'Eua. We visited the site where the watershed boundary had been fenced and taro crops were planted within the fenced watershed boundary (Figure 25).

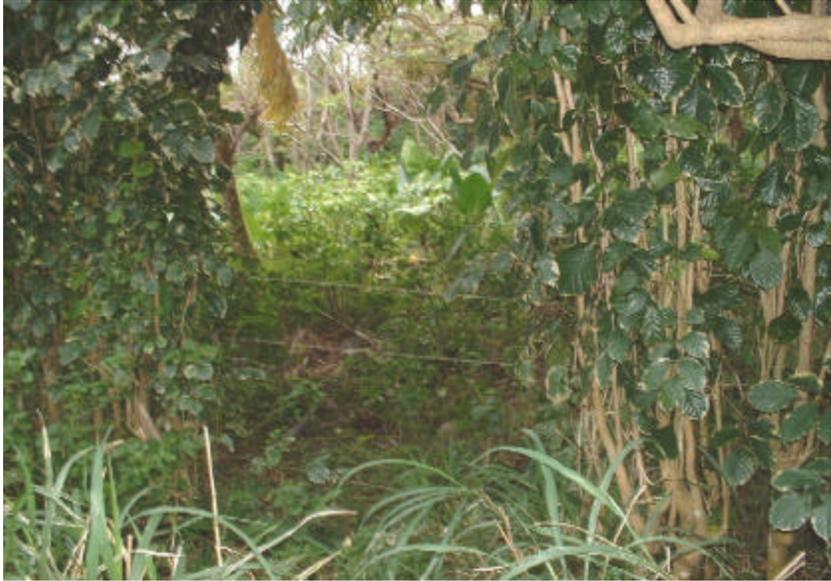
Figure 25. Taro crops grown within the fenced watershed boundary

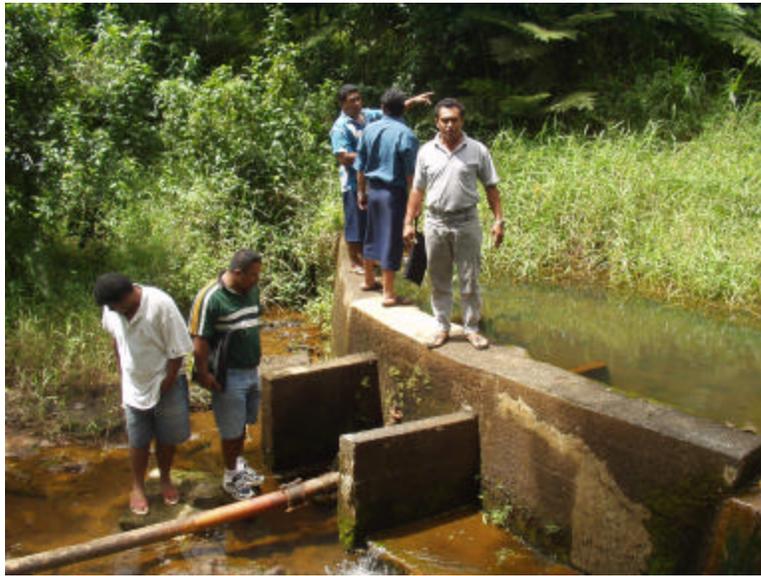
We first visited water intakes on the Vaisigano watershed, the water supply for the city of Apia (Figure 26). Three main drainages in the Vaisigano watershed converge to serve Apia). A hydro power station is also located near the water storage and filtration area on the river (Figure 27).

Figure 26. Vaisigano Water Intakes

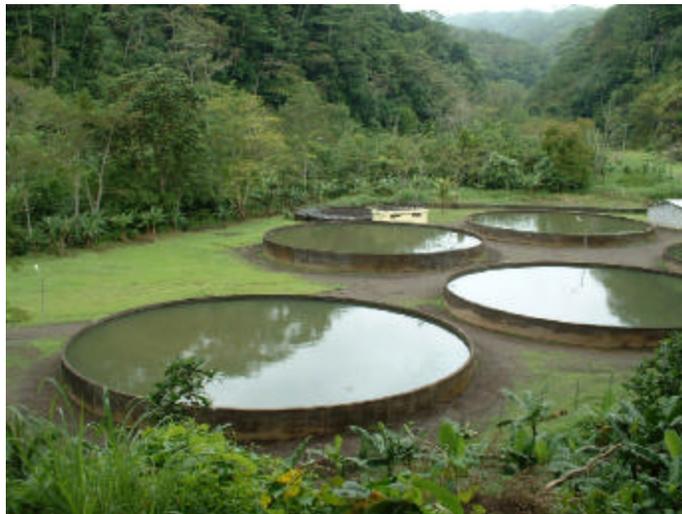
Figure 27. Water Storage tanks for Viasigano Watershed

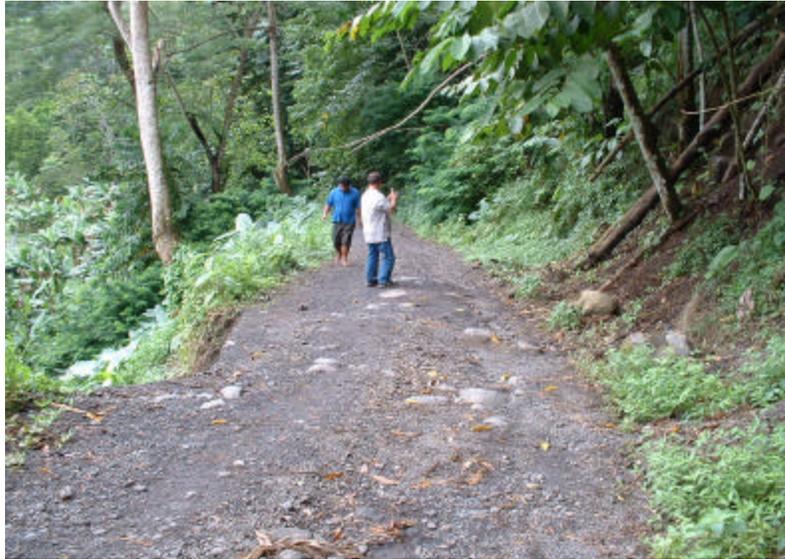
The class discussed road construction and stabilization problems in the afternoon. Figure 28 shows the road accessing the water treatment facility and a slope where gabions were used to stabilize a small slide area. The effects of improper road drainage were demonstrated by pointing out a headcut and erosion above a small stream (Figure 29).

Figure 28. Road to water storage tanks in Vaisagano Watershed

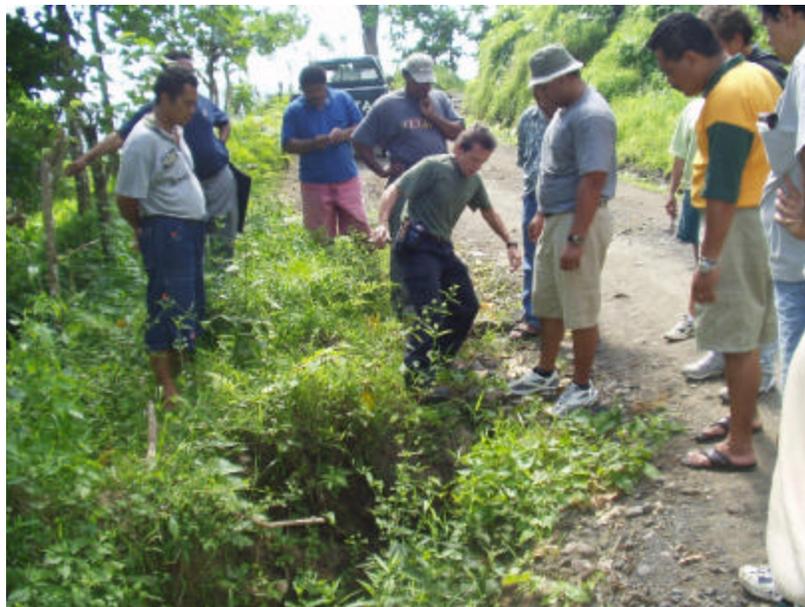
Figure 29. Class demonstration of erosion caused by improper drainage

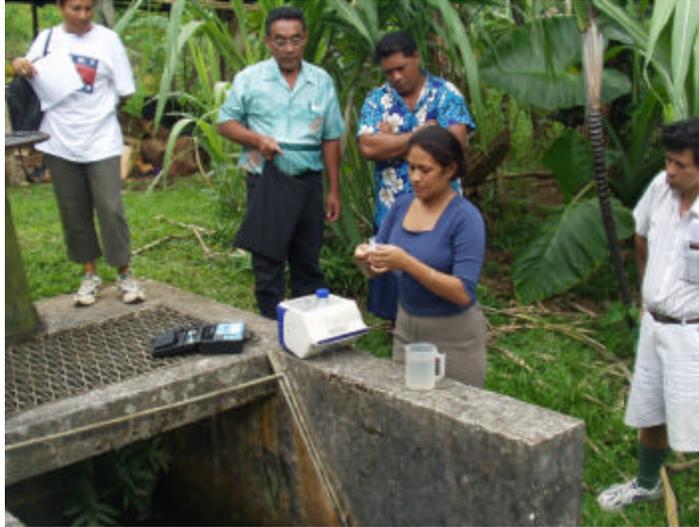
Figure 30. Field demonstration of water sample collection and testing.

At the water storage and hydropower site, Ms. Kuinimeri A. Finau demonstrated how water samples are taken (Figure 30) and provided an overview of the water quality parameters analyzed by the Samoan Water Authority. The class later met with one of the local farmers that practices agroforestry in the Vaisigano watershed in cooperation with the Forestry Department. The farmer was very pleased that agroforestry does provide for his food and helps prevent erosion. On the second day the class visited the headwater area of the Falefa watershed where we discussed landslide processes and erosion control on steep slopes. Figure 31 shows characteristics of old landslide remnant where trees have been planted. .

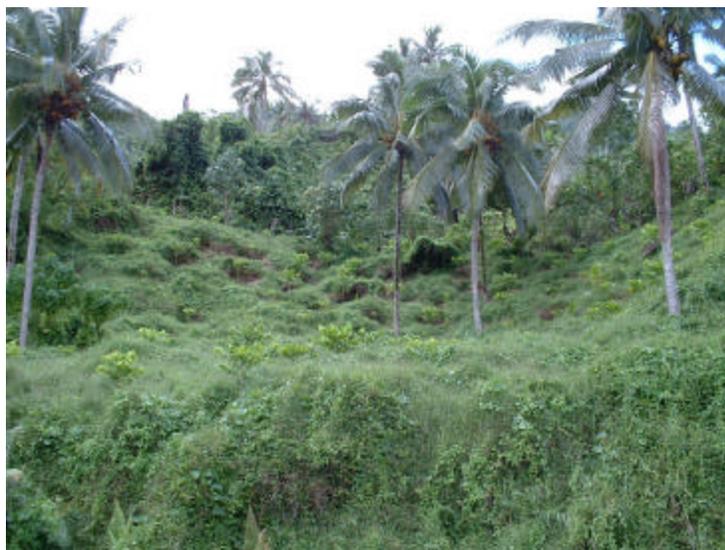
Figure 31. Old landslide remnant and tree planting.

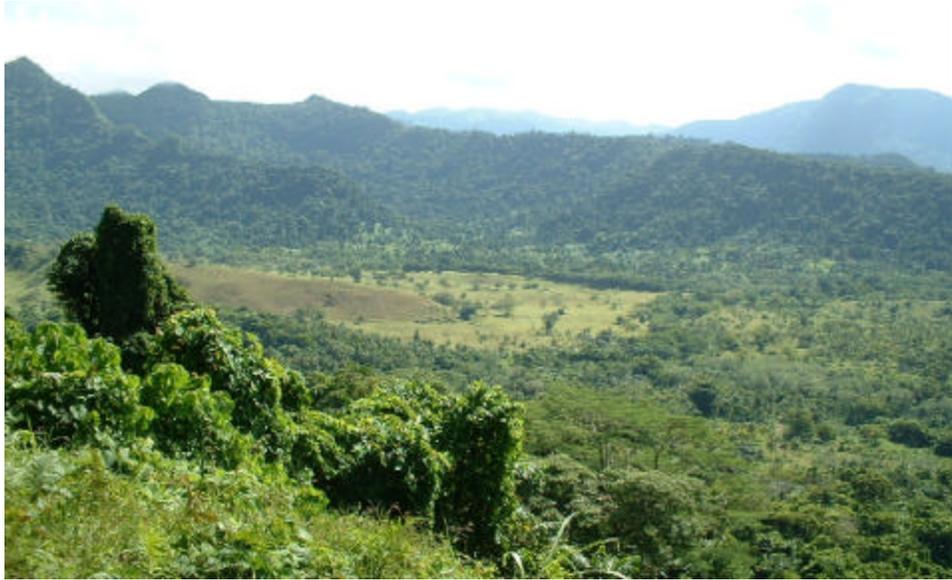
Maturo Paniani pointed out where trees had been planted horizontally below taro crops on very steep slopes. The trees were planted to control erosion and stabilize the slopes below where the crops were planted. Figure 32 provides an overview of the Falefa watershed. Grazing does occur in the middle of the watershed but this area does not drain into a stream that is used as a drinking water source.

Figure 32. Headwater view of Falefa watershed
